Figure C6: Survey results

Project: The Gable, Berewood

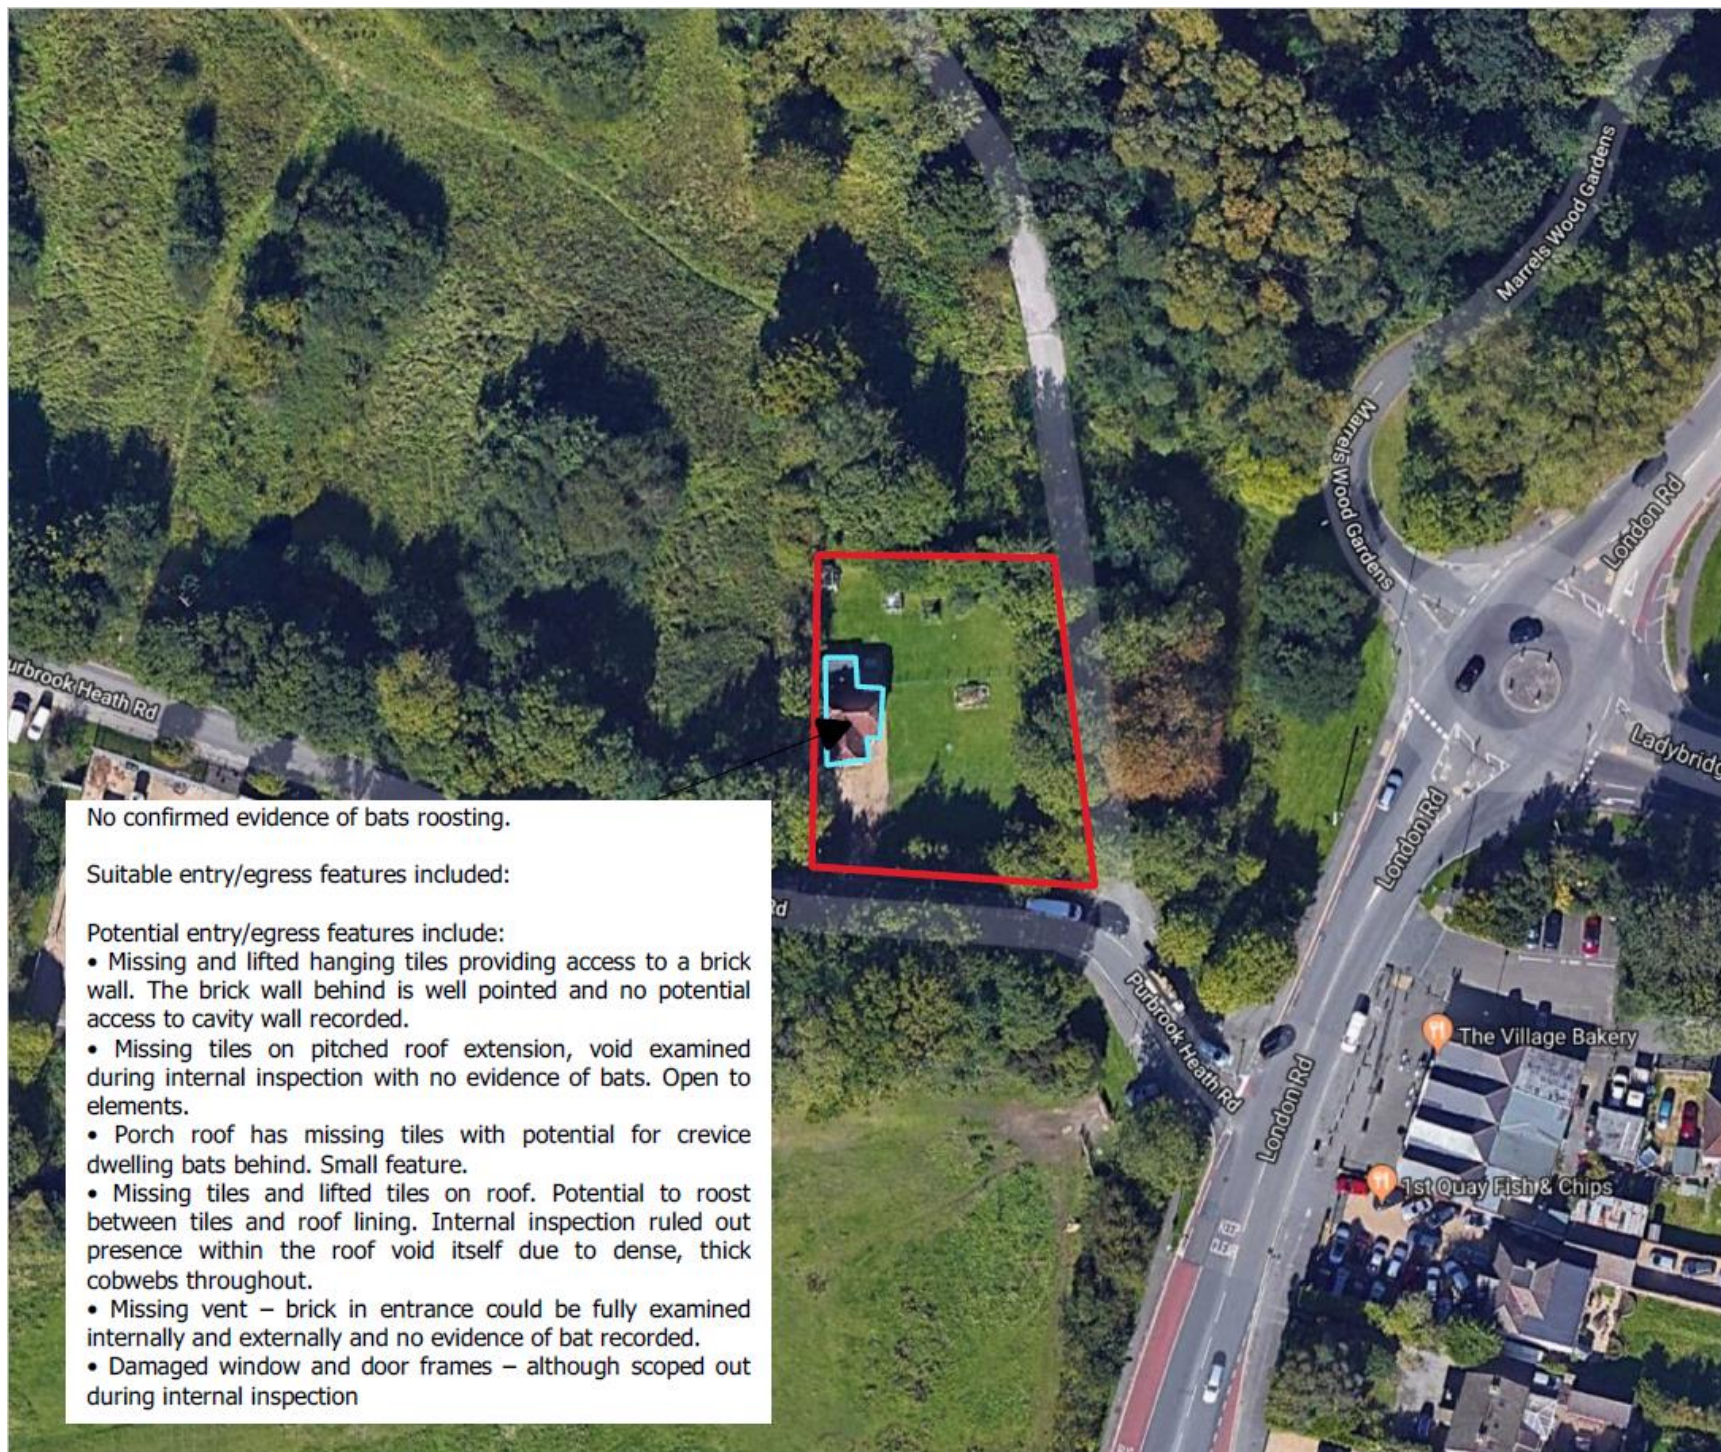
No confirmed evidence of bats roosting.

Potential entry/egress features include:

- Missing and lifted hanging tiles providing access to a brick wall. The brick wall behind is well pointed and no potential access to cavity wall recorded.
- Missing tiles on pitched roof extension, void examined during internal inspection with no evidence of bats. Open to elements.
- Porch roof has missing tiles with potential for crevice dwelling bats behind. Small feature.
- Missing tiles and lifted tiles on roof. Potential to roost between tiles and roof lining. Internal inspection ruled out presence within the roof void itself due to dense, thick cobwebs throughout.
- Missing vent – brick in entrance could be fully examined internally and externally and no evidence of bat recorded.
- Damaged window and door frames – although scoped out during internal inspection
