*Proposed Development on Land at Southmere Farm  
Langstone Road, Havant*

## Asbestos Refurbishment Survey

Carried out on behalf of: Knightsgate (UK) Ltd

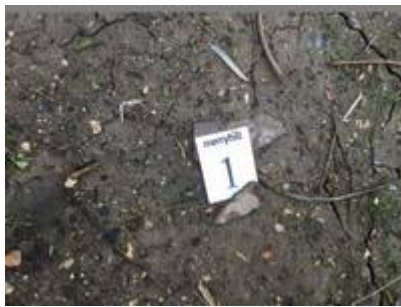
Location Ref: 1

Product Type: Asbestos cement

Damage: High damage: Visible debris

Action:  
Removal under HSE guidelines

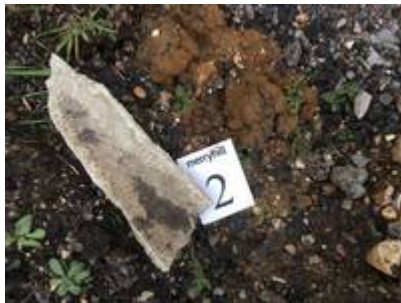
Location Ref: 2

Product Type: Asbestos cement

Damage: High damage: Visible debris

Action:  
Removal under HSE guidelines

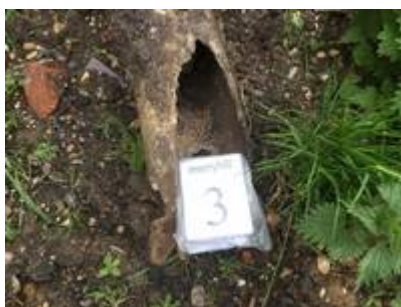
Location Ref: 3

Product Type: Asbestos cement

Damage: High damage: Visible debris

Action:  
Removal under HSE guidelines

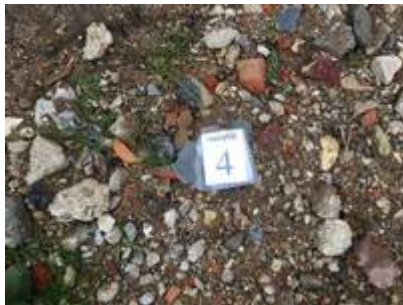
NADIS

No Action Required

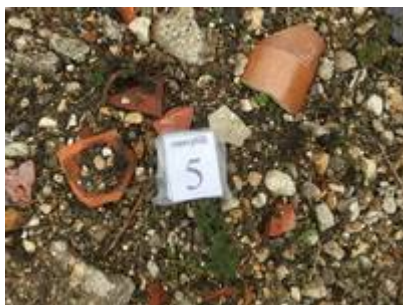
Asbestos cement

High damage: Visible debris

Removal under HSE guidelines

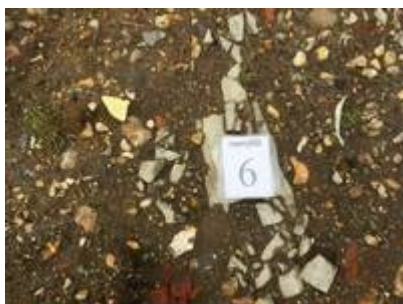
NADIS

No Action Required

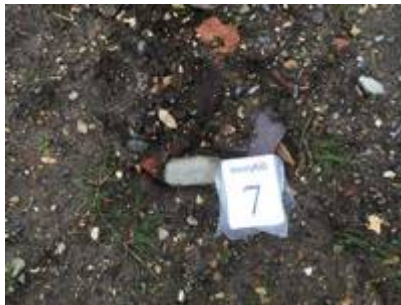
Location Ref: 7

Product Type: NADIS

Damage: NADIS

No Action Required

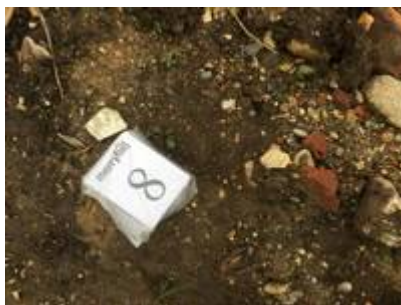
Location Ref: 8

Product Type: Asbestos cement

Damage: High damage: Visible debris

Removal under HSE guidelines

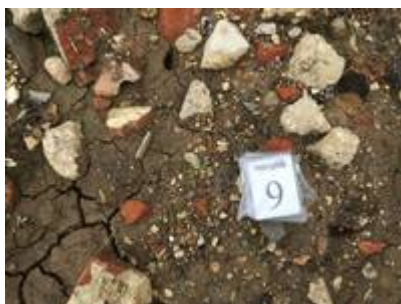
Location Ref: 9

Product Type: NADIS

Damage: NADIS

No Action Required

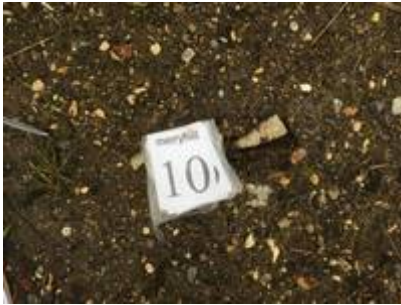
High damage

0.1m<sup>2</sup>

Removal under HSE guidelines
