# **TECHNICAL REPORT ON A SUBSIDENCE CLAIM**

**Crawford Reference: SU1700265**

**Ms Penelope Dormer  
Gutner Lane  
Hayling Island  
Hampshire  
PO11 0RN**

## **SUBSIDENCE CLAIM**

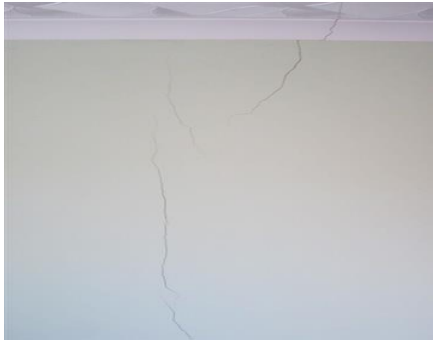
Lounge - Main crack damage to right hand elevation - junction of extension and main building

The principal damage takes the form of tapering vertical and diagonal cracking up to approximately 4mm in width to right hand elevation of the Lounge. Further cracking was recorded below the windows to the left hand right hand elevations of the main building up to 3mm in width.

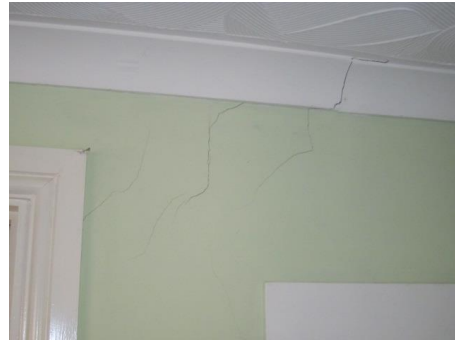
Lounge - Crack damage - towards the front elevation of the extension at the junction of the main building

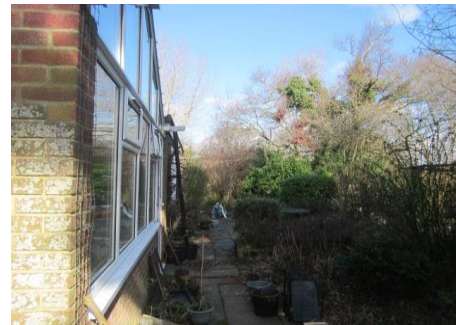
Vegetation to the rear of the property

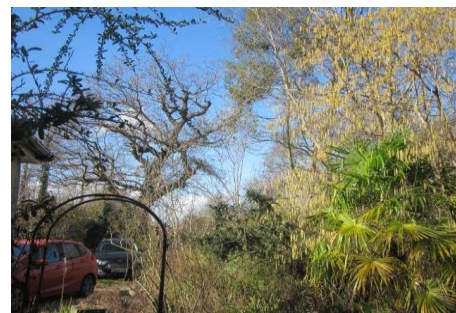
Vegetation to the front left hand side of property

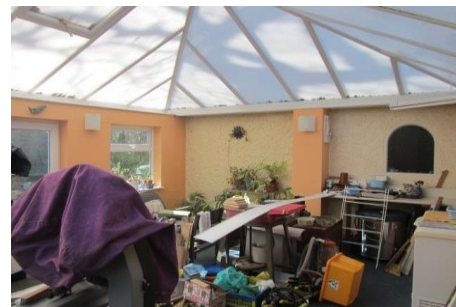
View across workshop / conservatory

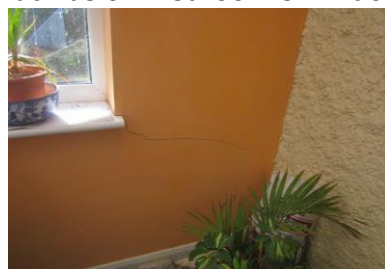
Conservatory / Workshop - Crack damage below right hand elevation window
