***Project ref: TV190518***

22<sup>nd</sup> May 2019

# ***CCTV Survey Report***

**SITE: 55 New Road**

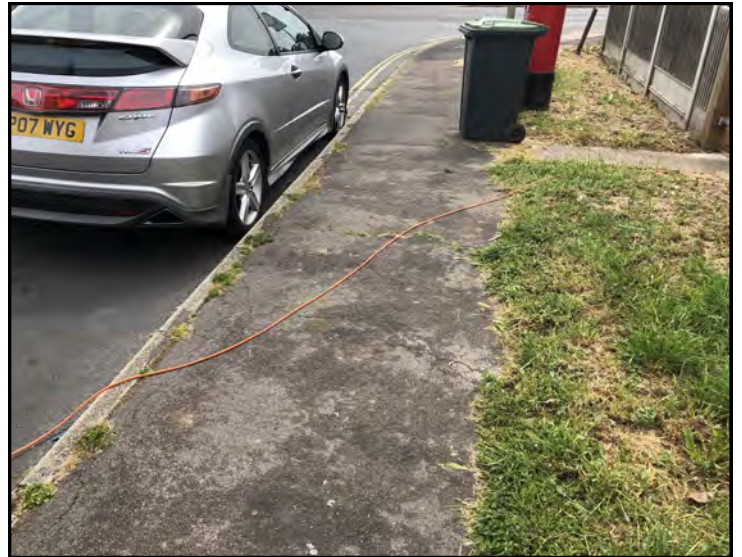
BURIED IC5

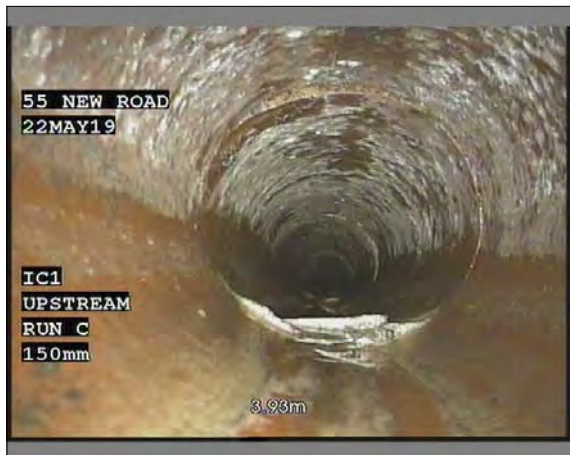
Photo: 003.JPG, VCR No.: 00003  
 3.93m, Scale, light at joint, from 5 to 7 o'clock

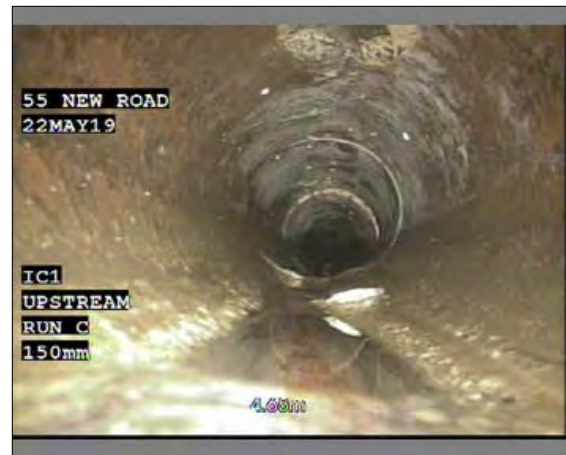
Photo: 004.jpg, VCR No.: 00003  
 4.65m, Hole in sewer, from 12 to 1 o'clock

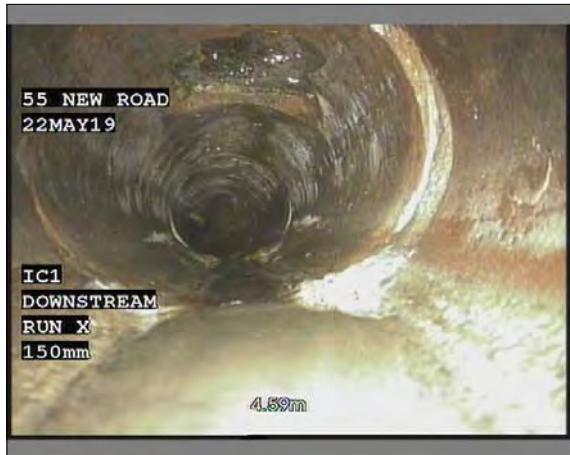
Photo: 006.JPG, VCR No.: 00004  
 4.59m, Broken sewer, from 11 to 2 o'clock

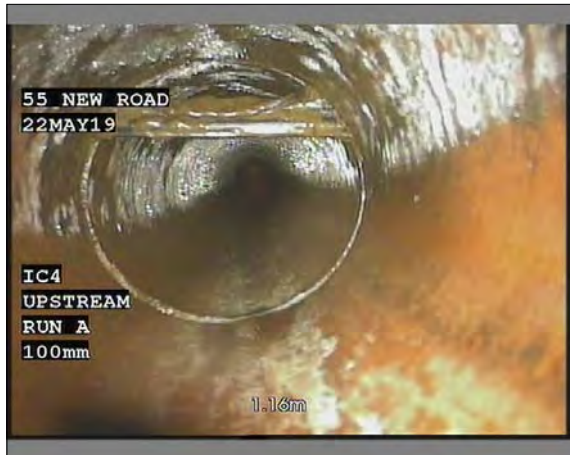
Photo: 009.JPG, VCR No.: 00006  
 1.16m, Obstruction, from 10 to 2 o'clock, 10% height loss
