Site: The Manor, Edward Gardens, Bedhampton  
Date Visited: 27 November 2018  
Date Prepared: 04 12 2018 revised April 2019  
Area of Work: Front Porch

Porch to west elevation

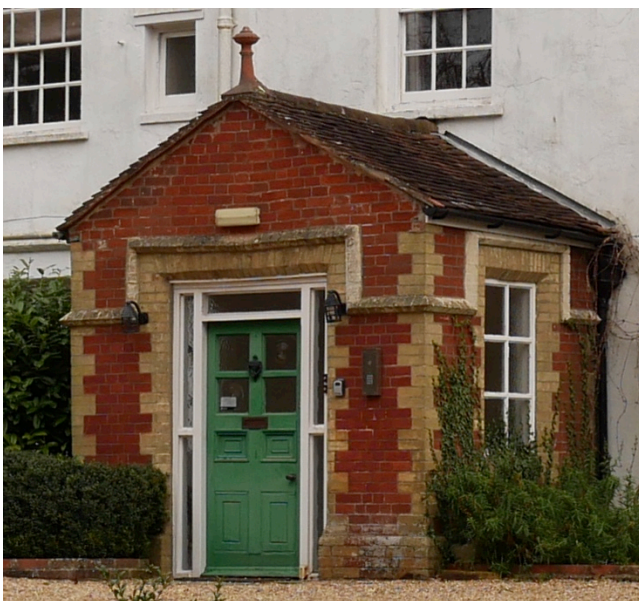
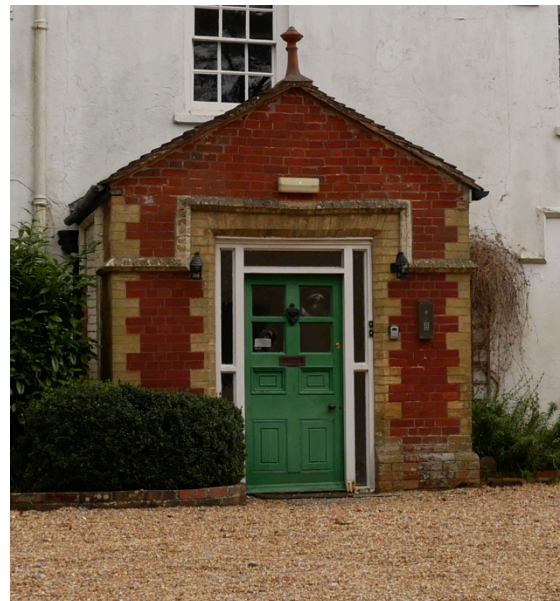
*Porch intact before works – 17 June 2018 taken by Murphy Associates. Note finial, dry verge, guttering and downpipe with hopper in corner to each side. It is not proposed that the external lights and entry systems be reinstated.*

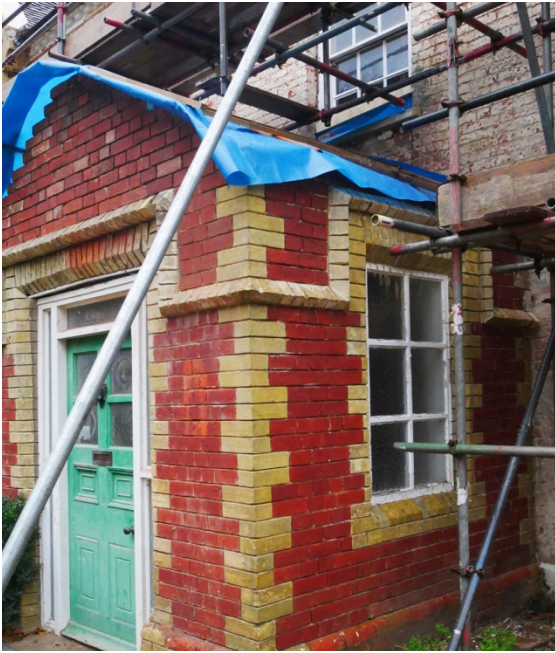
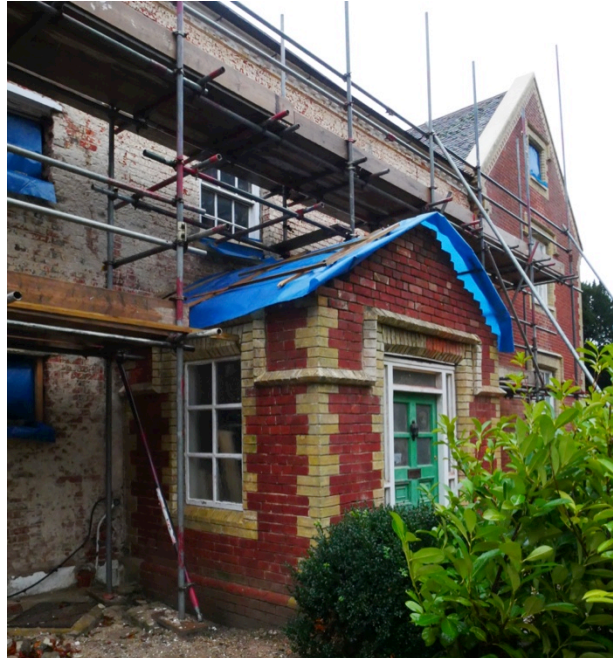
*Exterior of Porch (November 2018). SW corner is parting from the main elevation.*

| A3. | Gap between porch wall in SW corner and West face |
| | <ul style="list-style-type: none"> <li>Rake out joint using stonemasons quirks and chisels ensuring that the remaining mortar is sound and that the back of the joint is left square</li> <li>Brush and flush with fresh water</li> </ul> |

| | <ul style="list-style-type: none"> <li>Wet down surrounding area to prevent suction of moisture from the newly applied mortar</li> <li>Form new lime mortar fillet at junction with main elevation using NHL3.5 : Evenly grade washed sharp sand (not marine)</li> <li>See specification for</li> </ul> |

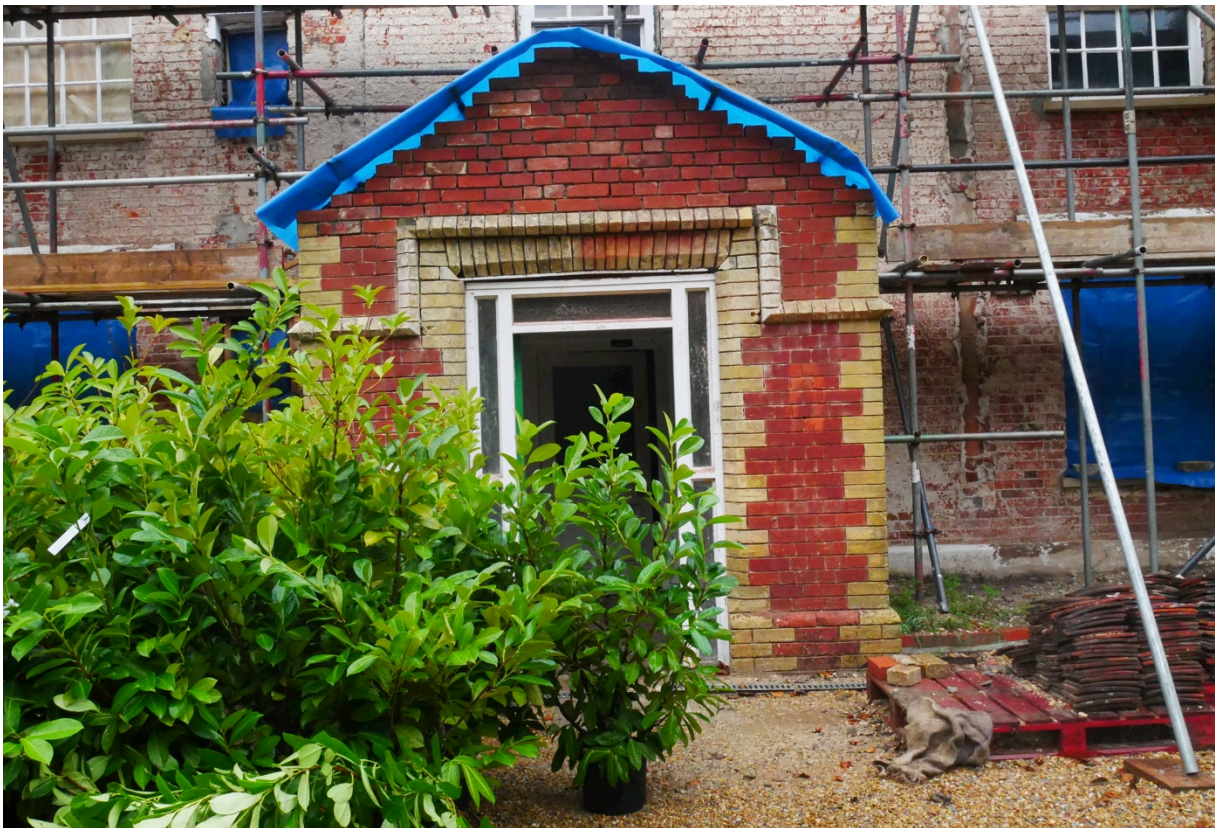
*Tiles salvaged and stored on pallet for reuse (November 2018)*

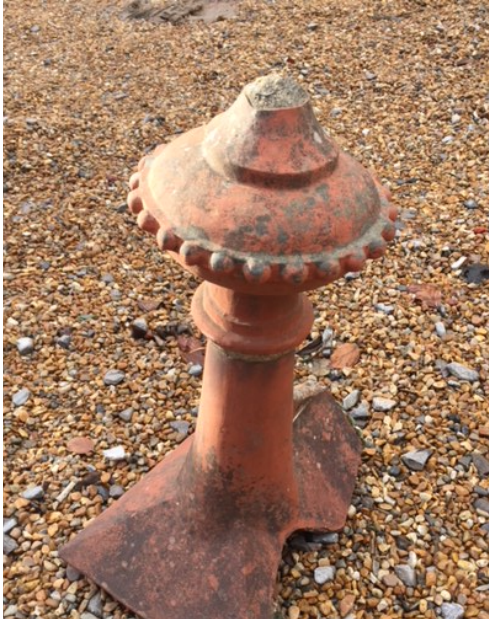
*Damaged Terracotta finial to be replaced to match.*

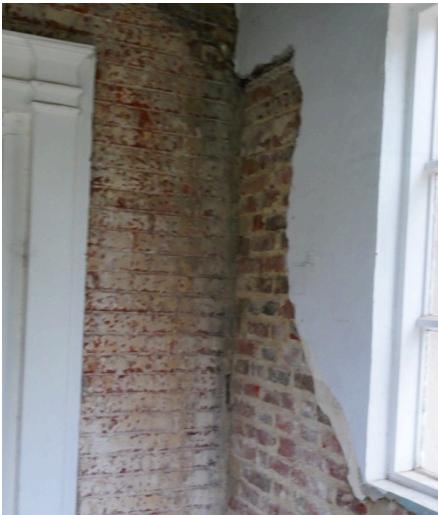
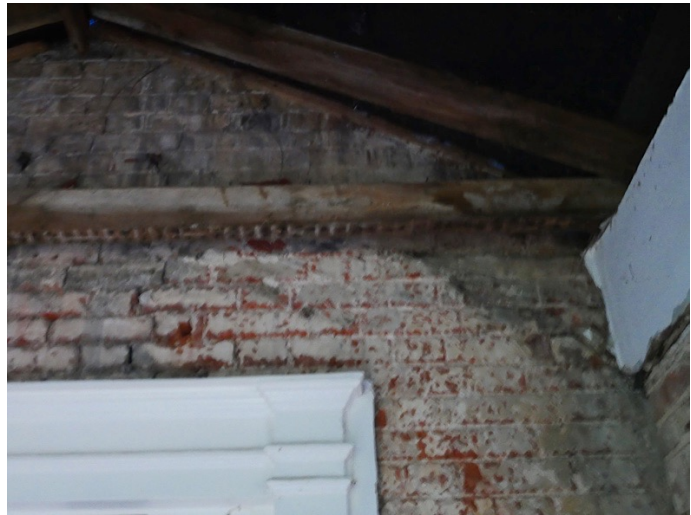
*Interior: evidence of plaster finish and scar of previous smaller porch. Also evidence of damp and rot to end of rafters which require new sections spliced in with scarf repair.*

| A1. | Repairs to existing rafters |
| | <ul style="list-style-type: none"><li>• Mark and record all existing rafters including ridge board</li><li>• Inspect existing rafters and ridge board for soundness</li><li>• Where unsound establish extent and if the timber is a modern replacement</li></ul> |

| | <ul style="list-style-type: none"> <li>Where identified as modern replace in its entirety using a timber type to match the historic timber porch, ensuring wherever possible to supply timber with a similar moisture content to the existing.</li> <li>Allow for replacement of ridge board of a length and dimension to match the existing and of a similar timber with a similar moisture content.</li> <li>Where rafter feet have rotted replace with new and fix in place with timber locks or similar and approved.</li> <li>If more then 2/3<sup>rd</sup> intact repair and replace with new timber of a similar moisture content and type, using scarf repairs. If required reinforce the joint with stainless steel coachbolts to prevent a deflection / disengagement.</li> <li>All mechanical fixings to allow for some tolerance of movement associated with the shrinkage of new timbers. This shall be achieved with the use of stainless steel washers between the timbers and / or drilling of elliptical holes.</li> <li>Where entire rafter is to be replaced, ensure joinery and fixing matches the existing.</li> </ul> |
