# Visual Tree Assessment and Picus Tomograph Decay Investigation Test

10 Culver Drive Hayling Island PO11 9LX

Investigation by Kim Gifford

Date 3<sup>rd</sup> May 2018

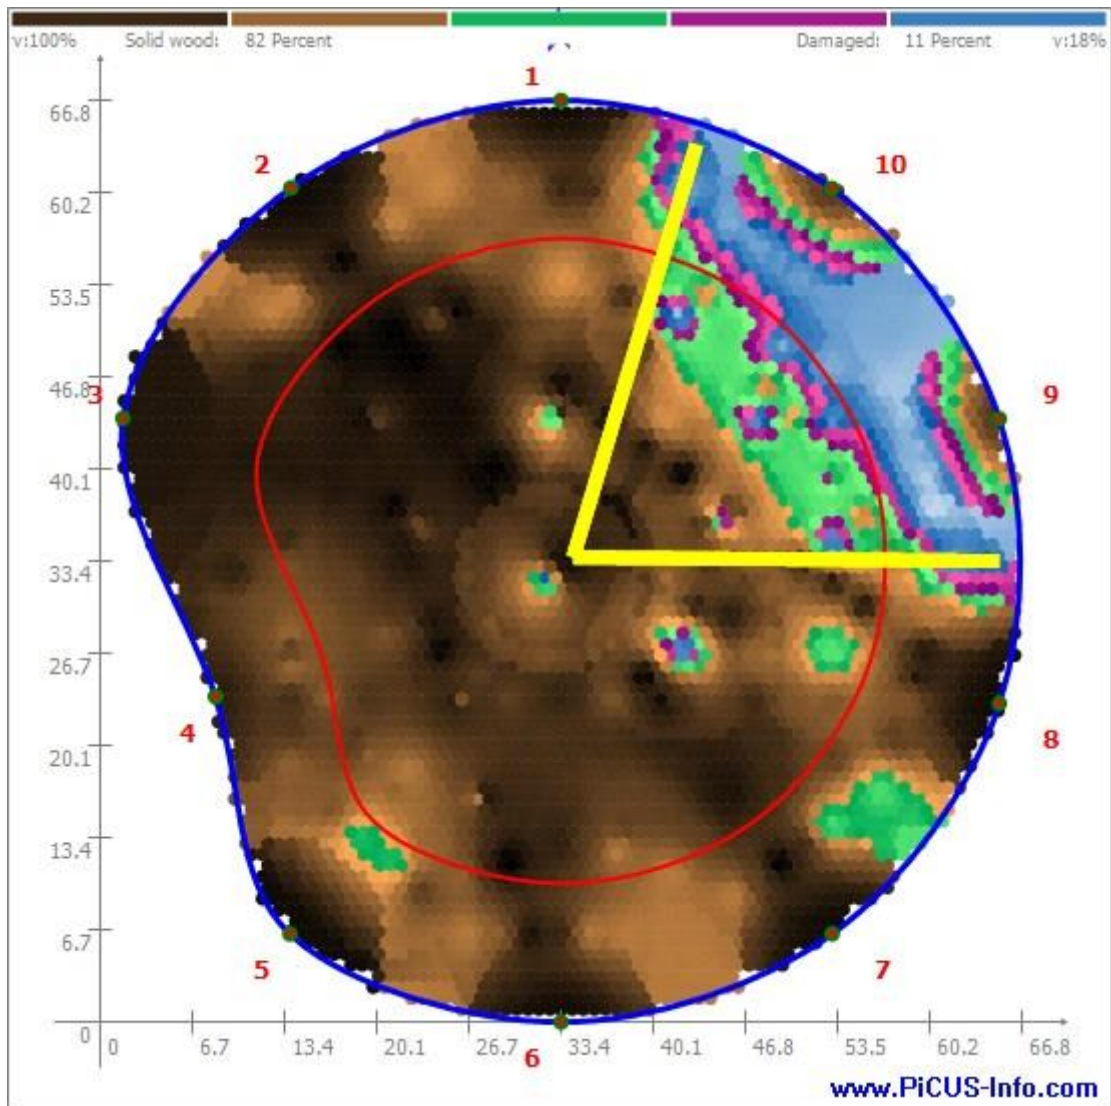
## Picus Test 1 T3 Holm Oak leaning with spilt stem :

### Test Level:80cms

**Analysis:** Low readings in the area of test. The Picus test collective data represents altered timber result at the time of inspection.

**Recommendation:** T3 Holm Oak shows altered timber in the area of test. This stem is leaning eastwards and at risk of breakage. It is recommended that it would be appropriate to remove this stem within the near future on the ground of health and safety. This action would leave the remaining group open and exposed with low amenity value.

**It is therefore recommended that the whole group of T1,T2, T3, T4 Holm Oak are removed completely and replanted with 4 no. new heavy standard English Oak (*Quercus robur*) transplants within the near future.**
