**BELLWAY HOMES LTD (WESSEX) & THE  
BORROW FOUNDATION LTD  
PADNELL GRANGE  
WATERLOOVILLE**

**FLOOD RISK ASSESSMENT AND  
DRAINAGE STRATEGY**

**MARCH 2019**

| <b>Project Code:</b> | <b>A/BHPADNELL</b> |

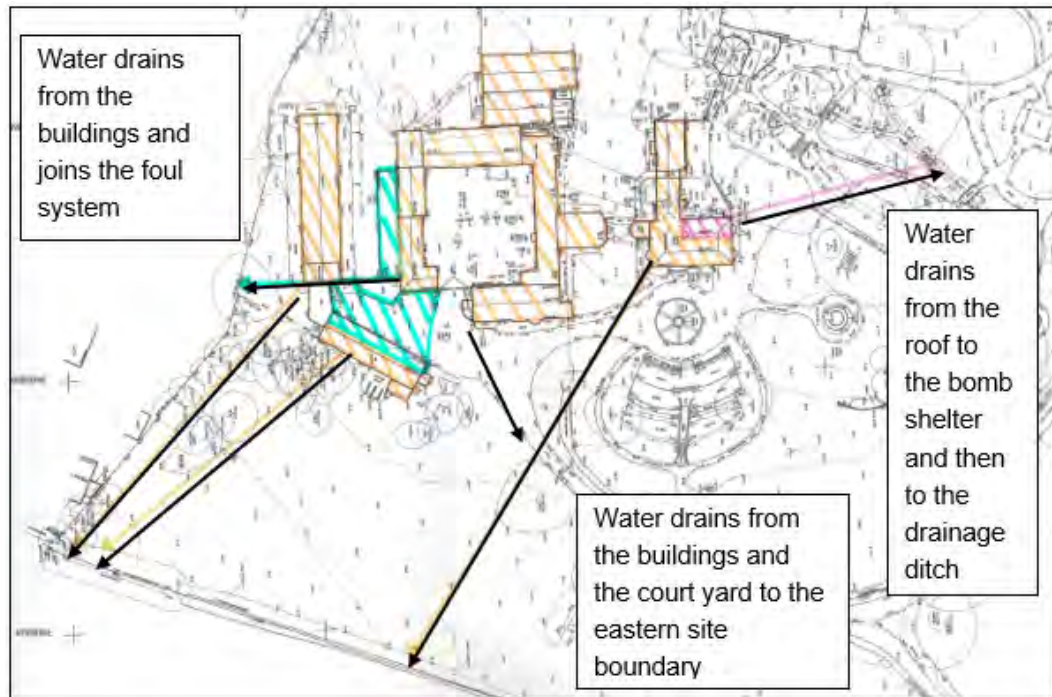
**Figure 2.1: Estimated Existing Drainage**

- 2.8 The site generally doesn't have a surface water system. Many of the down pipes from the buildings drain straight onto the ground and run-off overland into the surrounding network of ditches.
- 2.9 In July 2017 a CCTV survey of the site was commissioned to confirm the location and condition of the network. The CCTV survey (found in full in Appendix E) confirmed the

location of the existing drainage network and that generally the condition of both the surface water and foul network was poor.

- 2.10 The CCTV Survey also shows that some of the surface water pipes run towards the southern boundary and discharge into the foul sewer network.
- 2.11 Figure 2.1, which can be found in full in Appendix H, details where the buildings on site are believed to drain to. This has mainly been based on the topography of the site.

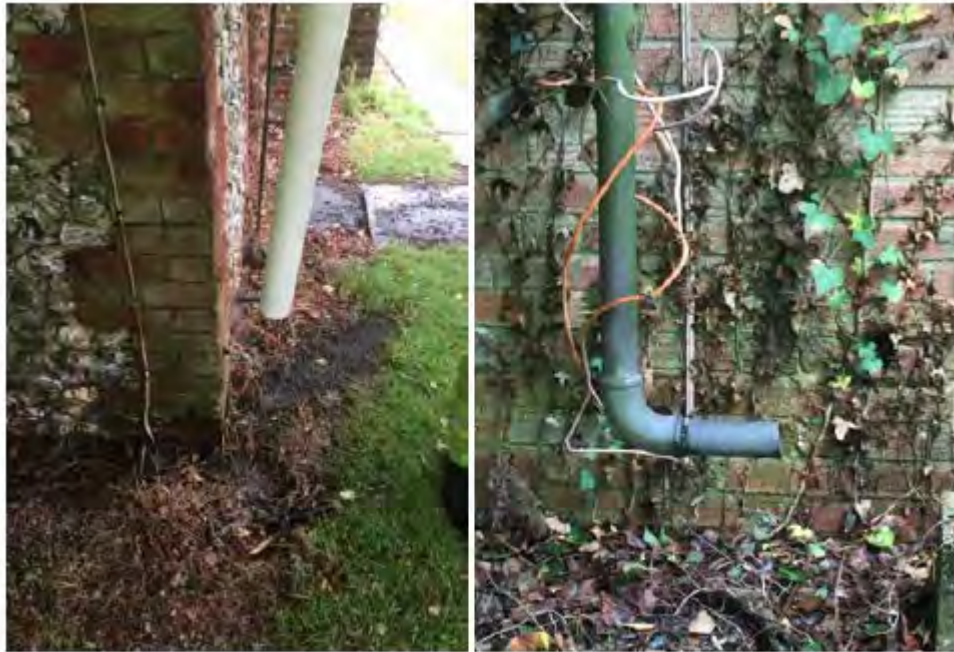
**Figure 5.1: Existing Down Pipes**

- 5.1 The site generally doesn't have a surface water system. Many of the down pipes from the buildings drain straight onto the ground (see Figure 5.1) and run-off overland into the surrounding network of ditches.

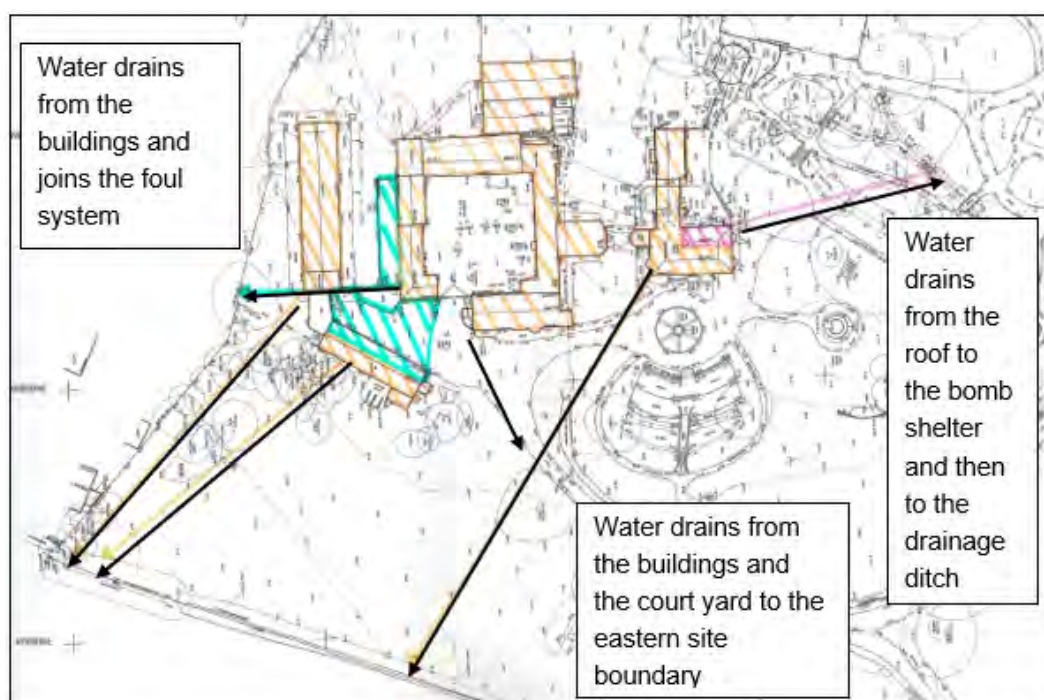
**Figure 5.2: Estimated Existing Drainage Layout**

- 5.2 In July 2017 a CCTV survey of the site was commissioned to confirm location and condition of the network. The CCTV survey (found in full in Appendix E) confirmed the location of the existing drainage network and that generally the condition of both the surface water and foul network was poor.
- 5.3 Figure 5.2, which can be found in full in Appendix H, details where the buildings on site are believed to drain to. This has mainly been based on the topography of the site.

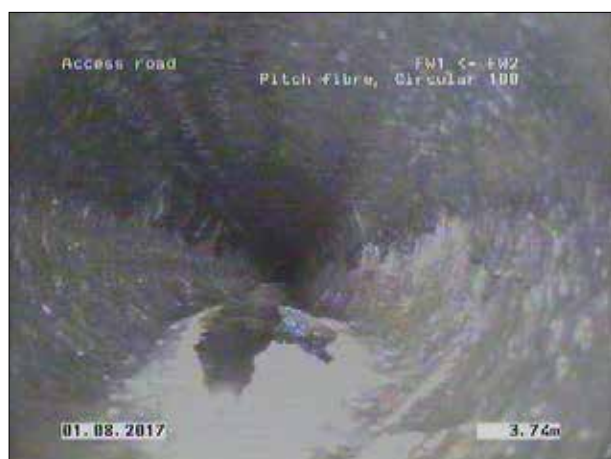
Photo: 1\_4a  
3.74m, Deformed drain/sewer 10 %

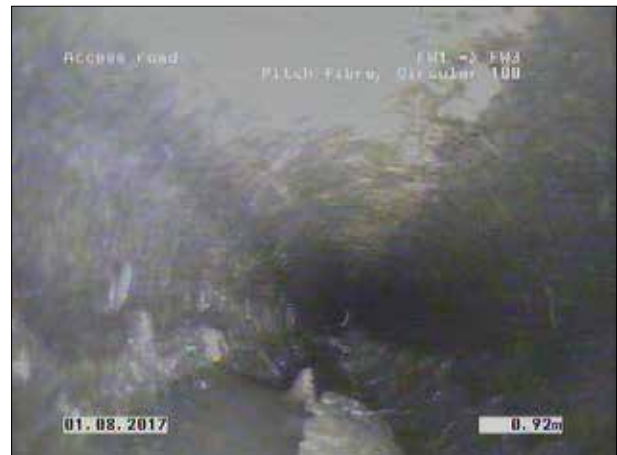
Photo: 13\_3a  
0.92m, Deformed drain/sewer 5 % Remark: blistered pitch fiber

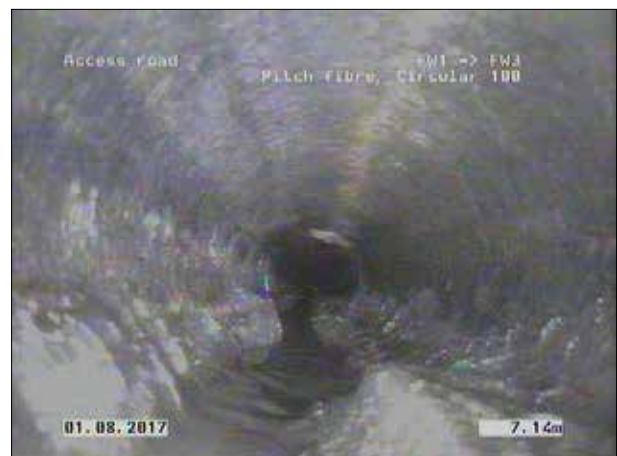
Photo: 15\_5a  
7.14m, Deformed drain/sewer 5 % Remark: blistered pitch fiber

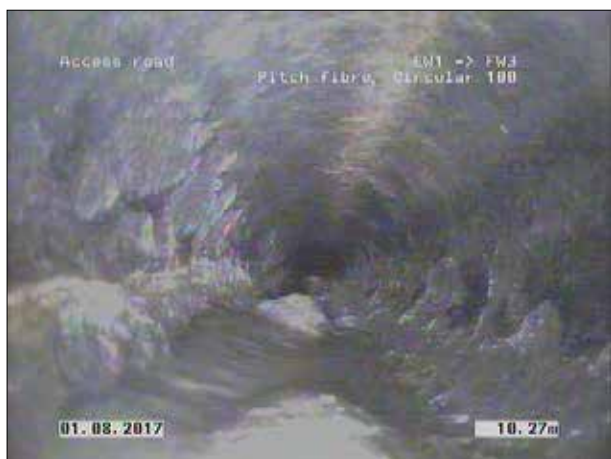
Photo: 16\_6a  
 10.27m, Deformed drain/sewer 10 % Remark: blistered pitch fiber

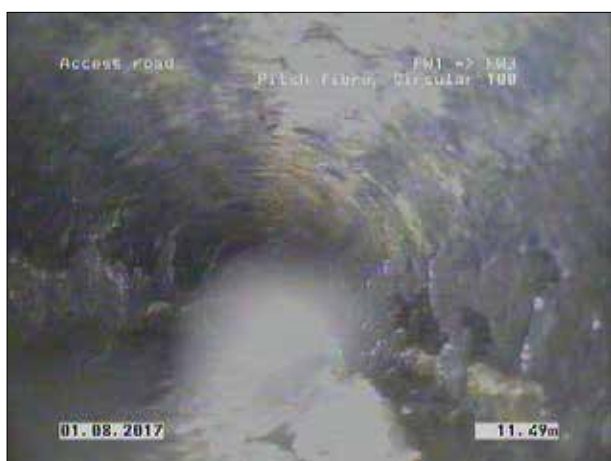
Photo: 18\_8a  
 11.49m, Survey abandoned, Remark: due to 20%disformed blister PF

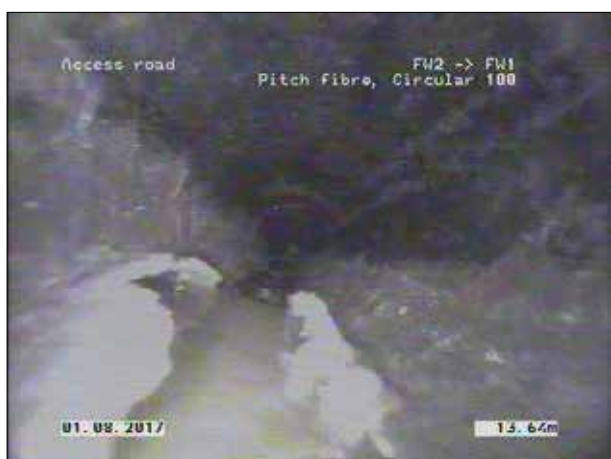
Photo: 32\_12a  
 13.64m, Deformed drain/sewer 10 %

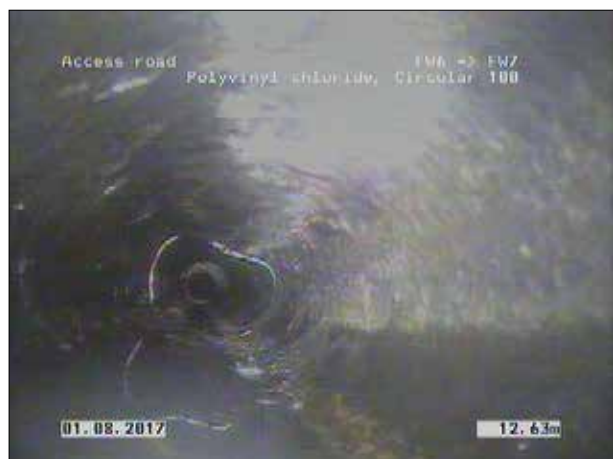
Photo: 7\_6a  
12.63m, Deformed drain/sewer 20 % Remark: unable to push  
past deformed line

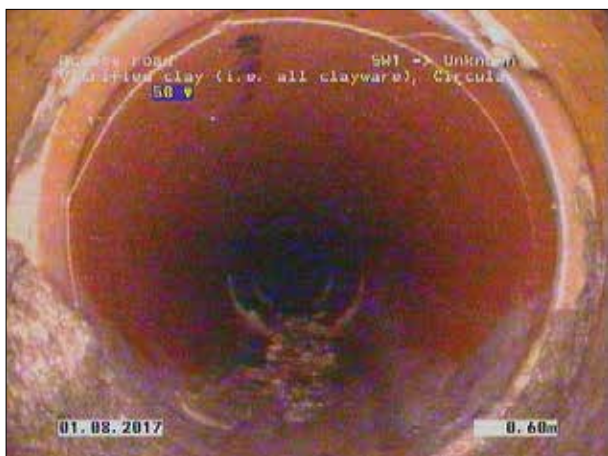
| | 0.60 | FCJ | | Circumferential Fracture at joint from 07 to 03 o'clock | 67_4a, b | 3 |

Photo: 67\_4a  
0.6m, Circumferential Fracture at joint from 07 to 03 o'clock

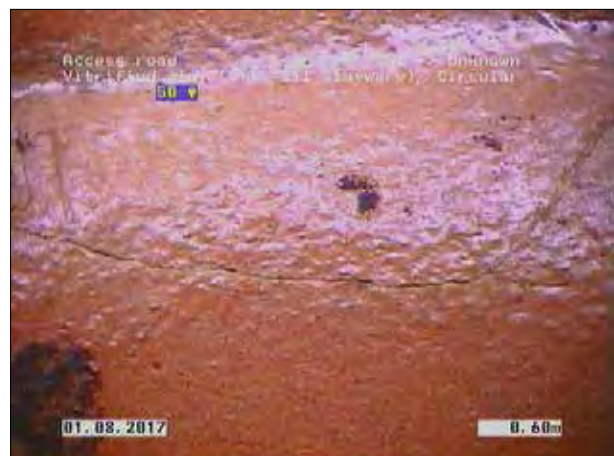
Photo: 67\_4b  
0.6m, Circumferential Fracture at joint from 07 to 03 o'clock

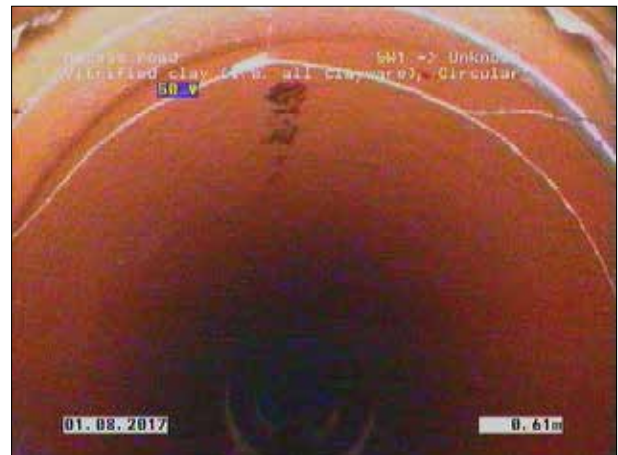
Photo: 76\_3a  
 0.61m, Circumferential Fracture at joint from 07 to 03 o'clock

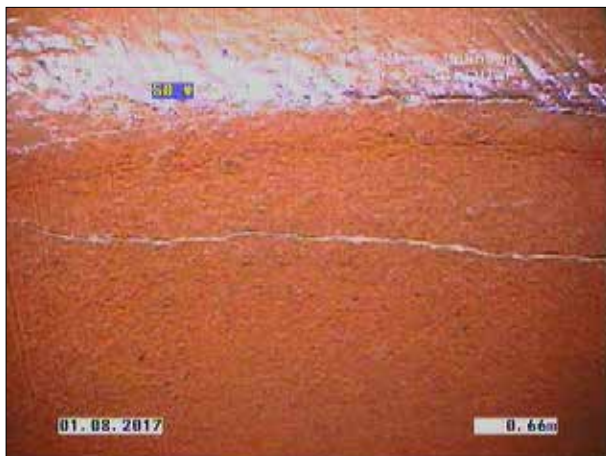
Photo: 76\_3b  
 0.61m, Circumferential Fracture at joint from 07 to 03 o'clock

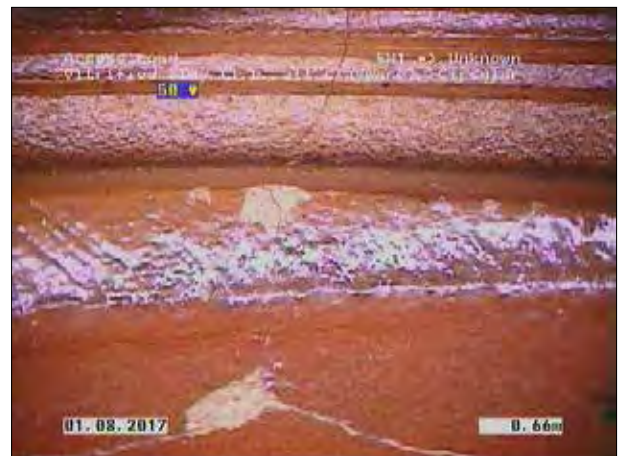
Photo: 77\_4a  
 0.66m, Fracture longitudinal at joint at 12 o'clock

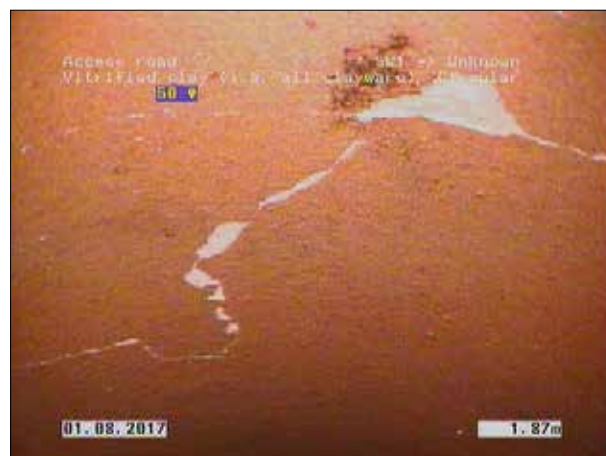
Photo: 79\_6a  
1.87m, Crack Circumferential at joint from 11 to 04 o'clock

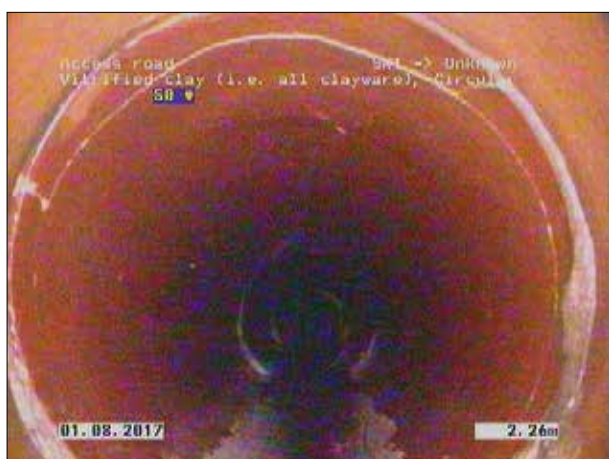
Photo: 80\_7a  
2.26m, Circumferential Fracture at joint from 09 to 05 o'clock

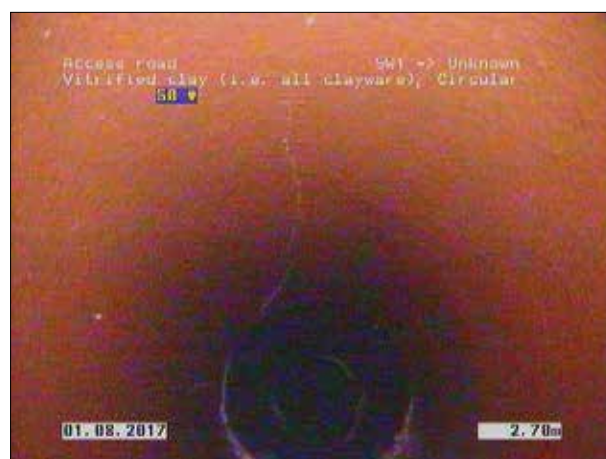
Photo: 81\_8a  
2.7m, Crack Longitudinal at 12 o'clock

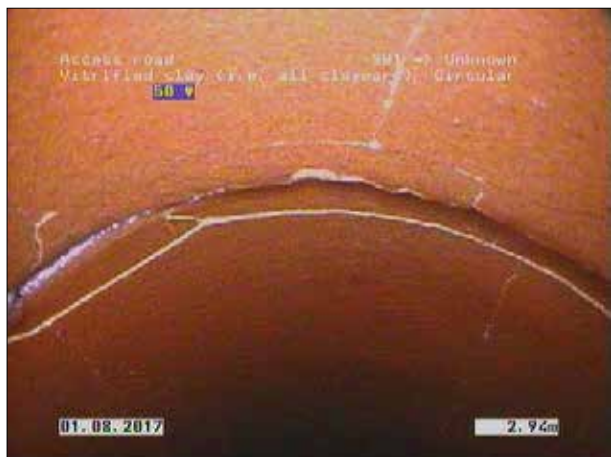
Photo: 82\_9a  
2.94m, Circumferential Fracture at joint from 09 to 03 o'clock

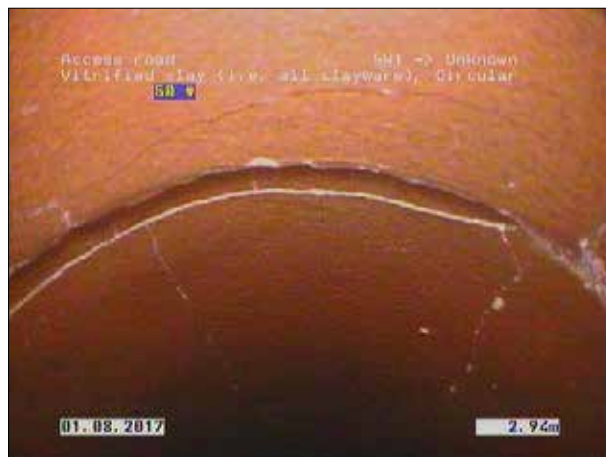
Photo: 82\_9b  
2.94m, Circumferential Fracture at joint from 09 to 03 o'clock

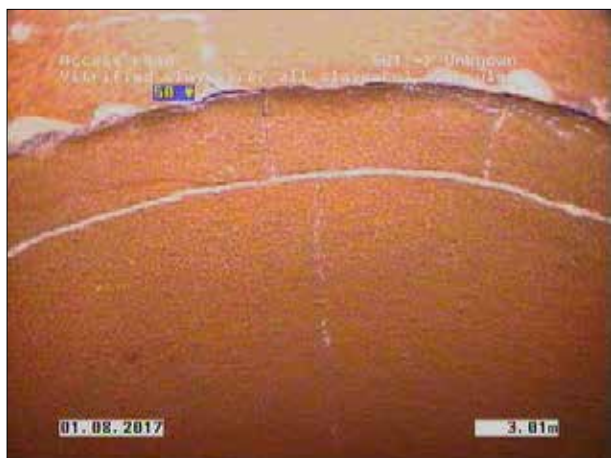
Photo: 83\_10a  
3.01m, Fracture longitudinal at joint at 12 o'clock

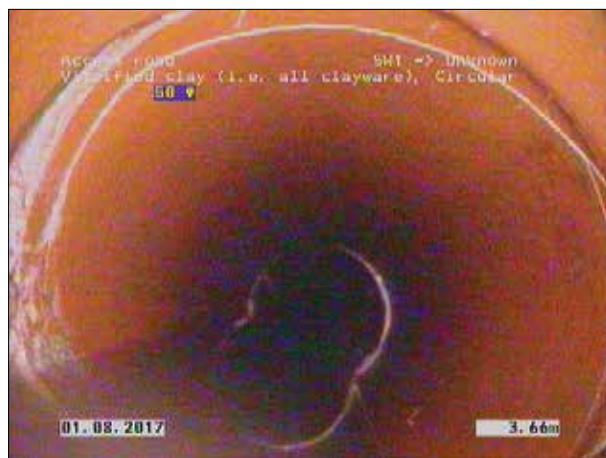
Photo: 84\_11a  
3.66m, Crack Circumferential at joint from 08 to 02 o'clock

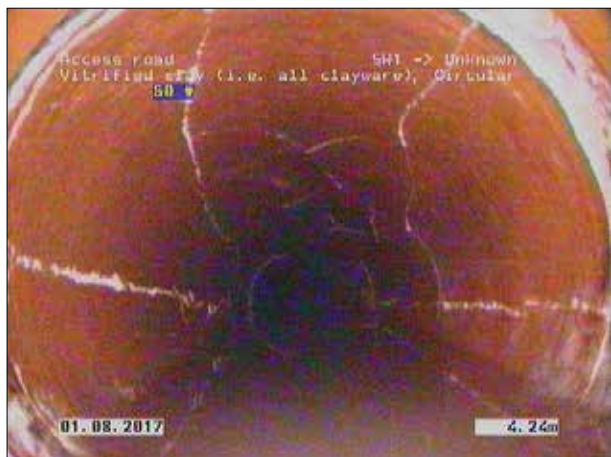
Photo: 86\_13a  
4.24m, Crack Longitudinal at 09 o'clock

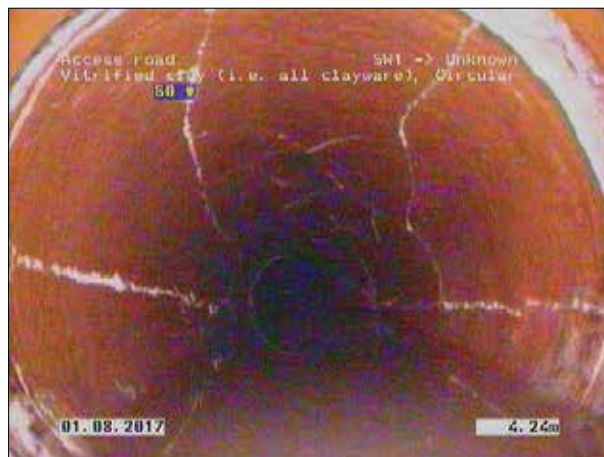
Photo: 87\_14a  
4.24m, Crack Longitudinal at joint at 11 o'clock

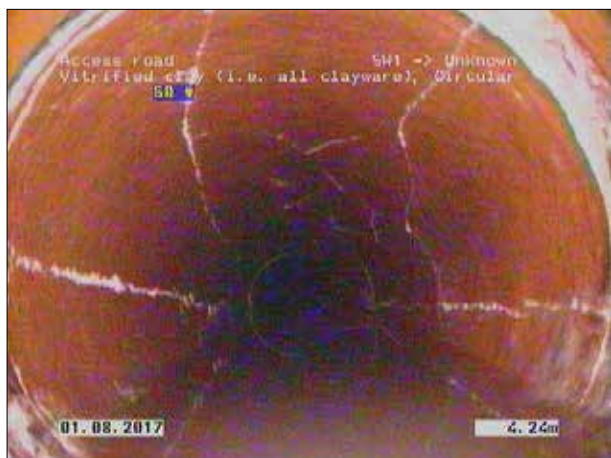
Photo: 88\_15a  
4.24m, Crack Longitudinal at joint at 02 o'clock

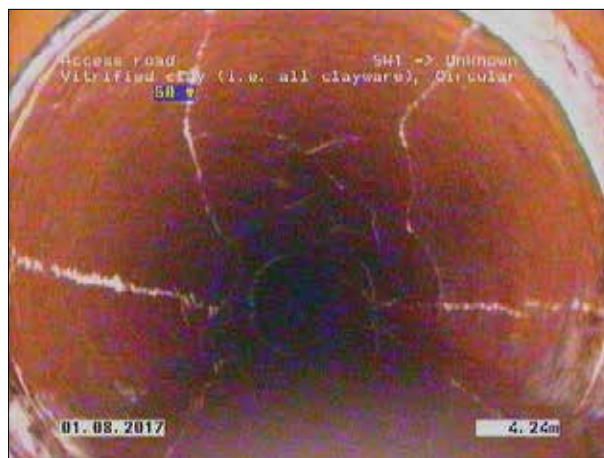
Photo: 89\_16a  
4.24m, Crack Longitudinal at joint at 04 o'clock

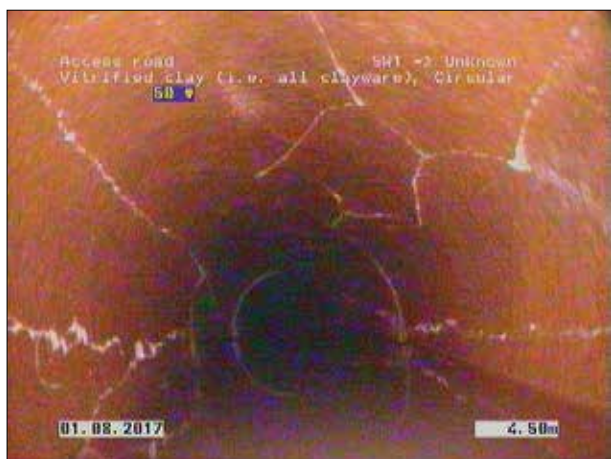
Photo: 90\_17a  
 4.5m, Multiple Cracks from 09 to 03 o'clock

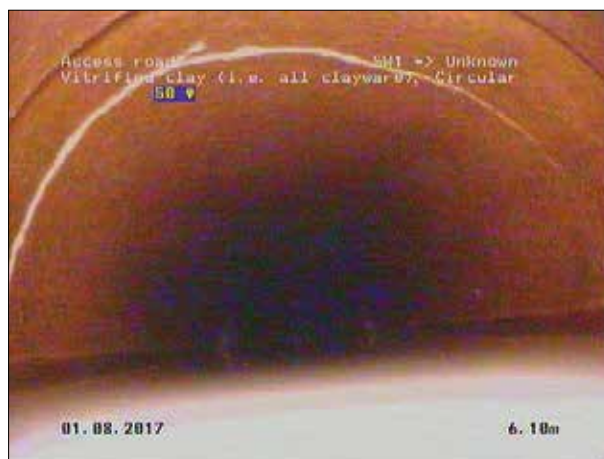
Photo: 92\_19a  
 6.1m, Crack Circumferential at joint from 09 to 02 o'clock

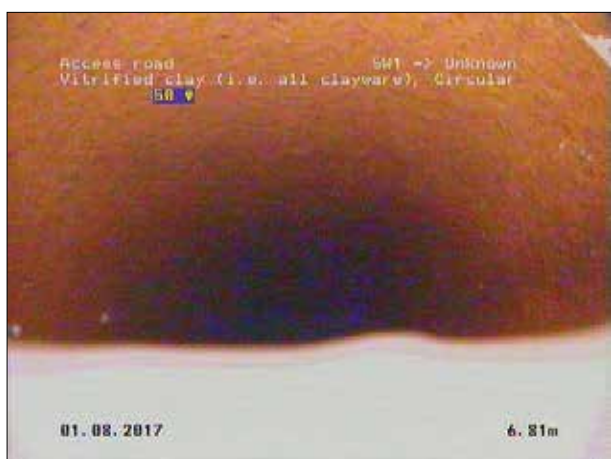
Photo: 94\_21a  
 6.8m, Survey abandoned, Remark: water level to high and loss of traction

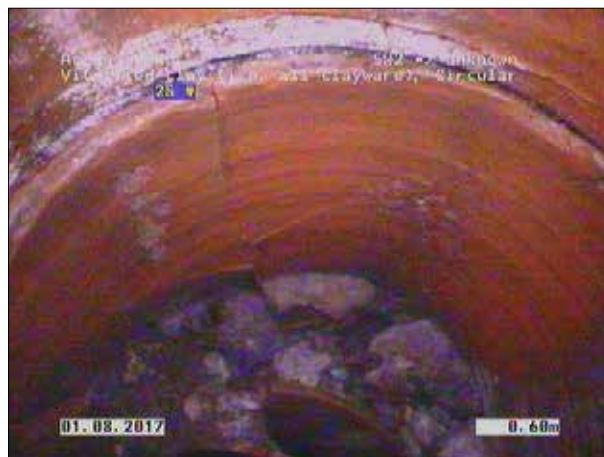
Photo: 97\_3a  
 0.6m, Fracture longitudinal at joint at 11 o'clock

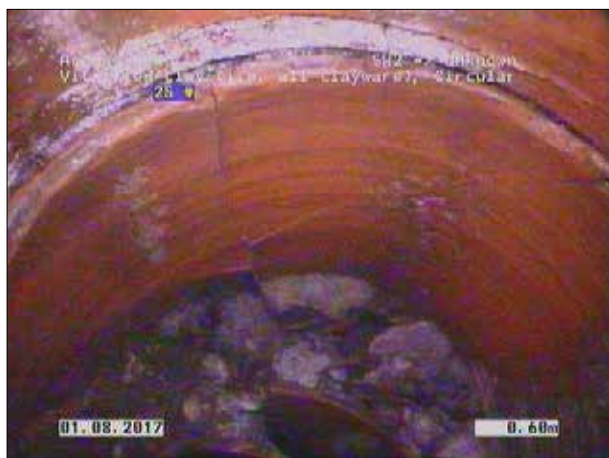
Photo: 98\_4a  
 0.6m, Circumferential Fracture at joint from 11 to 02 o'clock

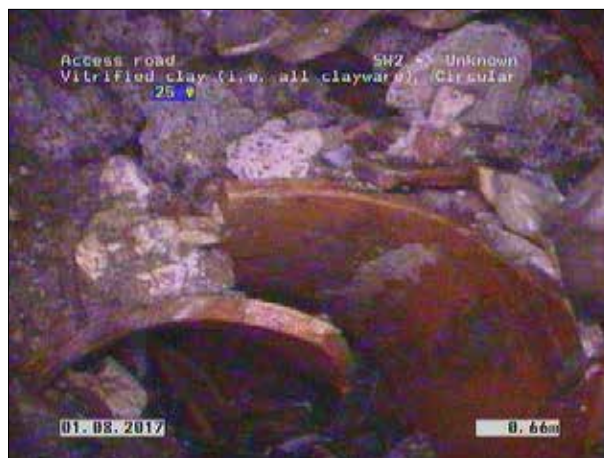
Photo: 99\_5a  
 0.66m, Collapsed drain/sewer Remark: collapsed line

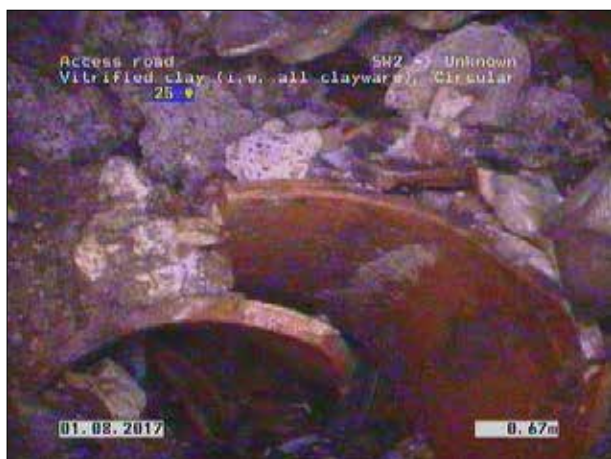
Photo: 100\_6a  
0.66m, Survey abandoned, Remark: collapsed line

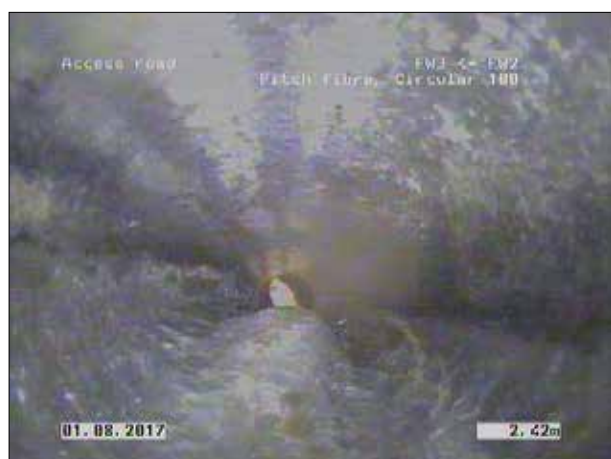
Photo: 104\_4a  
 2.4m, Deformed drain/ sewer 30 % Remark: blistered PF

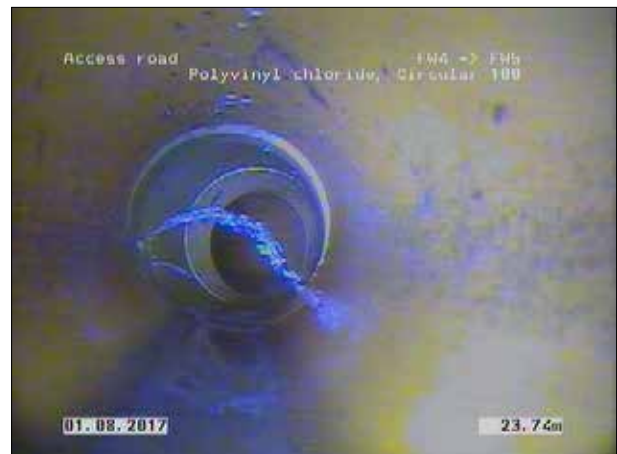
Photo: 17\_5a  
23.72m, Infiltration Running at 07 o'clock

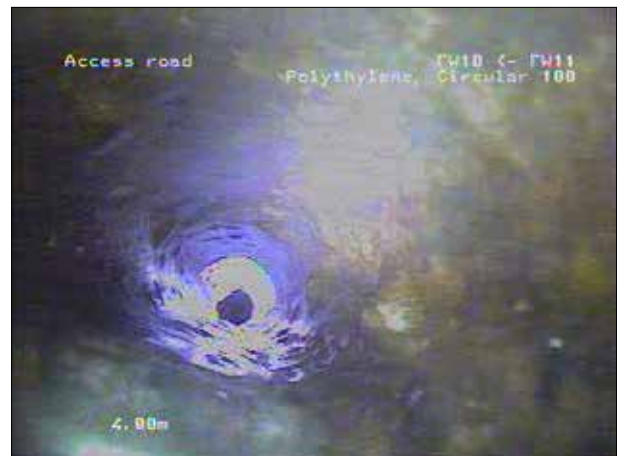
Photo: 168\_6a, 00:00:00  
 3.98m, Attached deposits encrustation from 04 to 07 o'clock 10 % cross-sectional area loss, Start

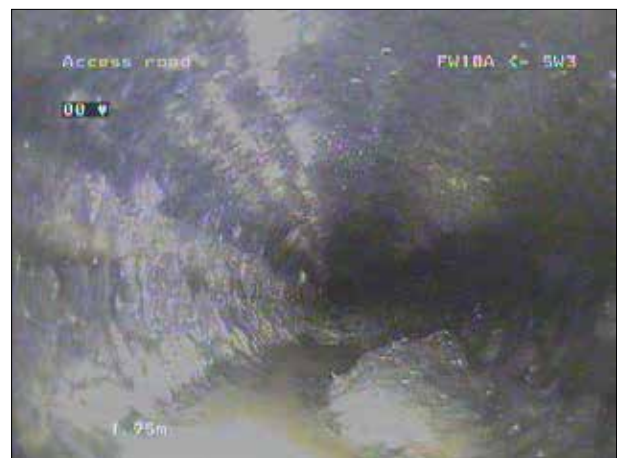
Photo: 174\_5a, 00:00:00  
1.95m, Deformed drain/sewer 10 % Remark: blistered pitch fiber

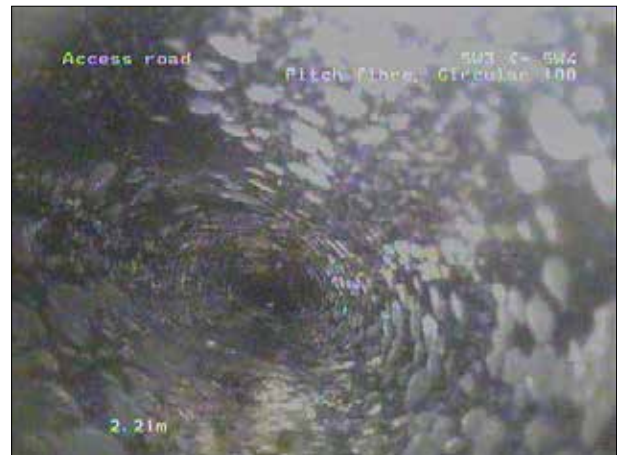
Photo: 186\_3a, 00:00:00  
 2.21m, Deformed drain/sewer 20 %

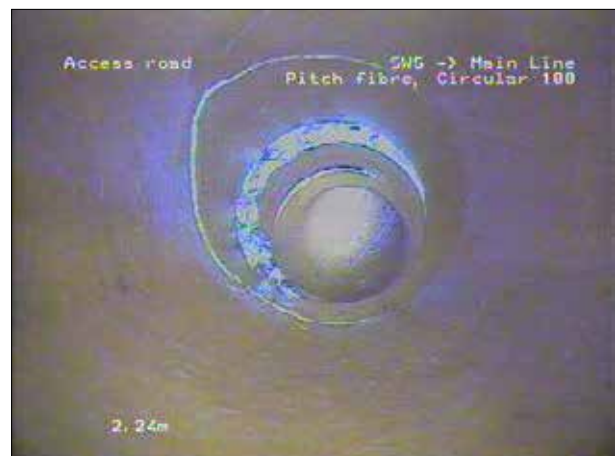
Photo: 30\_5a, 00:00:00  
 2.24m, Crack Circumferential at joint from 04 to 02 o'clock
