**EXISTING WINDOW CONDITION REPORT****for the proposed****REPLACEMENT OF FENESTRATION, DORMER WINDOW, ROOF TILES  
AND RE-POINTING OF CHIMNEY****to****12 Queen Street, Emsworth. PO10 7YA****Condition report of the existing first, second and attic floor level windows**

This report is produced to assess the condition of the above windows in consideration for replacement or repair.

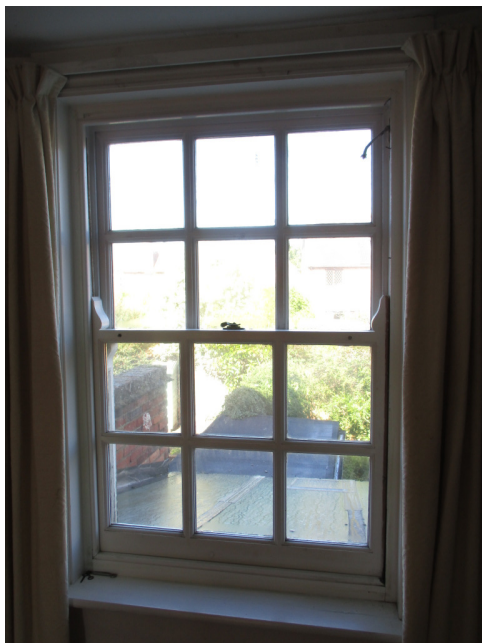
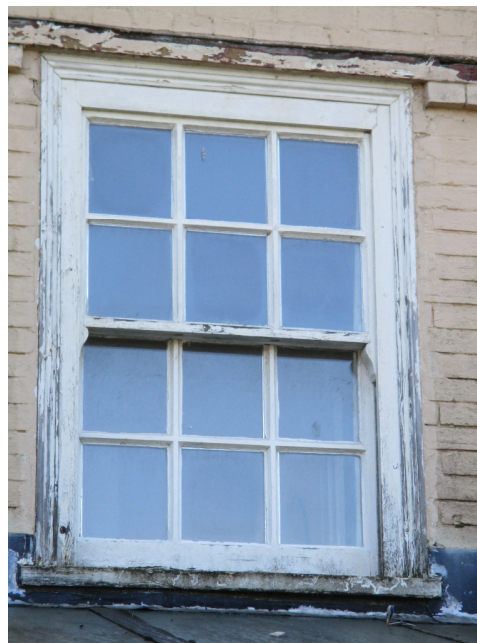
**W.1:**

Location: Bed 2 - 1360mm (h) x 910mm (w)  
Condition: Fair – showing signs of wrot to external cill, sash cord and pulley broken. Not original as beading is incorrect to the original style, as quite chunky with ovolo style beading. Single glazed.

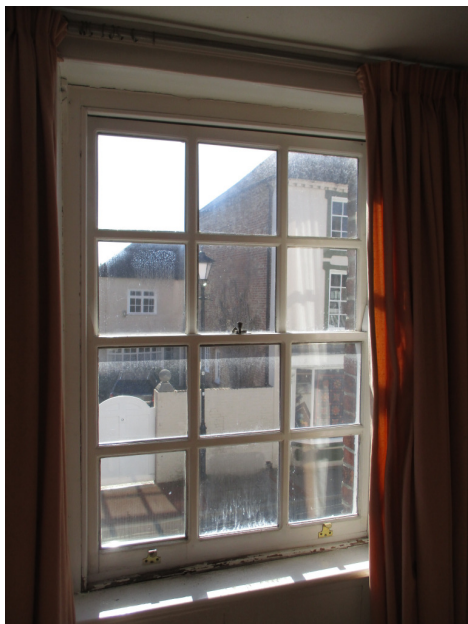
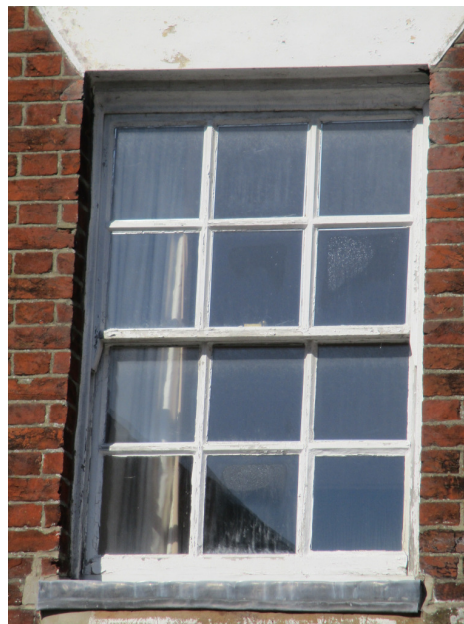
**W.2**

Location: Bed 1 - 1400mm (h) x 1030mm (w)  
Condition: Fair – visible signs of decay and wrot to bottom stiles of frame and likely the cill too. The cill is covered with a lead dressing. Not original as beading is incorrect to original style being quite chunky with ovolo style beading and also thin double glazing.

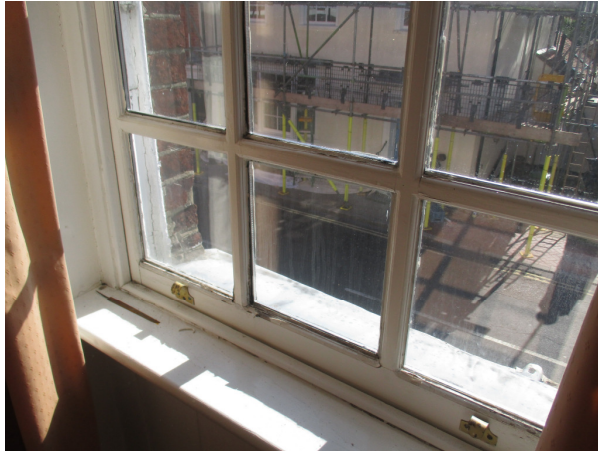
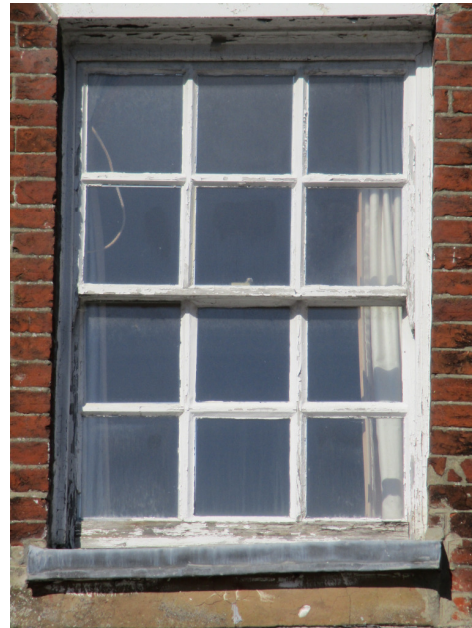
**W.3**

Bed 1 - 1400mm (h) x 1030mm (w)

Fair/Good – Equal window to W.2 but slightly better condition. Again double glazed with thin double glazing and not original.

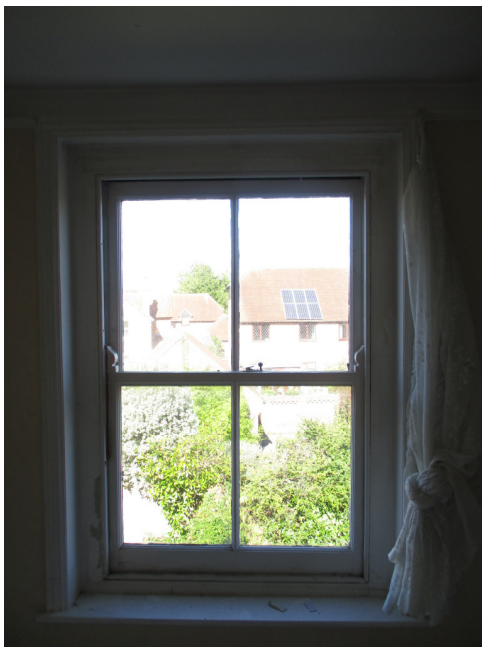
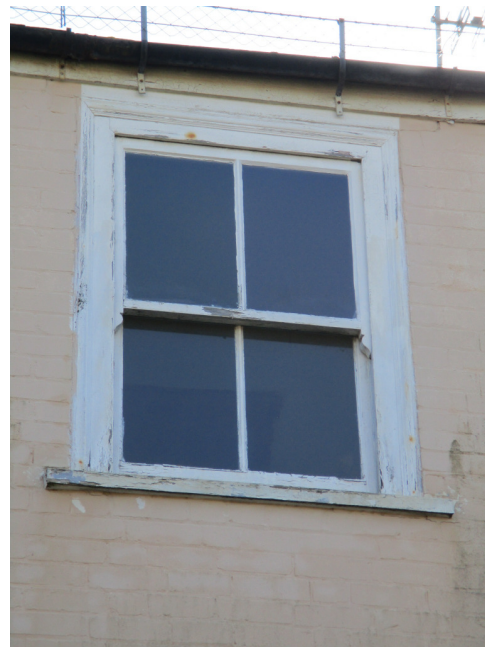
**W.4**

Bathroom - 1415mm (h) x 1000mm (w)

Good – No obvious visible decay but in need of painting. Sash broken but is still openable. Single glazed. Possibly original.

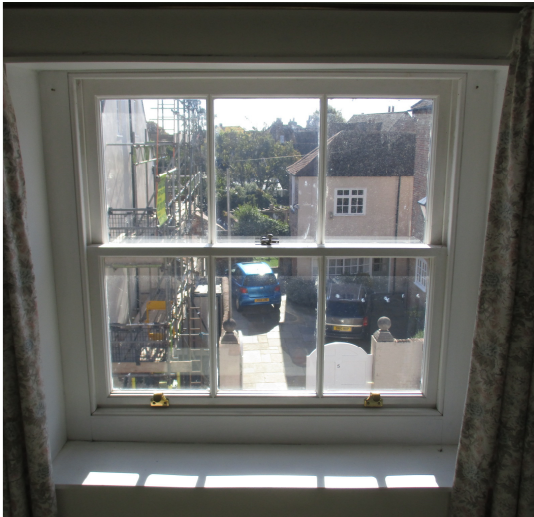
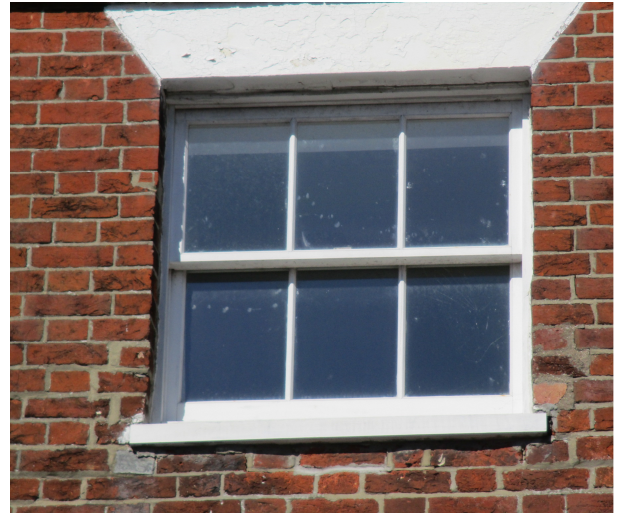
**W.5**

Location : Bed 3 - 985mm (h) x 1090mm (w)  
Condition: Good – No visible signs of decay and appears to be a recently replaced window in the original style. Single glazed.

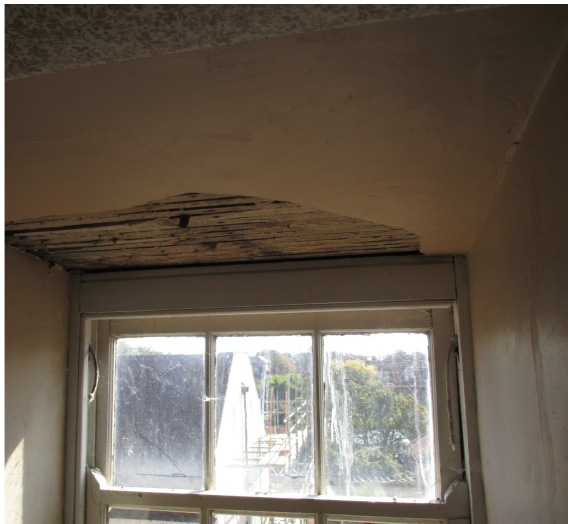
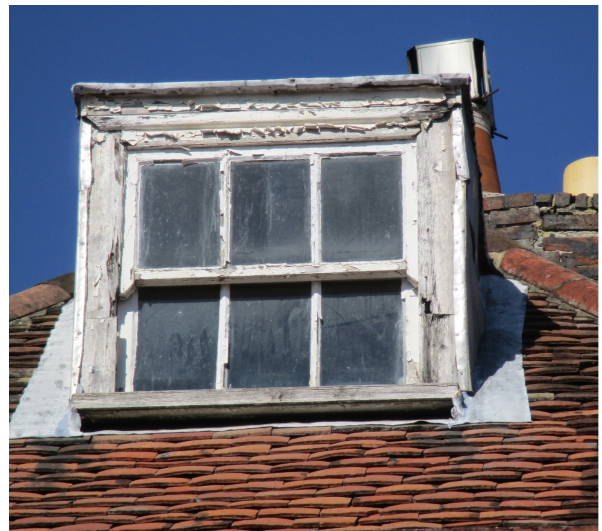
**W.6**

Location : Attic - 1040mm (h) x 935mm (w)  
Condition: Poor – Visible signs of wrot in the cill and side of frame. Not openable and fixed in place to prevent falling. Single glazed and possibly original.  
The whole dormer window leadwork is in poor condition with signs of water ingress damage internally to ceiling.
