## Visual Tree Assessment & Management Strategy Report

41a St.Catherines Road, Hayling Island

*-prepared on behalf of Mr & Mrs R Busby –*

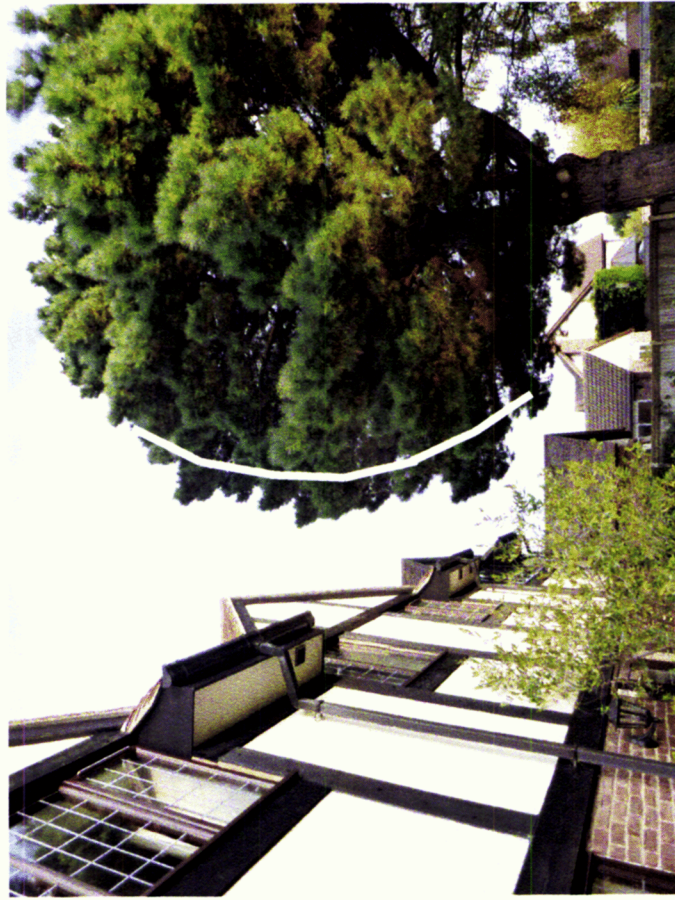
The north side of the crown and its relationship to the property illustrating the degree of pruning which is proposed.

Noting the previous crown lifting works to the north, south and west sides and the absence of same on the east side.

2. Reduce the lateral spread to the north side by 0.5m to increase the clearance from the building line but always making final cuts adjacent to living growth points thus leaving a radial spread of around 6.5m.

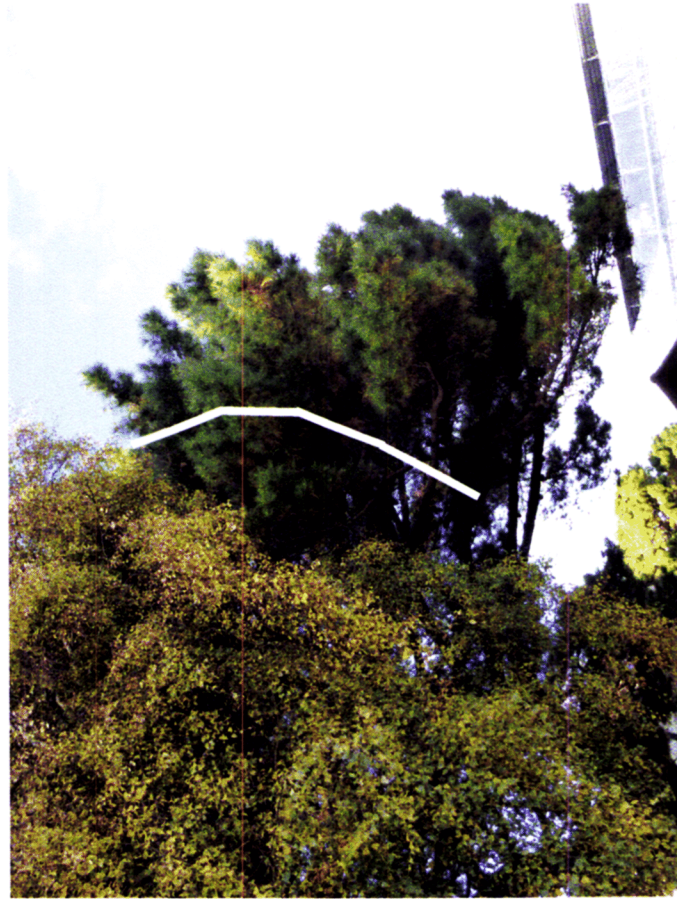
The east side of the crown with the excess/bulge of lower crown growth and illustrating the degree of pruning back that is proposed.

3. Reduce the lateral spread to the east side by between 1.5m to 2m leaving a radial spread of around 7.5m to 8m but always making final cuts adjacent to living growth points.

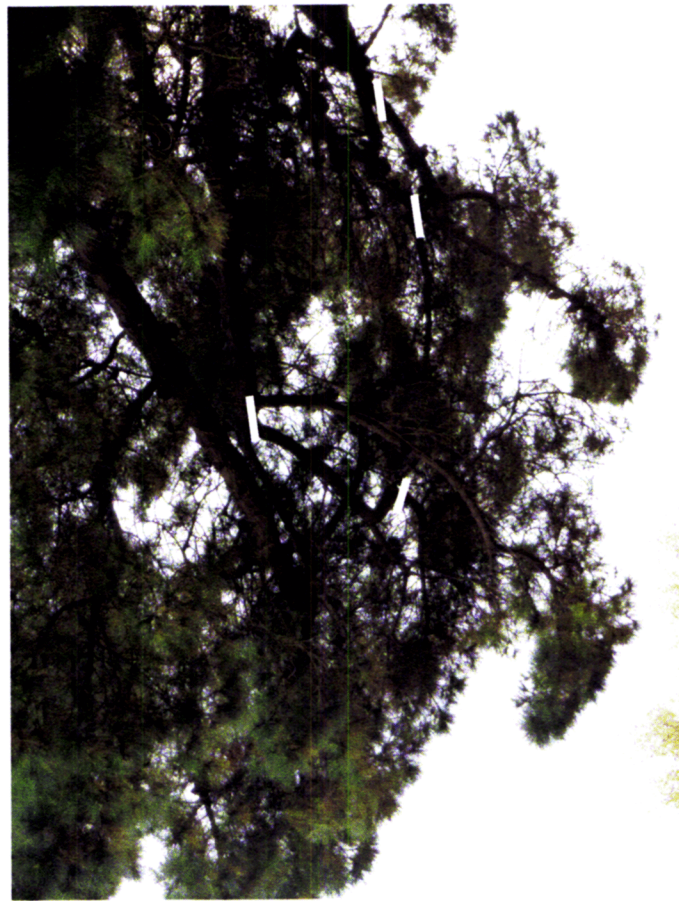
The underside of the branch spread to the east side illustrating where 'dropper' branches would be removed from the main limbs to give a more upswept form.

4. Crown lift on the east side only by removing the smaller diameter (up to 70mm diameter) 'dropper' branches that grow down from under the main laterals thus preserving the major limbs but giving the tree a more upswept form to this side. The object being to train the tree to grow in an upswept fashion with less scope for significant purely lateral spread in the future.

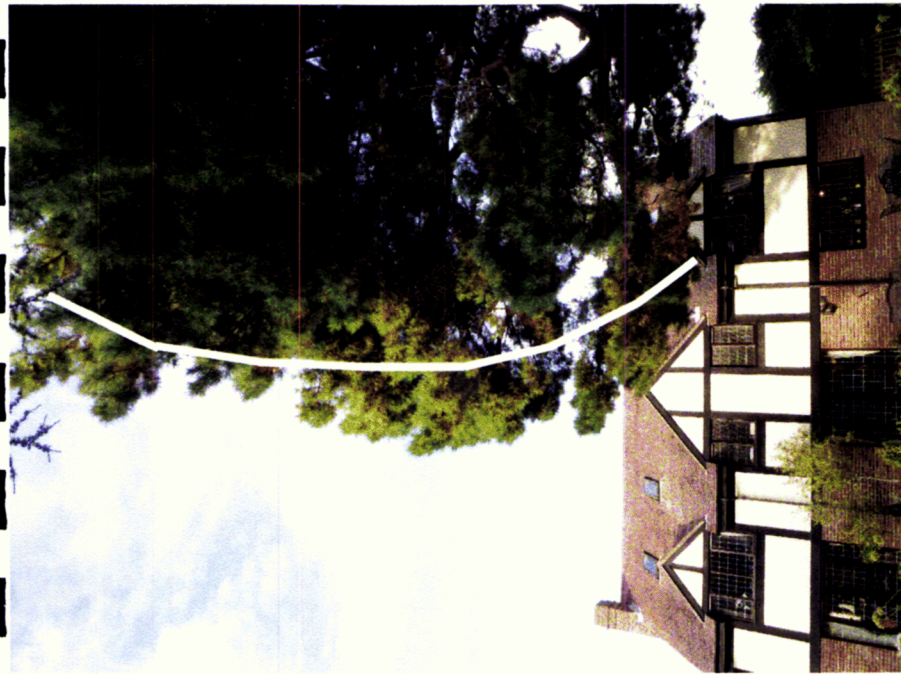
The west side of the crown illustrating the degree of pruning work proposed.

5. Reduce the lateral spread to the west side by 0.5m to 1m leaving a radial spread of between 8m to 8.5m but always making final cuts adjacent to living growth points.

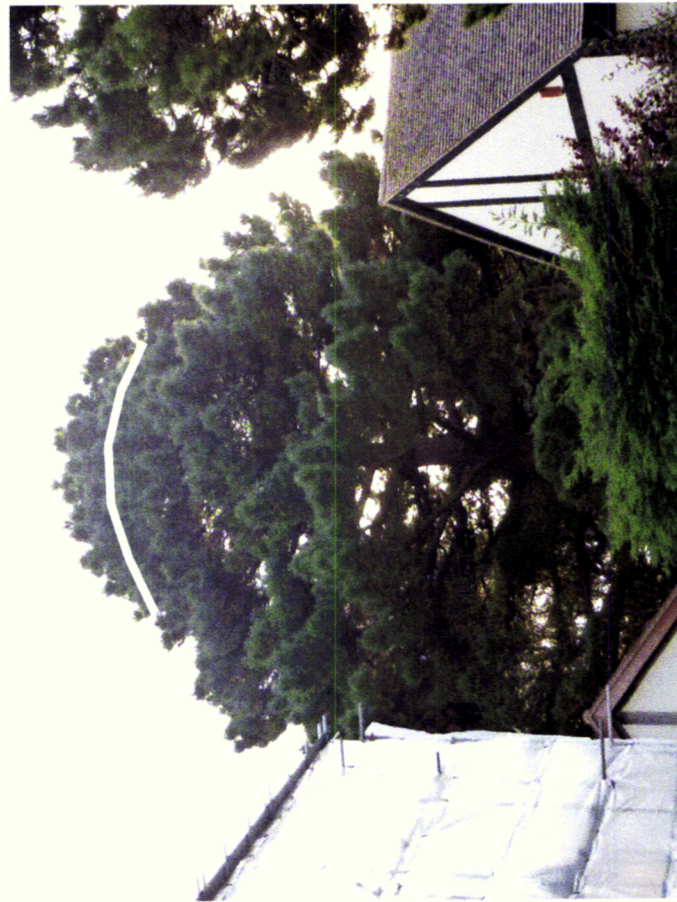
The top of the tree illustrating the degree of reduction that is proposed.

- Therefore the following works are recommended :-
  1. Reduce in overall height by between 0.5m to 1m but always making final cuts adjacent to live foliage.
