# **Procter & Gamble**

## **Phase 2 Site Investigation**

Procter & Gamble Product Supply (UK) Ltd,  
Havant

August 2003

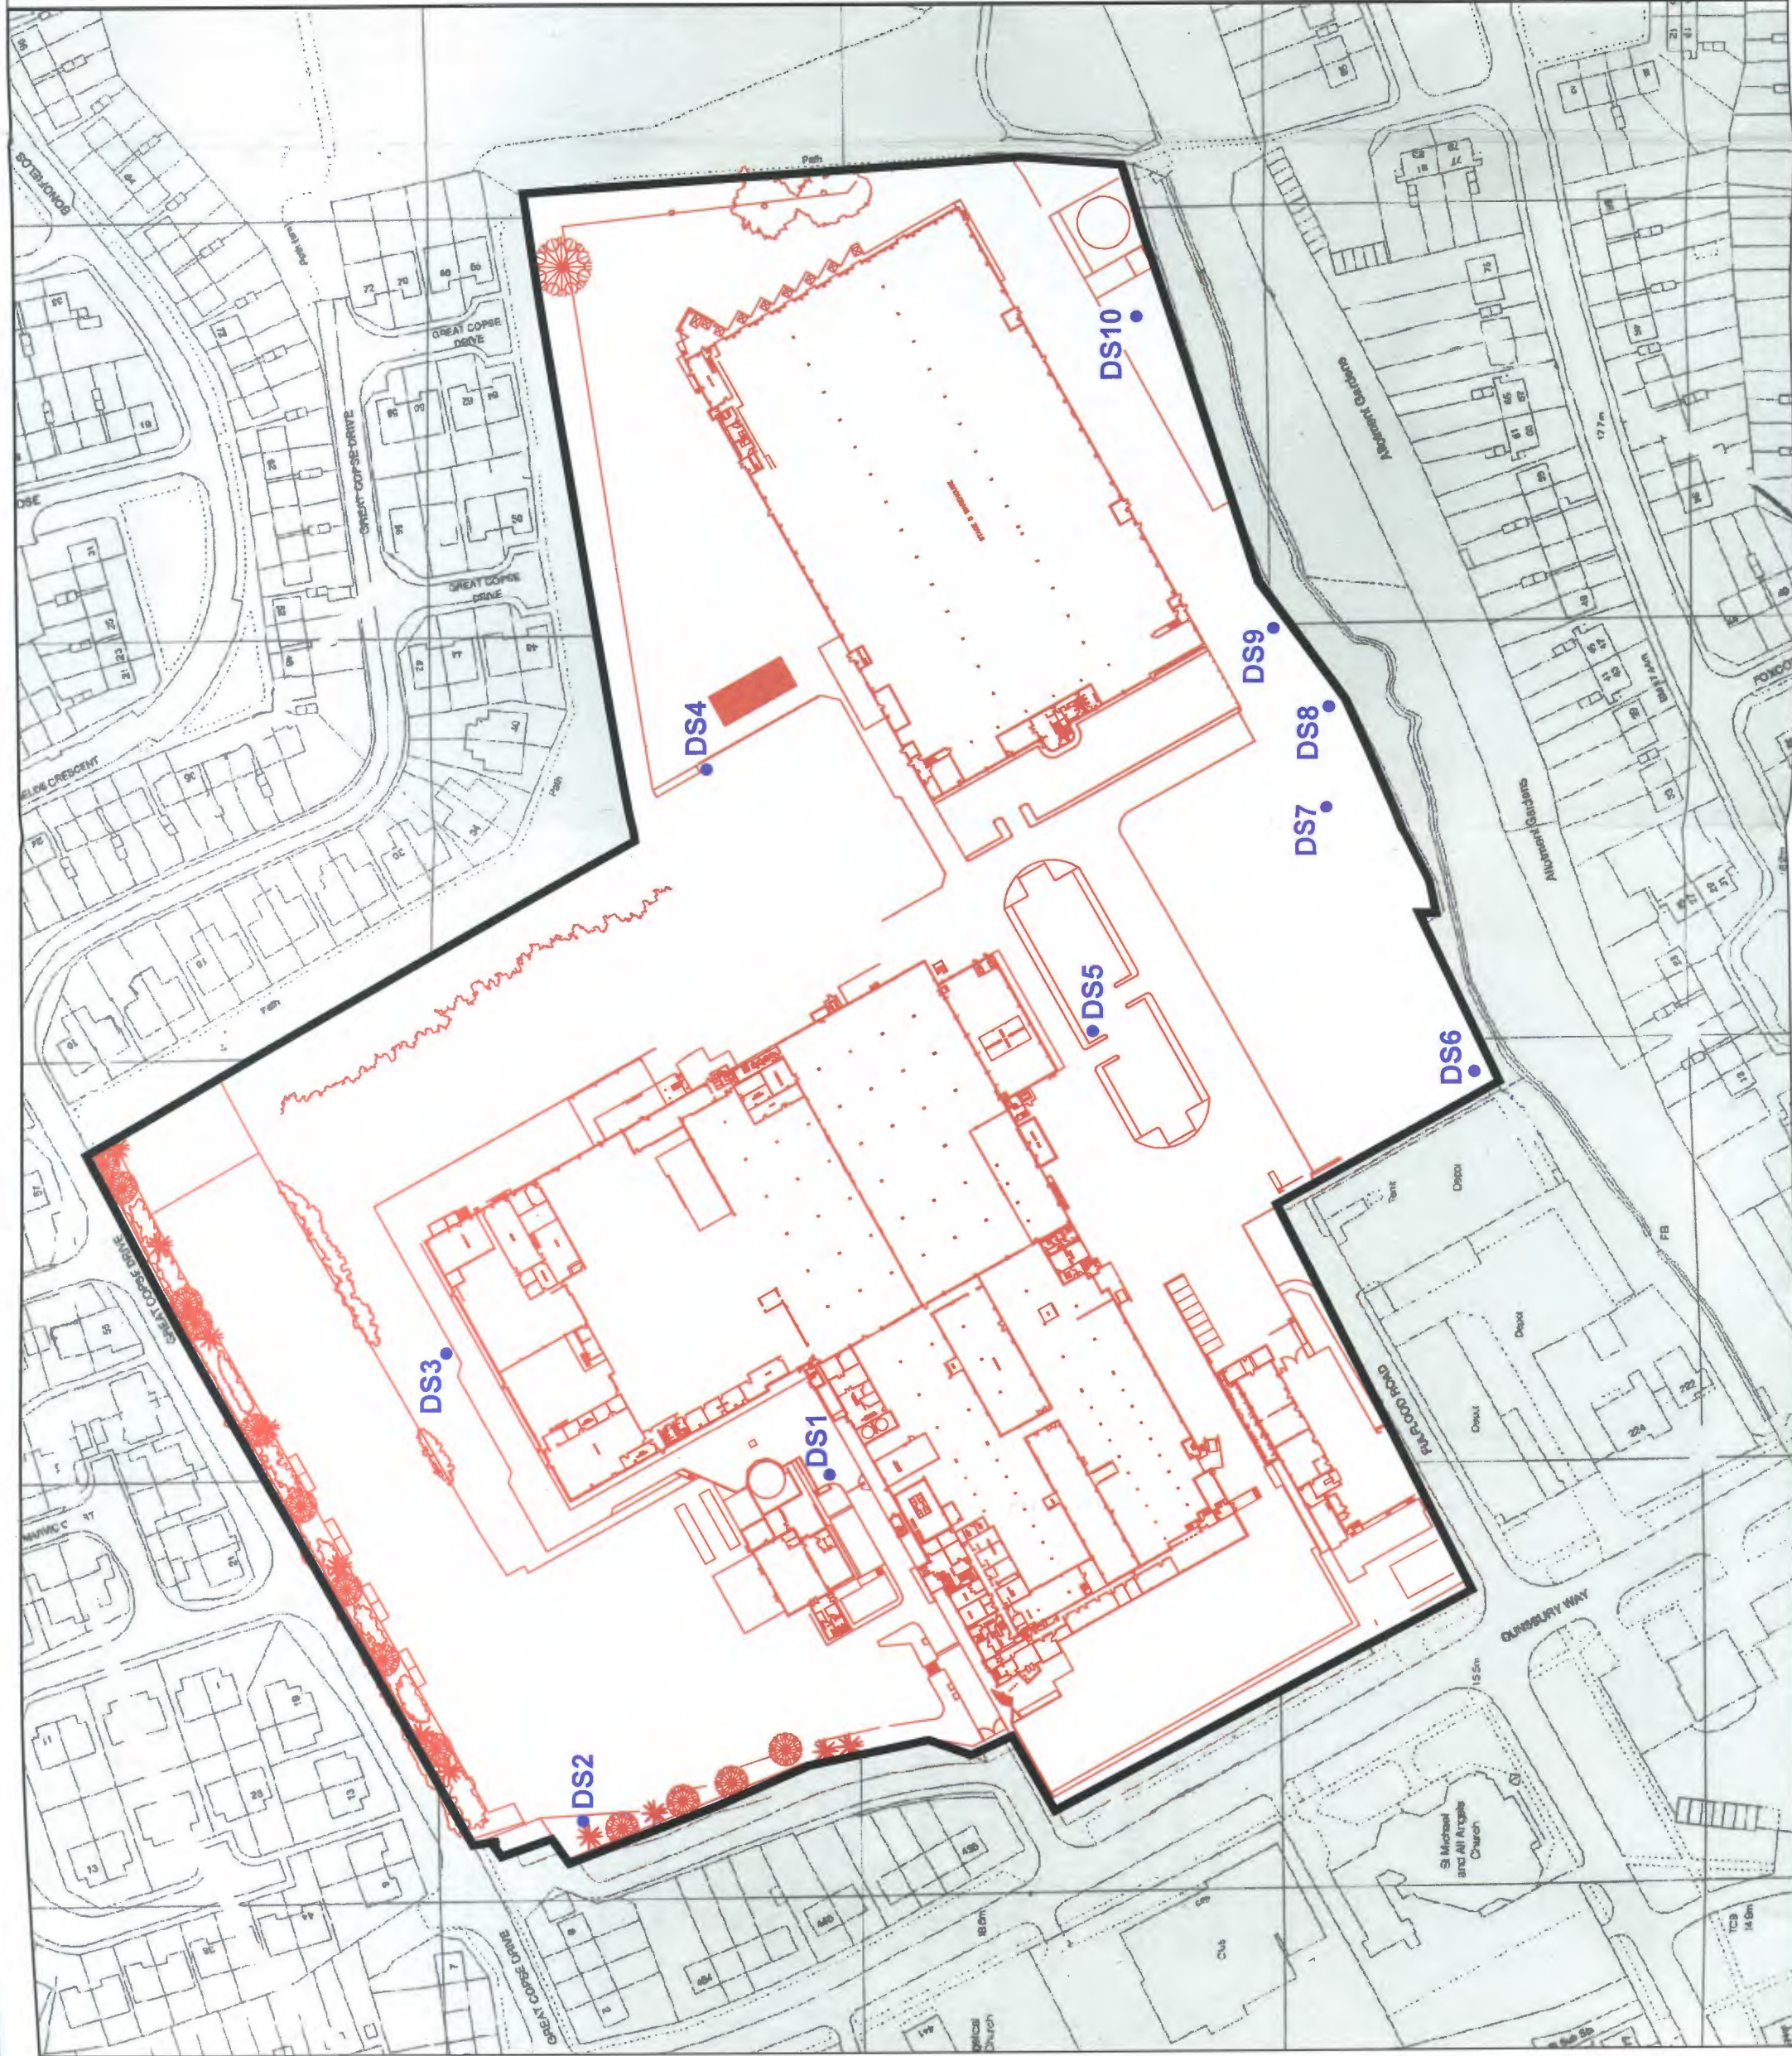
Figure 3.1  
Sample Locations

Slight elevations in PAH concentrations in soil were observed above generic guideline values in sample location DS10. (See Figure 3.1 for details of sampling locations)

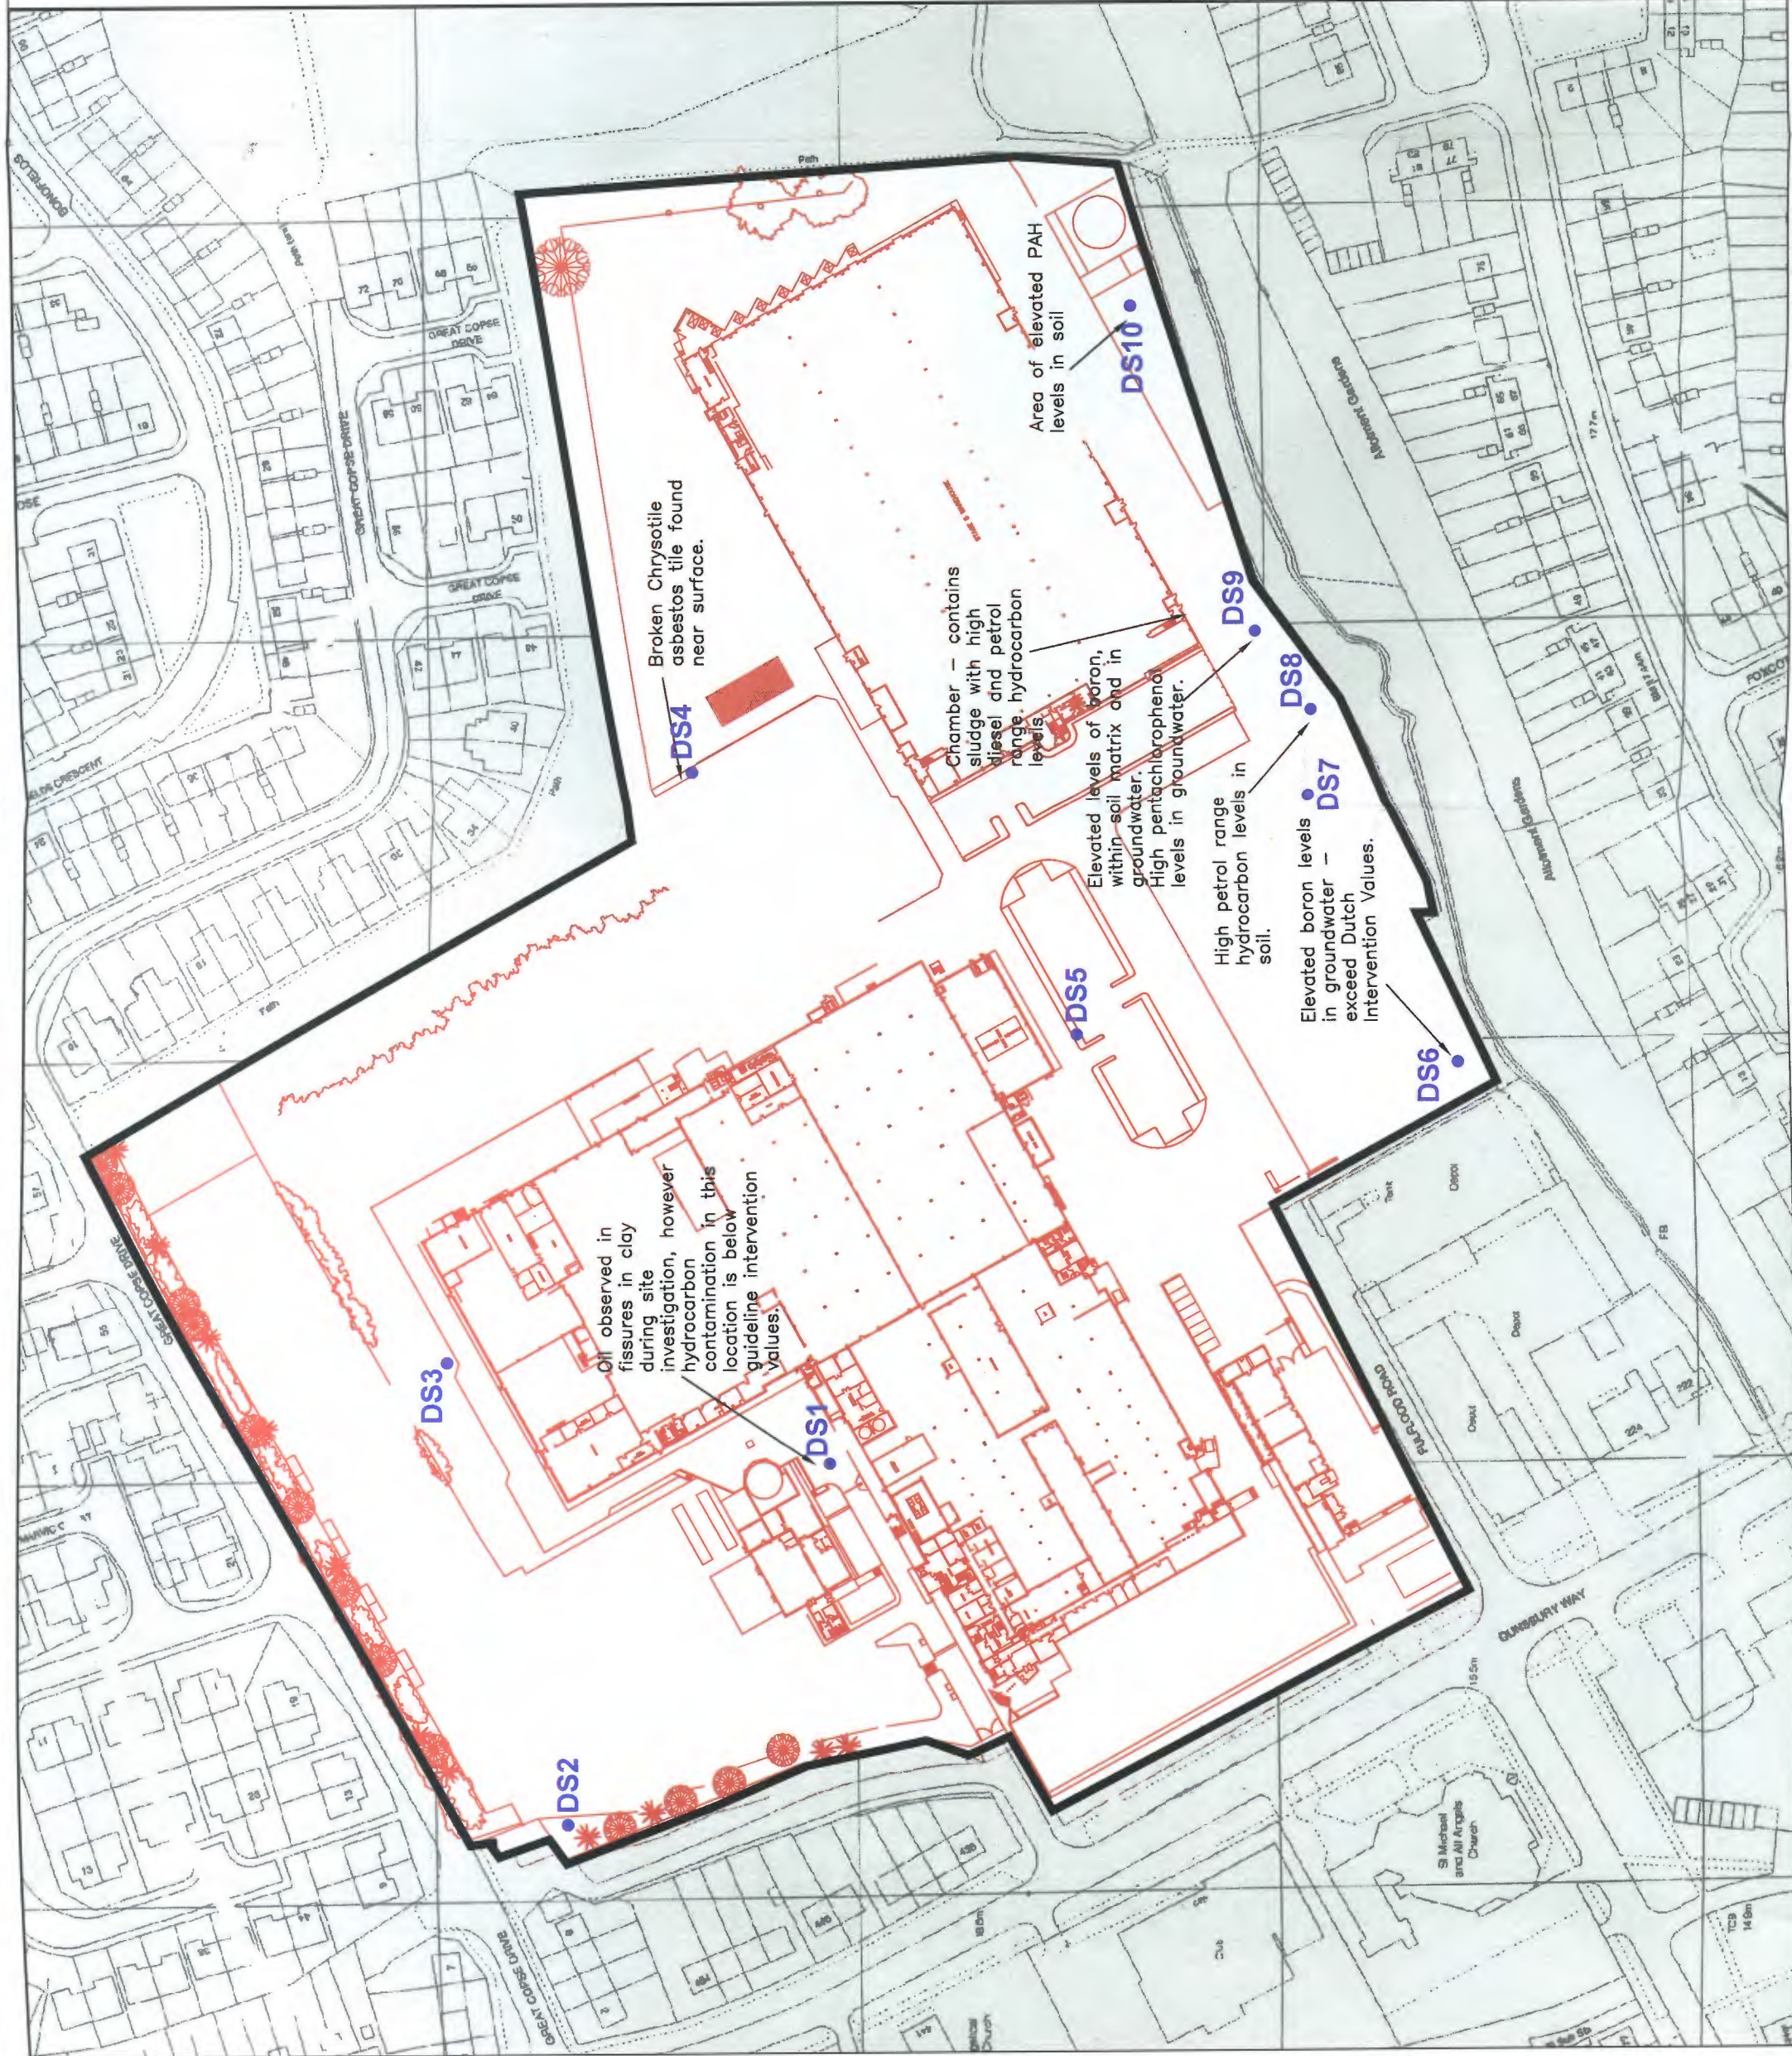
Figure 6.1  
Contamination Issues (identified during site  
investigation on 2nd and 3rd July, 2003)

The presence of asbestos cement tile at sampling location DS4 poses a moderate to high risk to site redevelopment workers. It is possible that asbestos may also be deposited elsewhere in the Made Ground behind the warehouse on site, however, the extent of the hazard is unknown. It is also possible that site redevelopment workers without PPE will come into contact with the areas of PAH and petroleum hydrocarbon contamination on site, so the risk associated with this hazard has been assessed as moderate.

The groundwater around sampling locations DS6 and DS9 has been noted to have elevated levels of boron, and high levels of pentachlorophenol were observed at DS9. Therefore, contamination of the perched groundwater has already occurred. The groundwater in the chalk underlying the site is not considered to be at risk as the clays which overlie it are around 70 m thick.

High levels of boron were found in the groundwater in DS9 and near the surface of DS10. This localised area of boron contamination could pose a moderate risk to flora in that area of the site.

- Isolated areas of hydrocarbon contamination from historical leakages and spillages.
- elevated phytotoxic metals (copper and zinc) encountered in shallow Made Ground in the area of DS10;
- Elevated boron in the area of DS10;
- Removal of all fragments of asbestos cement tile;

- Removal and further investigation of oil evident within the cable pit near DS1. Free phase oil contamination has been identified in DS1 indicating that the oil in the cable pit may be leaking into the soil. The route of the cable pit should be identified. During decommissioning and removal, any soils impacted by spillages should also be excavated and validation testing undertaken.
