# Arboricultural Appraisal Report

## Subsidence Damage Investigation at:

Leisurelands  
Gutner Lane  
Hayling Island  
Hampshire  
PO11 0RN

| MWA REF: | SUB170613-1561 |

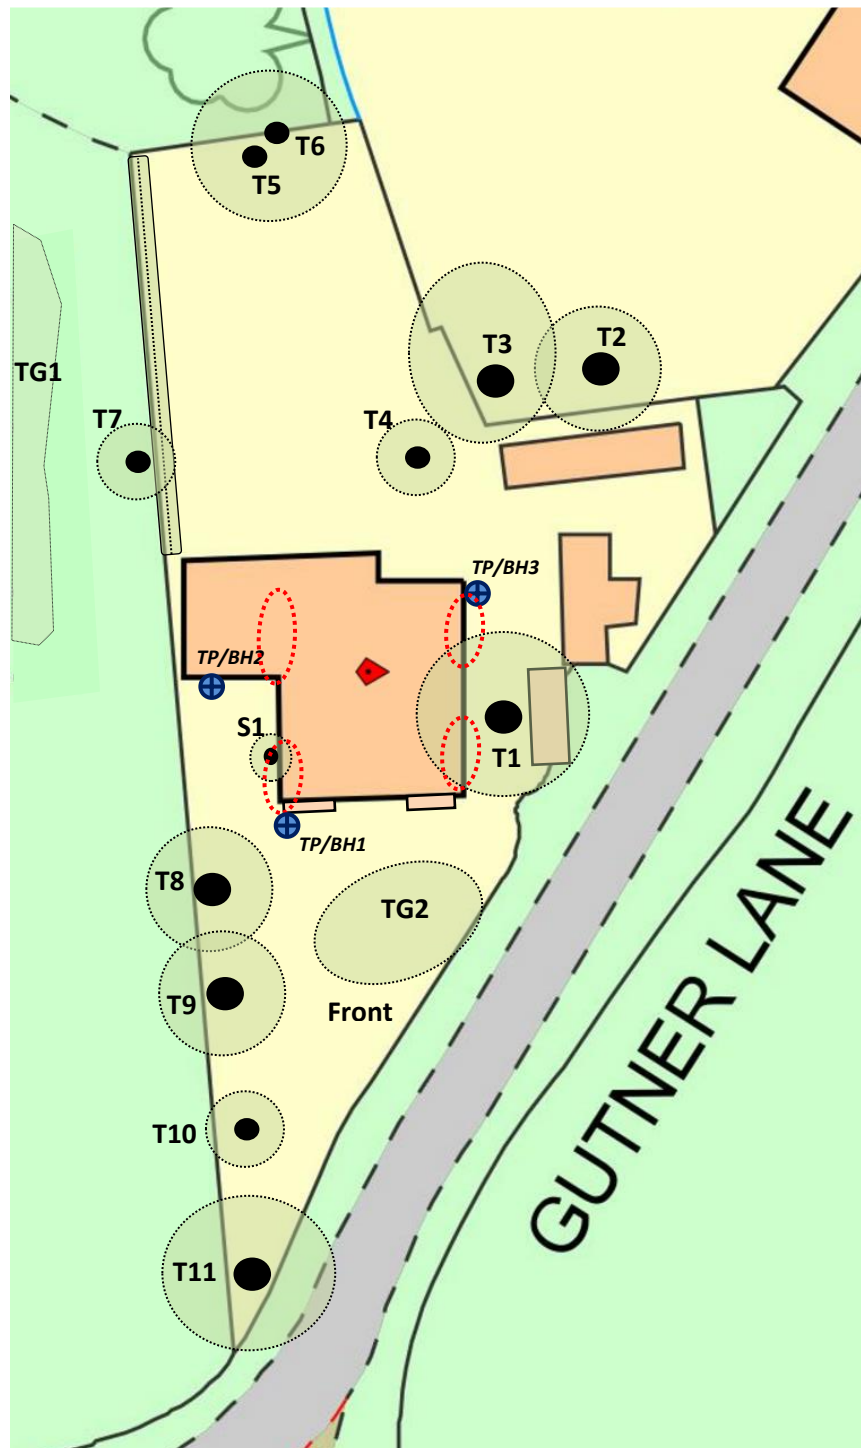
Approximate areas of damage

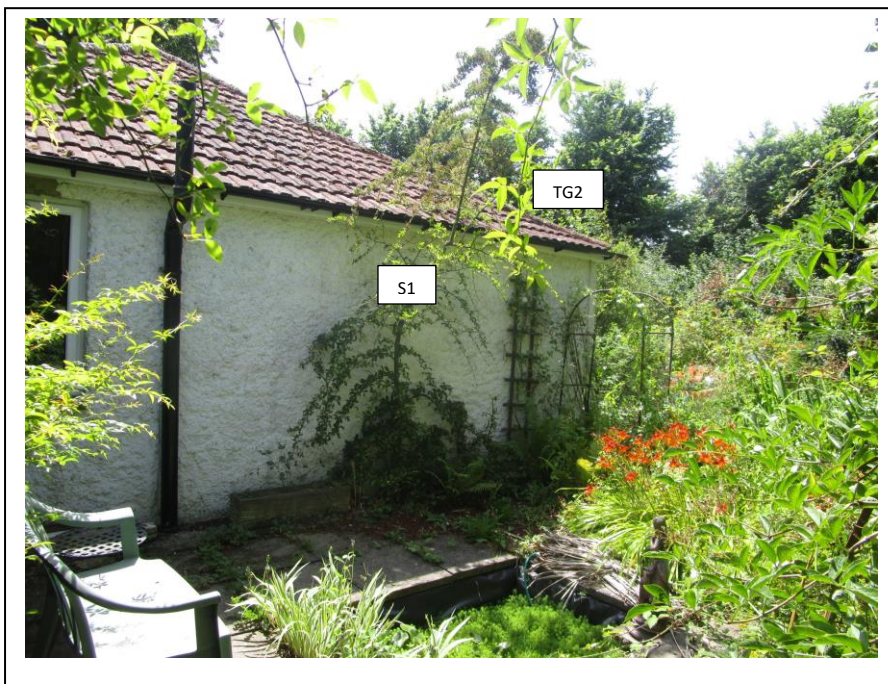
View of S1

| Tree No. | Species | Ht. (m) | Dia. (mm) | Crown Spread (m) | Dist. to building (m) | Age Classification | Ownership |
|---|---|---|---|---|---|---|---|
| S1 | Pyracantha | 3 | 45 | 2 | 0.1 | Younger than property | Policy Holder |
| Management history | | Lifted. | | | | | |

| Tree No. | Species | Ht. (m) | Dia. (mm) | Crown Spread (m) | Dist. to building (m) | Age Classification | Ownership |
|---|---|---|---|---|---|---|---|
| Recommendation | | Remove and treat stump to inhibit regrowth. | | | | | |
