## **Tree Comments**

Northshore, 40 Sinah Lane, Hayling Island, PO11 0HH

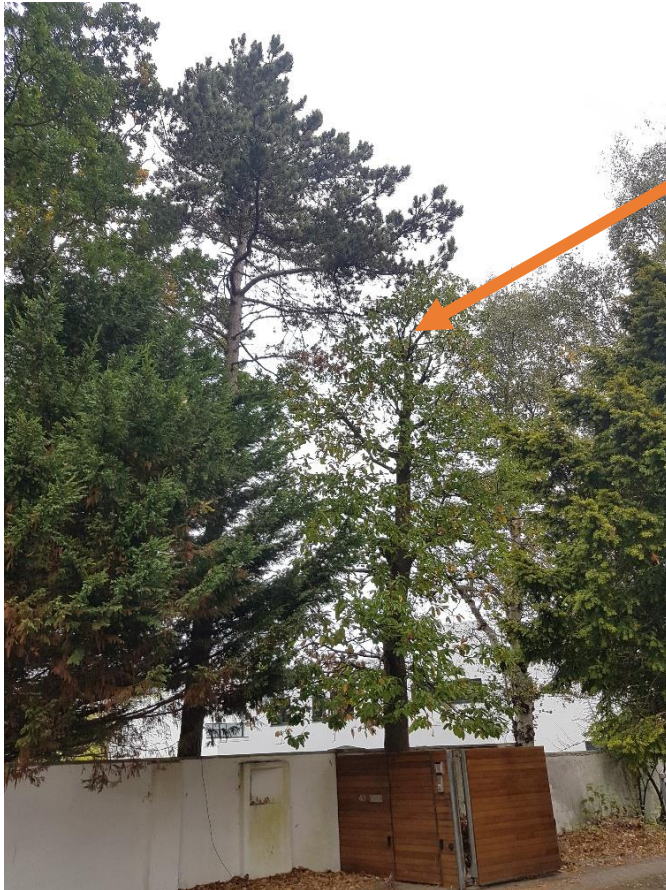
Tree 2 – Sweet Chestnut – Covered by TPO.

Of the trees shown in the photo above, the work schedule looks to remove the Conifer on the left-hand-side (non-TPO tree). The Pine and the Silver Birch will be retained, the central tree is the Sweet Chestnut – recommended for removal due to damage to wall.

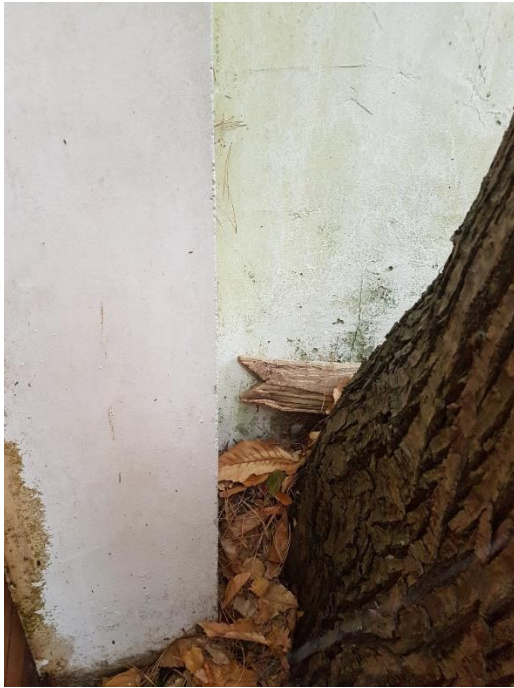
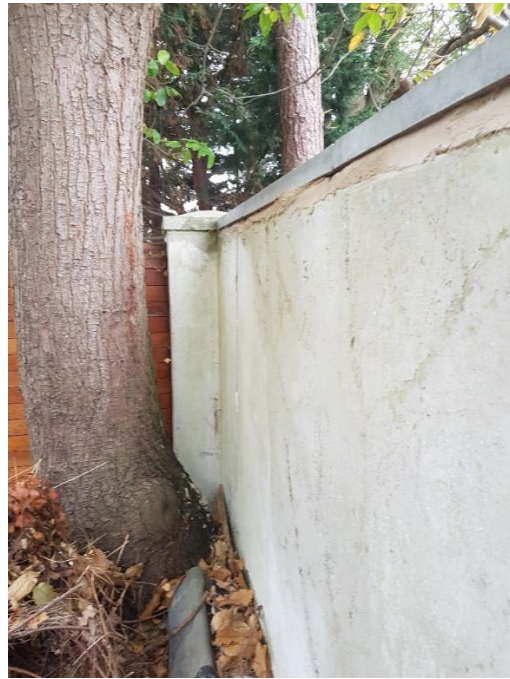
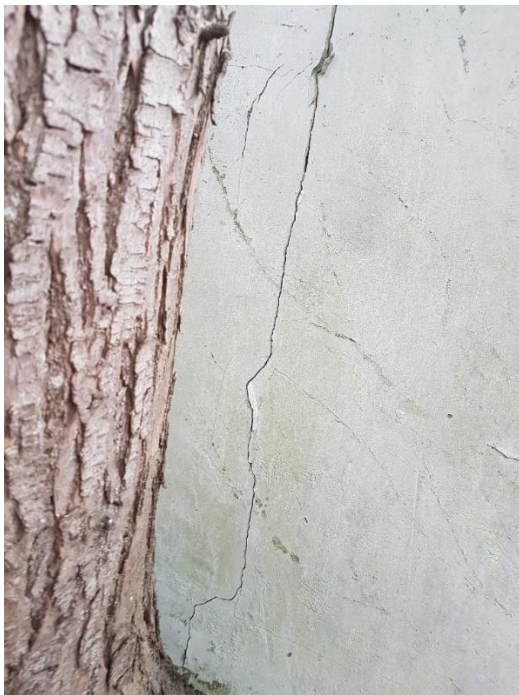
The buttress of the tree is against the wall as shown in the first photo above, the others clearly show the crack.

Given the trees to be retained at the front of the property, including the Pine and Silver Birch, we don't feel that this location needs a replacement tree. Happy to include one further within the site.

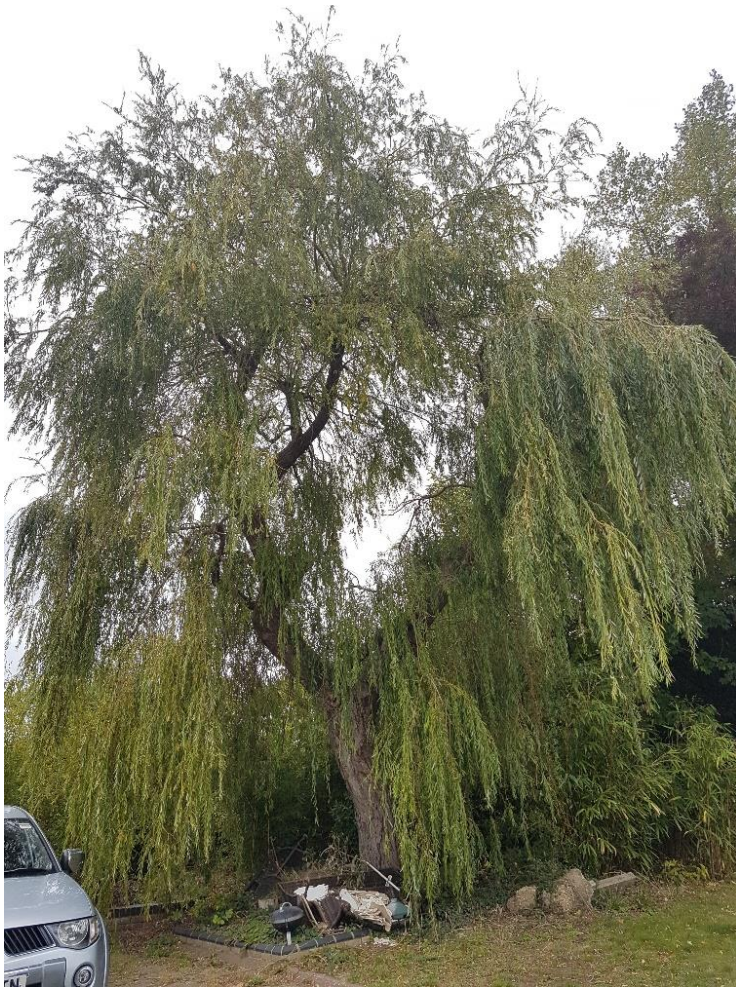
### Tree 5 – Willow – Covered by TPO

The tree is a semi-mature Willow, the justification of the TPO is not clear. The tree is completely locked within the site, it has no open public view and can only be seen by two neighbouring properties.

The tree has been subject to pollarding as a management and therefore is not of the best form.

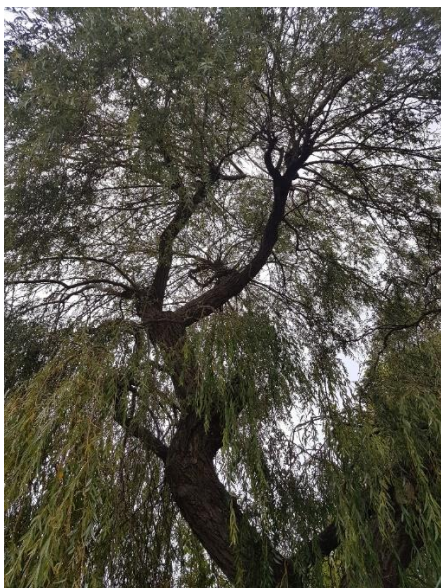
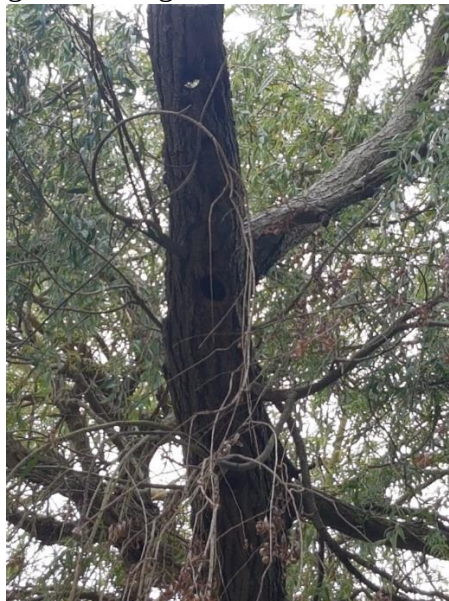
Given the poor form of the tree and the noted holes in those structural branches we propose removal and provide a replacement within the rear garden.

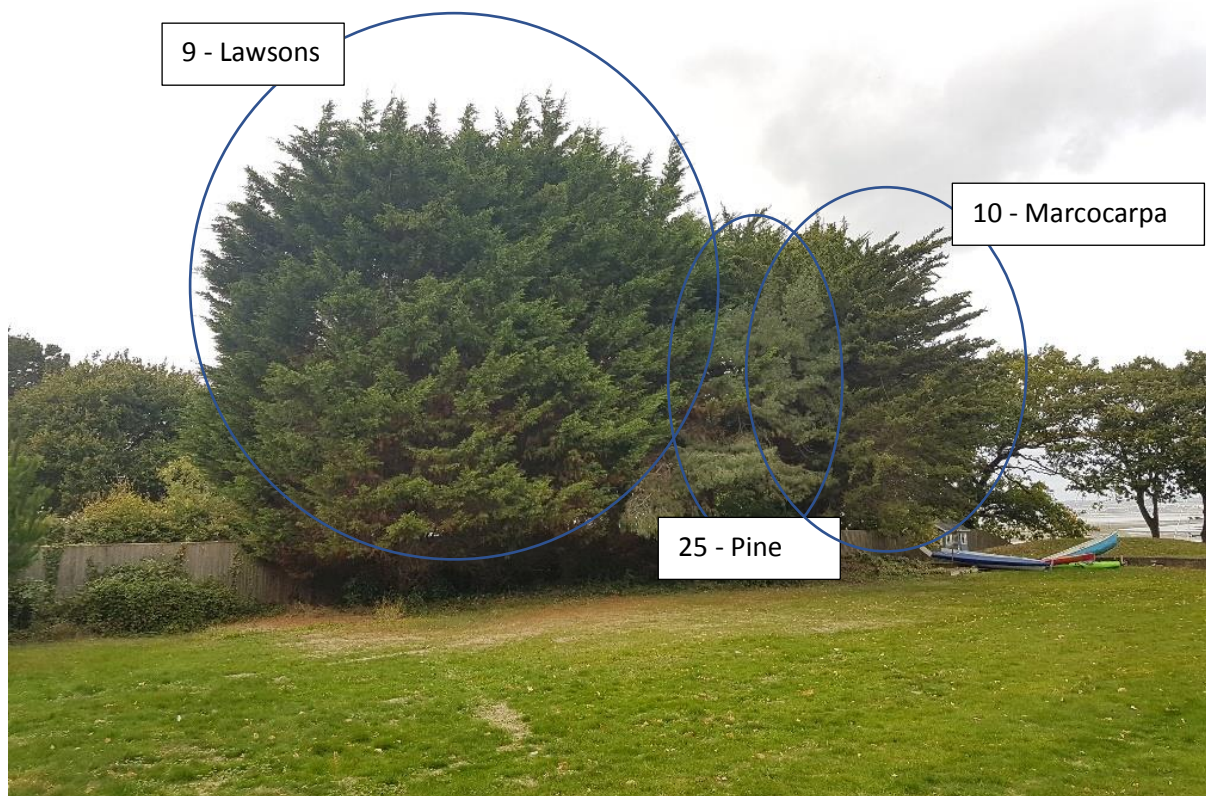
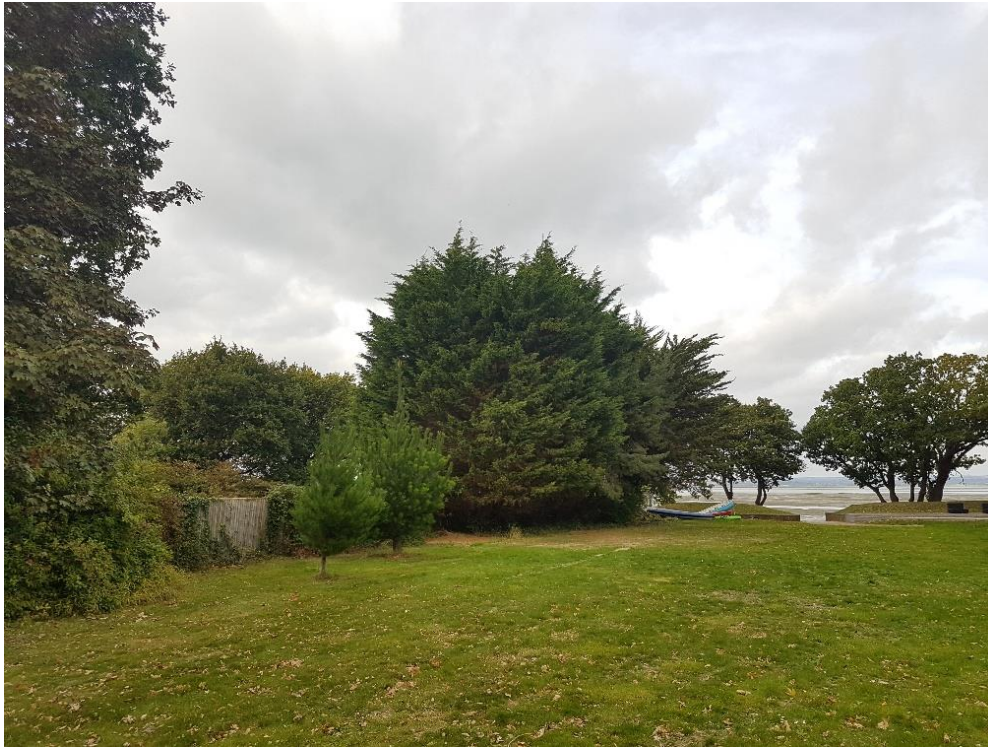
#### Trees 9, 10 & 25 – Mixed group TPO

The mixed TPO group, can only be described as a landscape group. It is believed that the Conifers were previously managed and maintained in both height and width to provide screening to and from the surrounding gardens. Again, there is not public view of these trees and they offer little to the surrounding gardens.

Due to the lack of recent management of the group, the trees have continued to grow and are now all in poor form and will allow little future management. Therefore, along with part of the garden re-development project they should be removed. It would be part of the scheme to look at replanting with other trees to provide boundary screening, while each offering more in terms of appearance and character for the garden.

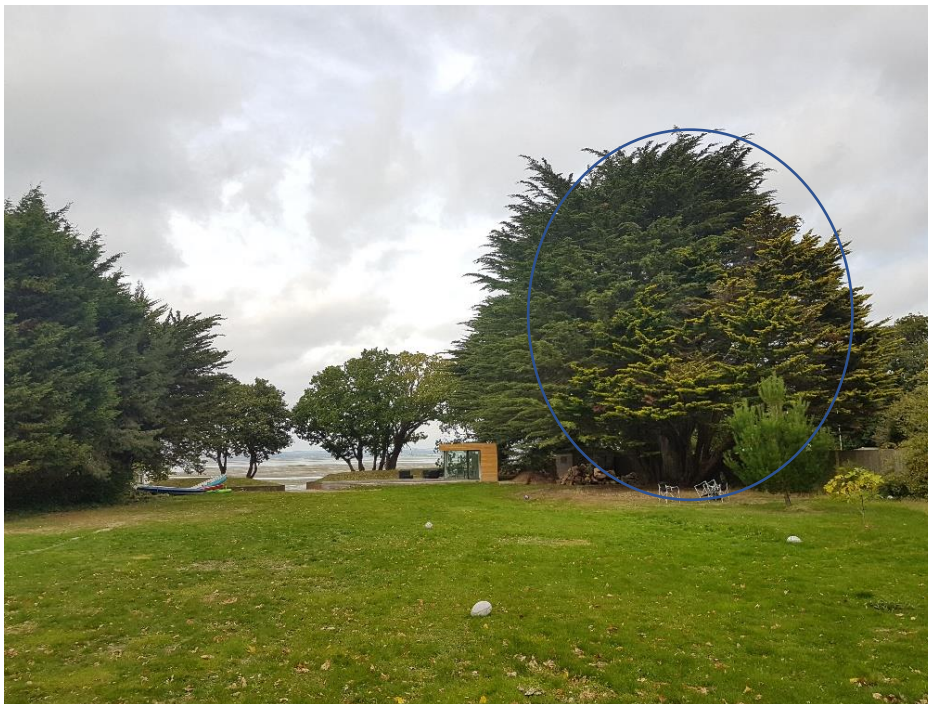
Tree 14 – Lawson – Possible Group TPO

The group 9, 10 & 25 can be seen on the left, the group 14 is on the right. There is a larger individual Conifer (Macrocarpa) behind, but the Lawson mix group blocks this from view. The size and spread of the group reduced the feature tree presence of the rear boundary (coastline) Oaks.
