BS 5837 Report on the Trees in Relation to  
Bosmere Junior School in Havant

**Client: Hampshire County Council**

**Date: December 2017**

| <b>Date Revised:</b> | 22/02/18 | <b>Authored by:</b> | Laurence Johns, Arboriculturalist, BSc. | 1 of 35 |

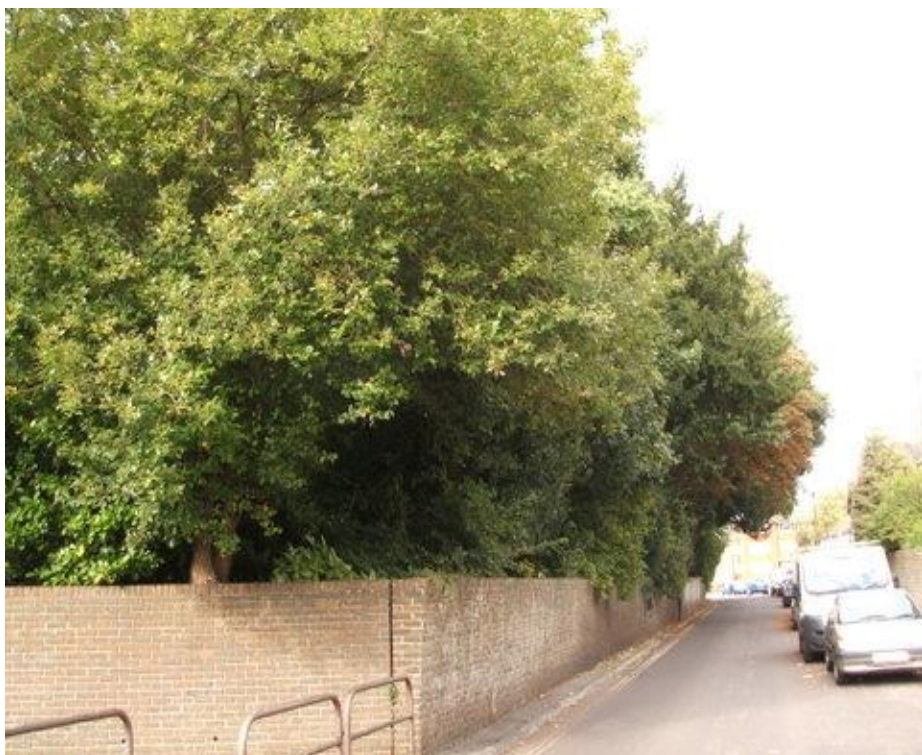
Looking north at unstable brick boundary wall with trees behind.

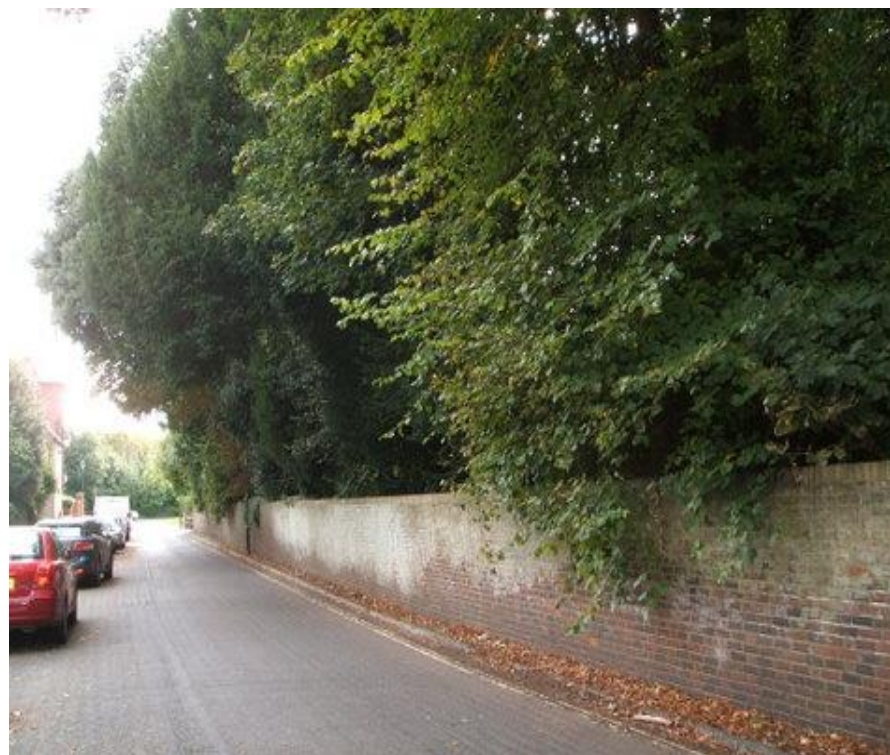
Looking south at unstable boundary wall along South Street.

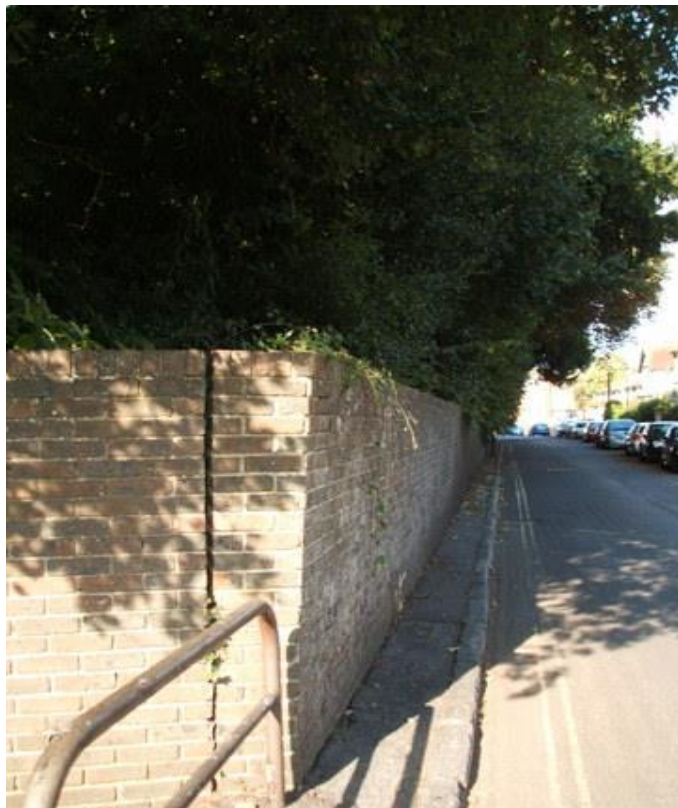
Looking north at widening gap between walls.

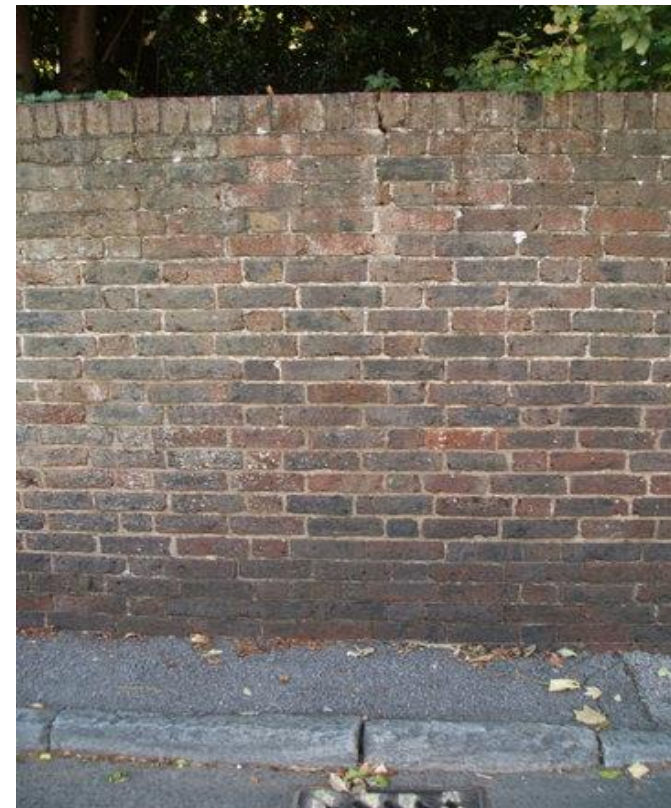
Looking west at a crack in boundary wall.

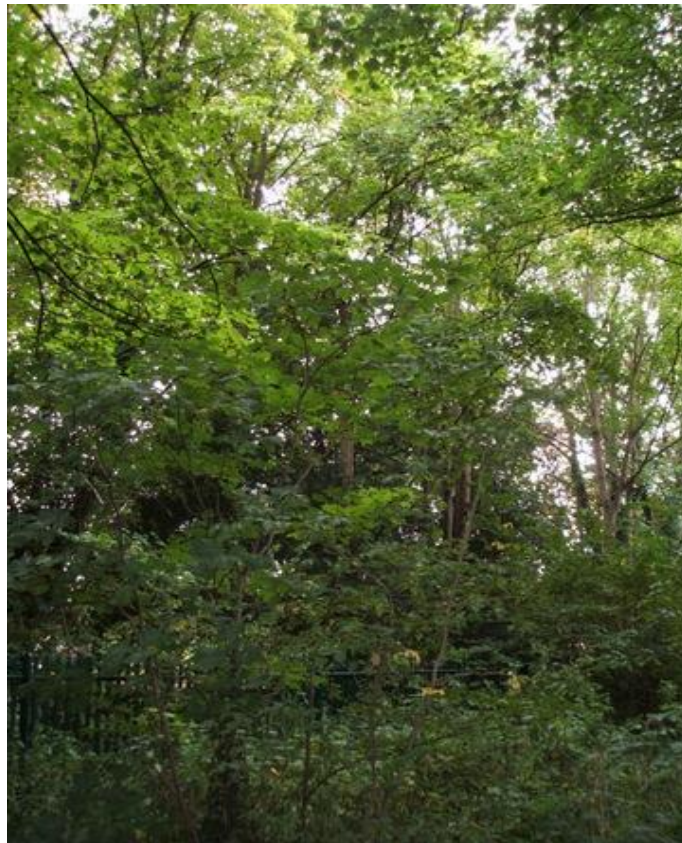
Dense undergrowth between trees next to wall.

- 7.7 Clearing approximately a 2m strip of the dense undergrowth and thick epicormic growth along the wall is necessary for the remedial works to proceed, but is also beneficial to the copse providing more light and growing space for it's trees and possibly increasing the bio-diversity of the area. No impact to remaining trees.

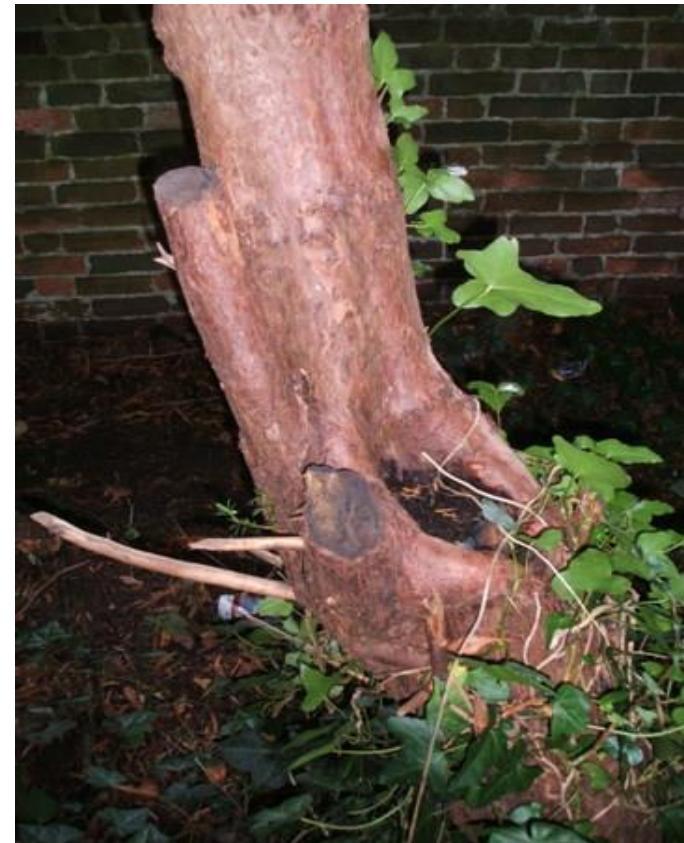
- 7.6 Small self set trees T5, T10, and T12 are Yew (*Taxus baccata*) trees and together with an Elder T29 (*Sambucus nigra*) have grown within the dense undergrowth beneath the more developed trees. These have grown to a poor form with defects due to the suppressed light conditions caused from surrounding trees. It is recommended to remove these trees to create more developing space for the adjacent trees and also provide more suitable locations for the stabilisation equipment.  
(See **Appendix 1**: Photographs of surveyed site).  
(See **Appendix 2**: DRAWING 3: Recommended Tree Removal Plan).

Small Yew with a cavity with decay on tree T10.
