23 Tower Street  
Emsworth  
Hampshire  
PO10 7BH

Replacement of Existing Windows

## **Heritage Statement**

February 2018

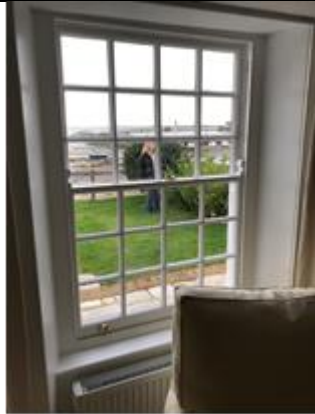
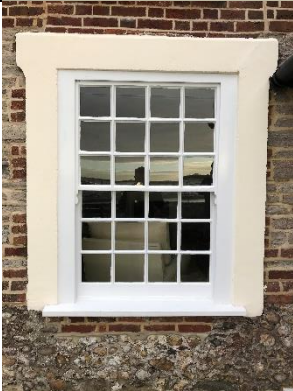
| W.03 | | | White Timber frame sash |

Work was undertaken prior to this proposal (2018) in 2015 to restore the building. This included extensive repair and decoration work to the windows. The work undertaken on these windows included scarfing some of the framework with new timber. One window that this repair work was carried out on was W.03 where timber covers were placed at the bottom of the uprights of the frame.

Despite the works carried out in 2015, the windows continue to leak extensively during high winds and heavy rain and we therefore propose to replace the windows with exact replicas of the existing windows to stop the leaking and to retain the buildings heritage.

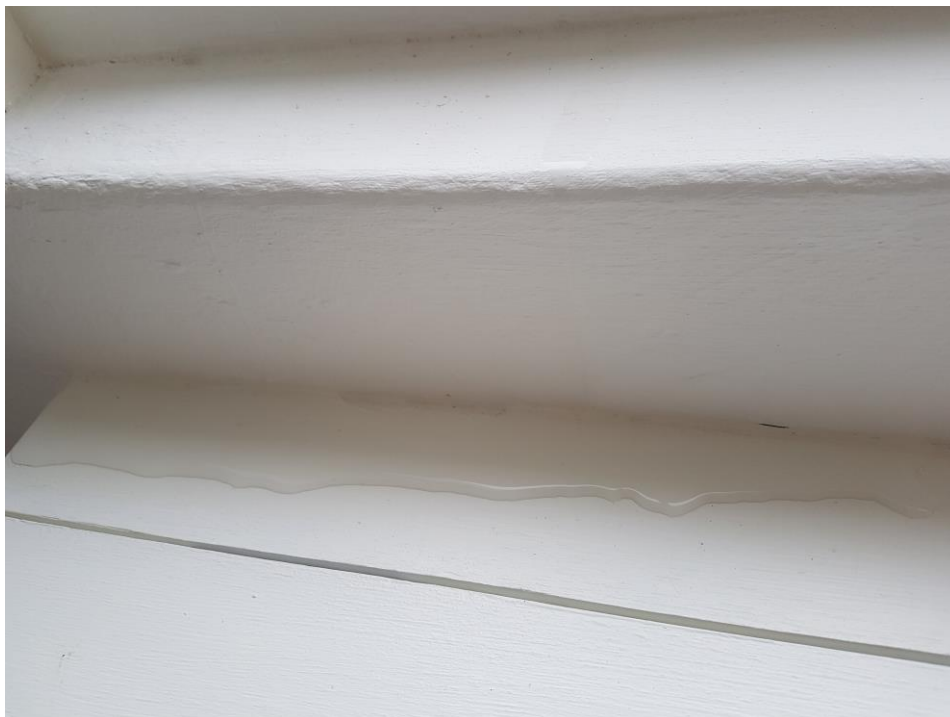
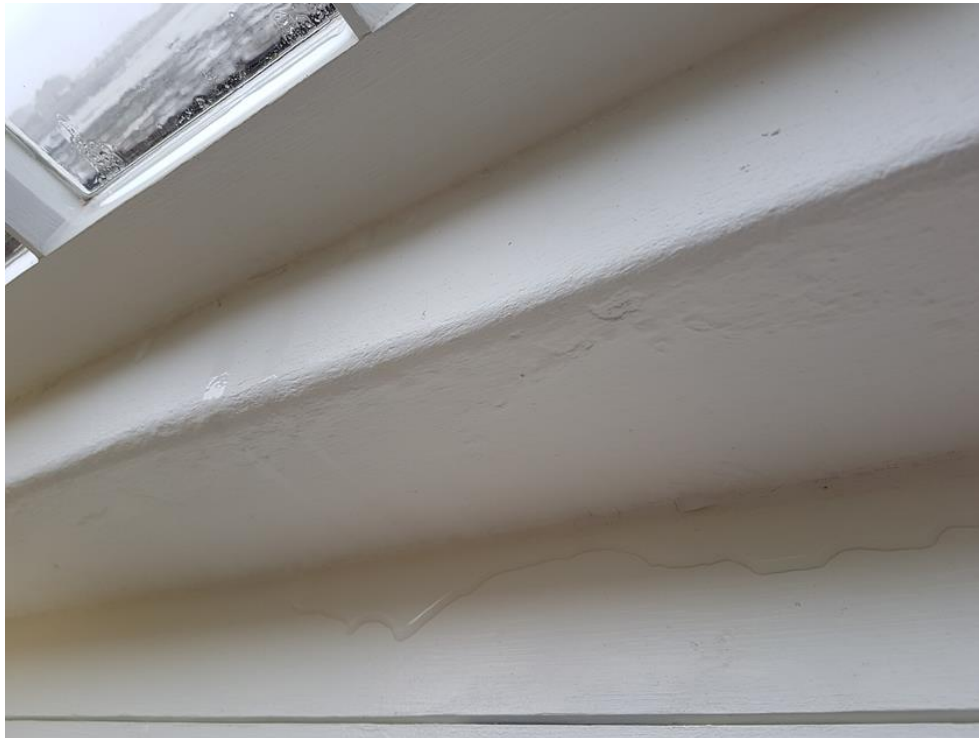
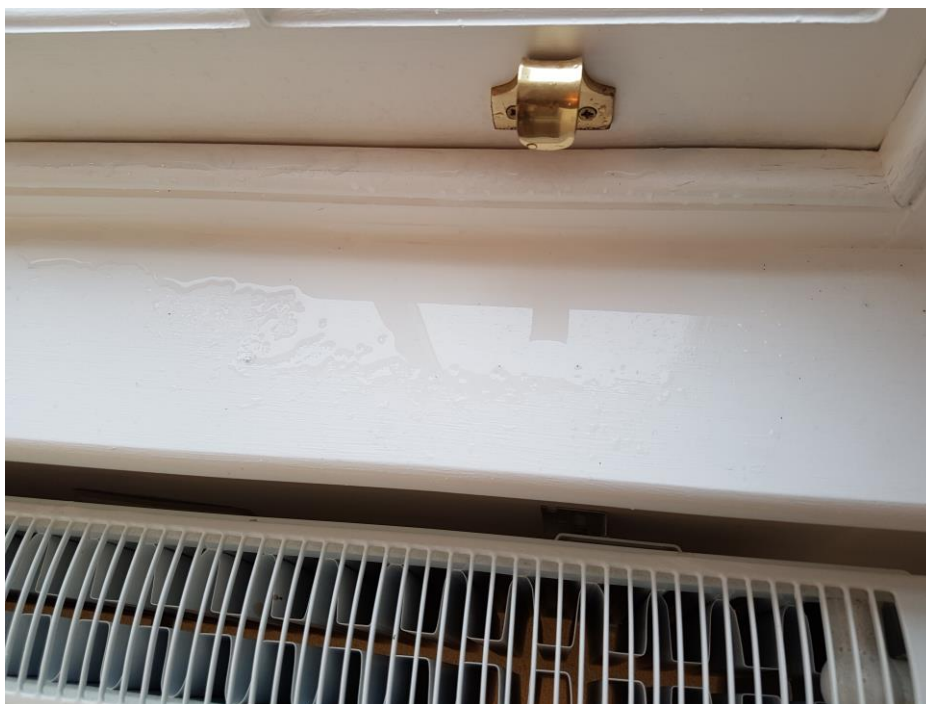
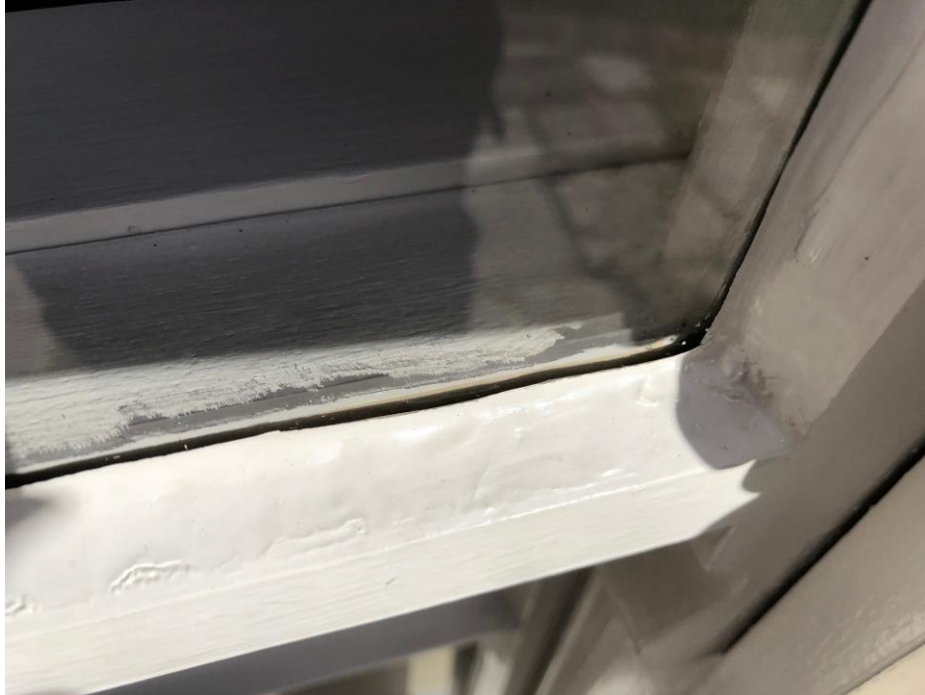
**The following photos show the build up of water internally due to leakages through the windows.**

Despite there being restoration and decoration work undertaken on the windows in 2015, there is still issues with water leakage and we believe the only way to fix this is to replace the existing windows.
