# Visual Tree Assessment

**29 St Catherine Road Hayling Island PO11 0HF.**

Investigation by Kim Gifford

**Date 23<sup>rd</sup> September 2018**

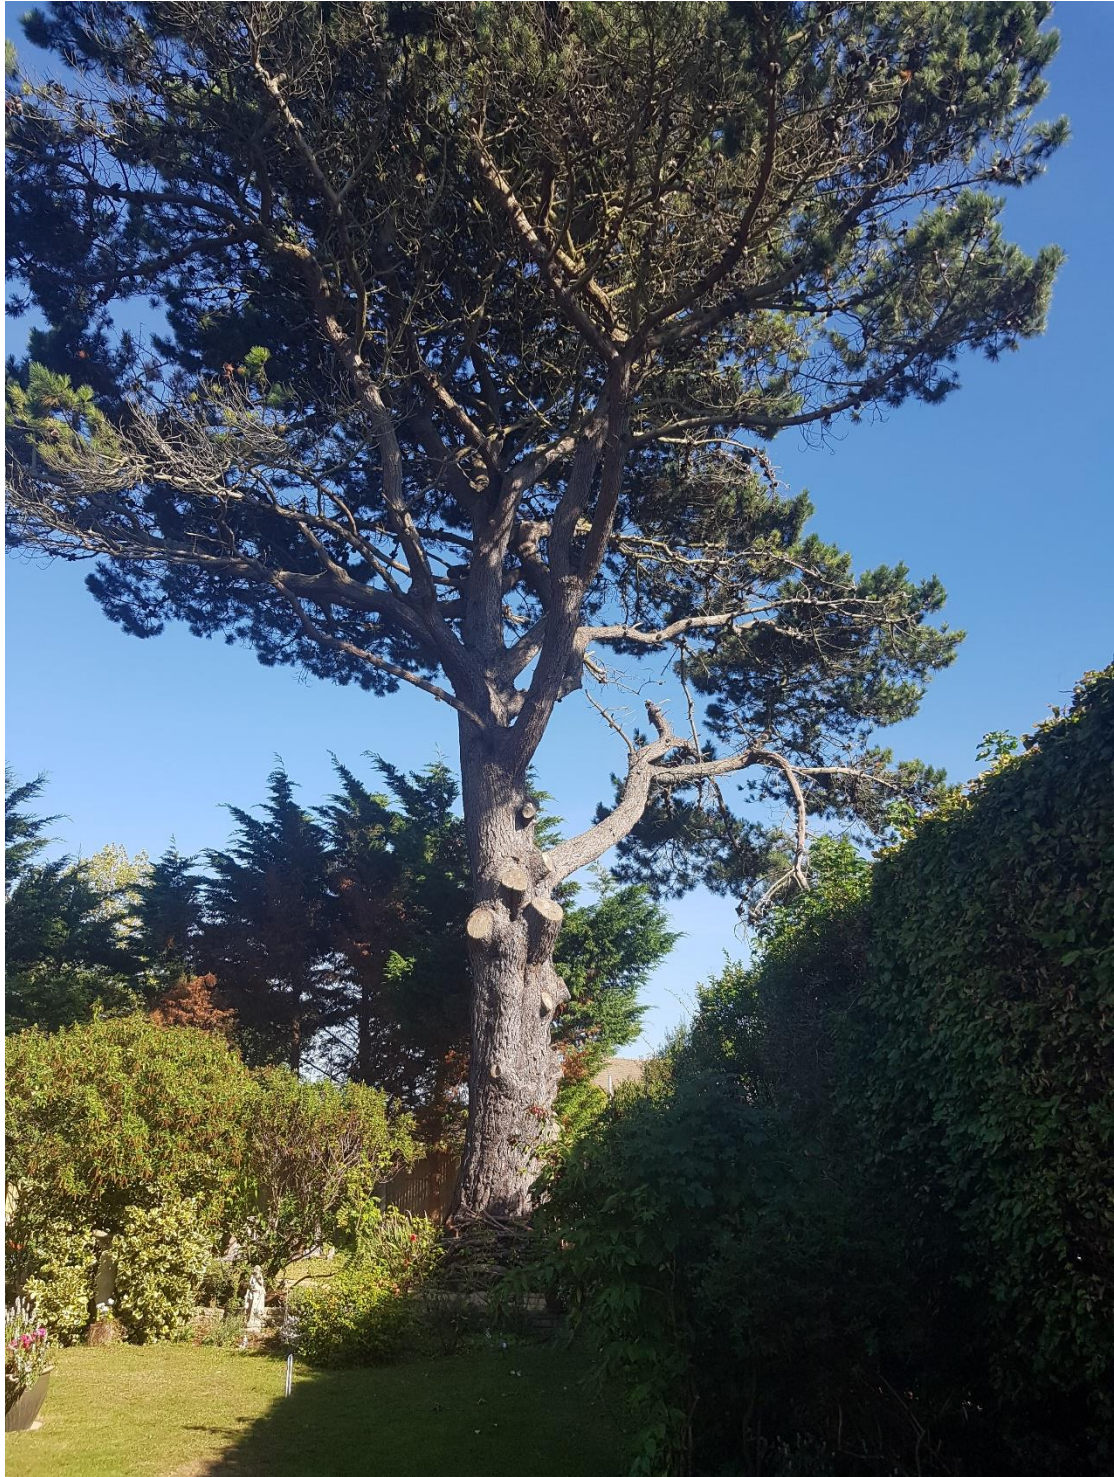
**Upper Crown: Extended branch structure overall with heavily overweighted branch ends.**

*Figure 1 – over extended crown*

It is, therefore, appropriate to recommend the T1 Monterey Pine is completely removed within the future on the ground of health and safety.

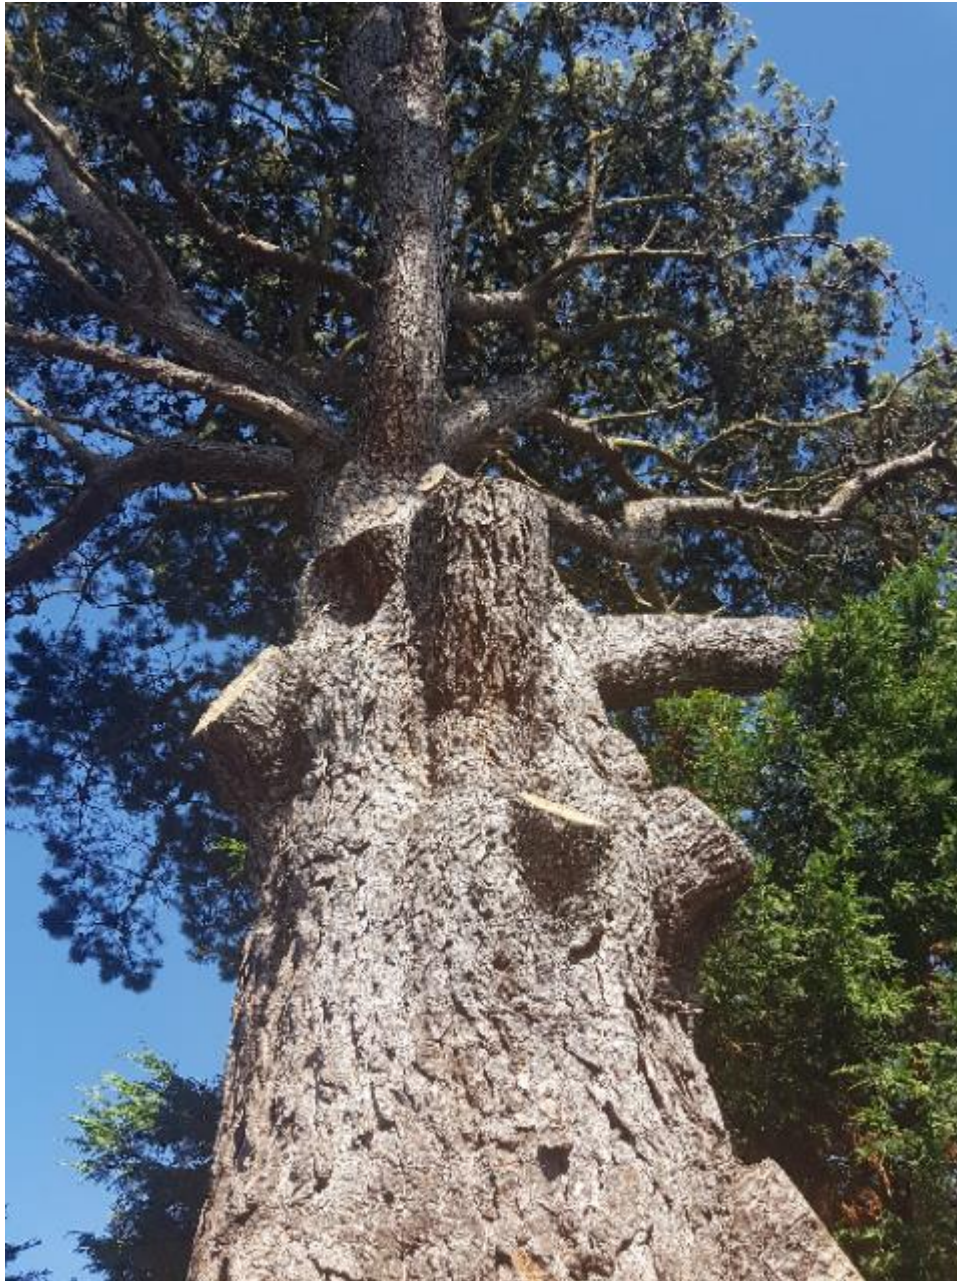
**General description:** Tree position situated in the east corner of the rear garden of 29 St Catherines Road. The crown predominately overhangs three gardens. This specimen is in rapid decline overall with historic and recent major branch breakage and failure progressively throughout. There is evidence of many major branch wounds extensively on the main stem up to 12m on the south and southwestern side of the trunk.

**Trunk condition: 5m to the main union, occlusions on stem occluding and occluded poor pruning wounds from old cuts. Many old wounds close together from the regular cutting back and branch removal.**

*Figure 2 - branch wounds in the main trunk*

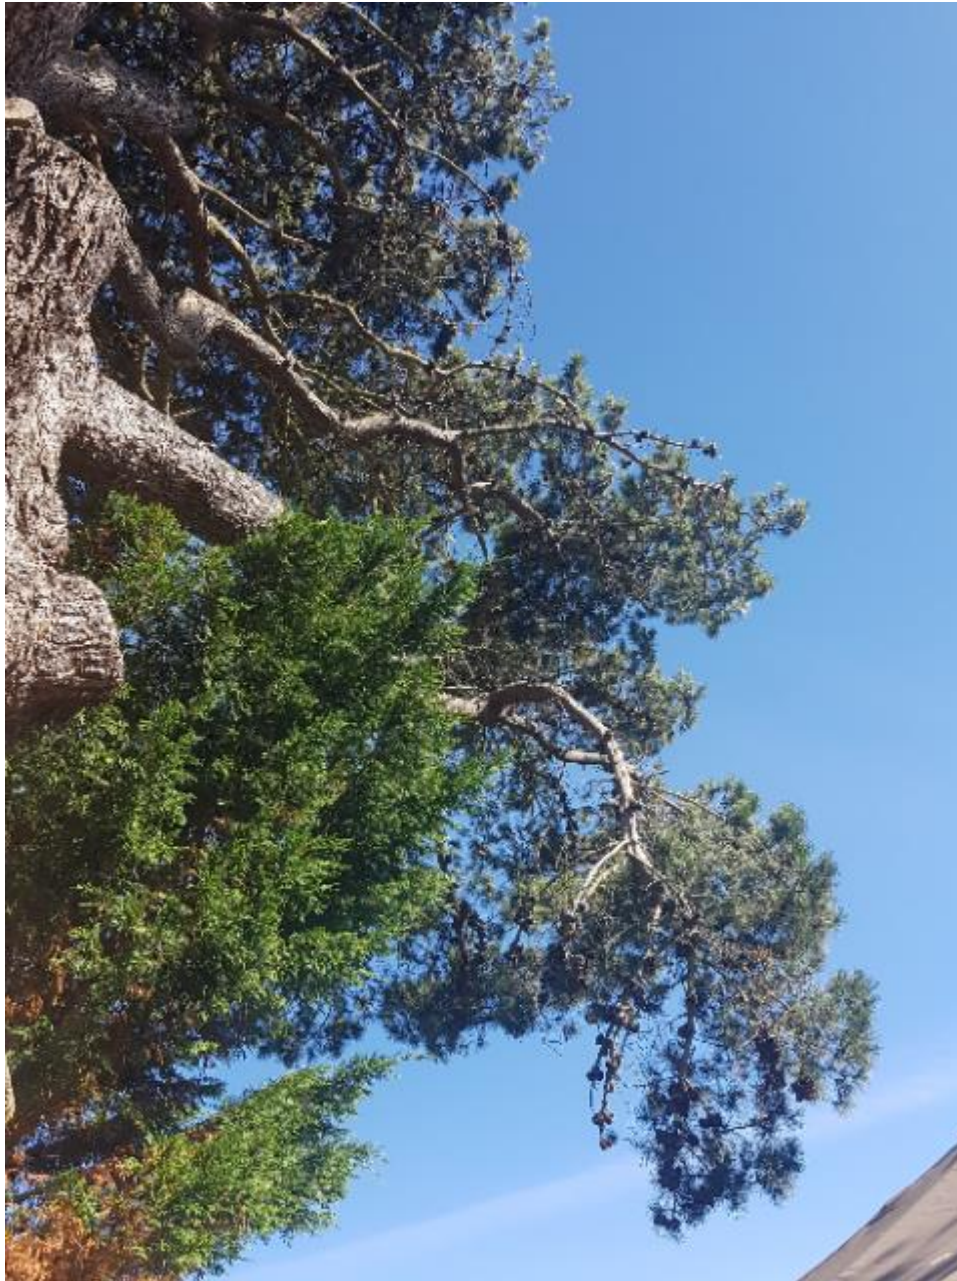
This specimen is in extensive decline evident by the continual major branch breakage throughout the crown. This renders the T1 Monterey Pine a major health and safety hazard in this location. The Pine has progressively lost over 22 major limbs over the years and recently dropped limbs into a neighbouring garden.

*Figure 3 - broken hanging branches*

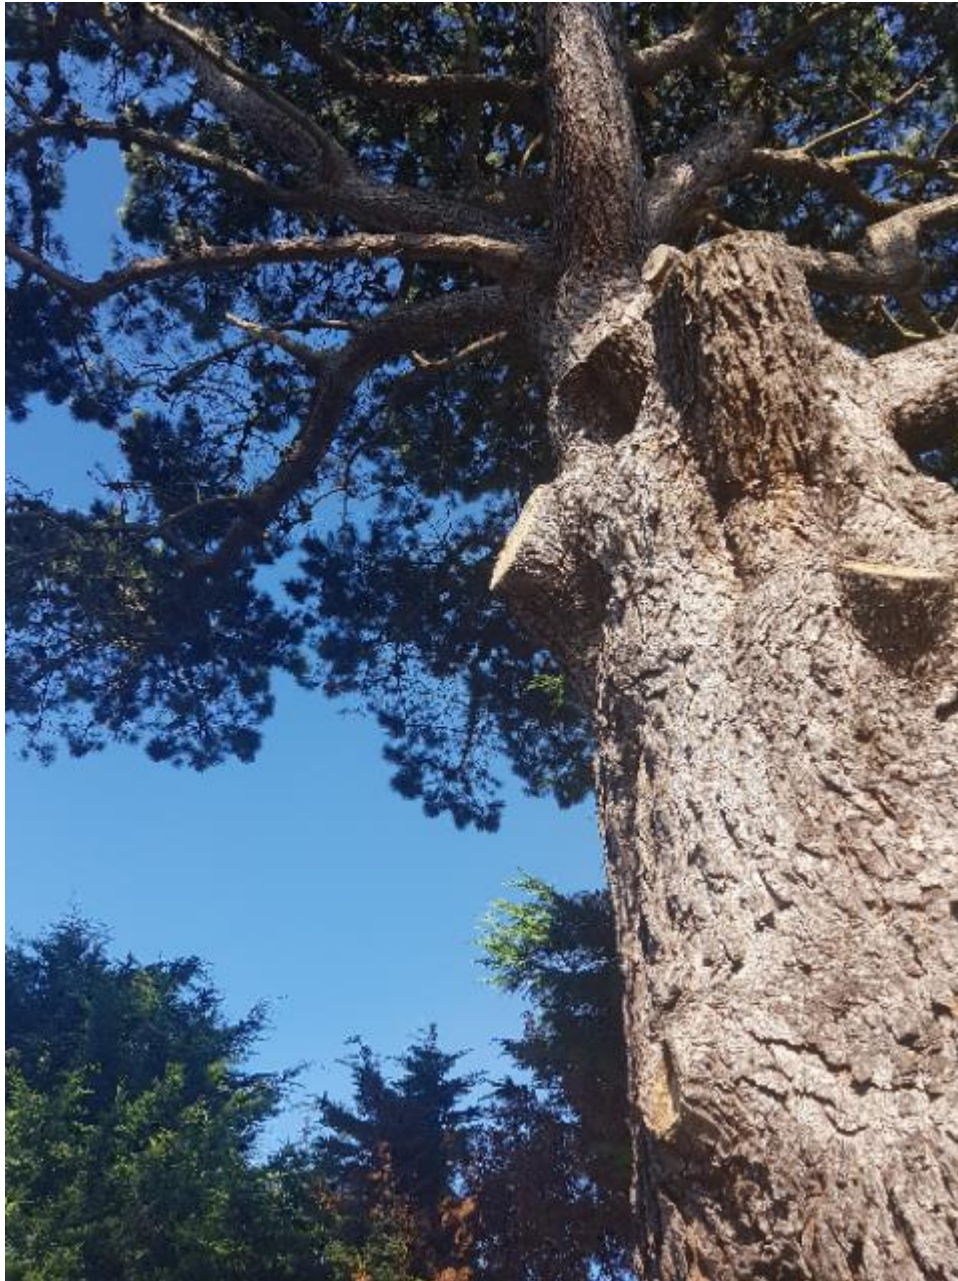
The crown is now unbalanced and exposed to high winds. This exposure leads to abnormal stress on the remaining branch structure.

*Figure 4 - unbalanced exposed crown*
