## Section Inspection - 06/04/2018 - MH2X

| Road: | 42 Hulbert Road | Inspected Length: | 22.51 m | Upstream Pipe Depth: | 0.300 m |

Project Name  
42 HULBERT ROAD

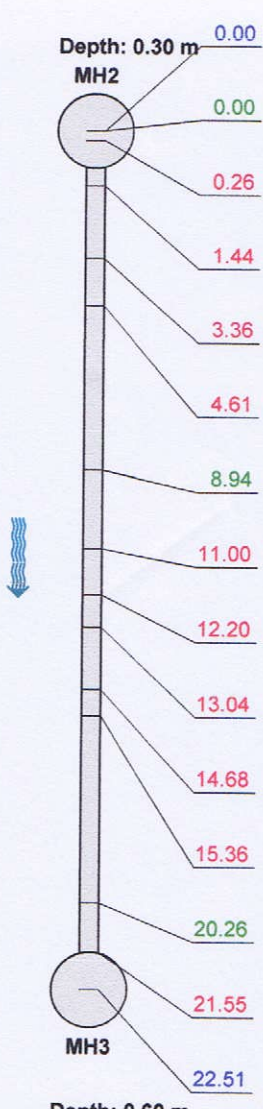
| Scale: 1:196 | Position [m] | Code | Observation | MPEG | Photo | Grade |
|---|---|---|---|---|---|---|
| | 0.26 | CCJ | Crack, circumferential at joint, at 12 o'clock | 00:00:18 | | 2 |
| | 1.44 | CCJ | Crack, circumferential at joint, at 12 o'clock | 00:00:33 | | 2 |
| | 3.36 | CCJ | Crack, circumferential at joint, at 12 o'clock | 00:00:52 | | 2 |
| | 4.61 | CCJ | Crack, circumferential at joint, at 12 o'clock | 00:01:07 | | 2 |
| | 8.94 | RF | Roots, fine | 00:01:48 | | 2 |
| | 11.00 | CCJ | Crack, circumferential at joint, at 12 o'clock | 00:02:13 | | 2 |
| | 12.20 | CCJ | Crack, circumferential at joint, at 12 o'clock | 00:02:30 | | 2 |
| | 13.04 | CCJ | Crack, circumferential at joint, at 12 o'clock | 00:02:41 | | 2 |
| | 14.68 | CC | Crack, circumferential, at 12 o'clock | 00:03:08 | | 2 |
| | 15.36 | CCJ | Crack, circumferential at joint, at 12 o'clock | 00:03:20 | | 2 |
| | 20.26 | ID | Infiltration, dripping, at 12 o'clock | 00:04:11 | | |
| | 21.55 | FMJ | Fracture, multiple at joint, at 12 o'clock | 00:04:29 | | 4 |

| Scale: 1:196 | Position [m] | Code | Observation | MPEG | Photo | Grade |
|---|---|---|---|---|---|---|
| | 22.51 | MHF | Finish node type, manhole, reference number: MH3: HP JET AND LINER NEEDED | 00:04:38 | | |
