Sites:

Site Visit Date: **20<sup>th</sup> February 2018**

Client: **Vivid Housing Association**

**Prepared by  
Jonnie Setterfield BSc (Hons)  
Our Ref 0218-2315-JGS (3)  
February 2018**

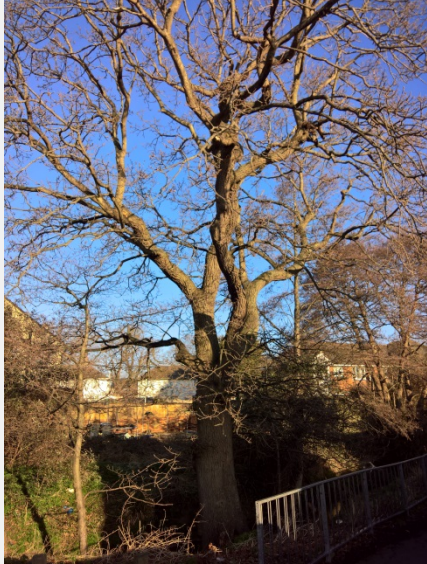
**T3259 - Oak**

| Tree No. | Tree Species | Hgt (m) | Past Management | Age Class | Risk Target | TPO | Defects | Works | Work Priority |
|---|---|---|---|---|---|---|---|---|---|
| T3259<br>Tag:1363 | Oak | 15m to 20m | No significant recent management | Mature | High (Inspect again within 2018) | No protection<br>Havant online search | Leaning tree over high target area, located on stream bank. Significant basal decay cavity on stem, multiple pruning wounds on main stem. Major decay noted within stem. | Pollard to 5m in height leaving main stem as habitat. | Works with 6 months |

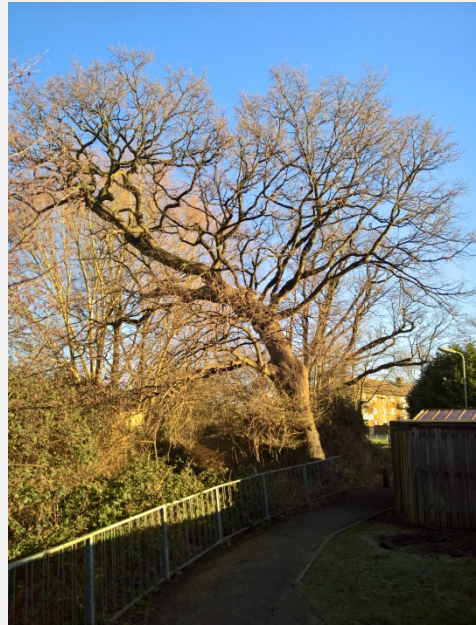
**T3255 - Oak**

| Tree No. | Tree Species | Hgt (m) | Past Management | Age Class | Risk Target | TPO | Defects | Works | Work Priority |
|---|---|---|---|---|---|---|---|---|---|
| T3255<br>Tag:1361 | Oak | 15m to 20m | No significant recent management | Mature | High (Inspect again within 2018) | No protection<br>Havant online search | Leaning tree over high target area, located on stream bank. Significant basal decay cavity on stem, multiple pruning wounds on main stem. Major decay noted within stem. | Pollard to 4m in height leaving main stem as habitat. | Works with 6 months |

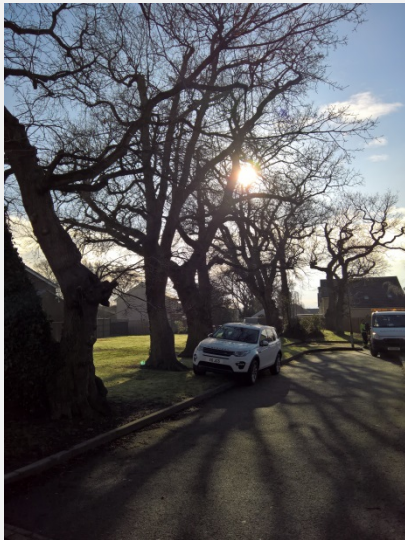
**T3172- T3179 - Oaks**

T3174, T3175, T3177, T3178 and T3179, were noted to show no signs of major internal decay on the main stem, however it hosts many long lateral limbs over the adjacent building and paths. Given this trees location we have recommended that the trees are subjected to a reduction of the long lateral limbs is implemented.

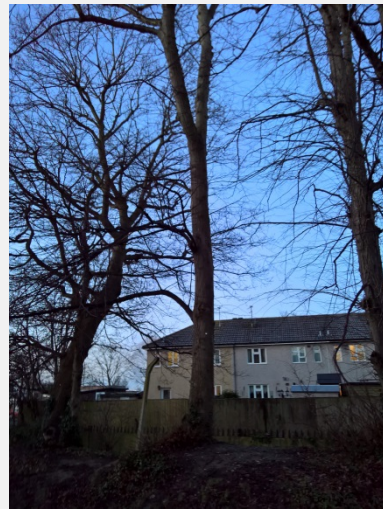
**T3193 - Lime**

| Tree No. | Tree Species | Hgt (m) | Past Management | Age Class | Risk Target | TPO | Defects | Works | Work Priority |
|---|---|---|---|---|---|---|---|---|---|
| T3193<br>Tag:1355 | Lime | 15m to 20m | No significant recent management | Mature | High (Inspect again within 2018) | No protection<br>Havant online search | Major basal decay cavity from removed / failed twin stem. 10-20% crown dieback with moderate dead wood. Epicormics growth on main stem. Slightly asymmetric canopy. | Pollard to 4m in height. | Works with 6 months |

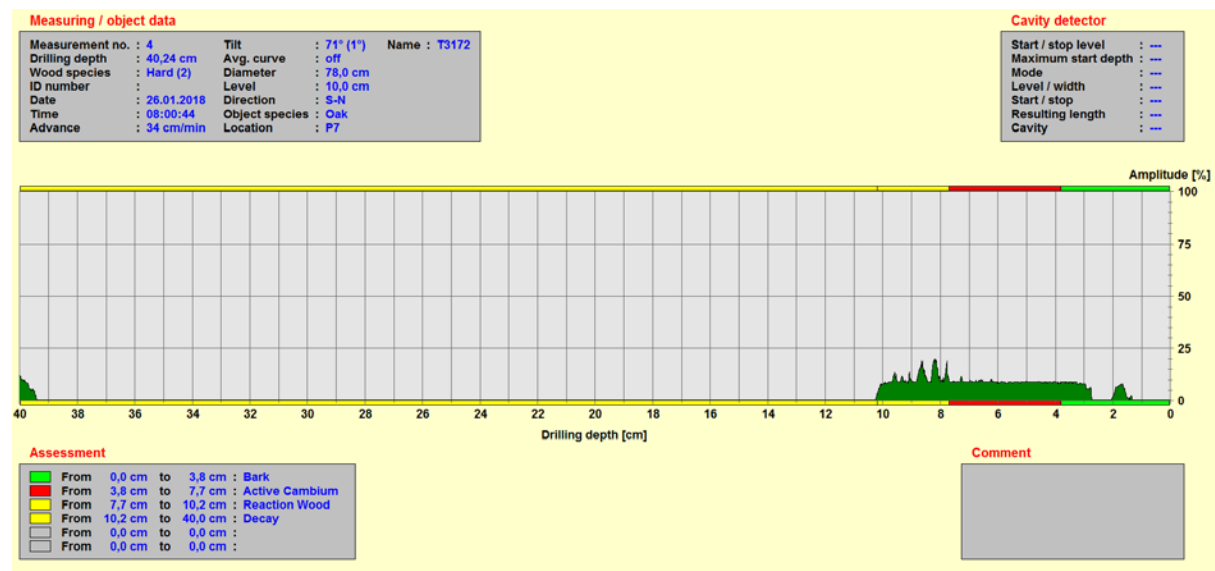
## T3172, Measurement 1

| Tree No. | Tree Species | Hgt (m) | Past Management | Age Class | Risk Target | TPO | Defects | Works | Work Priority |
|---|---|---|---|---|---|---|---|---|---|
| T3172<br>Tag:1337 | Oak | 15m to 20m | No significant recent management | Mature | High (Inspect again within 2018) | TPO Number: 1370<br>Tree Number: T6 | Major decay noted on southern side of stem, multiple pruning wounds on main stem. Subject to previous reduction. Moderate crown deadwood. Tree located in High Risk Zone. | Arrange meeting with Tree officer. Pollard to 3m (Monolith). Replacement plant area with Oak trees. | Works with 6 months |

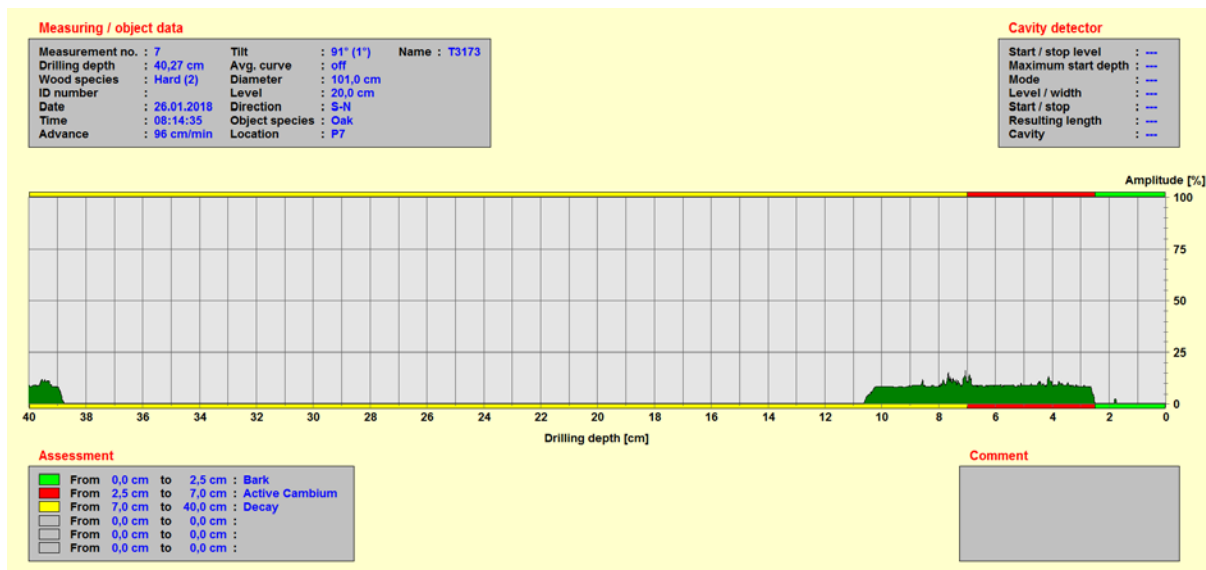
## T3173, Measurement 1

| Tree No. | Tree Species | Hgt (m) | Past Management | Age Class | Risk Target | TPO | Defects | Works | Work Priority |
|---|---|---|---|---|---|---|---|---|---|
| T3173<br>Tag:1338 | Oak | 15m to 20m | No significant recent management | Mature | High (Inspect again within 2018) | TPO Number: 1370<br>Tree Number: T8 | Major decay noted on Western side of stem, multiple pruning wounds on main stem. Subject to previous reduction. Moderate crown deadwood. Tree located in High Risk Zone. | Arrange meeting with Tree officer. Pollard to 3m (Monolith). Replacement plant area with Oak trees. | Works with 6 months |

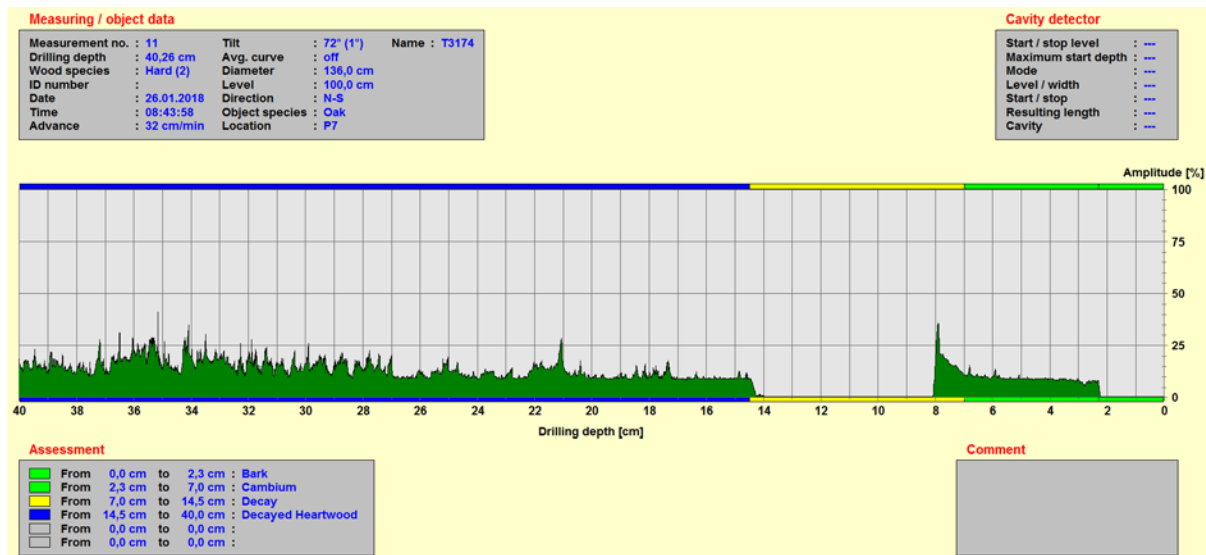
## T3174, Measurement 2

| Tree No. | Tree Species | Hgt (m) | Past Management | Age Class | Risk Target | TPO | Defects | Works | Work Priority |
|---|---|---|---|---|---|---|---|---|---|
| T3174<br>Tag:1339 | Oak | 15m to 20m | No significant recent management | Mature | High (Inspect again within 2018) | TPO Number: 1370<br>Tree Number: T7 | Major decay noted on Western side of stem, multiple pruning wounds on main stem. Subject to previous reduction. Moderate crown deadwood. Tree located in High Risk Zone., Major basal wounding. | Arrange meeting with Tree officer. Reduce to previous point 2-3m reduction, remove deadwood, climbing inspection. | Works with 6 months |

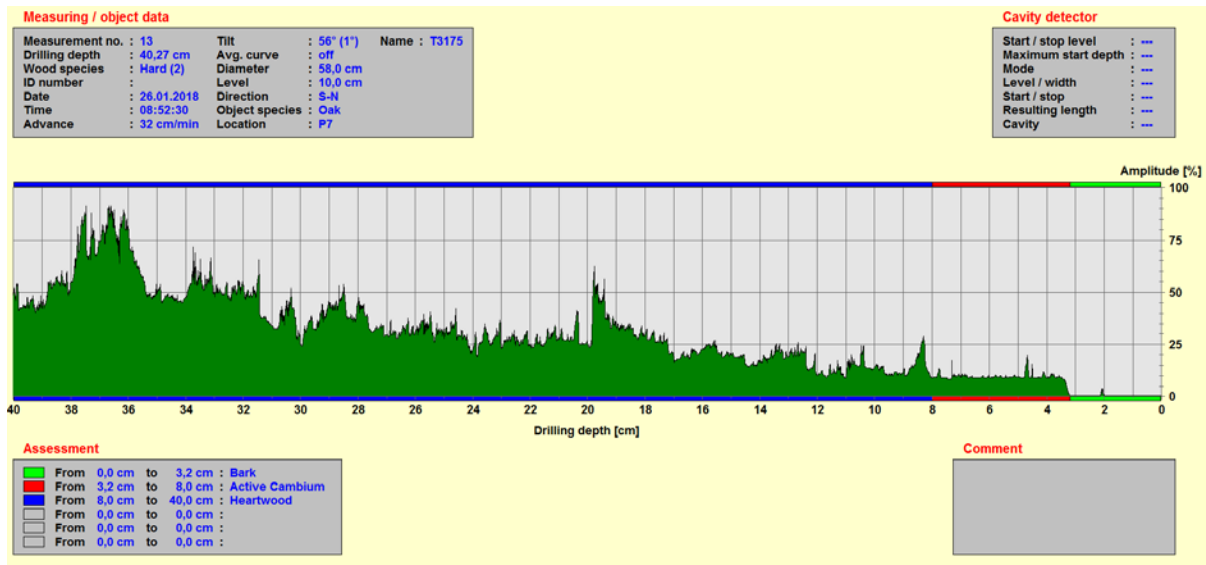
## T3175, Measurement 1

| Tree No. | Tree Species | Hgt (m) | Past Management | Age Class | Risk Target | TPO | Defects | Works | Work Priority |
|---|---|---|---|---|---|---|---|---|---|
| T3175<br>Tag:1340 | Oak | 15m to 20m | No significant recent management | Mature | High (Inspect again within 2018) | TPO Number: 1370<br>Tree Number: T5 | No gross defect noted, tree leaning over high target area, multiple pruning wounds on main stem. Minor crown dead wood noted. | Arrange meeting with Tree officer. Reduce long lateral limbs over car parking area by 1-2m. | Works with 6 months |

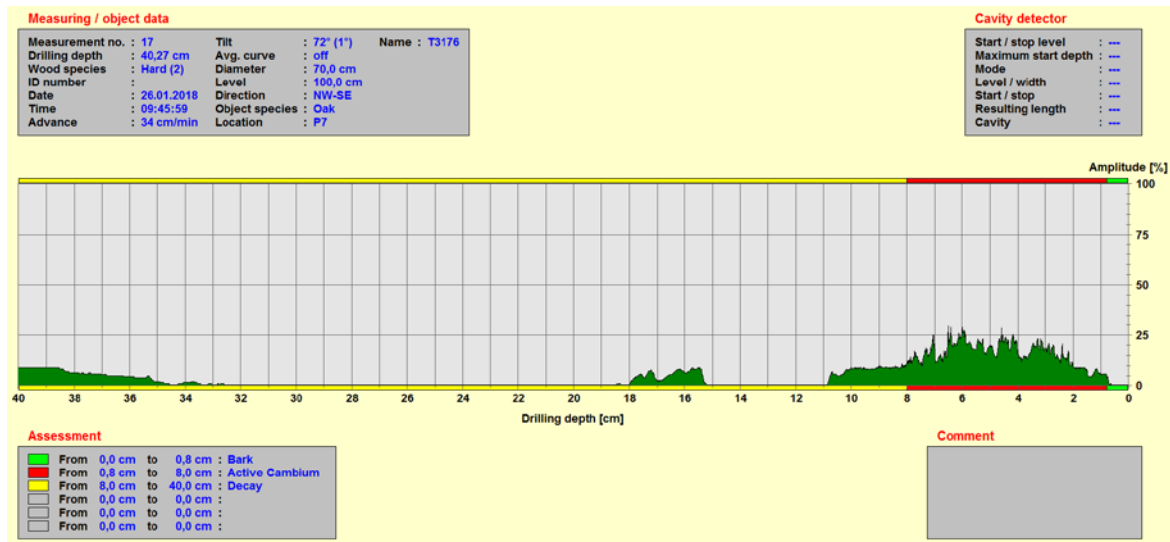
## T3176, Measurement 2

| Tree No. | Tree Species | Hgt (m) | Past Management | Age Class | Risk Target | TPO | Defects | Works | Work Priority |
|---|---|---|---|---|---|---|---|---|---|
| T3176<br>Tag:0980 | Oak | 15m to 20m | No significant recent management | Mature | High (Inspect again within 2018) | TPO Number: 1370<br>Tree Number: T4 | Decay wound at base on west side with moderate decay. Asymmetric canopy, moderate crown dead wood/ crown retrenchment. | Arrange meeting with Tree officer. Pollard to 6m. | Works with 6 months |

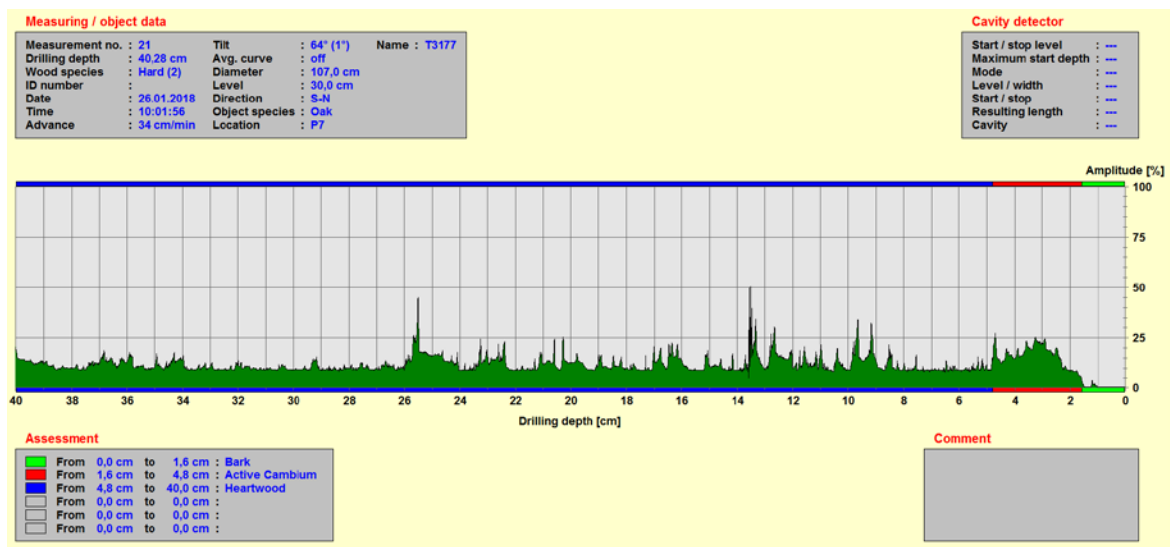
## T3177, Measurement 3

| Tree No. | Tree Species | Hgt (m) | Past Management | Age Class | Risk Target | TPO | Defects | Works | Work Priority |
|---|---|---|---|---|---|---|---|---|---|
| T3177<br>Tag:1341 | Oak | 15m to 20m | No significant recent management | Mature | High (Inspect again within 2018) | TPO Number: 1370<br>Tree Number: T3 | 10-20% crown retrenchment, moderate crown dead wood. Multiple pruning wounds on main stem. Wounding at base of tree with moderate decay noted, slightly asymmetric canopy. | Arrange meeting with Tree officer. Reduce by 1-2m all round to previous reduction points. | Works with 6 months |

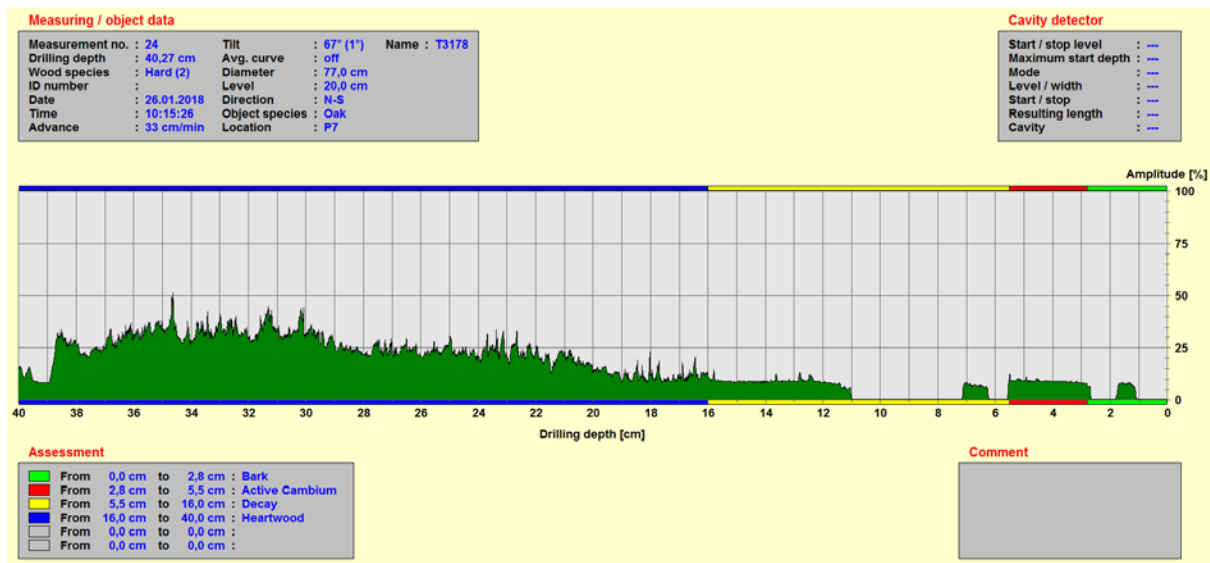
## T3178, Measurement 3

| Tree No. | Tree Species | Hgt (m) | Past Management | Age Class | Risk Target | TPO | Defects | Works | Work Priority |
|---|---|---|---|---|---|---|---|---|---|
| T3178<br>Tag:1342 | Oak | 15m to 20m | No significant recent management | Mature | High (Inspect again within 2018) | TPO Number: 1370<br>Tree Number: T2 | No gross defect noted, 10-20% crown retrenchment, moderate crown dead wood noted, multiple pruning wounds on main stem, wounding at base of tree minor/ moderate decay noted. Asymmetric canopy. Low vitality noted, Twin stemmed tree at 4m in height with moderate included union. | Arrange meeting with Tree officer. Reduce by 1-2m all round to previous points of reduction, remove deadwood. | Works with 6 months |

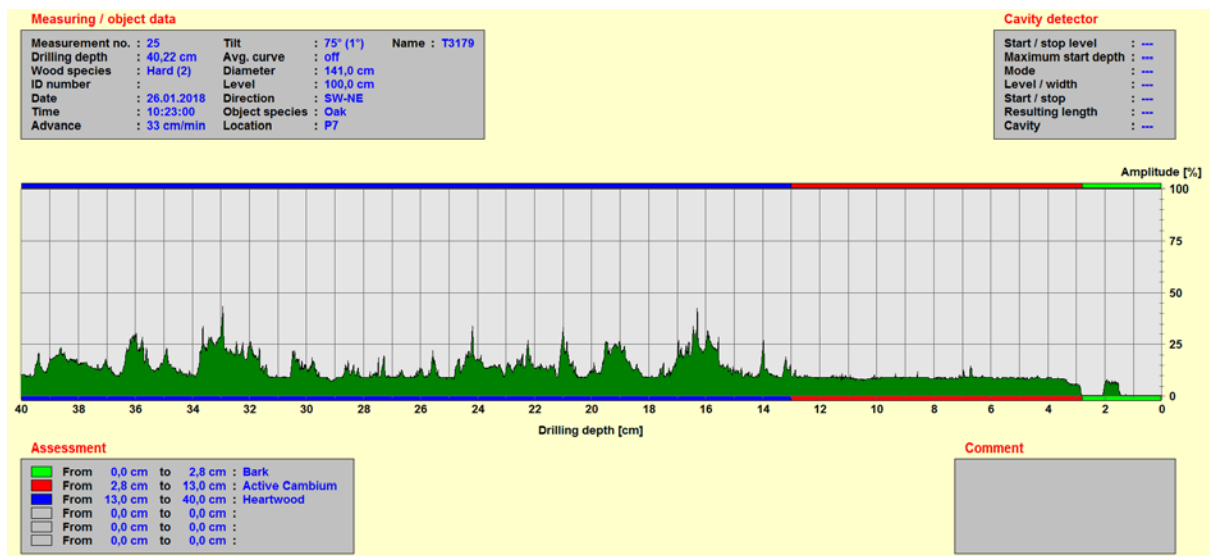
## T3179, Measurement 1

| Tree No. | Tree Species | Hgt (m) | Past Management | Age Class | Risk Target | TPO | Defects | Works | Work Priority |
|---|---|---|---|---|---|---|---|---|---|
| T3179<br>Tag:0926 | Oak | 15m to 20m | No significant recent management | Mature | High (Inspect again within 2018) | TPO Number: 1370<br>Tree Number: T1 | No gross defect noted, unable to fully inspect due to Ivy. Twin stem at 1.4m in height with moderate included union. Evidence of previous branch failure, multiple pruning wounds on main stem. Subject to previous reduction. | Arrange meeting with Tree officer. 15% crown thin all round, remove deadwood and undertake climbing inspection. Remove ivy re-inspect. | Works with 6 months |
