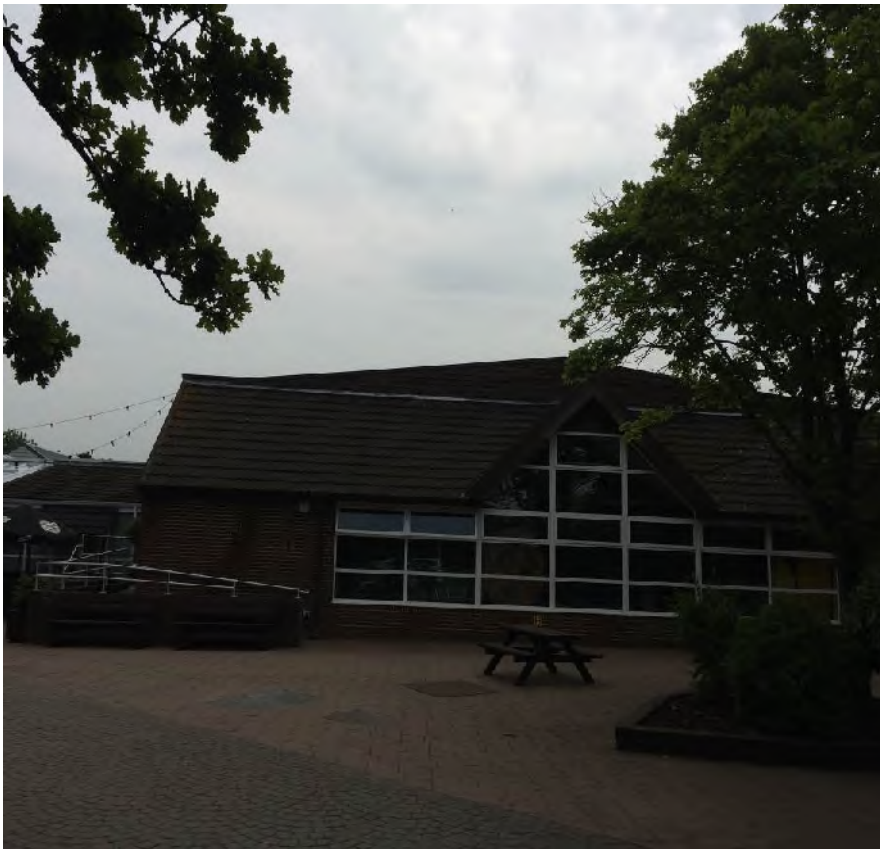
**PHOTOPLATE 151**

External Ballroom

Corrugated roof sheets forming pitched roof

Chrysotile

Very low

Mark and manage

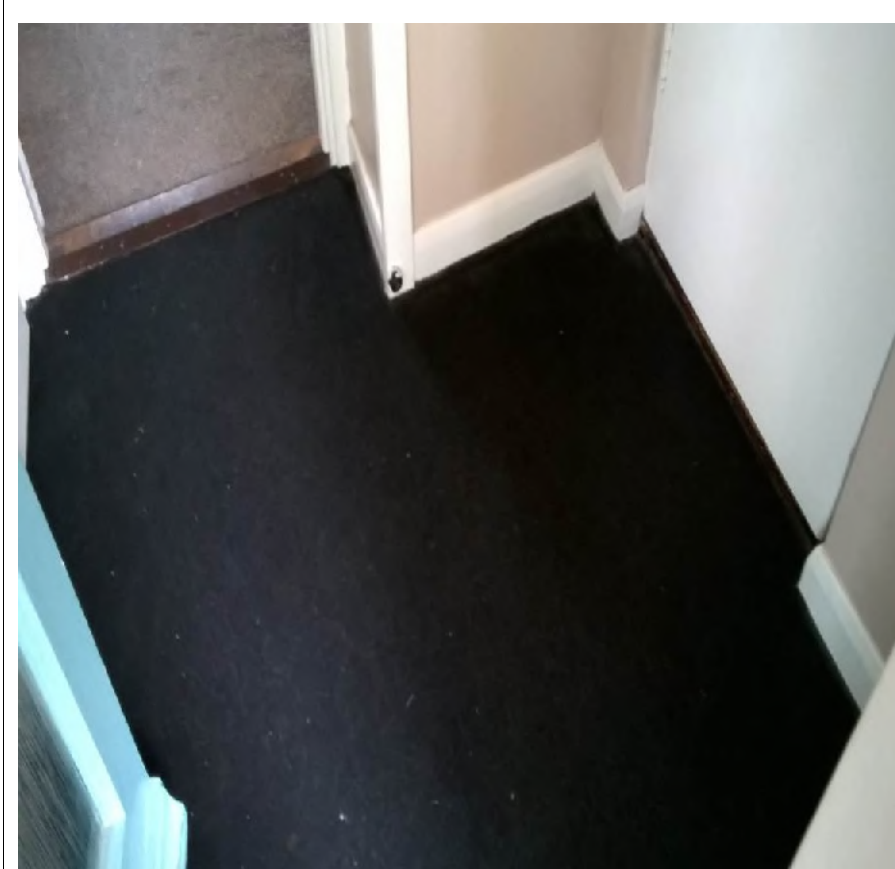
**PHOTOPLATE 153**

Ground Floor Hall

Floor tiles (Black) beneath cupboard  
carpet (cupboard removed)

Chrysotile

Very low

Mark and manage

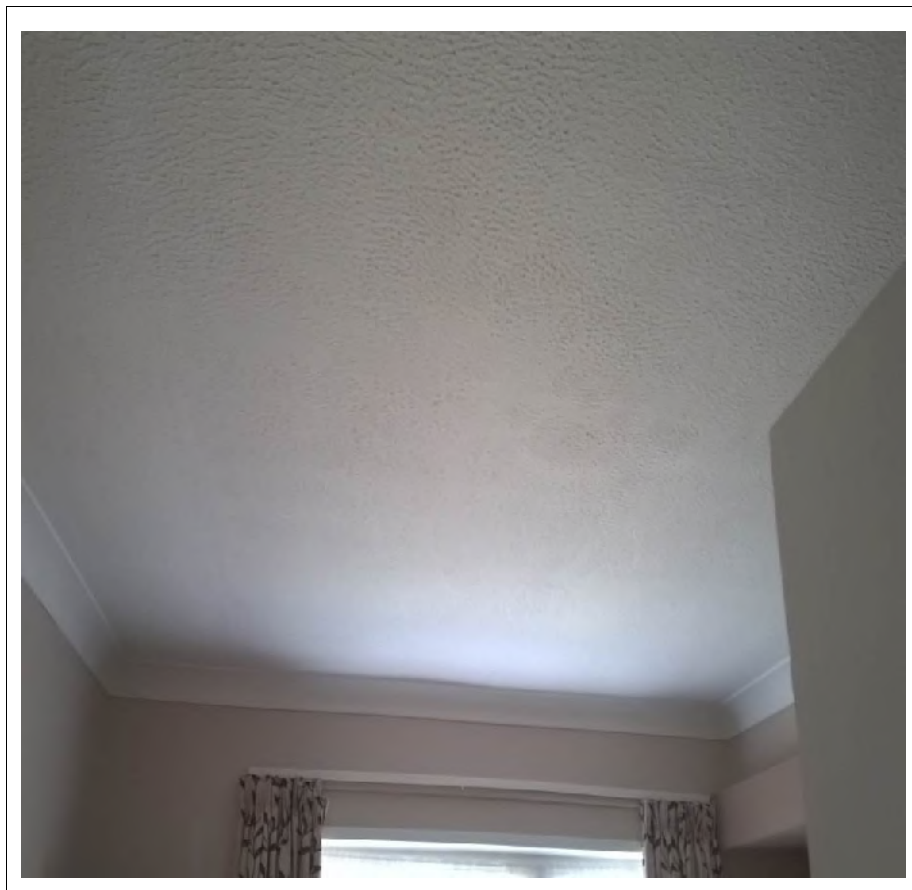
**PHOTOPLATE 155**

Ground Floor Bathroom

Textured coating to ceiling (removed but continues to bedroom &amp; hall)

Chrysotile

Very low

Mark and manage

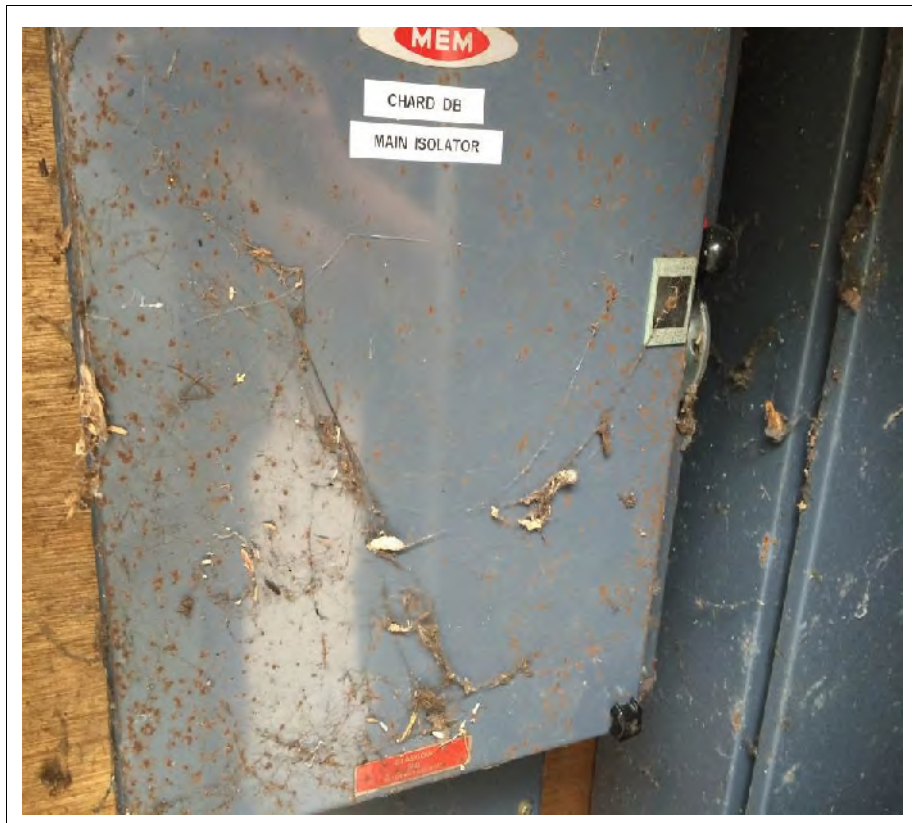
**PHOTOPLATE 156**

Ground Floor Electrical Cupboard

Woven flash guards within electrical switch gear

Presumed Chrysotile

Low

Mark and manage

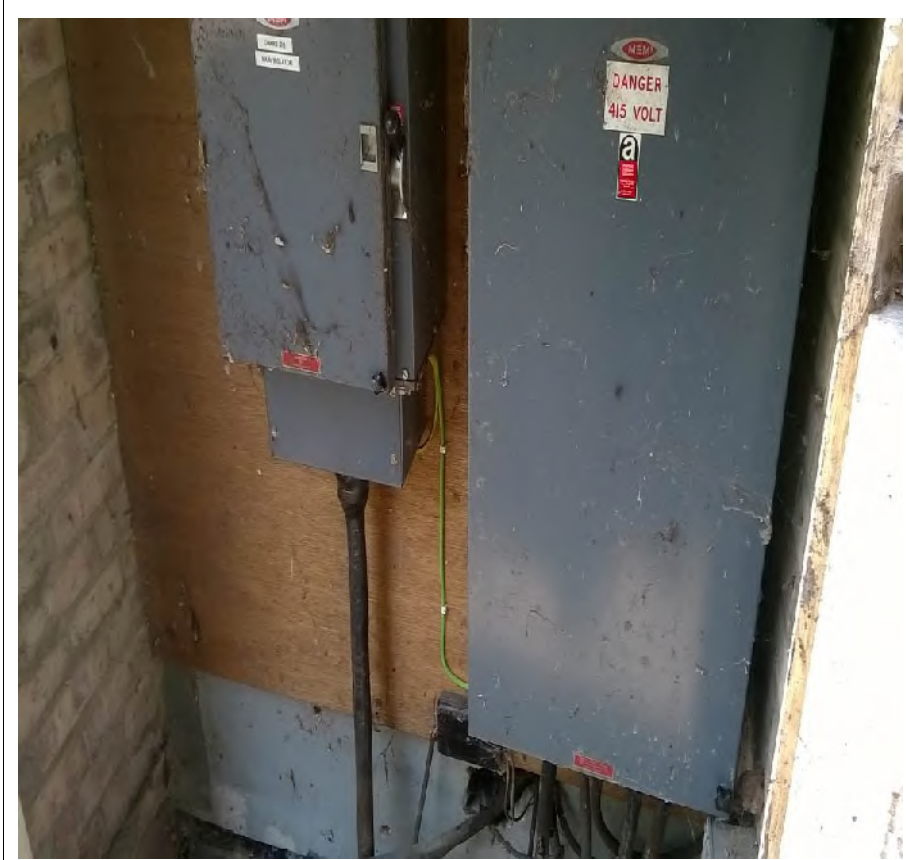
PHOTOPLATE 159

Ground Floor Electrical Cupboard

Resin pipe leading into floor

Chrysotile

Very low

Mark and manage

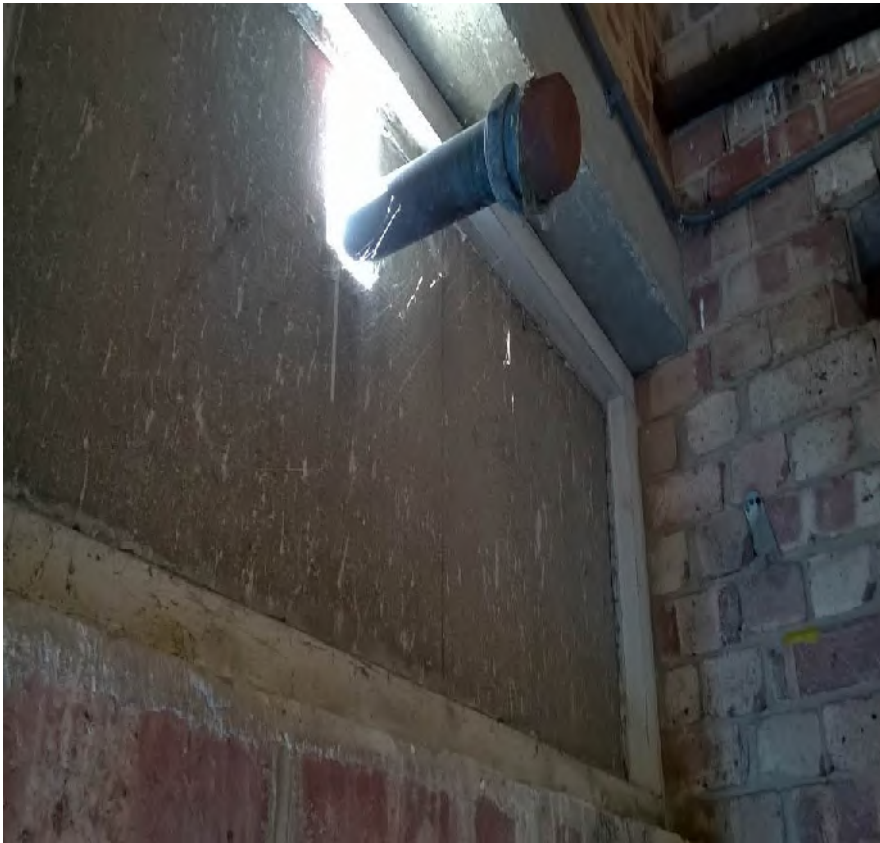
**PHOTOPLATE 163**

Ground Floor Store

Infill panel above window

Chrysotile

Very low

Mark and manage

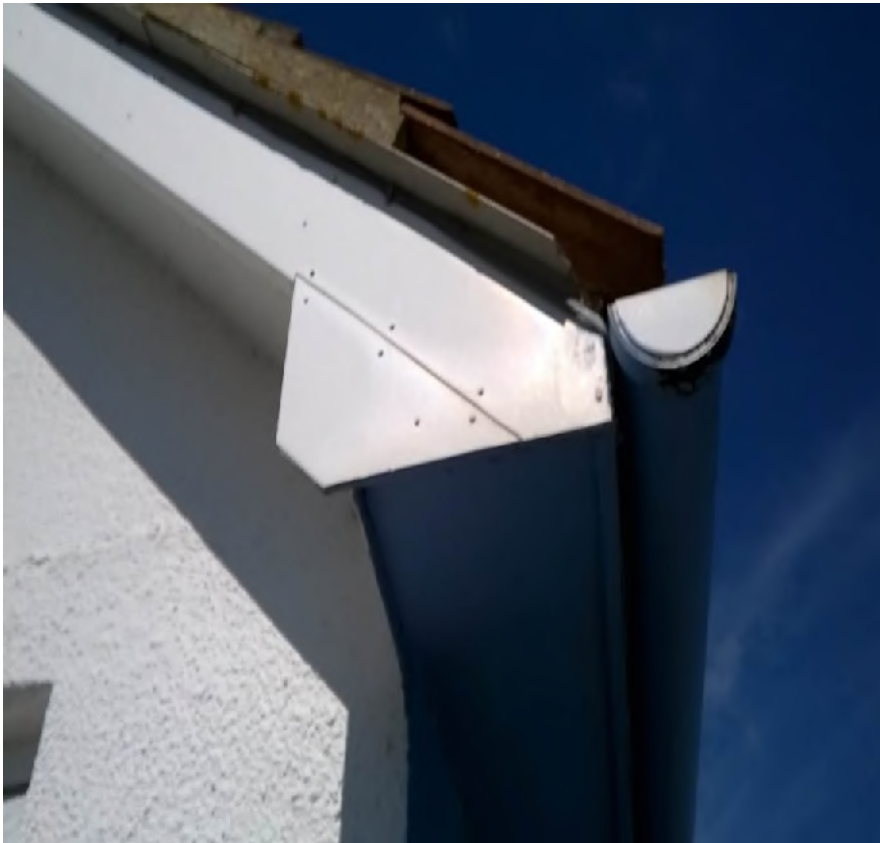
PHOTOPLATE 165

External Stores

Verge boards to gable end

Chrysotile

Very low

Mark and manage

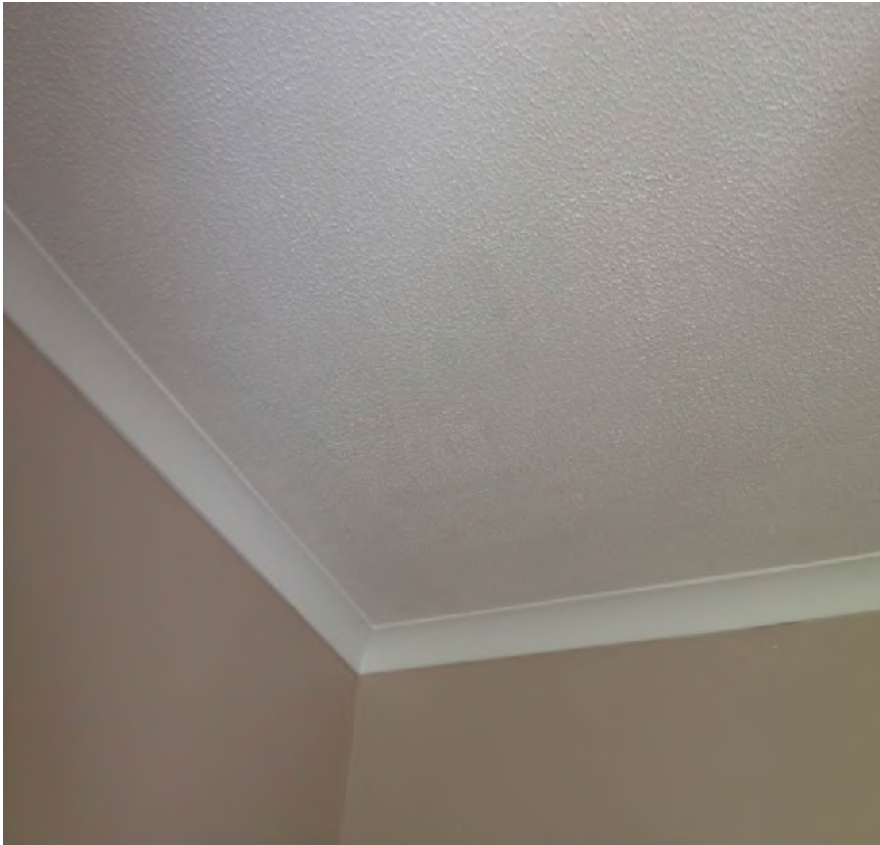
**PHOTOPLATE 169**

| Ground Floor Bedroom 2 |
| Textured coating to ceiling |
| Chrysotile |
| Very low |

| Sample Reference (Bulk ID) |
| - |
| Mark and manage |

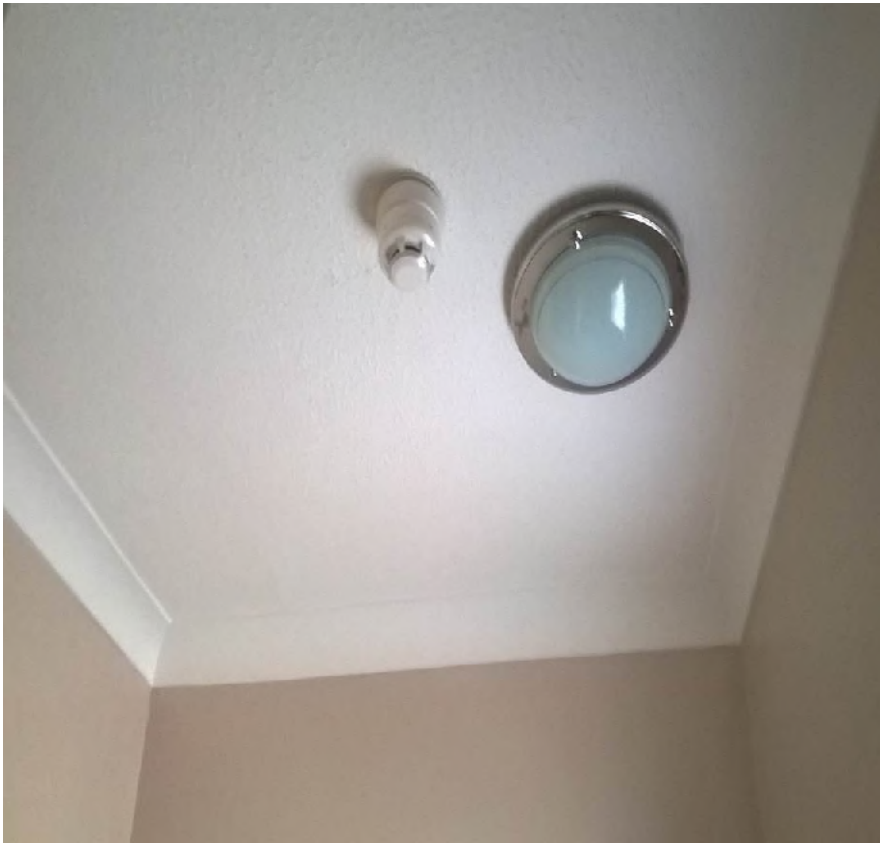
**PHOTOPLATE 173**

Ground Floor Bedroom 2

Textured coating to ceiling

Chrysotile

Very low

Mark and manage

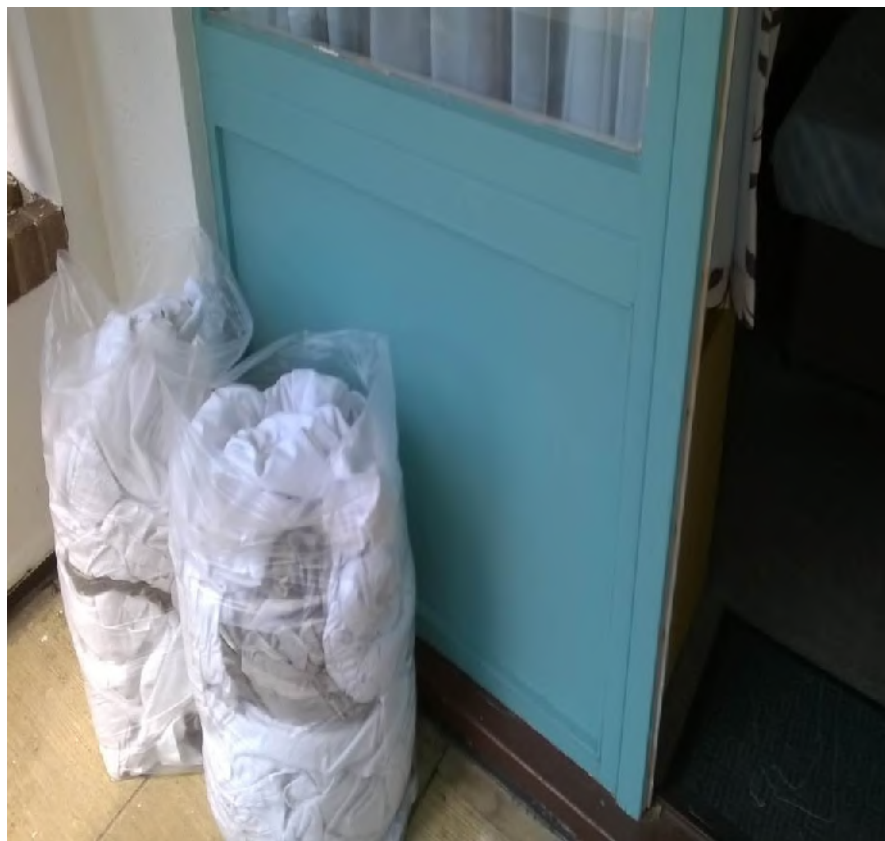
PHOTOPLATE 175

External Bedroom 1

Infill panel beneath window

Chrysotile

Very low

Mark and manage

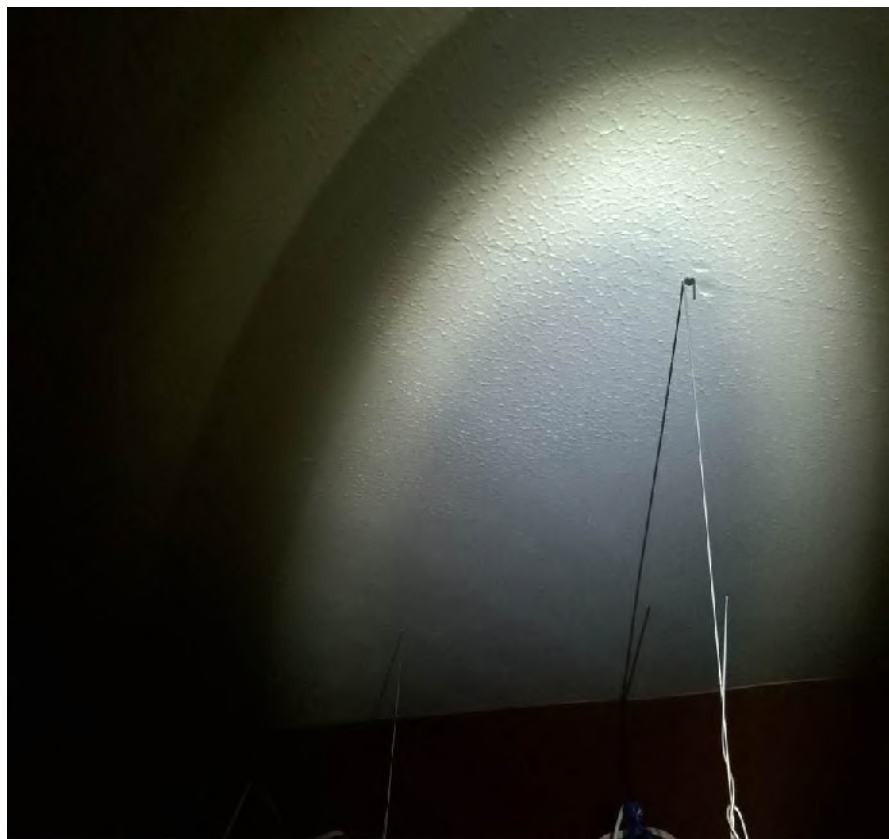
PHOTOPLATE 177

Ground Floor Restaurant

Above ceiling tiles adjacent to wine bar

Chrysotile

Very low

Mark and manage

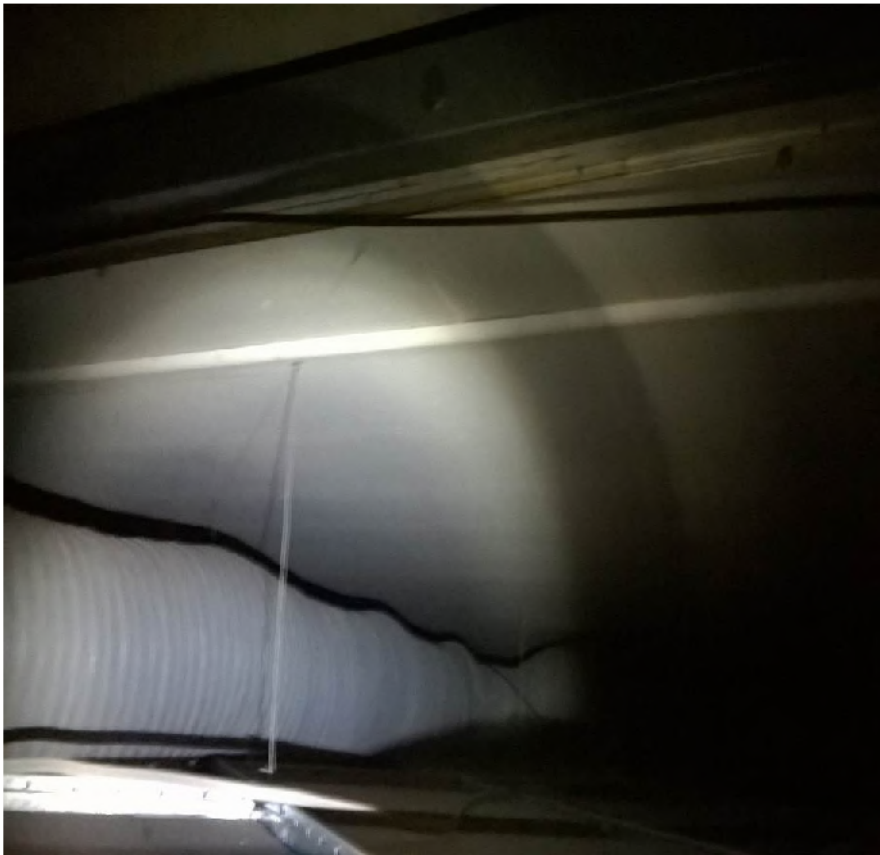
PHOTOPLATE 179

| Ground Floor Restaurant |
| Above suspended ceiling tiles adjacent to raised area |
| Chrysotile |
| Very low |

| Sample Reference (Bulk ID) |
| - |
| Mark and manage |

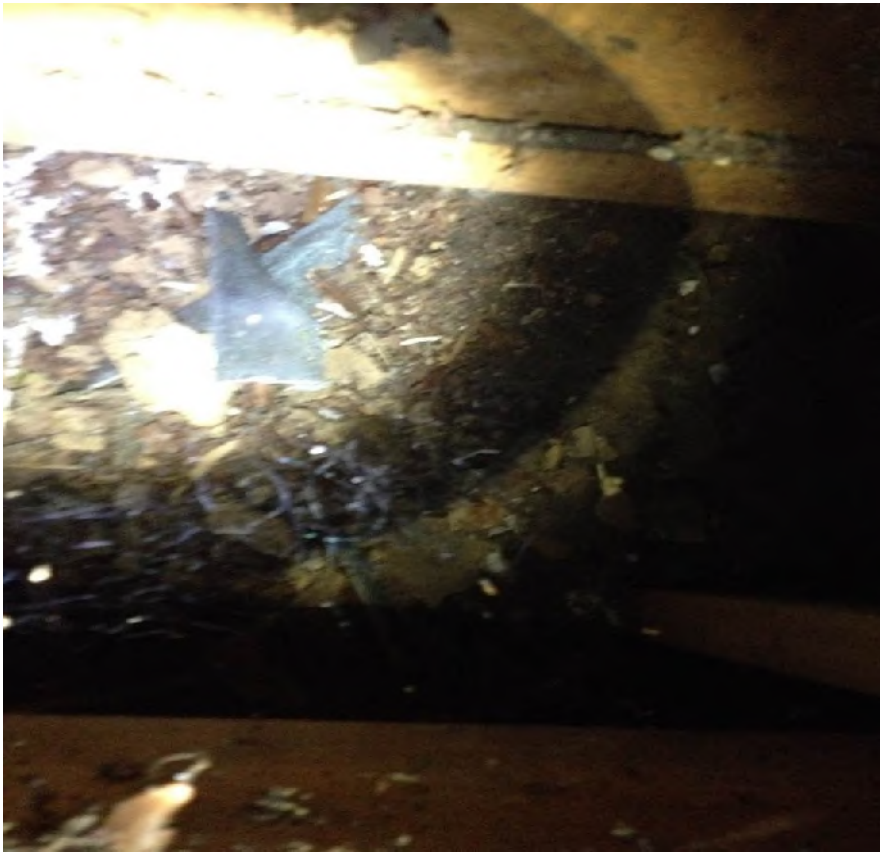
PHOTOPLATE 243

First Floor Store

Debris to floor and beneath broken floor board

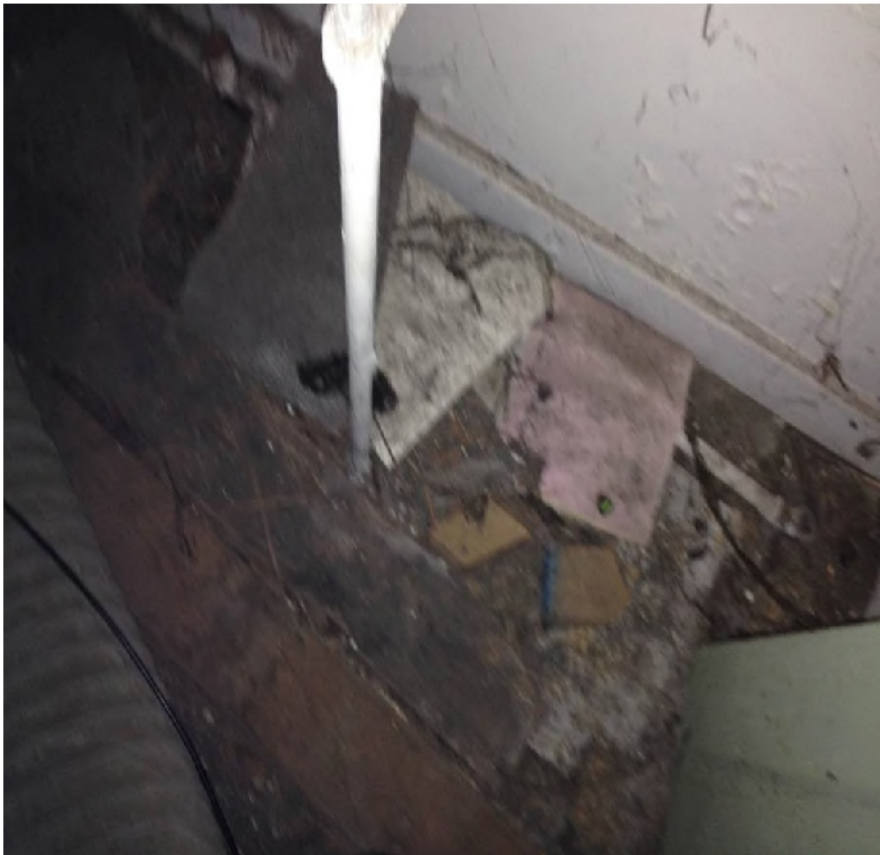
**PHOTOPLATE 263**

| First Floor Toilet |
| Debris to floor and beneath broken floor board |

| Sample Reference (Bulk ID) |
| - |
| Remove |
