**Culvert Inspection Services Framework Scheme  
2015 - EAST HAMPSHIRE & CHICHESTER CULVERT SURVEYS**

**Survey and Condition Assessment Report**

Watercourse: River Ems  
Site: Flour Mill, Emsworth  
Asset Ref: 07427N1020101R02  
Quick Ref: Lot 1 - EH4  
OnSite Ref: 487189

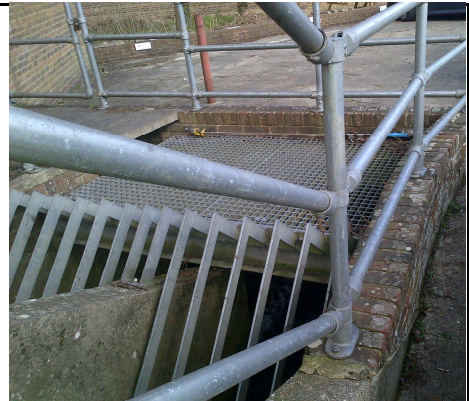
**Inlet /Headwall Details**

Size(mm): 2400x2100  
Construction Material: Brick  
Shape: Rectangular  
Location Details: In a car park  
Grid Reference: 475120 105824  
Access Restrictions: None  
Construction Features: Headwall with a fitted trash grille  
Condition: Good

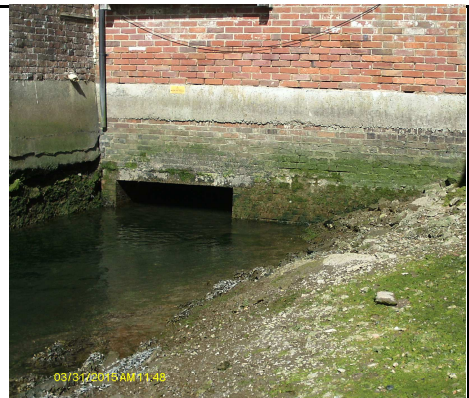
**Outlet /Headwall Details**

Size(mm): 5800x1840  
Construction Material: Brick  
Shape: Rectangular  
Location Details: On the side of a building  
Grid Reference: 475236 105734  
Access Restrictions: None  
Construction Features: Headwall  
Condition: Good

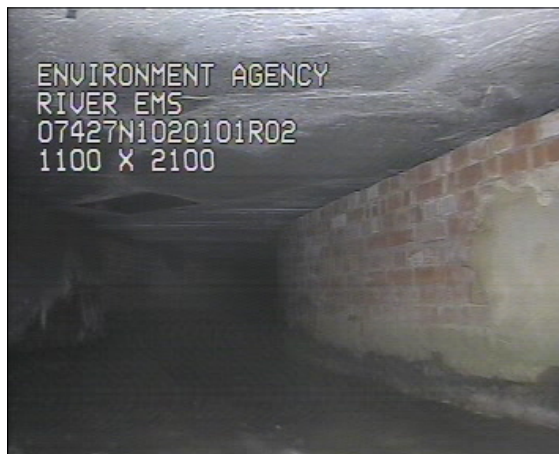
Photo: 1\_3A, 00:00:00  
 0m, General remark Remarks: BRICK WALLS WITH A CONCRETE SOFFIT AND INVERT

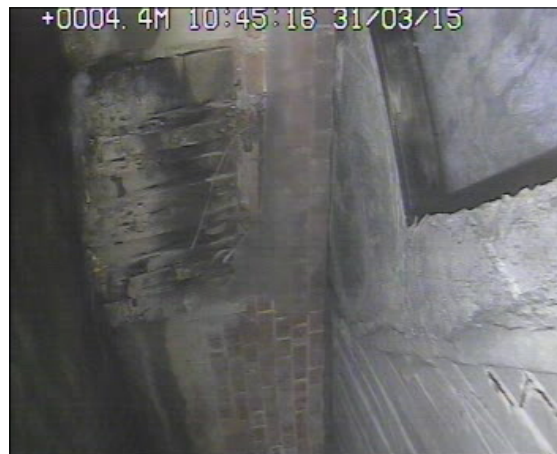
Photo: 1\_5A, 00:00:11  
 4.4m, General remark Remarks: OLD INLET ACCESS COVER

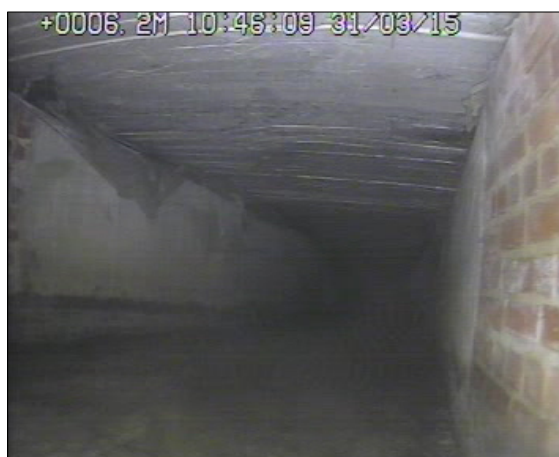
Photo: 1\_6A, 00:02:08  
 6.2m, Line of drain/sewer deviates right

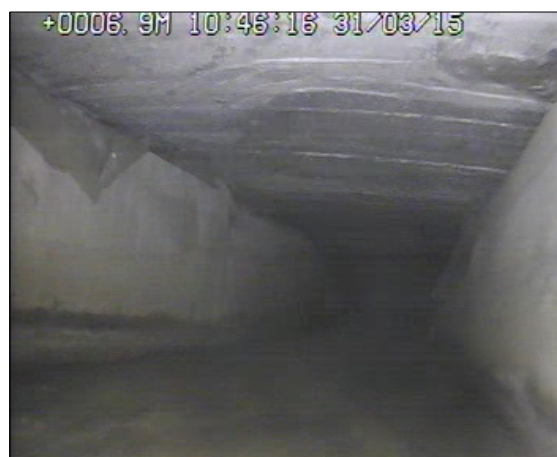
Photo: 1\_7A, 00:02:15  
 6.8m, Material of drain/sewer changes to Concrete

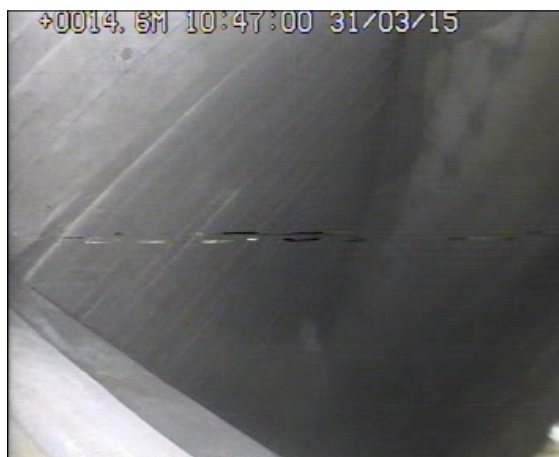
Photo: 1\_8A, 00:03:21  
 14.6m, General remark Remarks: PVC SHEET FROM SHUTTERING HANGING DOWN THROUGHOUT THE LENGTH

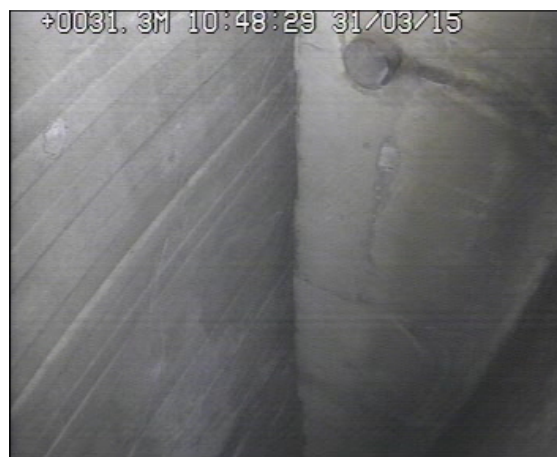
| Position | Code | Observation | Grade |
|---|---|---|---|
| 31.30 | CXI | Connection intruding at 02 o'clock dia 100 mm<br>intrusion 5 % | 2 |

Photo: 1\_9A, 00:04:28  
 31.3m, Connection intruding at 02 o'clock dia 100 mm intrusion 5 %

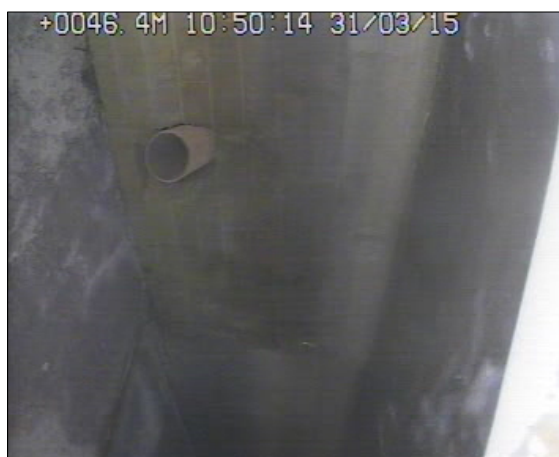
| Position | Code | Observation | Grade |
|---|---|---|---|
| 46.40 | CXI | Connection intruding at 02 o'clock dia 150 mm<br>intrusion 10 % | 3 |

Photo: 1\_10A, 00:06:16  
 46.4m, Connection intruding at 02 o'clock dia 150 mm intrusion 10 %

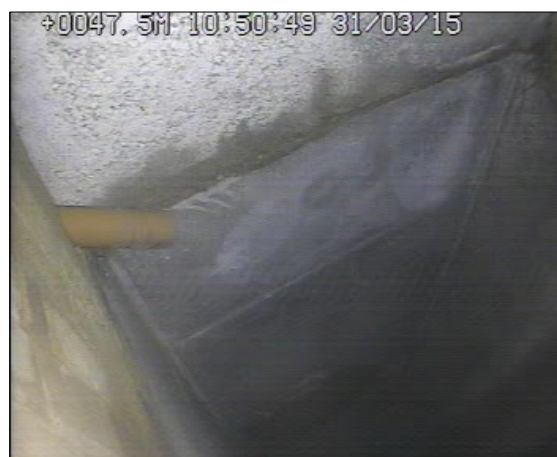
| Position | Code | Observation | Grade |
|---|---|---|---|
| 47.50 | CXI | Connection intruding at 11 o'clock dia 100 mm<br>intrusion 20 % | 3 |

Photo: 1\_11A, 00:07:03  
 47.5m, Connection intruding at 11 o'clock dia 100 mm intrusion 20 %

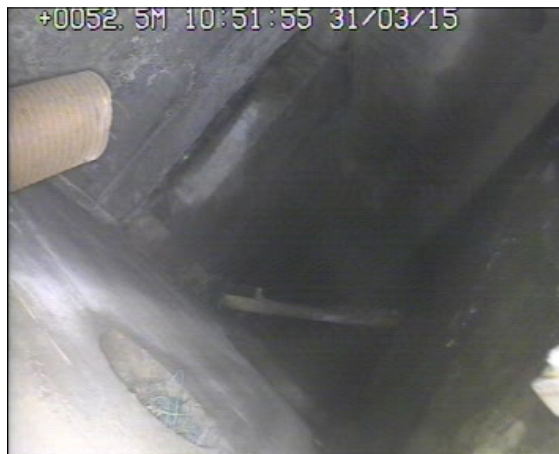
| Position | Code | Observation | Grade |
|---|---|---|---|
| 52.50 | CXI | Connection intruding at 10 o'clock dia 225 mm<br>intrusion 15 % | 3 |

Photo: 1\_12A, 00:08:10  
 52.5m, Connection intruding at 10 o'clock dia 225 mm intrusion 15 %

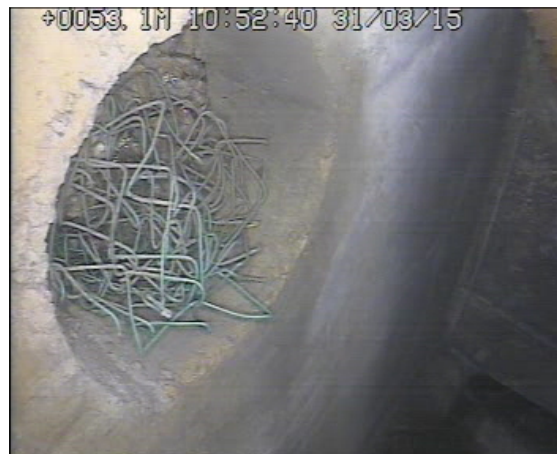
Photo: 1\_13A, 00:08:39  
 53.1m, Junction defective, connecting pipe is blocked, at 9 o'clock, diameter 225mm

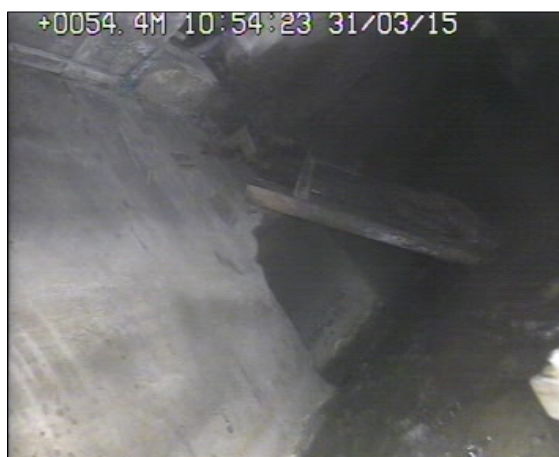
Photo: 1\_15A, 00:10:21  
 54.4m, Junction at 09 o'clock dia 600 mm Remarks: LARGE OPEN NON RETURN FLAP VALVE WITH A BROKEN HINGE

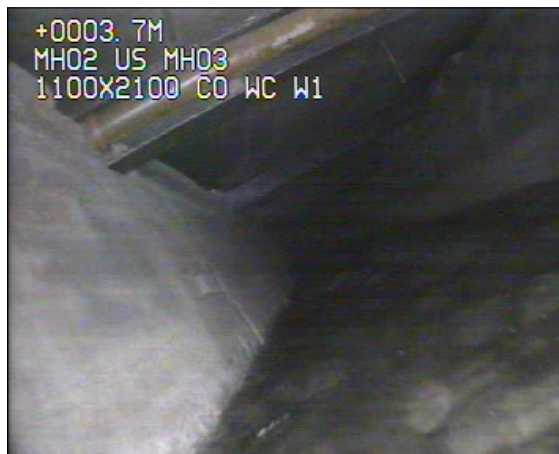
Photo: 3\_3A, 00:00:22  
 3.7m, Other obstacles, external pipe or cable, from 10 to 2 o'clock, 5% cross-sectional area loss Remarks: SERVICE PIPE

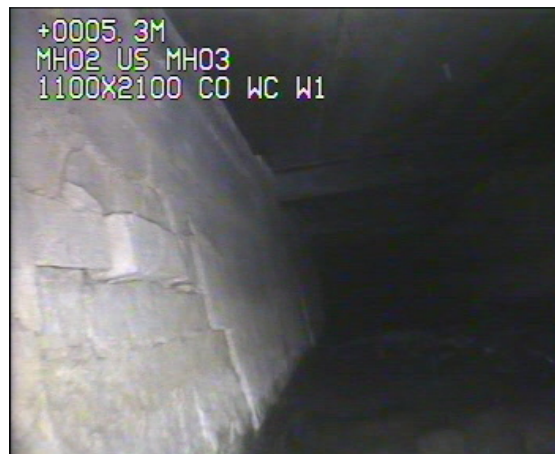
Photo: 3\_4A, 00:00:30  
 5.3m, Displaced bricks, at 3 o'clock Remarks: APPEARS TO BE AN OLD BLOCKED OFF JUNCTION

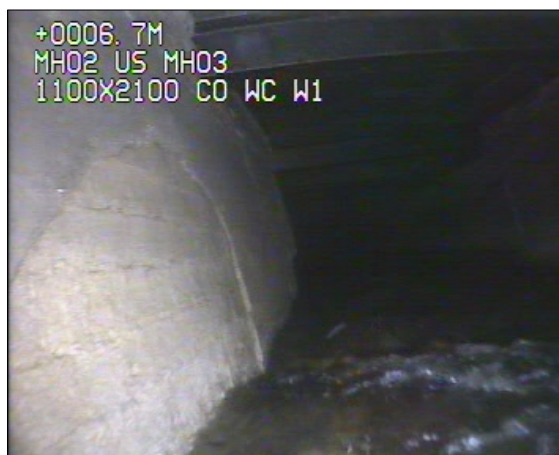
Photo: 3\_5A, 00:01:38  
 6.7m, General remark Remarks: PATCH OF RENDER MISSING BETWEEN 7 AND 10 O'CLOCK

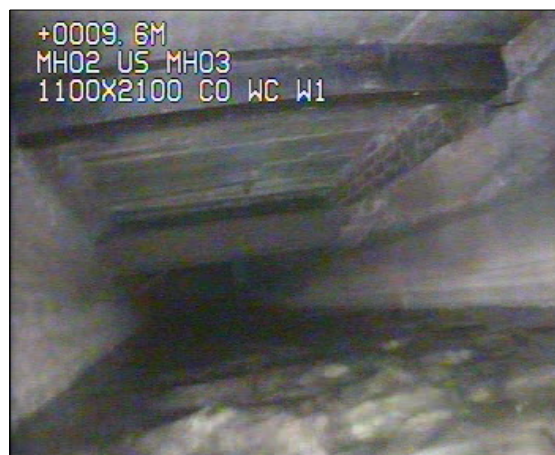
Photo: 3\_6A, 00:01:53  
 9.6m, Line deviates left

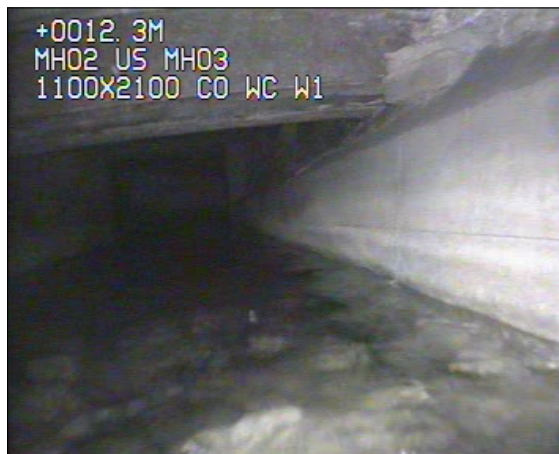
Photo: 3\_7A, 00:02:08  
 12.3m, Other obstacles, external pipe or cable, from 10 to 2 o'clock, 10% cross-sectional area loss  
 Remarks: SERVICE PIPE

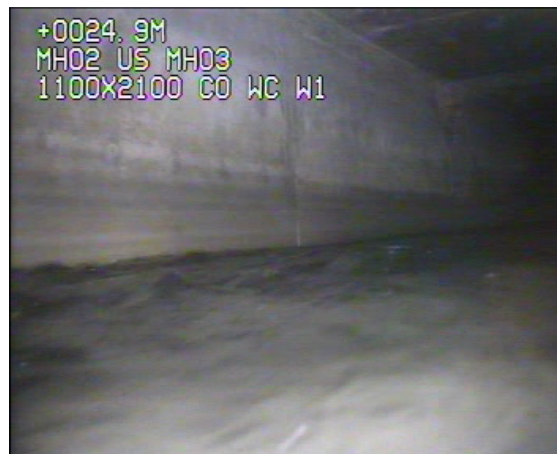
Photo: 3\_9A, 00:04:07  
 24.9m, Line deviates right

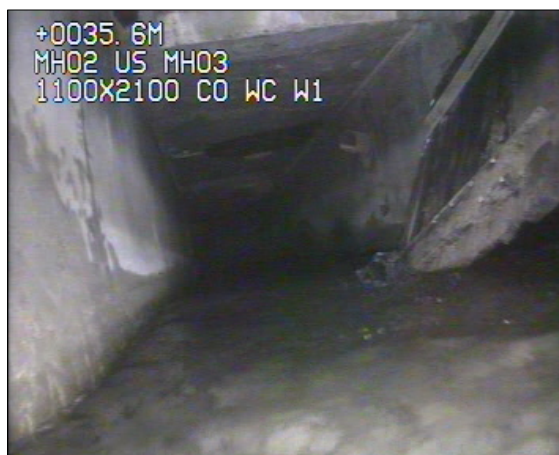
Photo: 2\_10A, 00:05:46  
 35.6m, General remark  
 Remarks: LARGE OPEN NON RETURN FLAP VALVE WITH A BROKEN HINGE ON THE RIGHT HAND SIDE

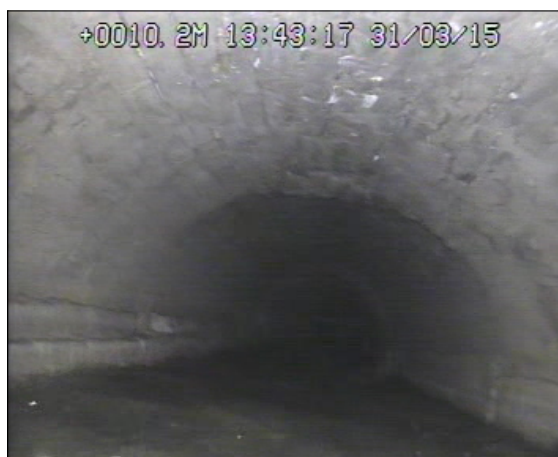
| | 10.20 | S01 | MM | Missing mortar, from 8 to 9 o'clock, between 15mm and 50mm, Start | 2 |

Photo: 3\_3A, 00:03:03  
 10.2m, Missing mortar, from 8 to 9 o'clock, between 15mm and 50mm, Start

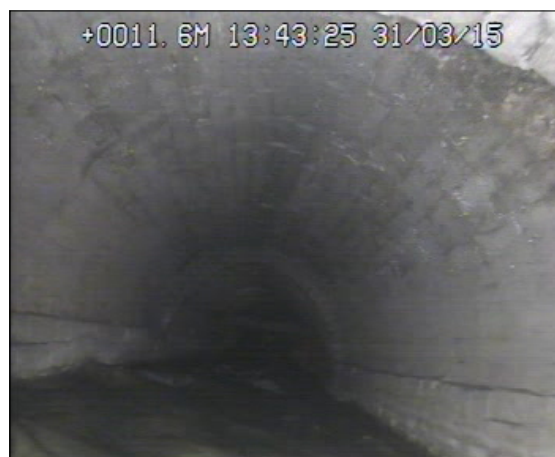
| | 11.60 | S02 | MM | Missing mortar, from 3 to 4 o'clock, between 15mm and 50mm, Start | 2 |

Photo: 3\_4A, 00:03:11  
 11.6m, Missing mortar, from 3 to 4 o'clock, between 15mm and 50mm, Start

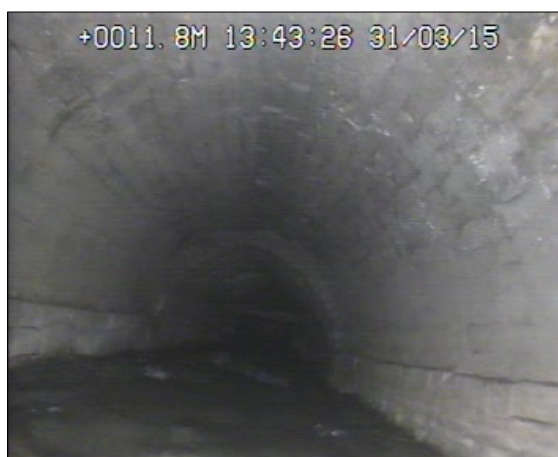
Photo: 3\_3A, 00:03:12  
 11.8m, Dimension changes, 1400mm high, 1500mm wide

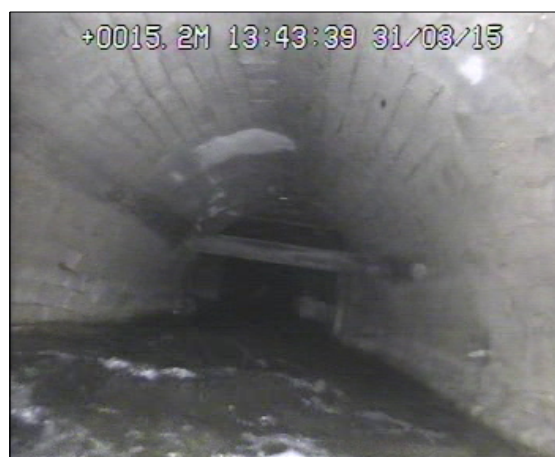
Photo: 3\_6A, 00:03:25  
 15.2m, Dimension changes, 1300mm high, 1500mm wide

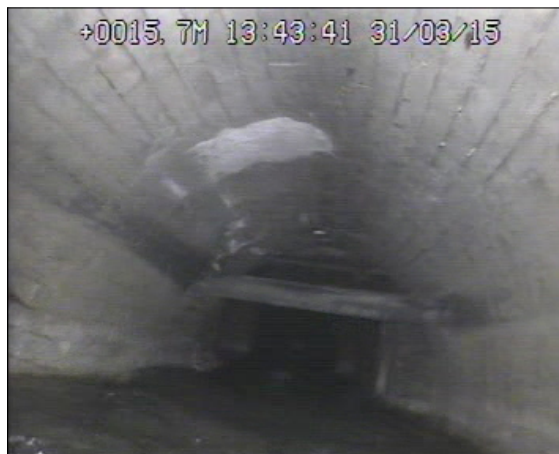
| | 15.70 | DB | | Displaced bricks, from 8 to 9 o'clock | 4 |

Photo: 3\_9A, 00:03:28  
 15.7m, Displaced bricks, from 8 to 9 o'clock

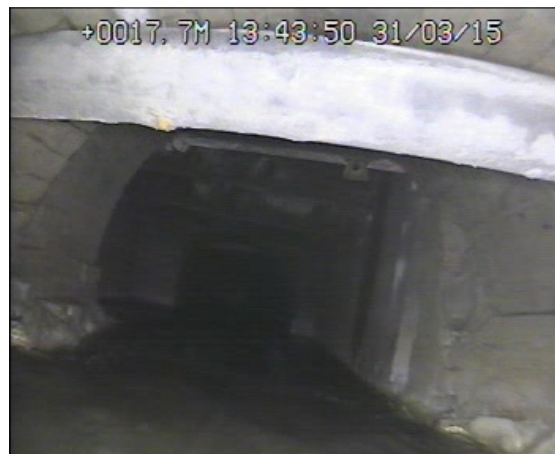
| | 17.70 | OBP | | Other obstacles, external pipe or cable, from 10 to 2 o'clock, 10% cross-sectional area loss<br>Remarks: SERVICE PIPE | 5 |

Photo: 3\_10A, 00:03:36  
 17.7m, Other obstacles, external pipe or cable, from 10 to 2 o'clock, 10% cross-sectional area loss  
 Remarks: SERVICE PIPE

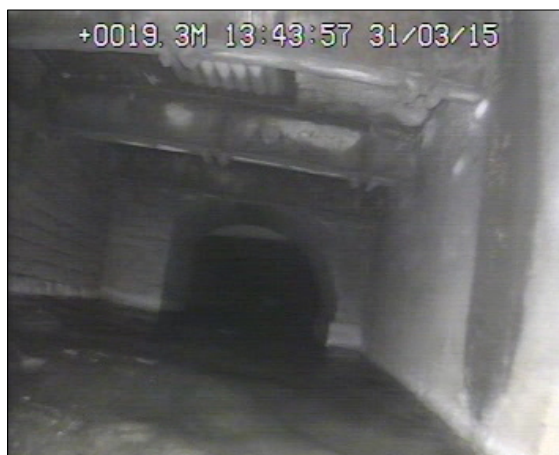
Photo: 3\_11A, 00:03:43  
 19.3m, Dimension changes, 2000mm high, 2000mm wide  
 Remarks: SQUARE SHAPE

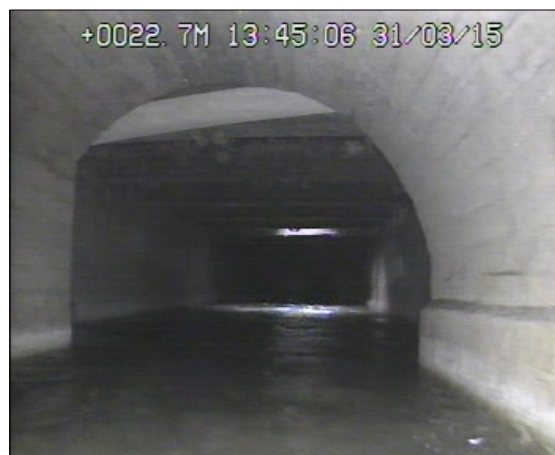
Photo: 3\_13A, 00:04:53  
 22.7m, Shape changes to arched, 1500mm high, 1700mm wide

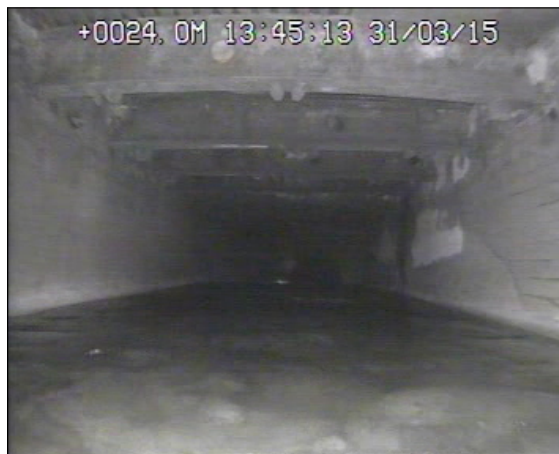
Photo: 3\_14A, 00:00:05  
 24m, Shape changes to rectangular, 1140mm high, 1700mm wide

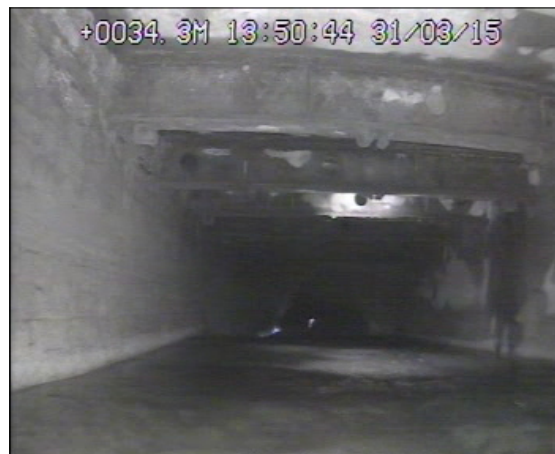
Photo: 3\_14A, 00:10:30  
 34.3m, General remark Remarks: MANHOLE WITHIN VIEW APPROXIMATELY 3M AWAY

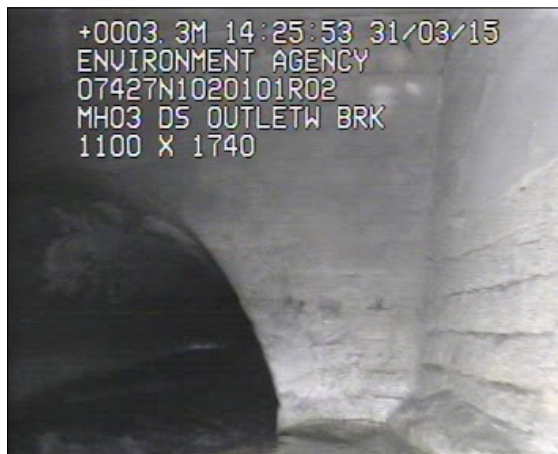
Photo: 4\_3A, 00:00:50  
 3.3m, Material changes, brick

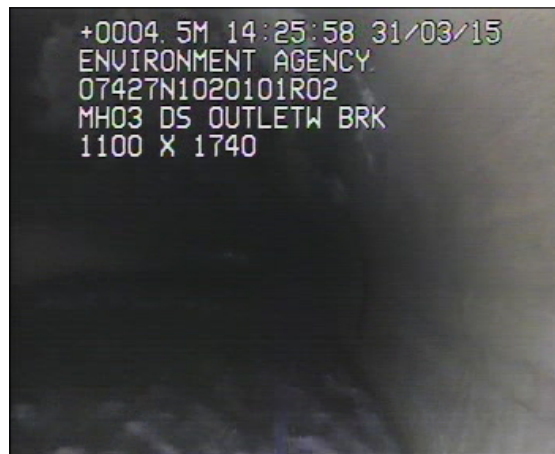
Photo: 4\_5A, 00:00:54  
 4.5m, Shape changes to arched, 800mm high, 1440mm wide  
 Remarks: APPROXIMATE SIZE

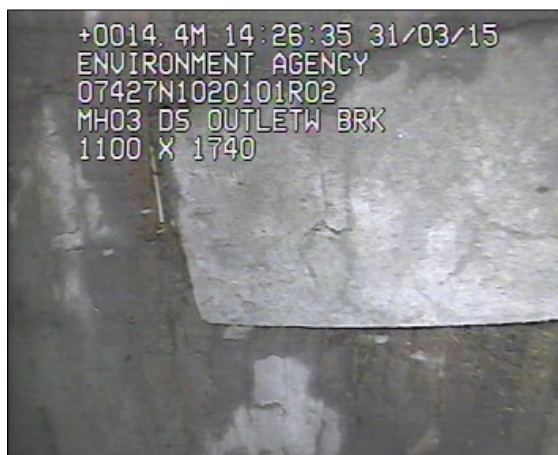
Photo: 4\_6A, 00:01:32  
 14.4m, Other obstacles protruding through wall, from 11 to 1 o'clock, 10% cross-sectional area loss  
 Remarks: LARGE PIECE OF CONCRETE STICKING THROUGH THE SOFFIT

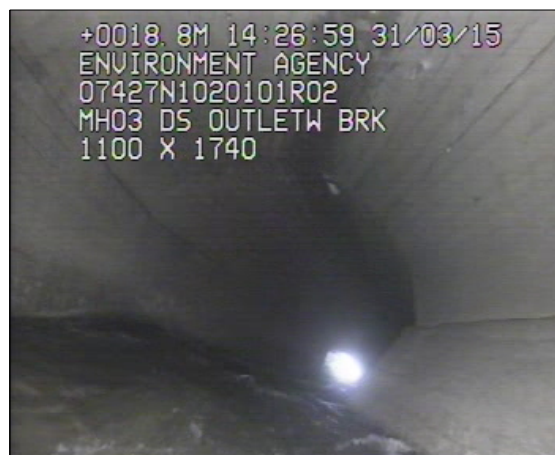
Photo: 4\_7A, 00:01:55  
 18.6m, Dimension changes, 1400mm high, 1440mm wide  
 Remarks: APPROXIMATE SIZE

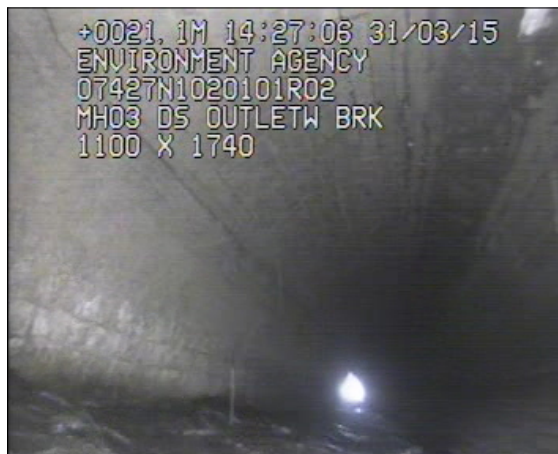
Photo: 4\_7A, 00:02:03  
 21.1m, Line deviates right

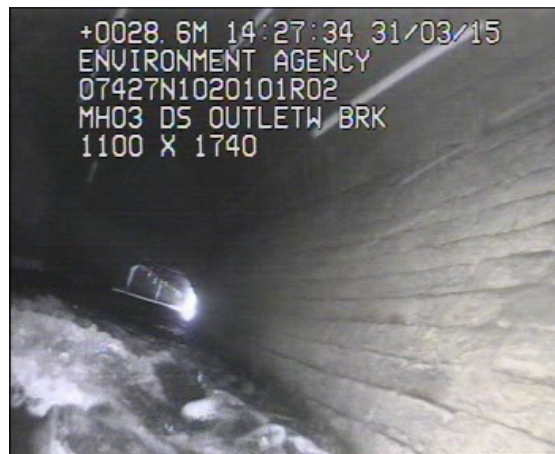
Photo: 4\_8A, 00:02:31  
 28.6m, Line deviates left

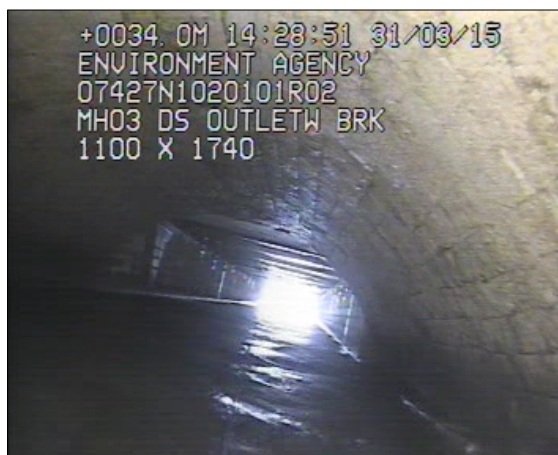
Photo: 4\_9A, 00:03:48  
 34m, Shape changes to arched, 1000mm high, 1400mm wide  
 Remarks: APPROXIMATE SIZE

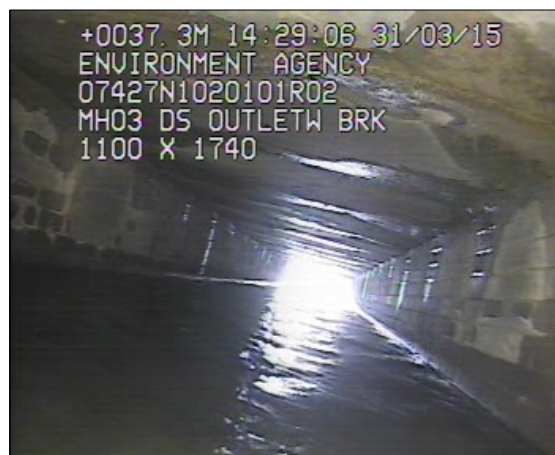
Photo: 4\_9A, 00:04:03  
 37.3m, Shape changes to rectangular, 1000mm high, 1630mm wide

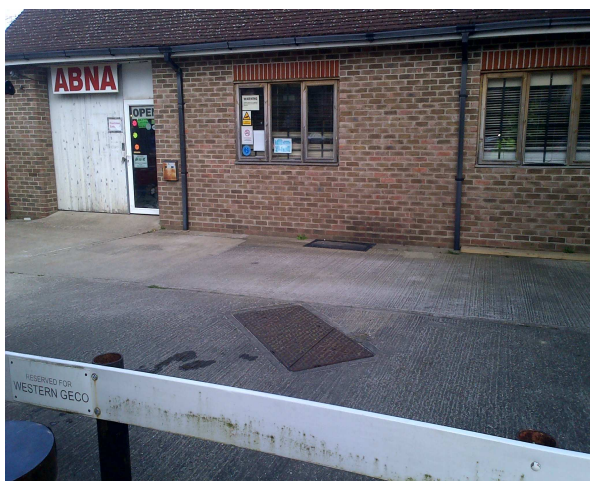
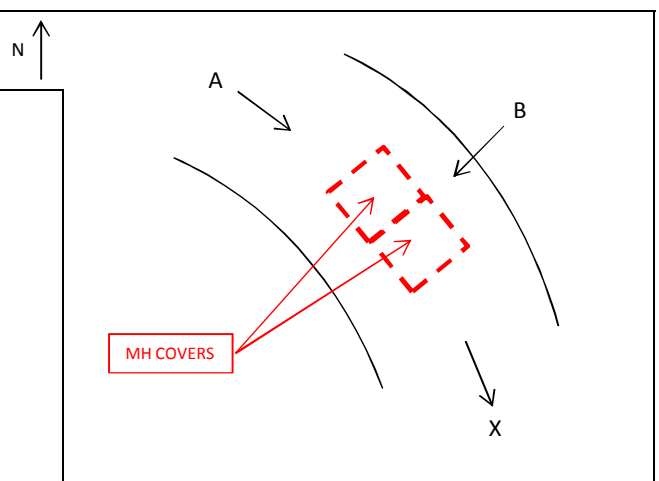
**LOCATION PHOTO**

THIS MANHOLE CONTAINS TWIN COVERS AND NO CHAMBER AS THE SHAFT DROPS STRAIGHT ONTO THE LINE OF THE CULVERT. THERE IS A LARGE NON RETURN FLAP VALVE OVER A JUNCTION WITHIN THIS CHAMBER WHICH HAS A BROKEN HINGE AND HAS PARTIALLY DROPPED INTO THE LINE OF THE CULVERT

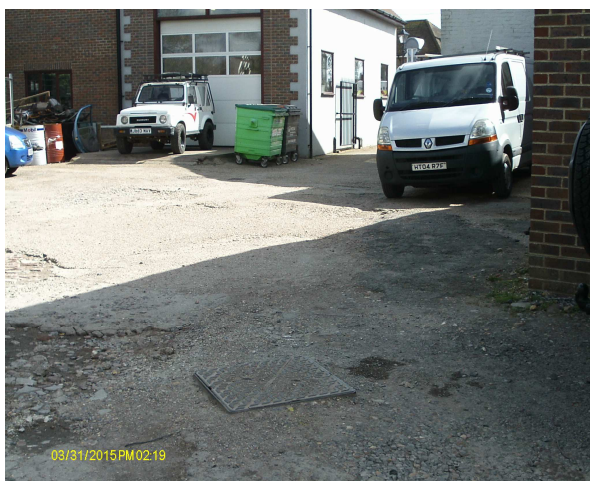
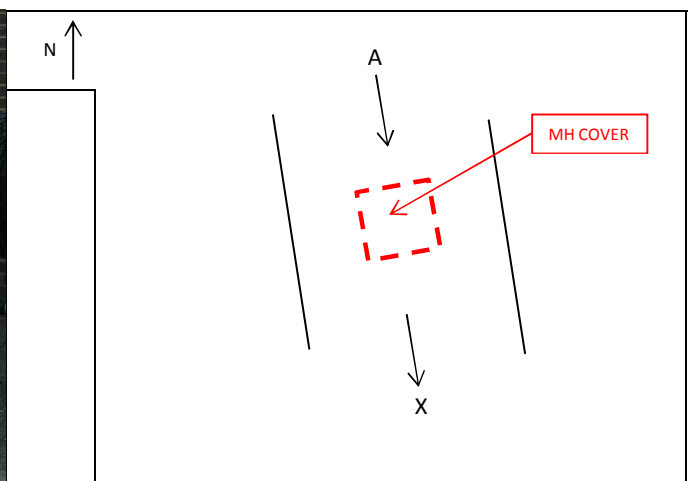
**THIS MANHOLE CONTAINS NO CHAMBER AND THE SHAFT DROPS STRAIGHT ONTO THE LINE OF THE CULVERT. UNABLE TO TAKE THE GRID REFS AND COVER LEVEL DUE TO A CAR BEING PARKED OVER THE MANHOLE COVER WHEN GPS WAS CARRIED OUT**
**LOCATION PHOTO**

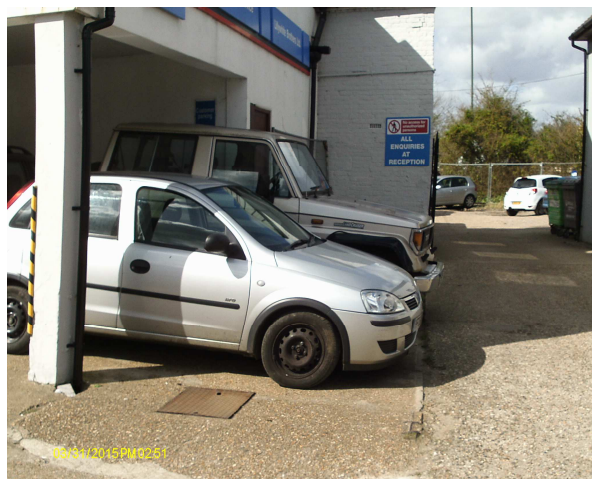
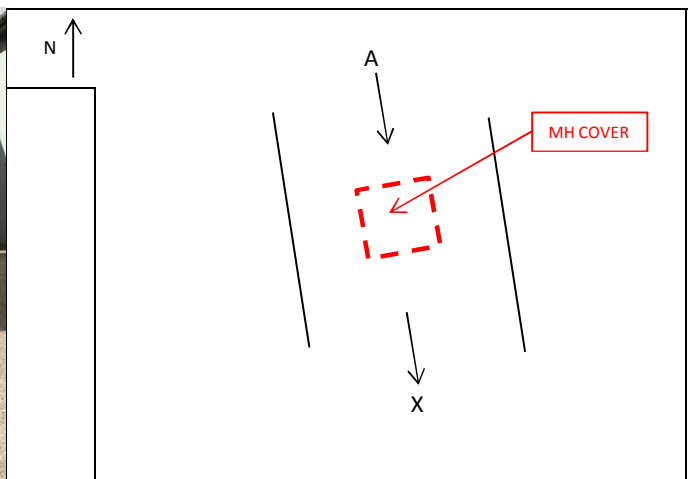
**THIS MANHOLE CONTAINS NO CHAMBER AND THE SHAFT DROPS STRAIGHT ONTO THE LINE OF THE CULVERT**
**LOCATION PHOTO**

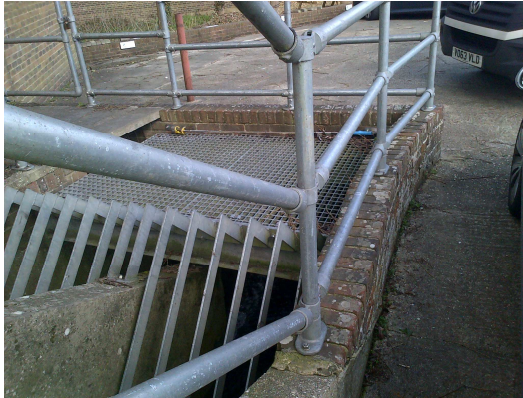
View of the Inlet

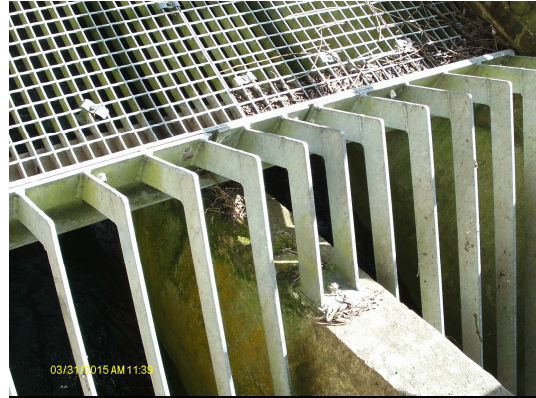
View of the Inlet trash grille

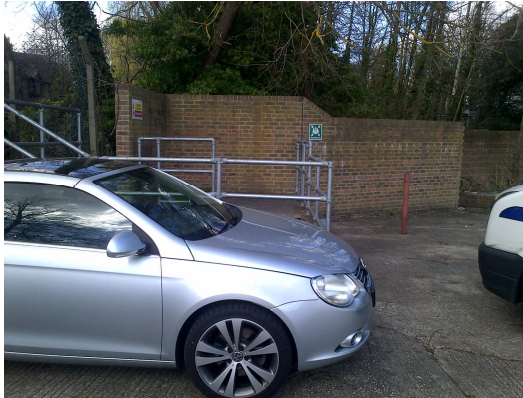
Inlet location next to the car park of the Old Flour Mill on Queen Street

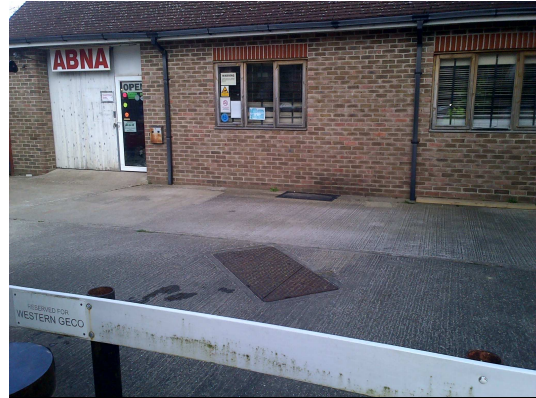
MH01 location outside Units 15 & 16 of the Old Flour Mill

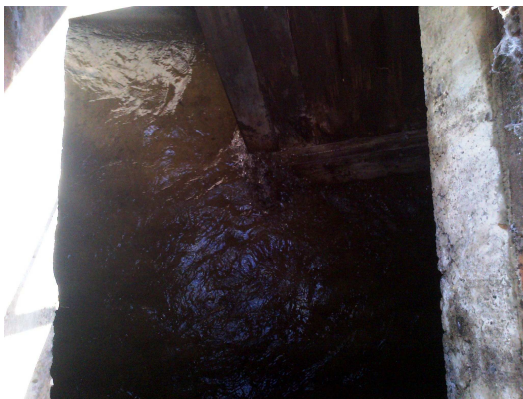
View into MH01

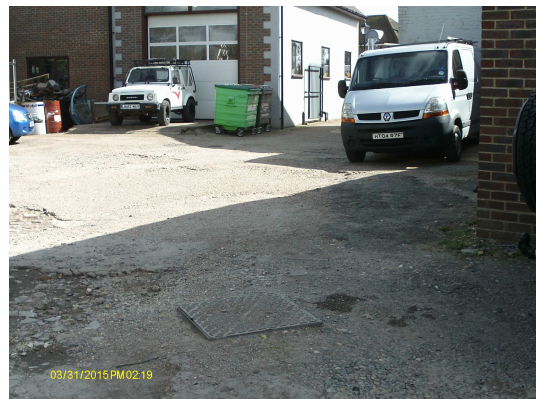
MH02 location at the rear of Lilywhite Bros Ltd garage on Queen Street

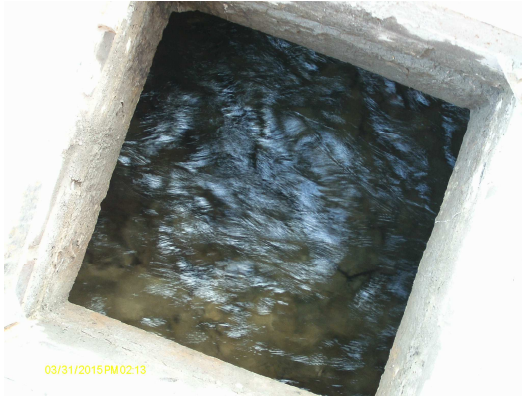
View into MH02

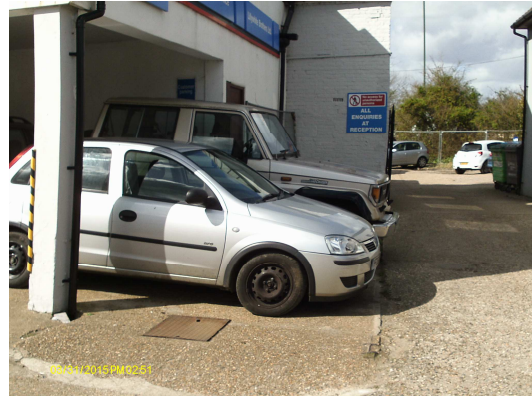
MH03 location outside the Lilywhite Bros Ltd garage on Queen Street

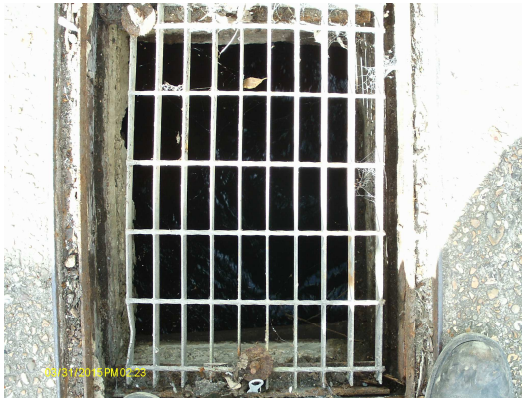
View into MH03

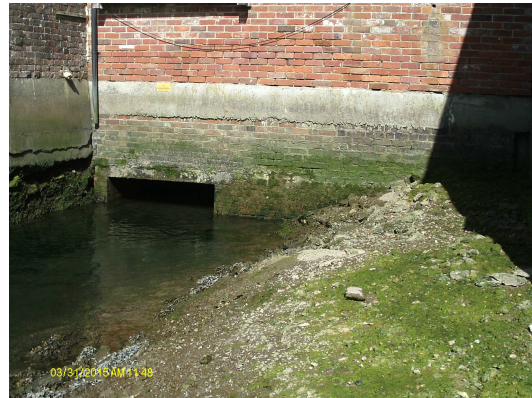
View of the Outlet located on the South side of No.8 Chequers Quay on the South side of Queen Street
