### Asbestos Survey

### MANAGEMENT RE-INSPECTION SURVEY REPORT

**Report Number:** J4850  
**On behalf of** Away Resorts  
Mill Rythe Holiday Village, 16 Havant Road,  
Hayling Island, Hampshire PO11 0PB

**Mill Rythe Holiday Village**  
**16 Havant Road**  
**Hayling Island**  
**Hampshire**  
**PO11 0PB**

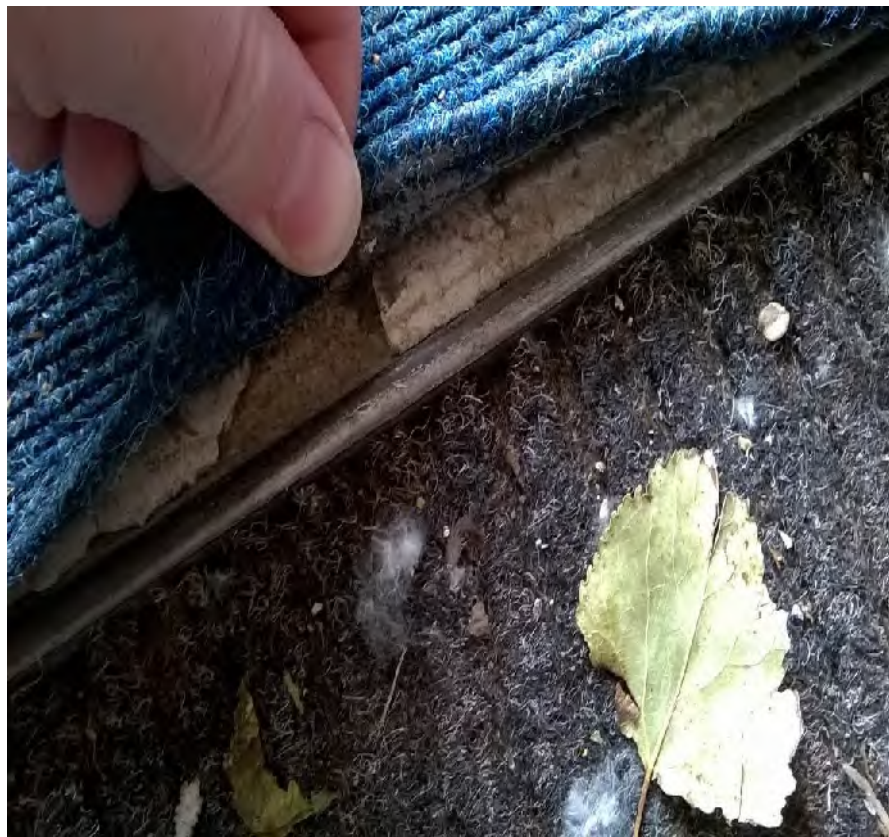
PHOTOPLATE 003

| Building: <b>Main</b> | | | | | |
|---|---|---|---|---|---|
| Ground Floor Corridor | 451 | 03 | Floor tiles (Grey) | Was found to contain Chrysotile (White Asbestos) | Mark and manage |

Ground Floor Corridor

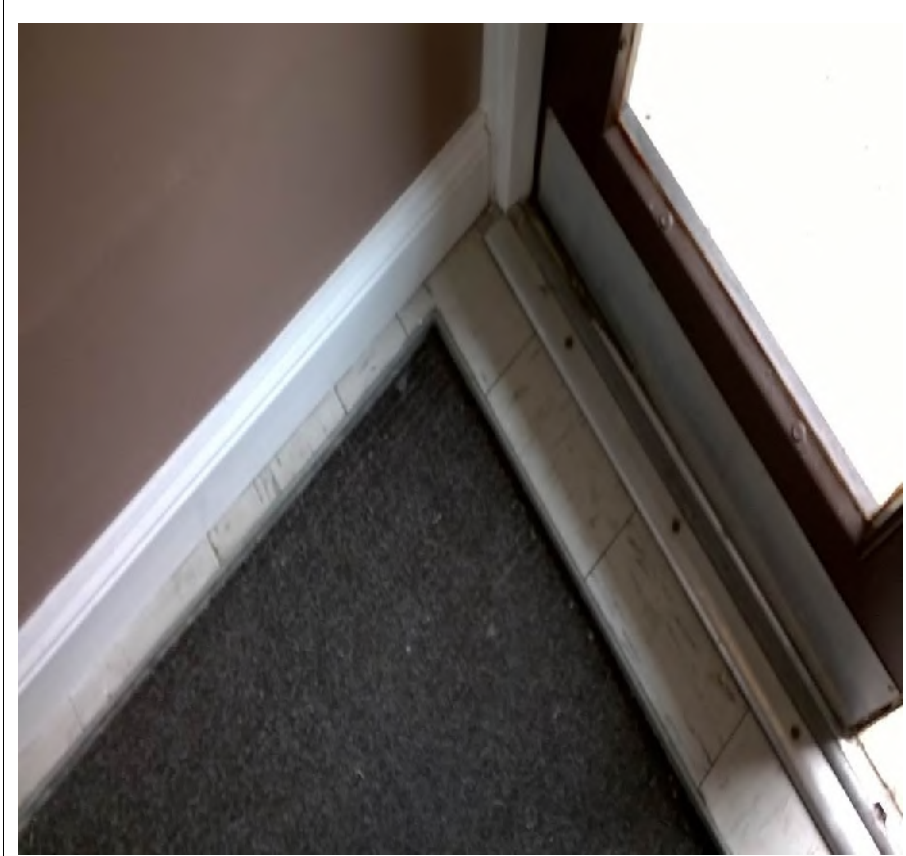
PHOTOPLATE 005

| Building: <b>Main</b> | | | | | |
|---|---|---|---|---|---|
| First Floor Corridor | 456 | 05 | Floor tiles (Grey) | Was found to contain Chrysotile (White Asbestos) | Mark and manage |

| First Floor Corridor |

| Sample Reference (Bulk ID) |
| - |
| Mark and manage |

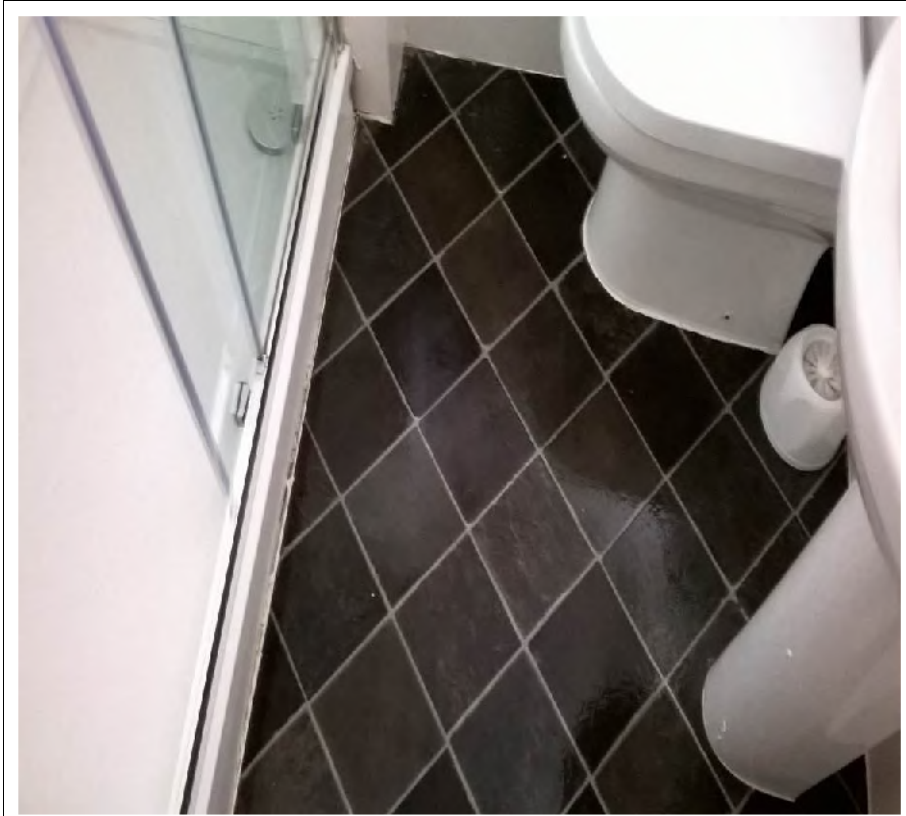
PHOTOPLATE 006

| Building: <b>Main</b> | | | | | |
|---|---|---|---|---|---|
| First Floor Bathroom | 459 | 06 | Vinyl floor covering beneath modern vinyl floor covering (Glued over) | Was found to contain Chrysotile (White Asbestos) | Mark and manage |

| First Floor Bathroom |

| Sample Reference (Bulk ID) |
| - |
| Mark and manage |

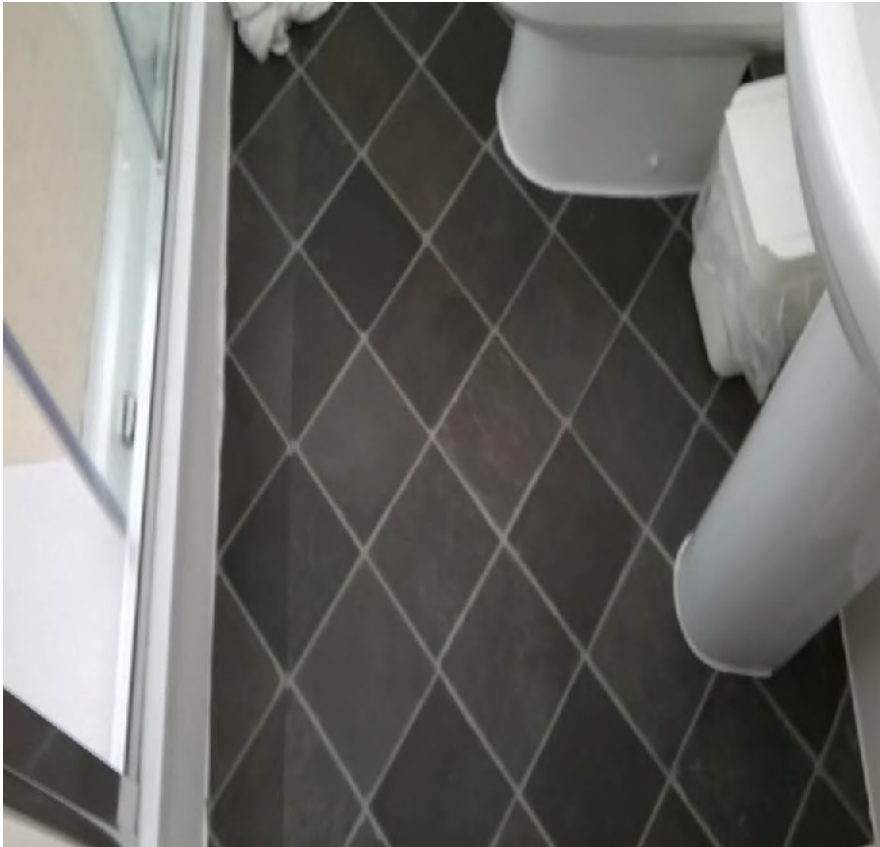
**PHOTOPLATE 007**

| Building: <b>Main</b> | | | | | |
|---|---|---|---|---|---|
| First Floor Bathroom | 460 | 07 | Floor tiles beneath vinyl floor covering (Glued over) | Was found to contain Chrysotile (White Asbestos) | Mark and manage |

First Floor Bathroom

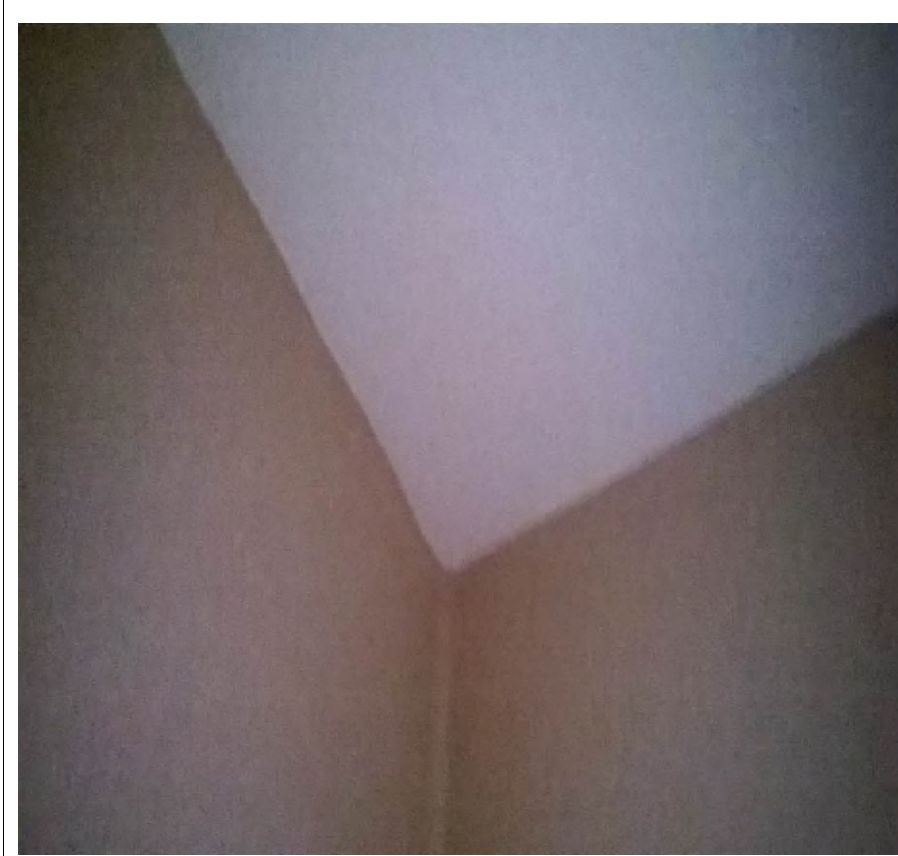
**PHOTOPLATE 011**

| Building: <b>Main</b> | | | | | |
|---|---|---|---|---|---|
| Ground Floor Hall | 275 | 11 | Textured coating to ceiling | Was found to contain Chrysotile (White Asbestos) | Mark and manage |

| Ground Floor Hall |

| Sample Reference (Bulk ID) |
| - |
| Mark and manage |

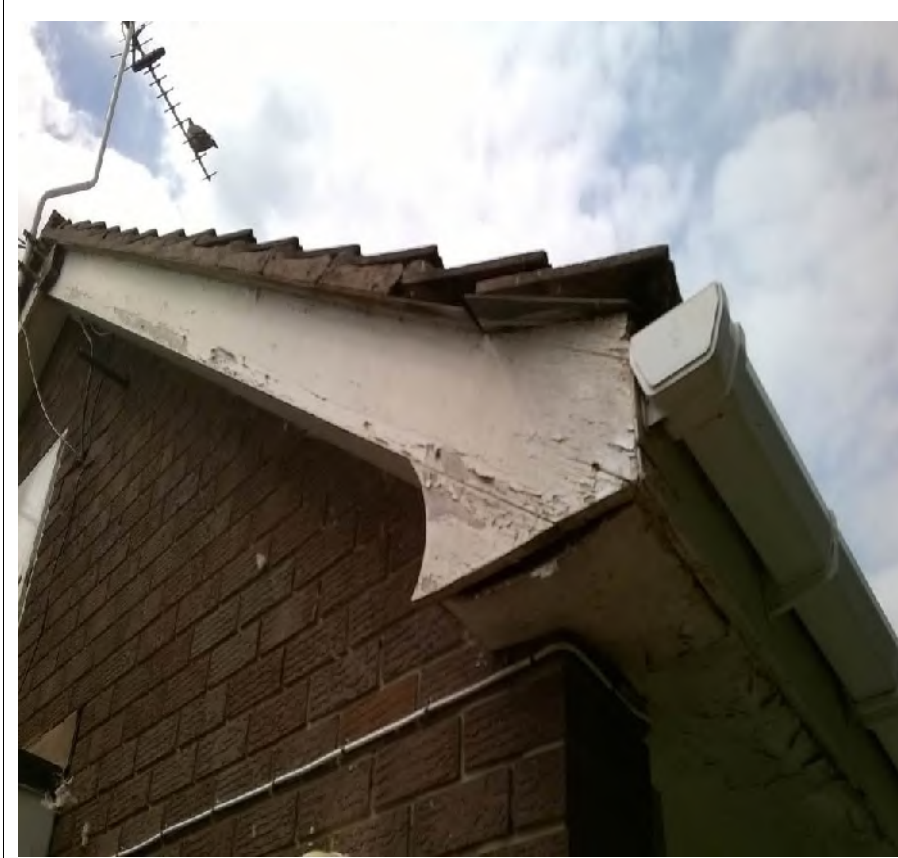
PHOTOPLATE 015

| Building: <b>Main</b> | | | | | |
|---|---|---|---|---|---|
| External End Elevation | 440 | 15 | Verge boards to end of elevation | Was found to contain Chrysotile (White Asbestos) | Mark and manage |

External End Elevation

Mark and manage

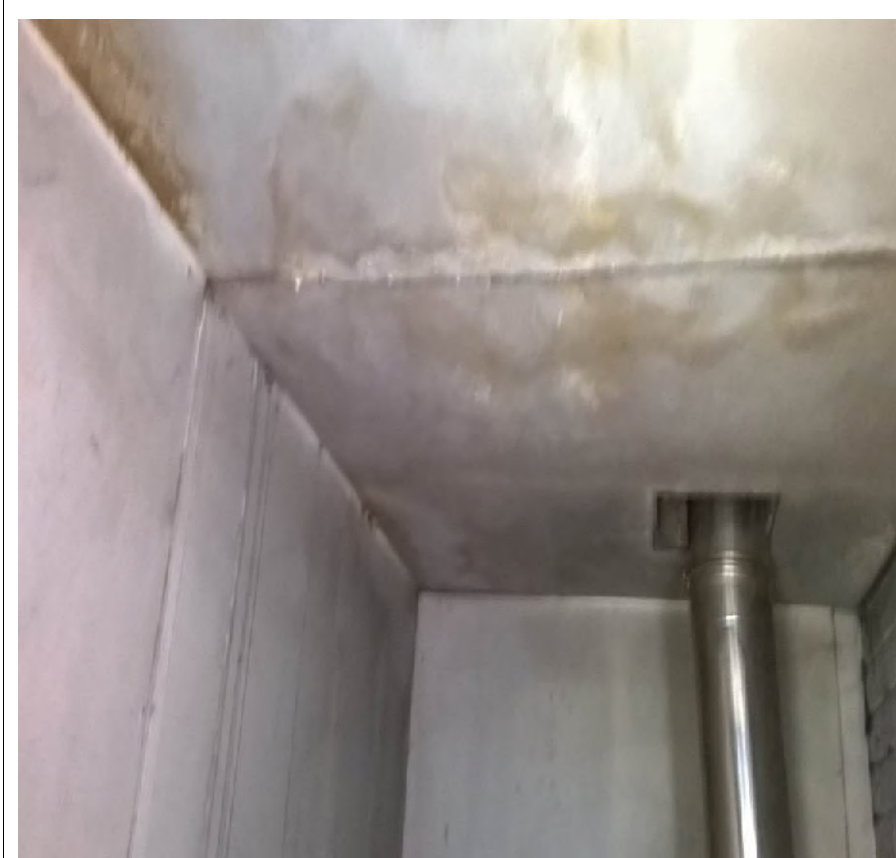
**PHOTOPLATE 017**

| Building: <b>Main</b> | | | | | |
|---|---|---|---|---|---|
| Ground Floor Boiler House | 482 | 17 | Panels forming the ceiling | Was found to contain Amosite (Brown Asbestos) | Mark and manage |

| Ground Floor Boiler House |

| Sample Reference (Bulk ID) |
| - |
| Mark and manage |

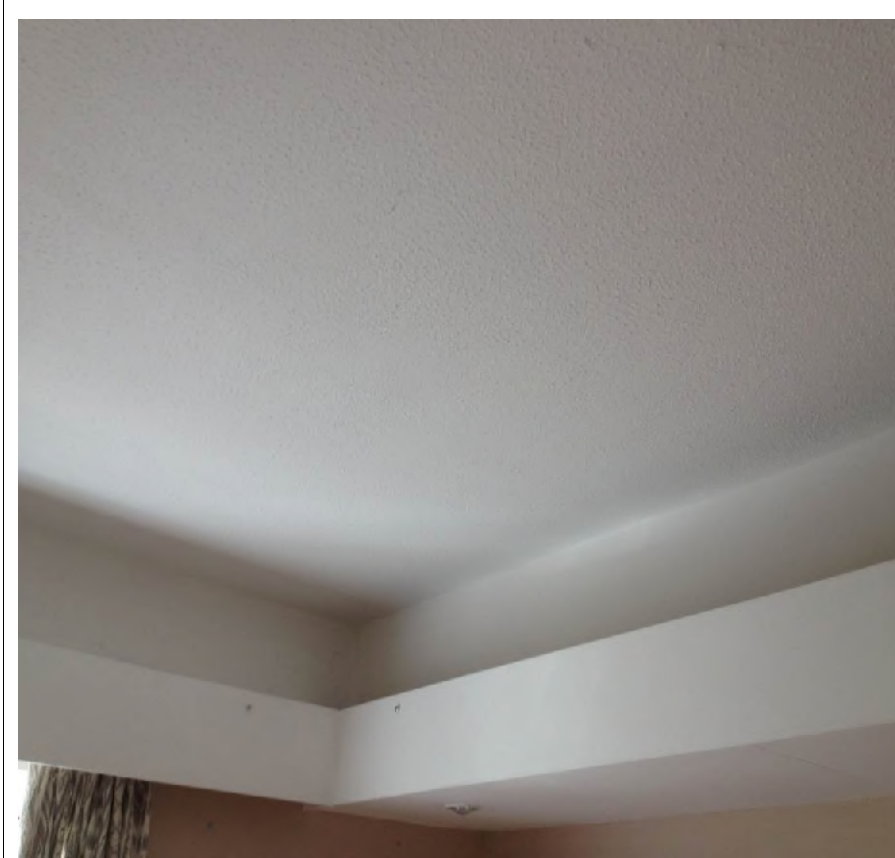
**PHOTOPLATE 021**

| Accommodation Block 21 (Tenby) | | | | | |
|---|---|---|---|---|---|
| First Floor Bedroom | 433 | 21 | Textured coating to ceiling | Was found to contain Chrysotile (White Asbestos) | Mark and manage |

First Floor Bedroom

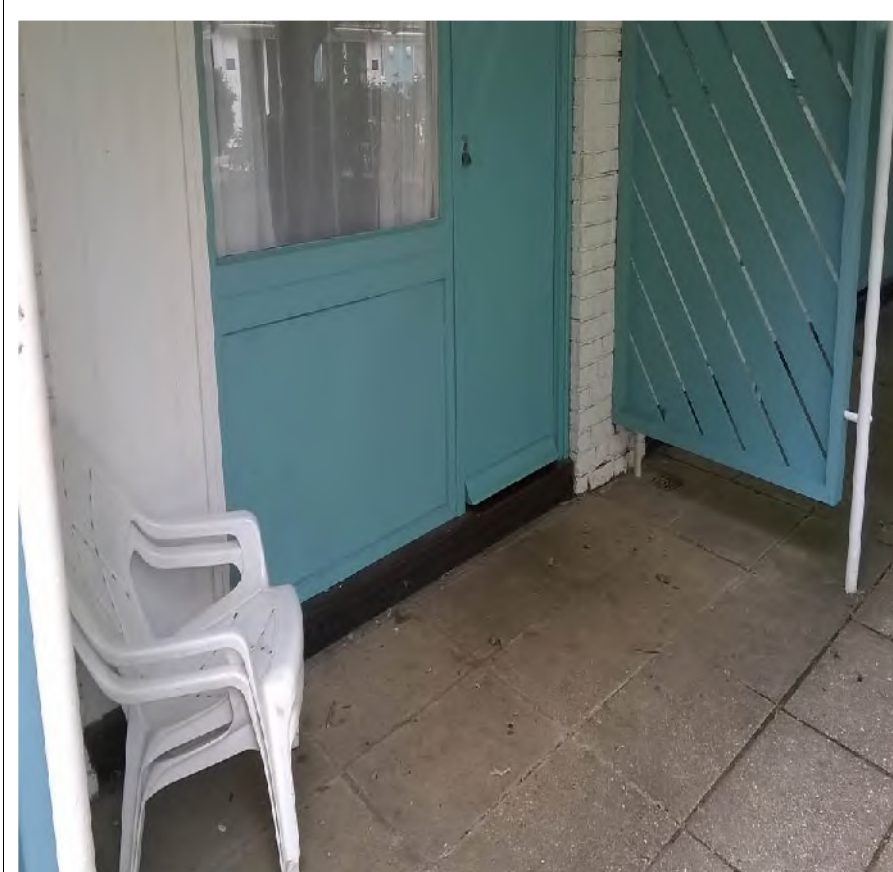
**PHOTOPLATE 033**

| Accommodation Block 21 (Tenby) | | | | | |
|---|---|---|---|---|---|
| External Bathroom | 330 | 33 | Infill panel beneath window | Was found to contain Chrysotile (White Asbestos) | Mark and manage |

| External Bathroom |

| Sample Reference (Bulk ID) |
| - |
| Mark and manage |

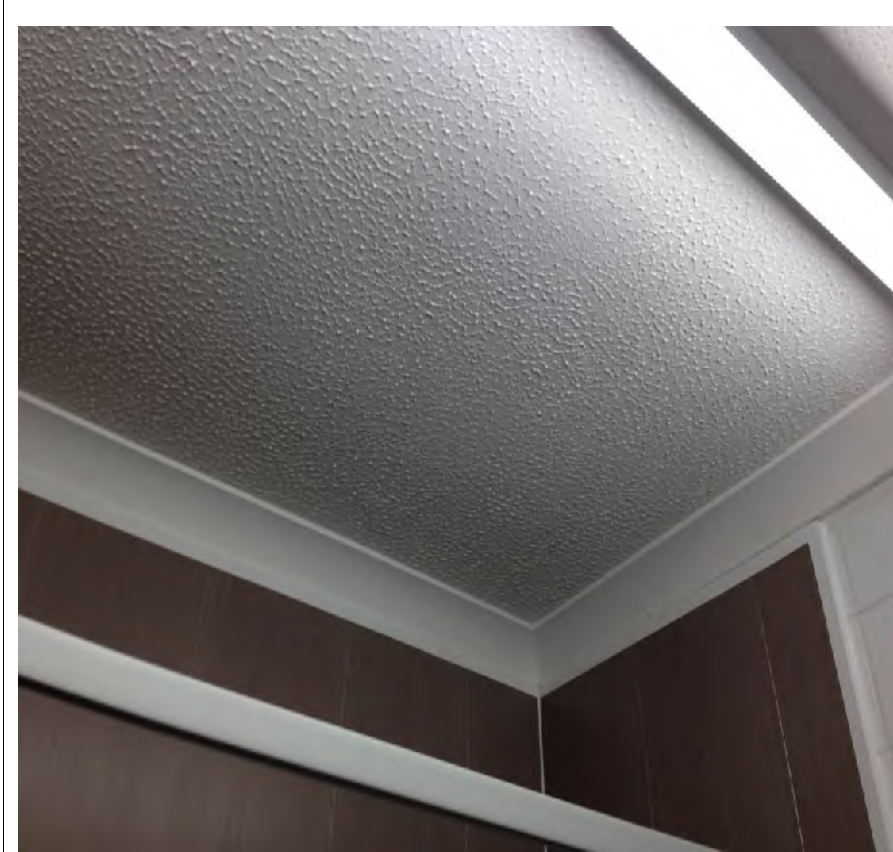
**PHOTOPLATE 037**

| Accommodation Block 21 (Tenby) | | | | | |
|---|---|---|---|---|---|
| Ground Floor Bathroom | 364 | 37 | Textured coating to ceiling | Was found to contain Chrysotile (White Asbestos) | Mark and manage |

| Ground Floor Bathroom |

| Item No. |
| - |
| Mark and manage |

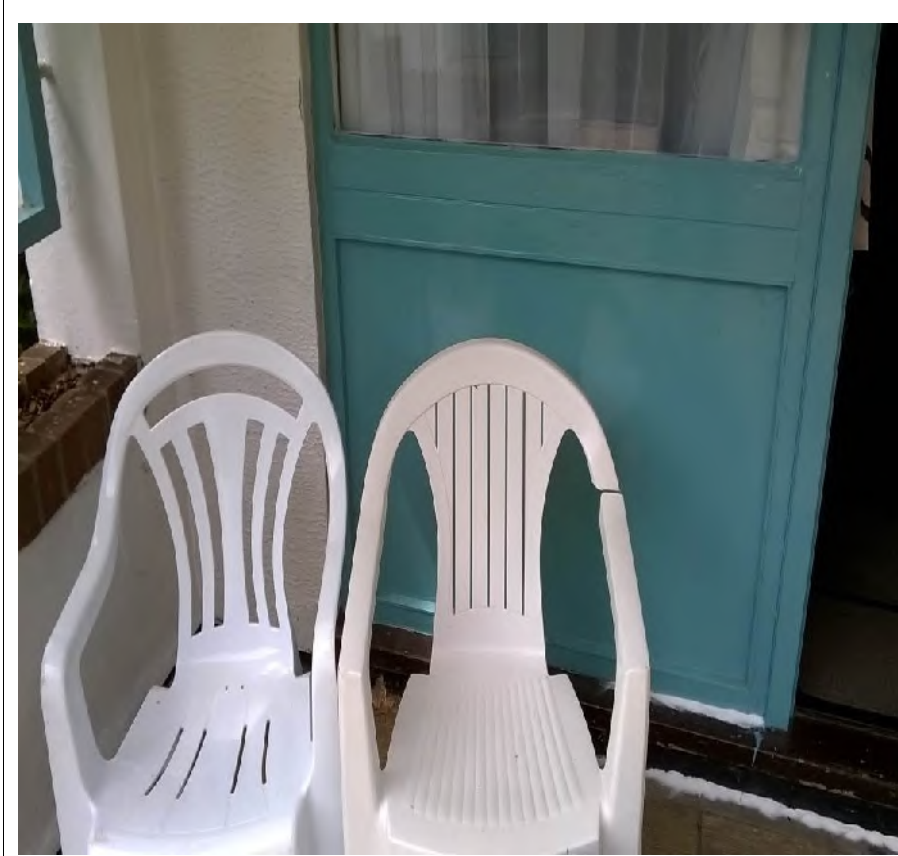
**PHOTOPLATE 043**

| Accommodation Block 5 (Norfolk) | | | | | |
|---|---|---|---|---|---|
| External Bedroom | 313 | 43 | Infill panel beneath window | Was found to contain Chrysotile (White Asbestos) | Mark and manage |

| External Bedroom |

| Sample Reference (Bulk ID) |
| - |
| Mark and manage |

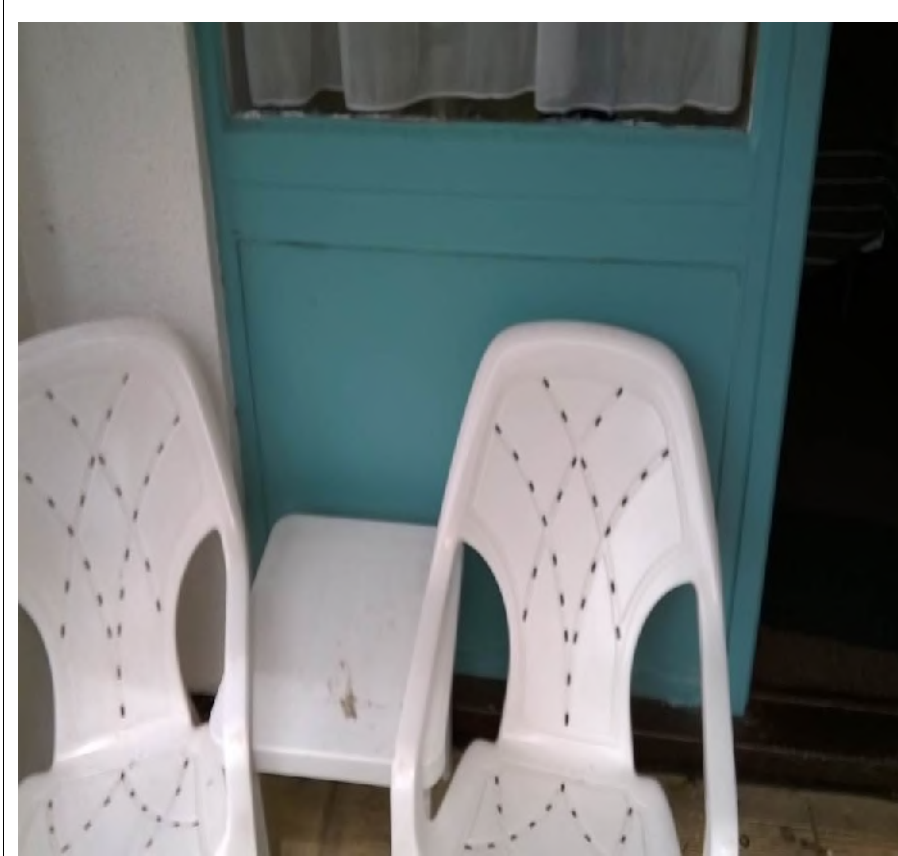
**PHOTOPLATE 047**

| Accommodation Block 5 (Norfolk) | | | | | |
|---|---|---|---|---|---|
| External Bedroom 1 | 303 | 47 | Infill panel beneath window | Was found to contain Chrysotile (White Asbestos) | Mark and manage |

| External Bedroom 1 |

| Sample Reference (Bulk ID) |
| - |
| Mark and manage |

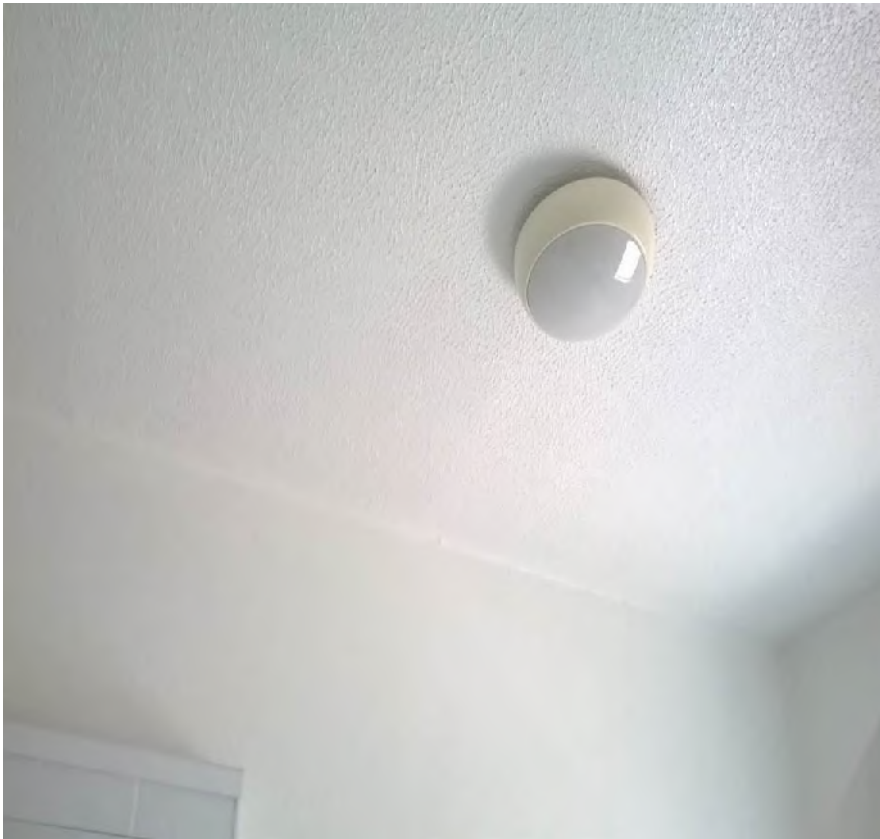
**PHOTOPLATE 049**

| Accommodation Block 5 (Norfolk) | | | | | |
|---|---|---|---|---|---|
| Ground Floor Bathroom | 317 | 49 | Textured coating to ceiling | Was found to contain Chrysotile (White Asbestos) | Mark and manage |

| Ground Floor Bathroom |

| Sample Reference (Bulk ID) |
| - |
| Mark and manage |

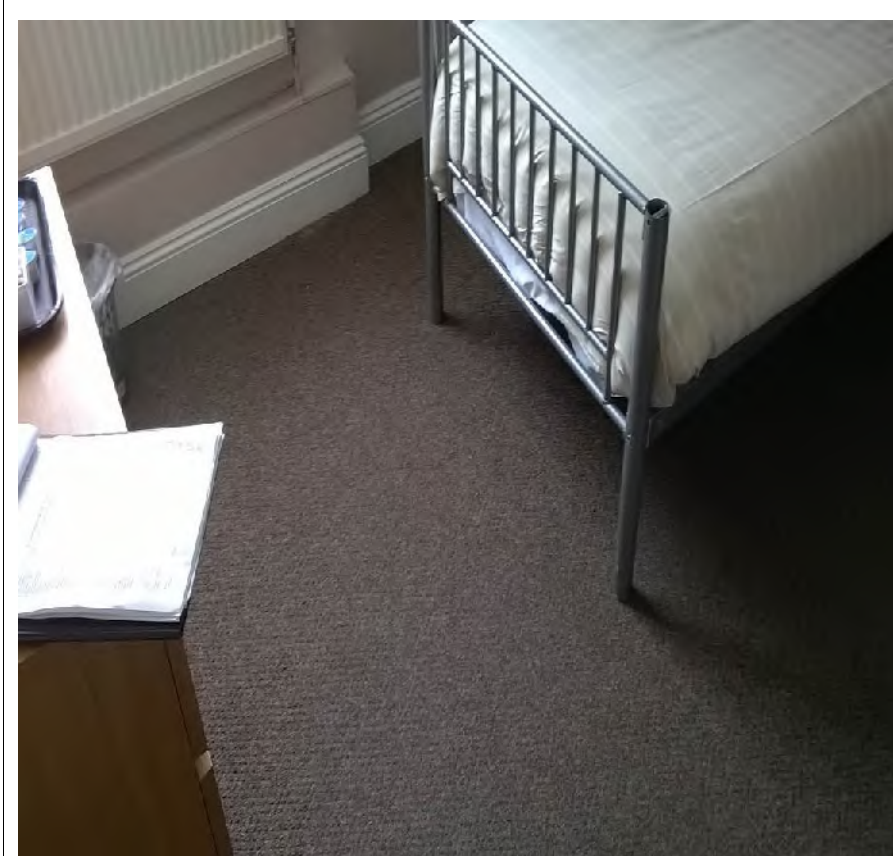
**PHOTOPLATE 053**

| Accommodation Block 5 (Norfolk) | | | | | |
|---|---|---|---|---|---|
| Ground Floor Bedroom | 392 | 53 | Floor tiles beneath carpet | Was found to contain Chrysotile (White Asbestos) | Mark and manage |

| Ground Floor Bedroom |

| Sample Reference (Bulk ID) |
| - |
| Mark and manage |

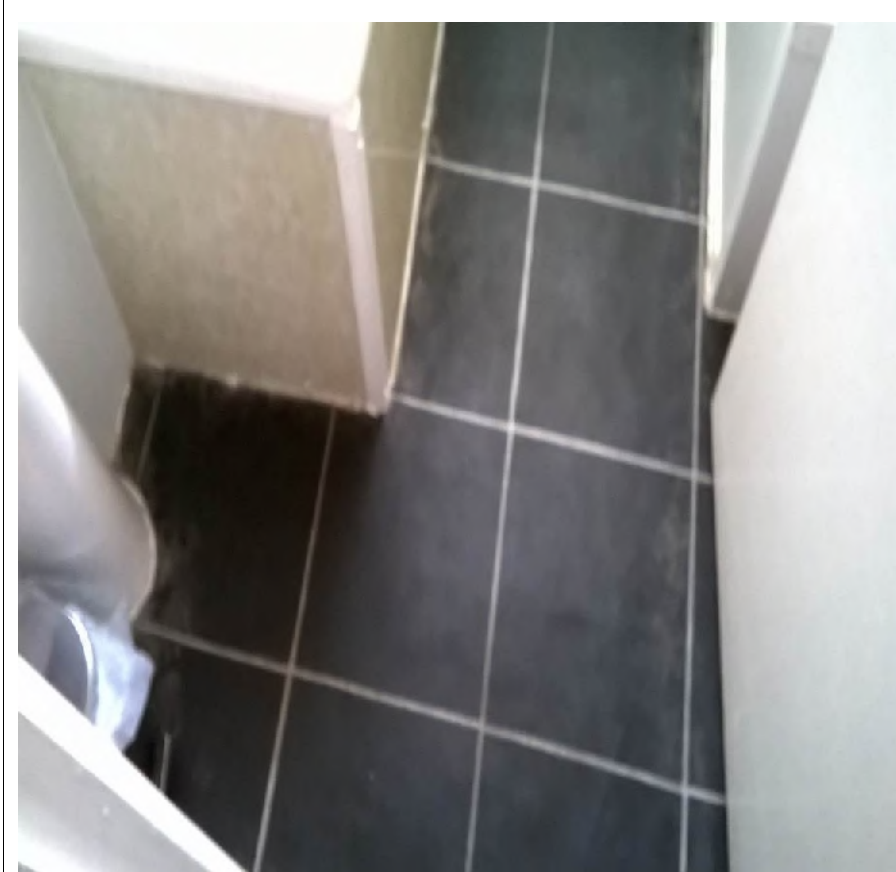
PHOTOPLATE 055

| Accommodation Block 5 (Norfolk) | | | | | |
|---|---|---|---|---|---|
| Ground Floor Bathroom | 398 | 55 | Floor tiles beneath the sampled vinyl floor covering | Was found to contain Chrysotile (White Asbestos) | Mark and manage |

| Ground Floor Bathroom |

| Sample Reference (Bulk ID) |
| - |
| Mark and manage |

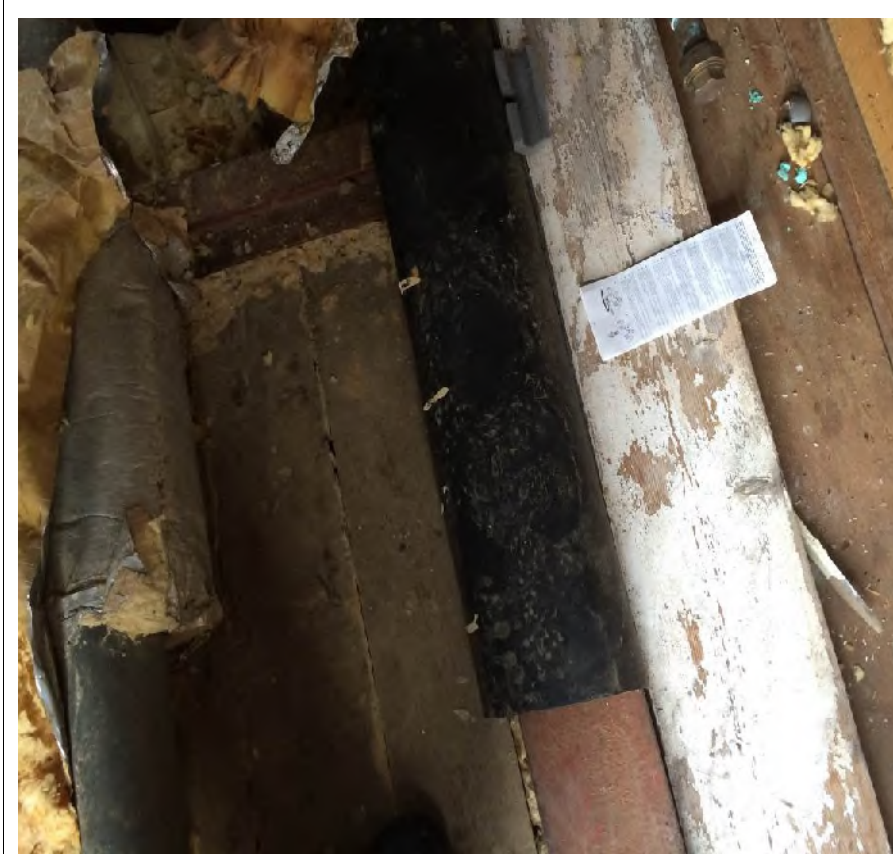
PHOTOPLATE 057

| Accommodation Block 5 (Norfolk) | | | | | |
|---|---|---|---|---|---|
| Second Floor Tank Room | 401 | 57 | Felt beneath metal tanks to RSJ's | Was found to contain Chrysotile (White Asbestos) | Mark and manage |

| Second Floor Tank Room |

| Sample Reference (Bulk ID) |
| - |
| Mark and manage |

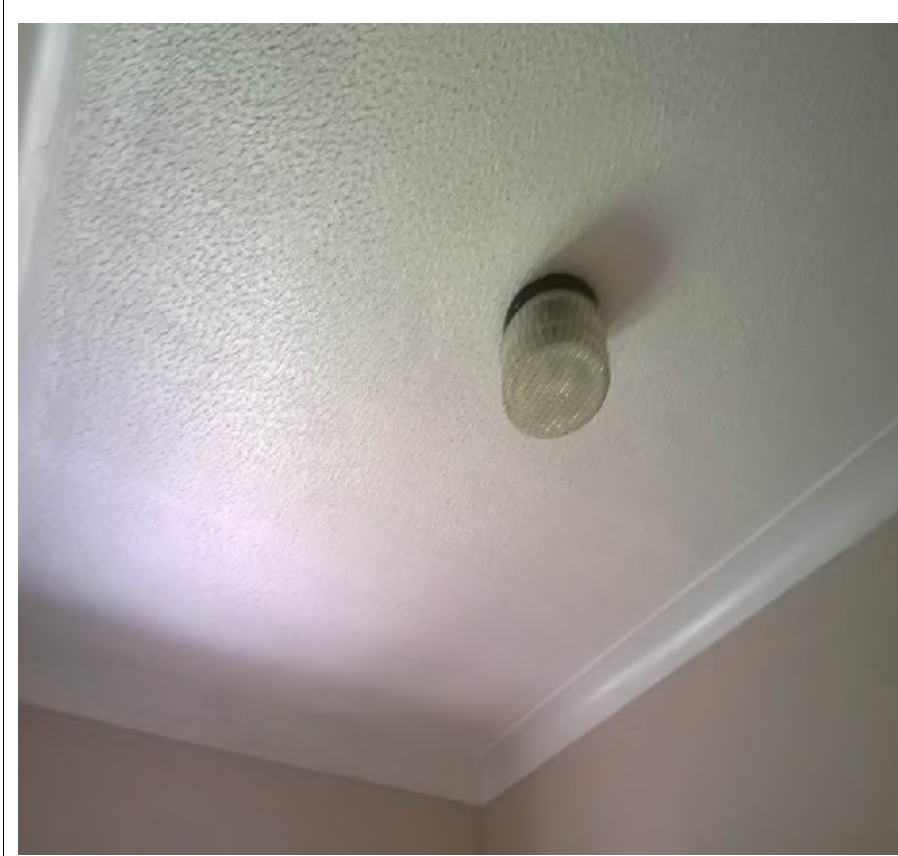
**PHOTOPLATE 065**

| Accommodation Block 5 (Norfolk) | | | | | |
|---|---|---|---|---|---|
| Ground Floor Bedroom 1 | 382 | 65 | Textured coating to ceiling | Was found to contain Chrysotile (White Asbestos) | Mark and manage |

| Ground Floor Bedroom 1 |

| Sample Reference (Bulk ID) |
| - |
| Mark and manage |

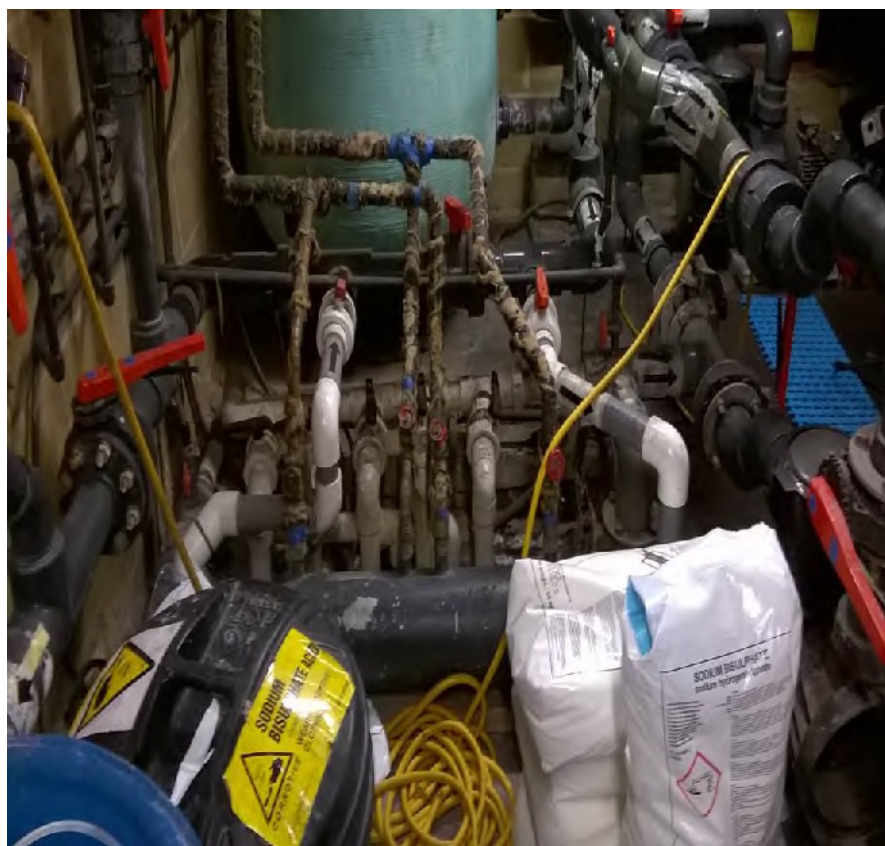
**PHOTOPLATE 069**

| Ground Floor Plant Room | 007 | 69 | Gasket to pipe work on left hand side upon entry | Was found to contain Chrysotile (White Asbestos) | Mark and manage |

Ground Floor Plant Room

Mark and manage

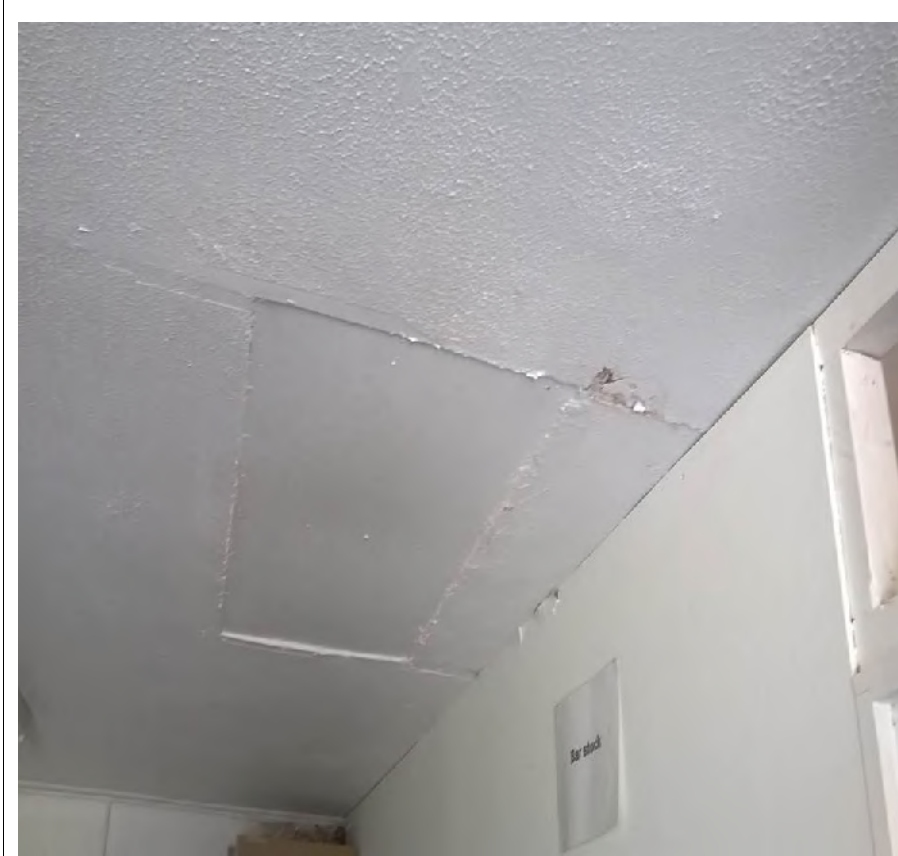
**PHOTOPLATE 073**

| Ground Floor Cellar | 059 | 73 | Textured coating to ceiling | Was found to contain Chrysotile (White Asbestos) | Encapsulate |

Ground Floor Cellar

Encapsulate

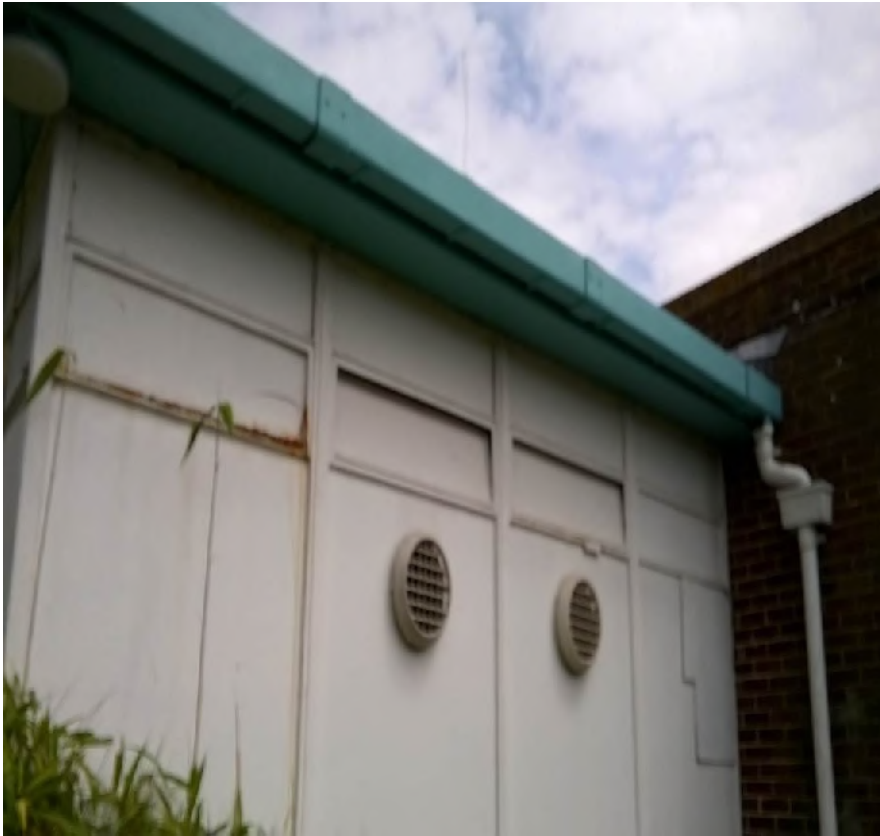
**PHOTOPLATE 077**

| External Office | 250 | 77 | Rainwater goods | Was found to contain Chrysotile (White Asbestos) | Mark and manage |

| External Office |

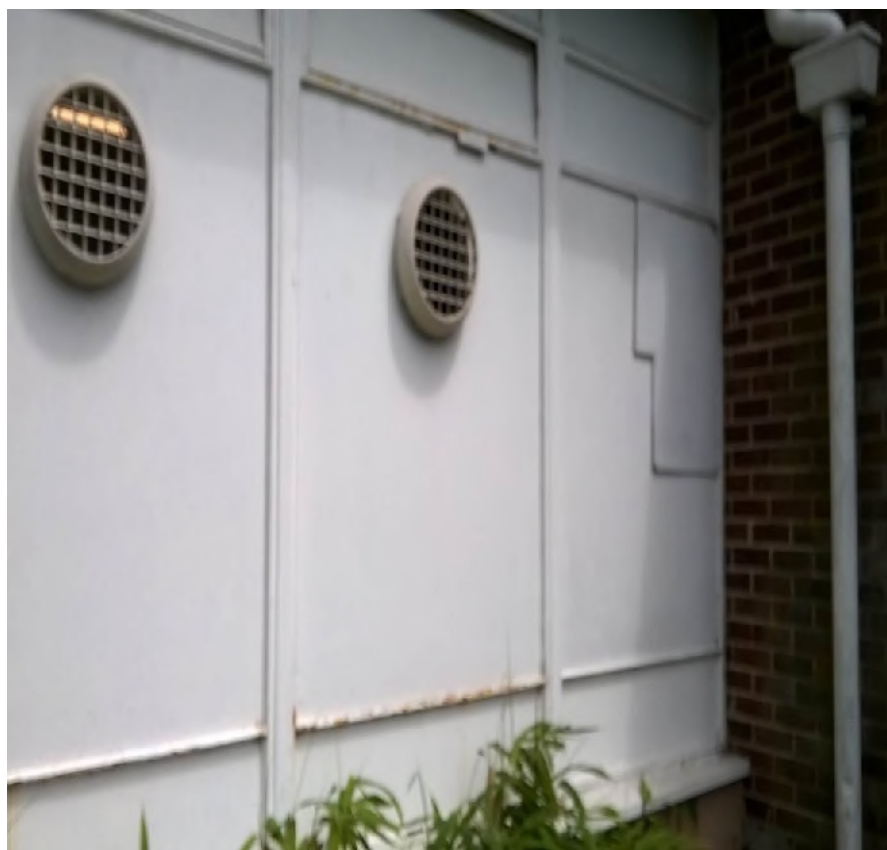
**PHOTOPLATE 085**

| External Circulation | 265 | 85 | Infill panel to window – slight damage to corner | Was found to contain Amosite (Brown Asbestos) | Mark and manage |

External Circulation

Mark and manage

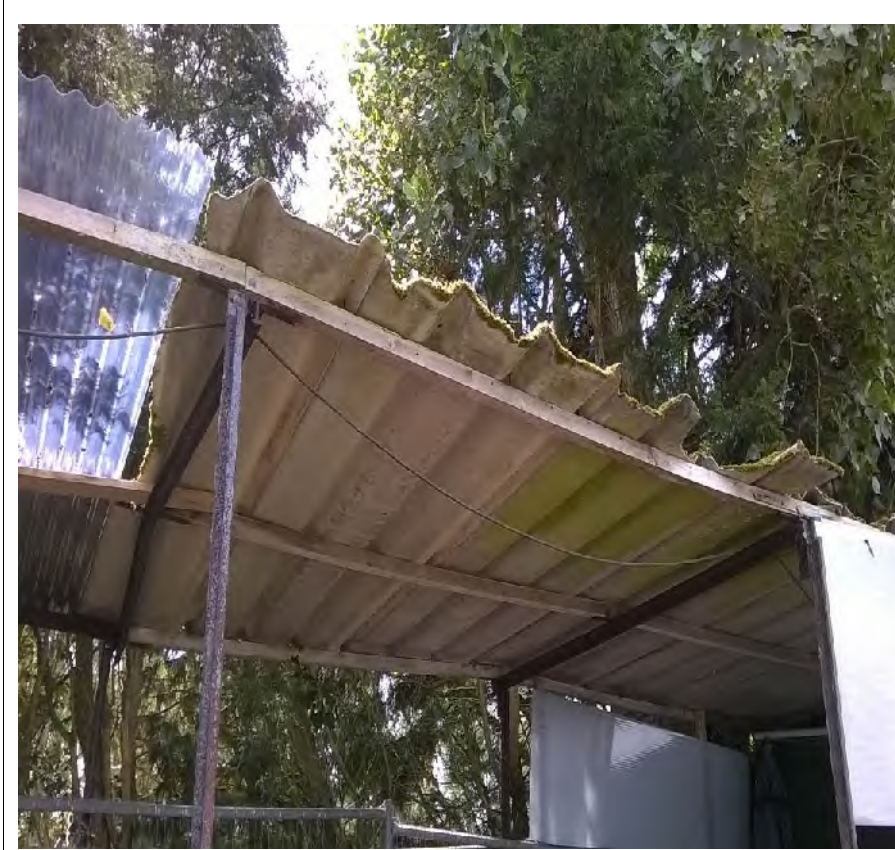
**PHOTOPLATE 093**

| External Store | 226 | 93 | Corrugated cement roof sheets | Was found to contain Chrysotile (White Asbestos) | Mark and manage |

| External Store |

| Sample Reference (Bulk ID) |
| - |
| Mark and manage |

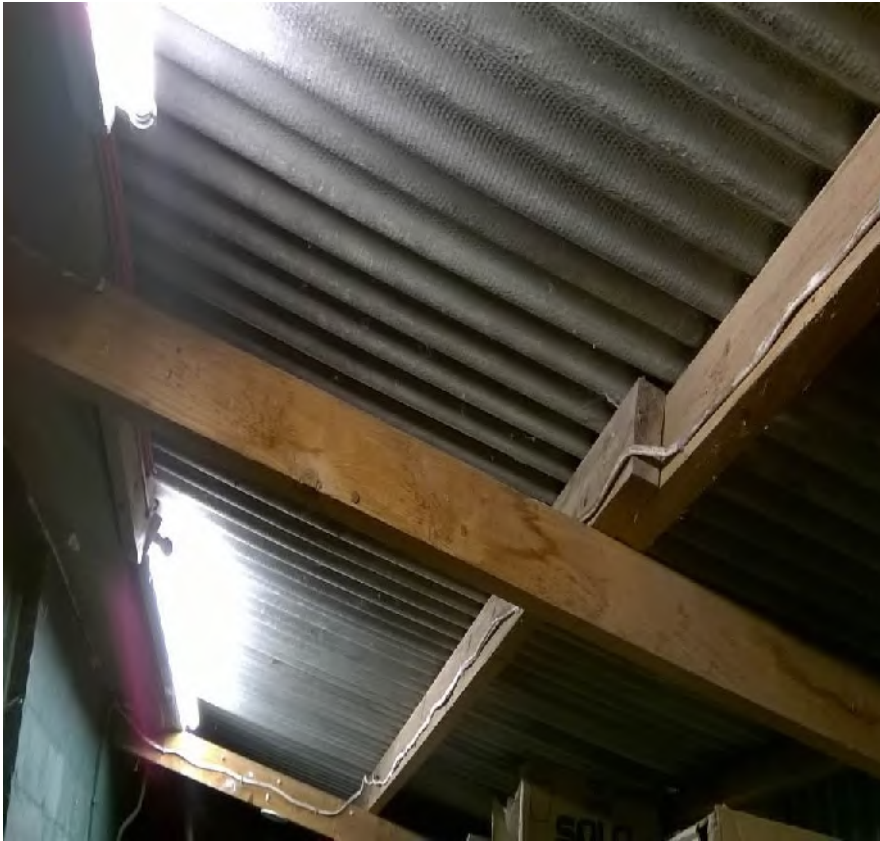
**PHOTOPLATE 099**

| Ground Floor Store | 495 | 99 | Corrugated roof sheets | Was found to contain Chrysotile (White Asbestos) | Mark and manage |

| Ground Floor Store |

| Sample Reference (Bulk ID) |
| - |
| Mark and manage |

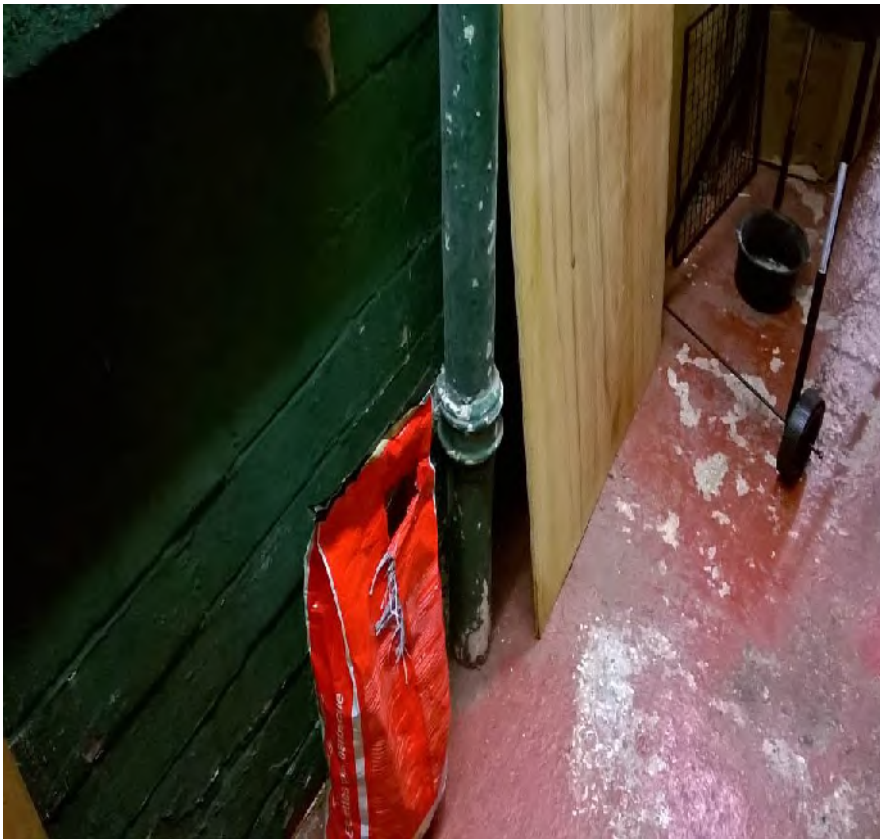
**PHOTOPLATE 101**

| Ground Floor Stores | 498 | 101 | Cement down pipe | Was found to contain Chrysotile (White Asbestos) | Mark and manage |

Ground Floor Stores

Mark and manage

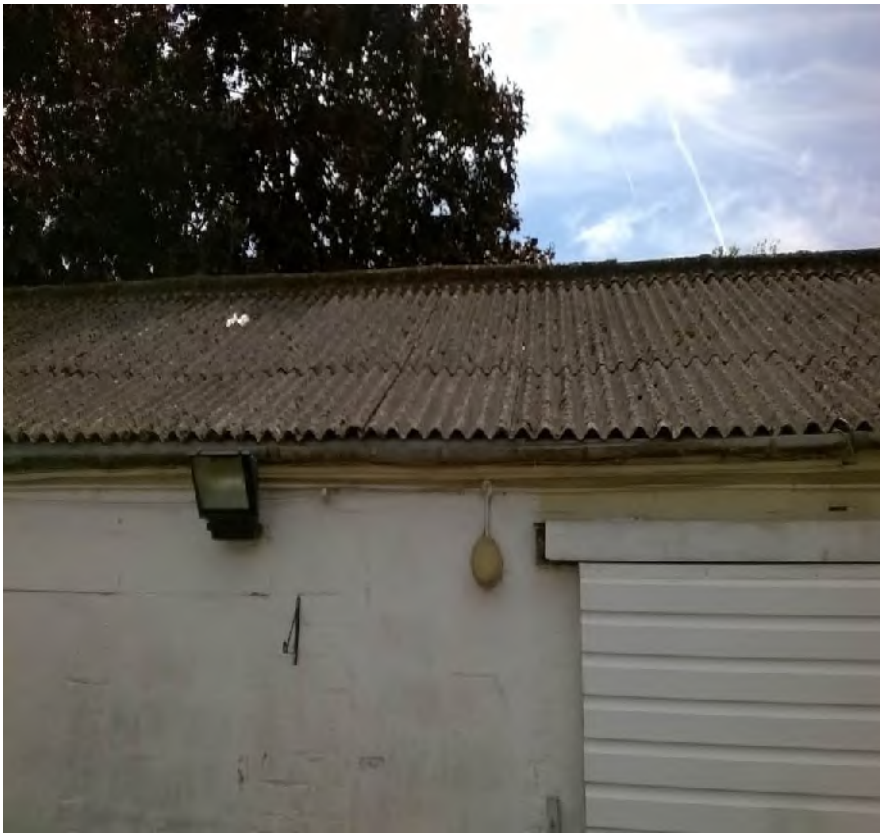
**PHOTOPLATE 103**

| External Roof Area | 502 | 103 | Corrugated roof sheets | Was found to contain Chrysotile (White Asbestos) | Mark and manage |

External Roof Area

Mark and manage
