## Arboricultural Report

**BS 5837:2012 Tree Survey, Arboricultural Impact Assessment,  
Method Statement & Tree Protection Plan**

**22 Manor Close, Havant PO9 1BD**

**Ref:** AS/PH/1117

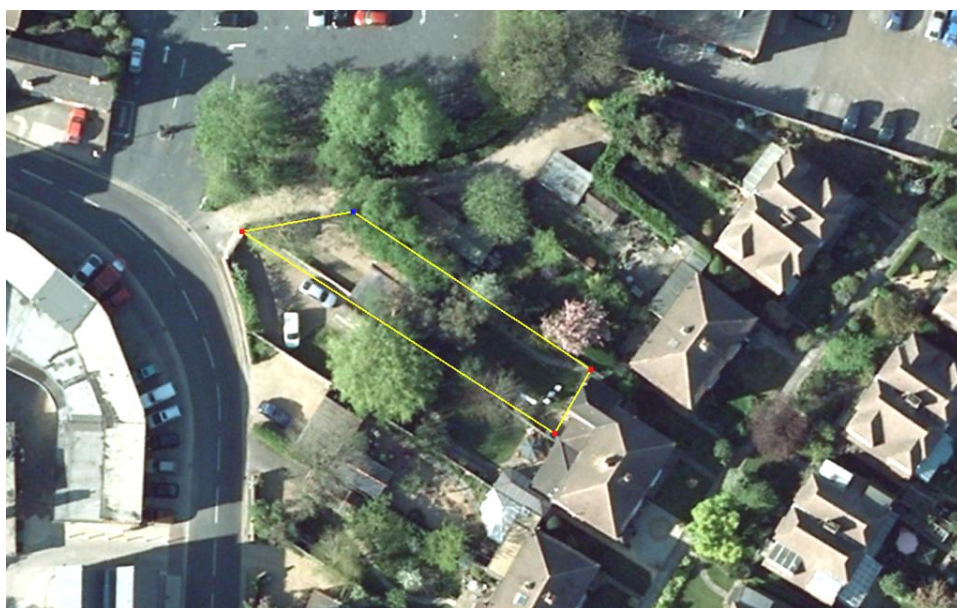
- 2.2 **Site Description:** this site is a long rear garden on level ground, which includes existing vehicular access, parking and a car port off Prince George Street. There are various mainly small-medium size garden trees within the site, and one mature Eucalyptus in the centre of the garden. The site measures approximately 320m<sup>2</sup>. It is bounded to the north and south by neighbouring gardens, to the east by the associated dwelling, and to the west by access drive and public highway as shown in Figure 1.

Figure 1. Aerial view showing the rear garden at 22 Manor Close (Google 2017)

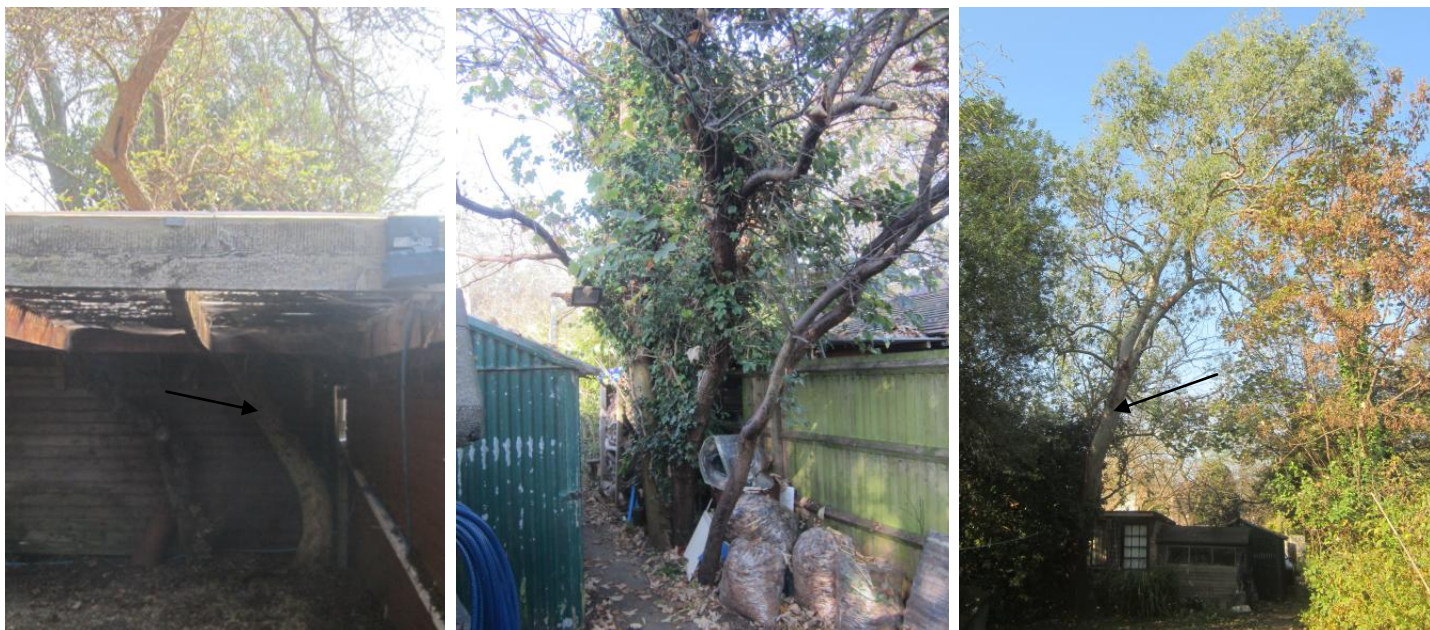
**3.6 Tree removal:** T3, T5 and G1 will require removal in order to facilitate this proposal; please see Figure 2 for views of these trees. T3 is a very poor specimen growing from within the current car port structure and due to its structurally and visually weak condition is recommended for removal regardless of any development (a BS5837 category U tree). T5 and G1 are all low quality category C trees. T5 has a leaning and unbalanced growth habit, and being a Eucalyptus is of typically vigorous growth and has quickly outgrown its garden location. G1 consists of a cluster of small diameter stems growing close to the boundary fence, with weak growth habit and poor form. None of the trees to be removed are of any significant public amenity or landscape value, and could comfortably be replaced with better quality specimens in more suitable positions to result in a net enhancement of amenity value in the longer term.

Figure 2. Trees to be removed (L-R): T3 growing through car port, G1 adjacent to boundary fence, and T5 leaning Eucalyptus further back within the rear garden

4.1 **Tree Works:** All required works as detailed above should be carried out prior to commencement of construction works.
