**REPORT TO SUPPORT A TREE PRESERVATION ORDER  
APPLICATION**

LAND ADJACENT TO  
3 TREE TOPS DRIVE  
COWPLAIN  
WATERLOOVILLE  
HAMPSHIRE  
PO8 8JF

SEPTEMBER 2016

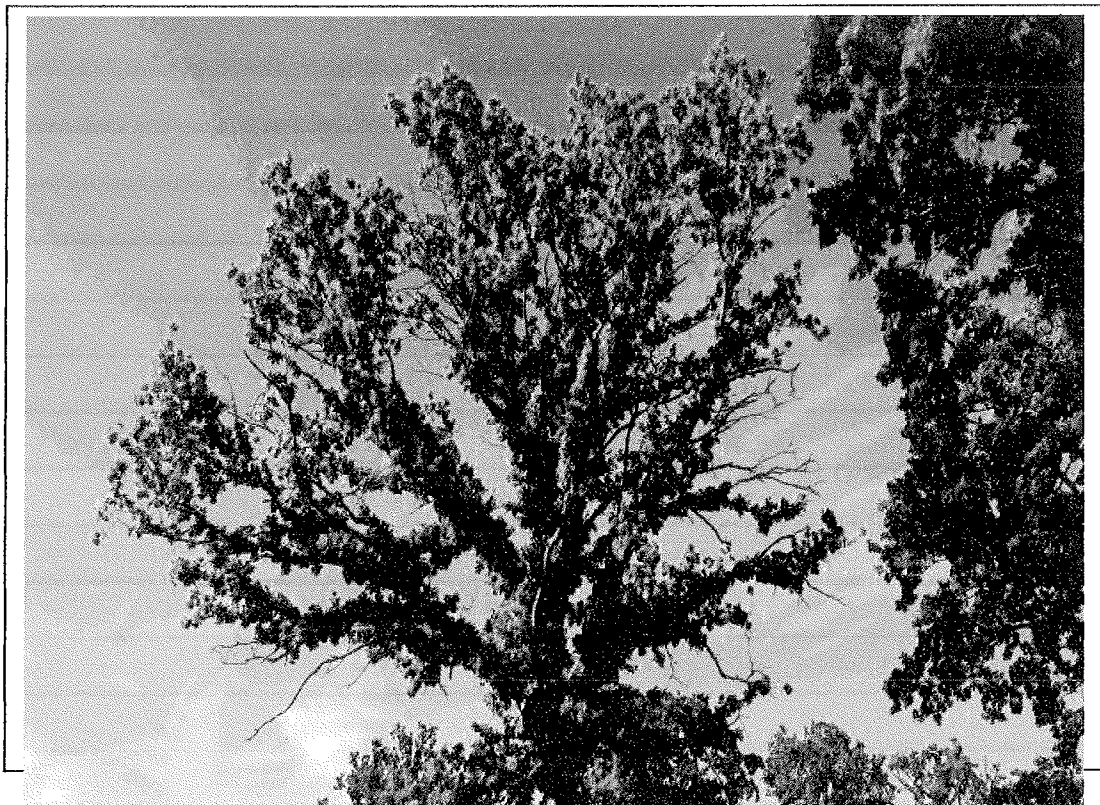
- The tree has been overly thinned in the past and has resulted in 'Lion's-tailing'.

- Water sprouts are endemic along all major scaffold limbs. These derive from latent buds in the bark and are indicative of a tree under stress. In this instance they may be present as a result of over-pruning. They often appear in response to stress.
- The Oak tree T1 is in irreversible decline and no amount of remedial work will rectify this.

View of T1 Oak from the construction site  
looking south

- 8.3 It is considered that an application should be made to Havant Borough Council for the removal of the tree and a replacement planted.
- 8.4 The majority of the trees on and around the site are early-mature and mature Oak trees. There are very few young trees present. Given this it is considered that the planting of a replacement Oak after removal will contribute to the continuity of tree cover on the site over time, providing visual amenity for future generations.

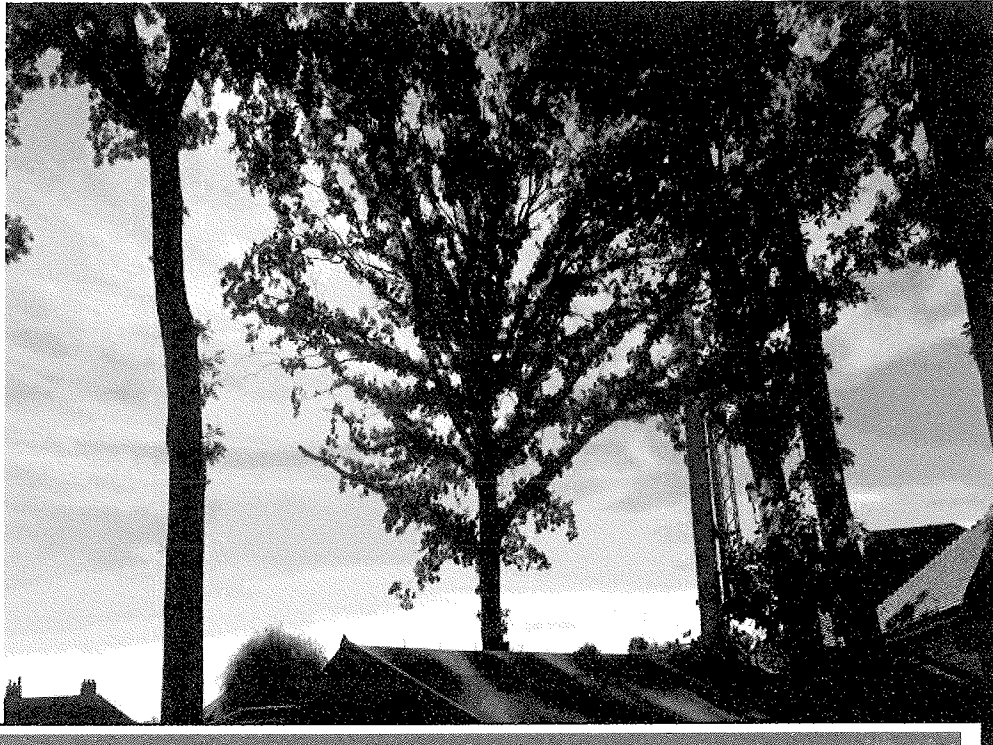
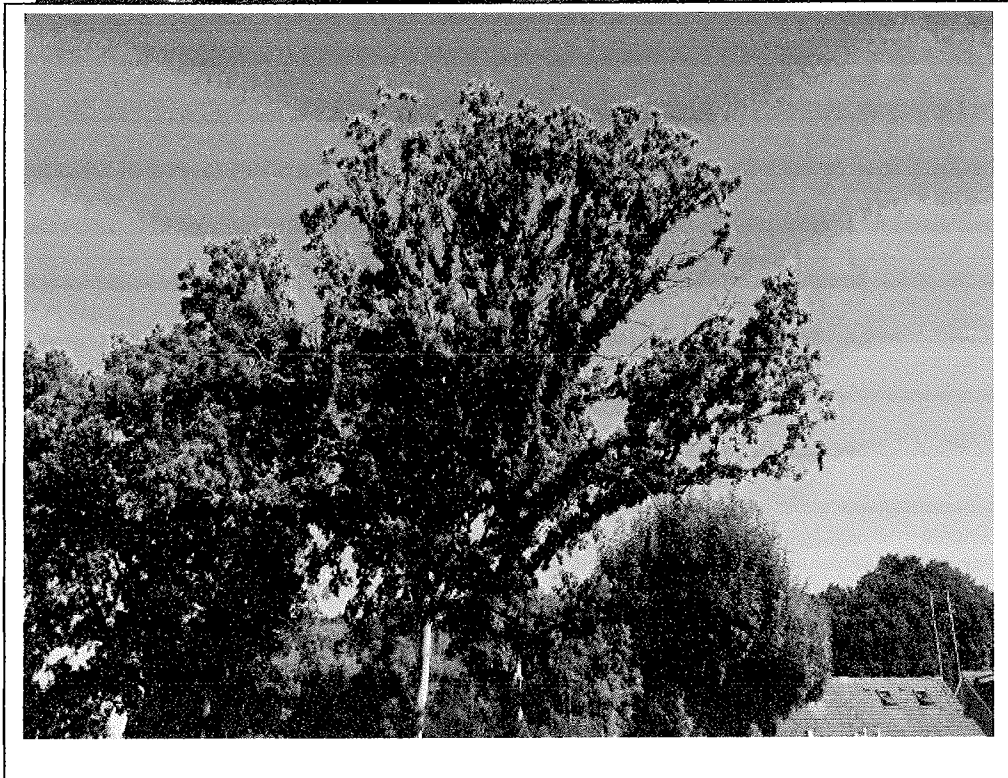
View from Tree Tops Drive looking  
West
