# Tree Report to BS 5837:2012

8, Barn Fold, Waterloooville,

November 2017

### Tree & Woodland Surveys

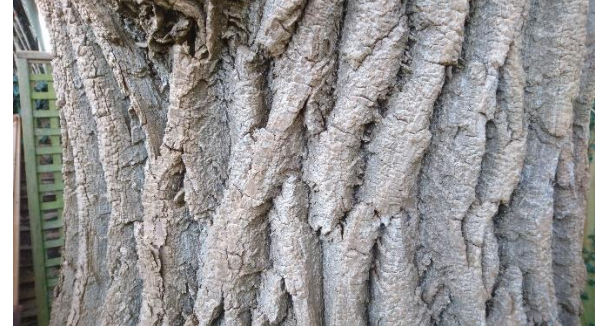
| | Bark detail showing current high vigour and healthy growth. |

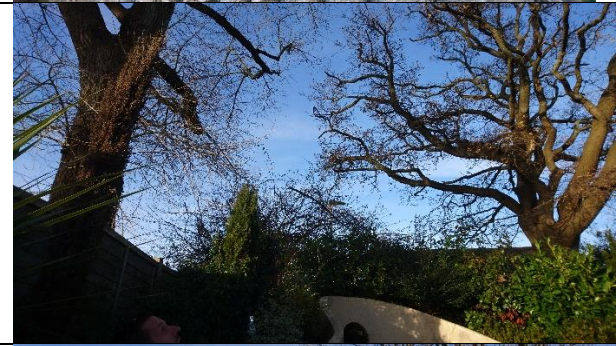
| | The Poplar on the Left showing some healthy epicormic growth. The Oak on the Right is unaffected by the build proposed at number 8. |

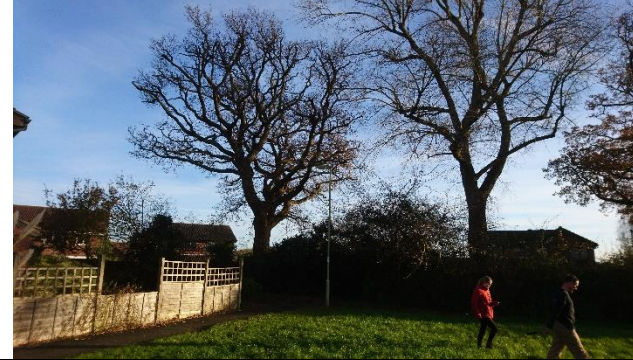
| Tree | Ht (m) | Dbh (cm) | Canopy radius | Category | RPA in metres | Canopy height | Comment |
|---|---|---|---|---|---|---|---|
| Populus robusta | 27 | 99 @1.5m | N 12<br>E 11<br>S 12<br>W 8 | A | 12 | 5 | Enormous tree of good form, out of scale with the development of houses and garden underneath. Past surgery has probably saved some limbs from failure. Wind resistance significant again now. Hard surface and sheds in rooting zone will be affecting the hydration. Time to be cut back again. |

| | The Poplar on the Right showing past surgery of good quality and the out-of-scale nature of the tree. |
