Arboricultural assessment/method statement report for:

1B Park Road

Purbrook

Surveyed by Ian Lansley 10/7/2017

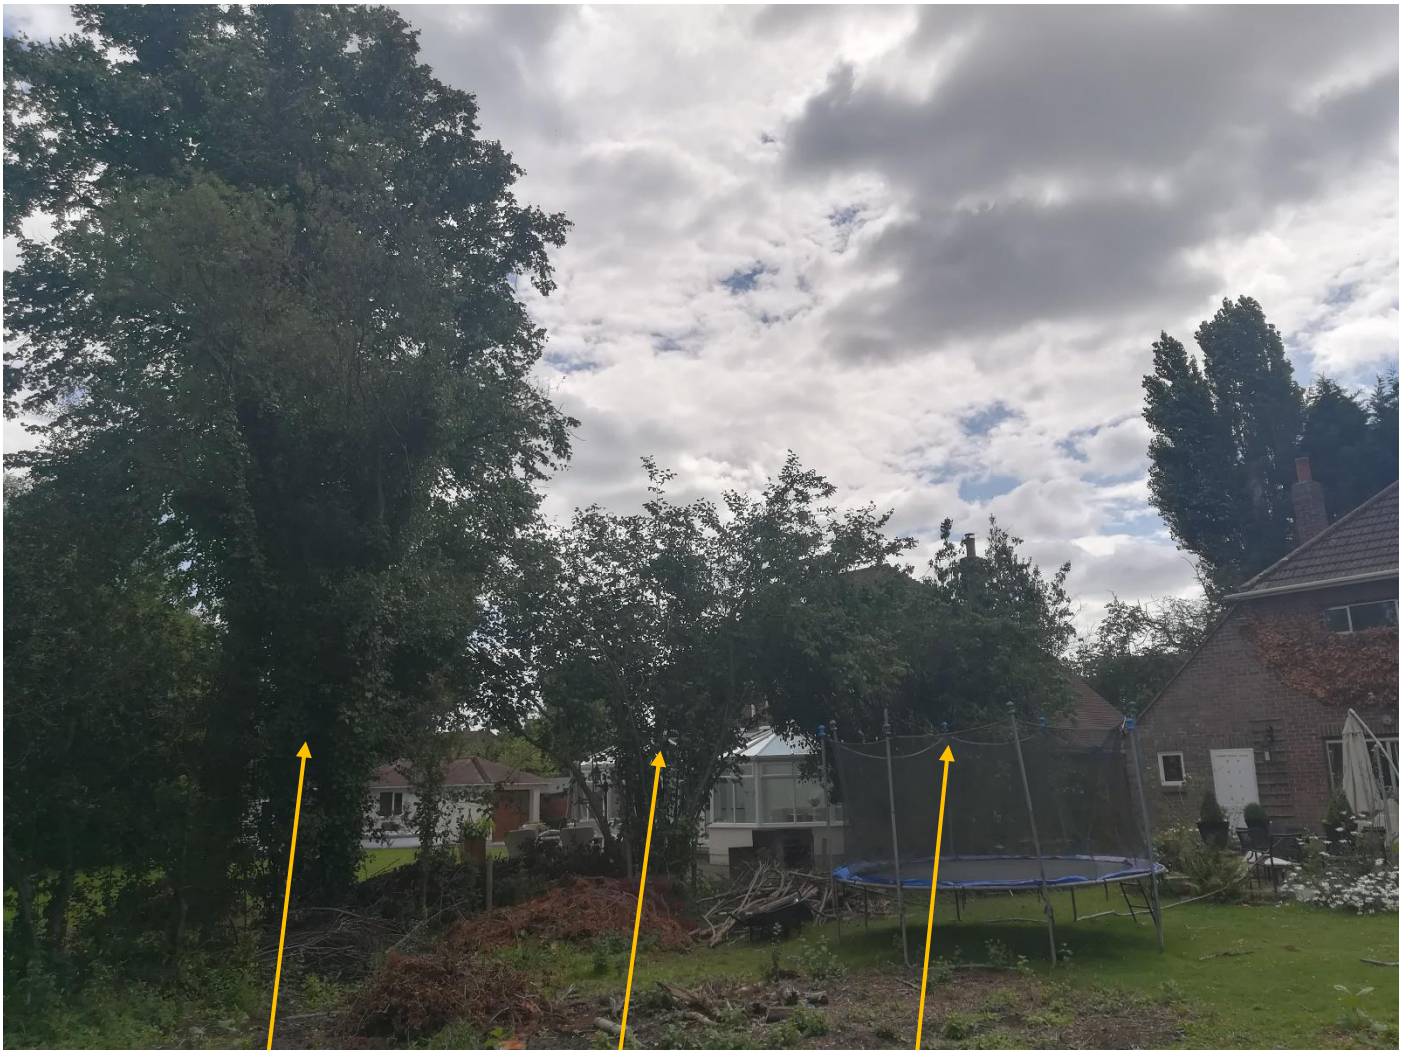
From the following photographs, it is possible to see that the boundary trees in question are in fact overgrown bushes or coppice, being Lilac and Hazel. There is also a small Holm Oak growing close to the boundary from the neighbouring property. The major tree is a Macrocarpa to the rear of the property.

Holm Oak

Hazel

Lilac

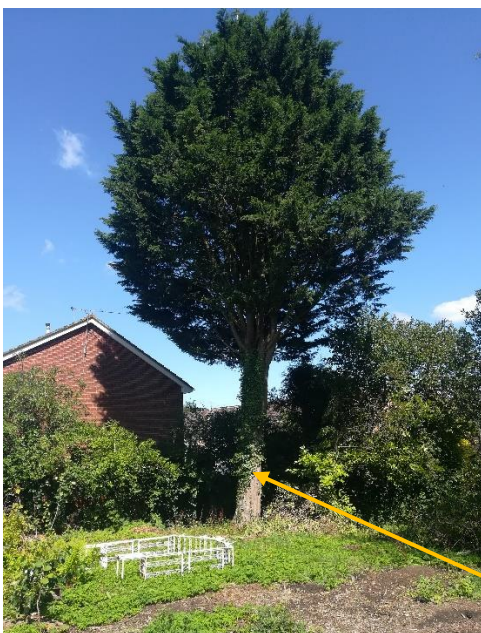
Lilac – multi-stem overgrown bush, no DBH measurement possible. Height 5.0m. Basal area 0.8mSq  
Hazel – multi-stem coppice regrowth, no DBH measurement possible. Height 5.3m. Basal area 0.7mSq  
Holm Oak – DBH of largest stem 28cm. Height 10.6m  
Macrocarpa – DBH 67cm, Height 18.7m

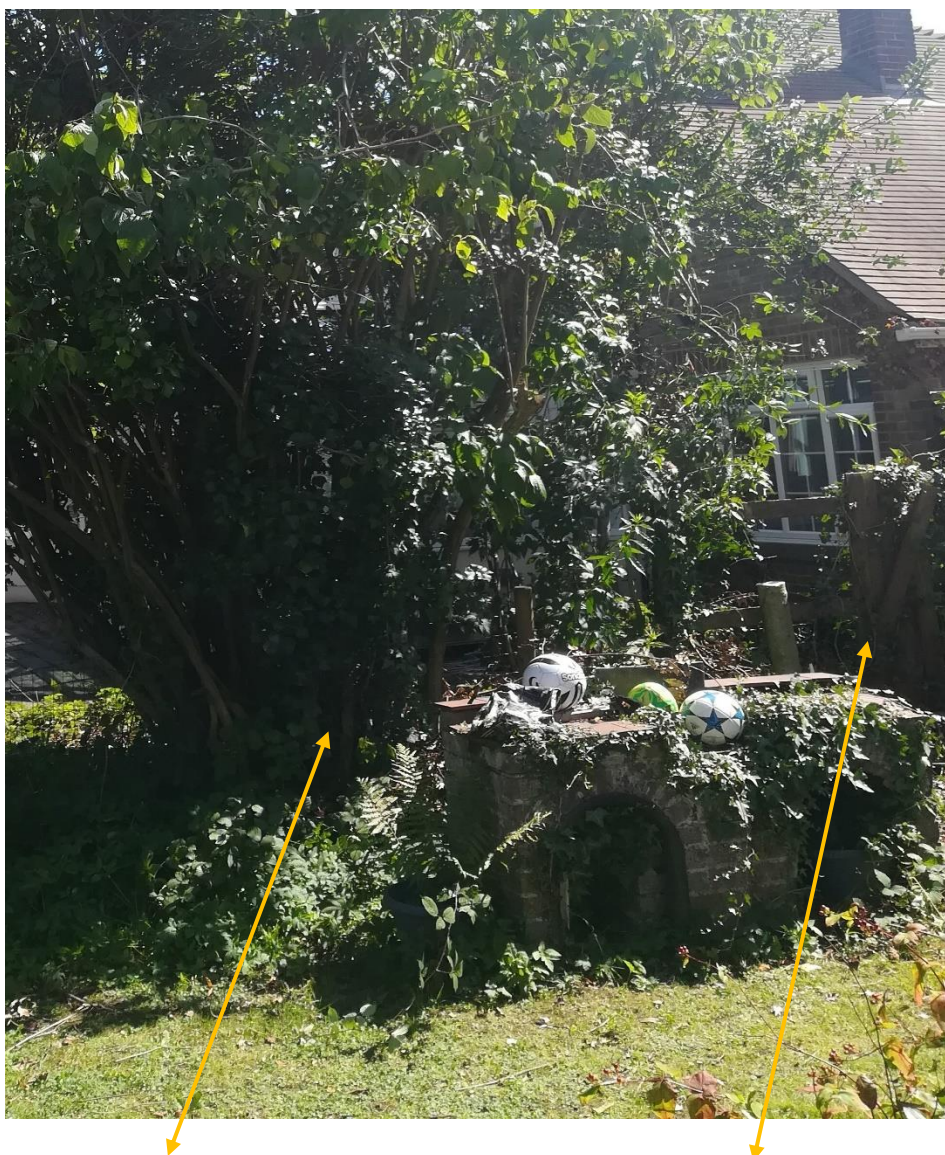
The owners of the property intend to remove the lilac as it is a boundary shrub which now grows through both sides of the boundary fence line. This fence line is very dilapidated and in need of replacement. See below.

Lilac encroaching into neighbouring land.

Broken and rotten fence line.

This Lilac is 5m from the present house and 2m from the corner of the proposed extension. As a result of this the rootzone would be affected. Although Lilac is a resilient shrub and would be able to cope with this intrusion, given its location as a garden shrub, I must recommend removal.

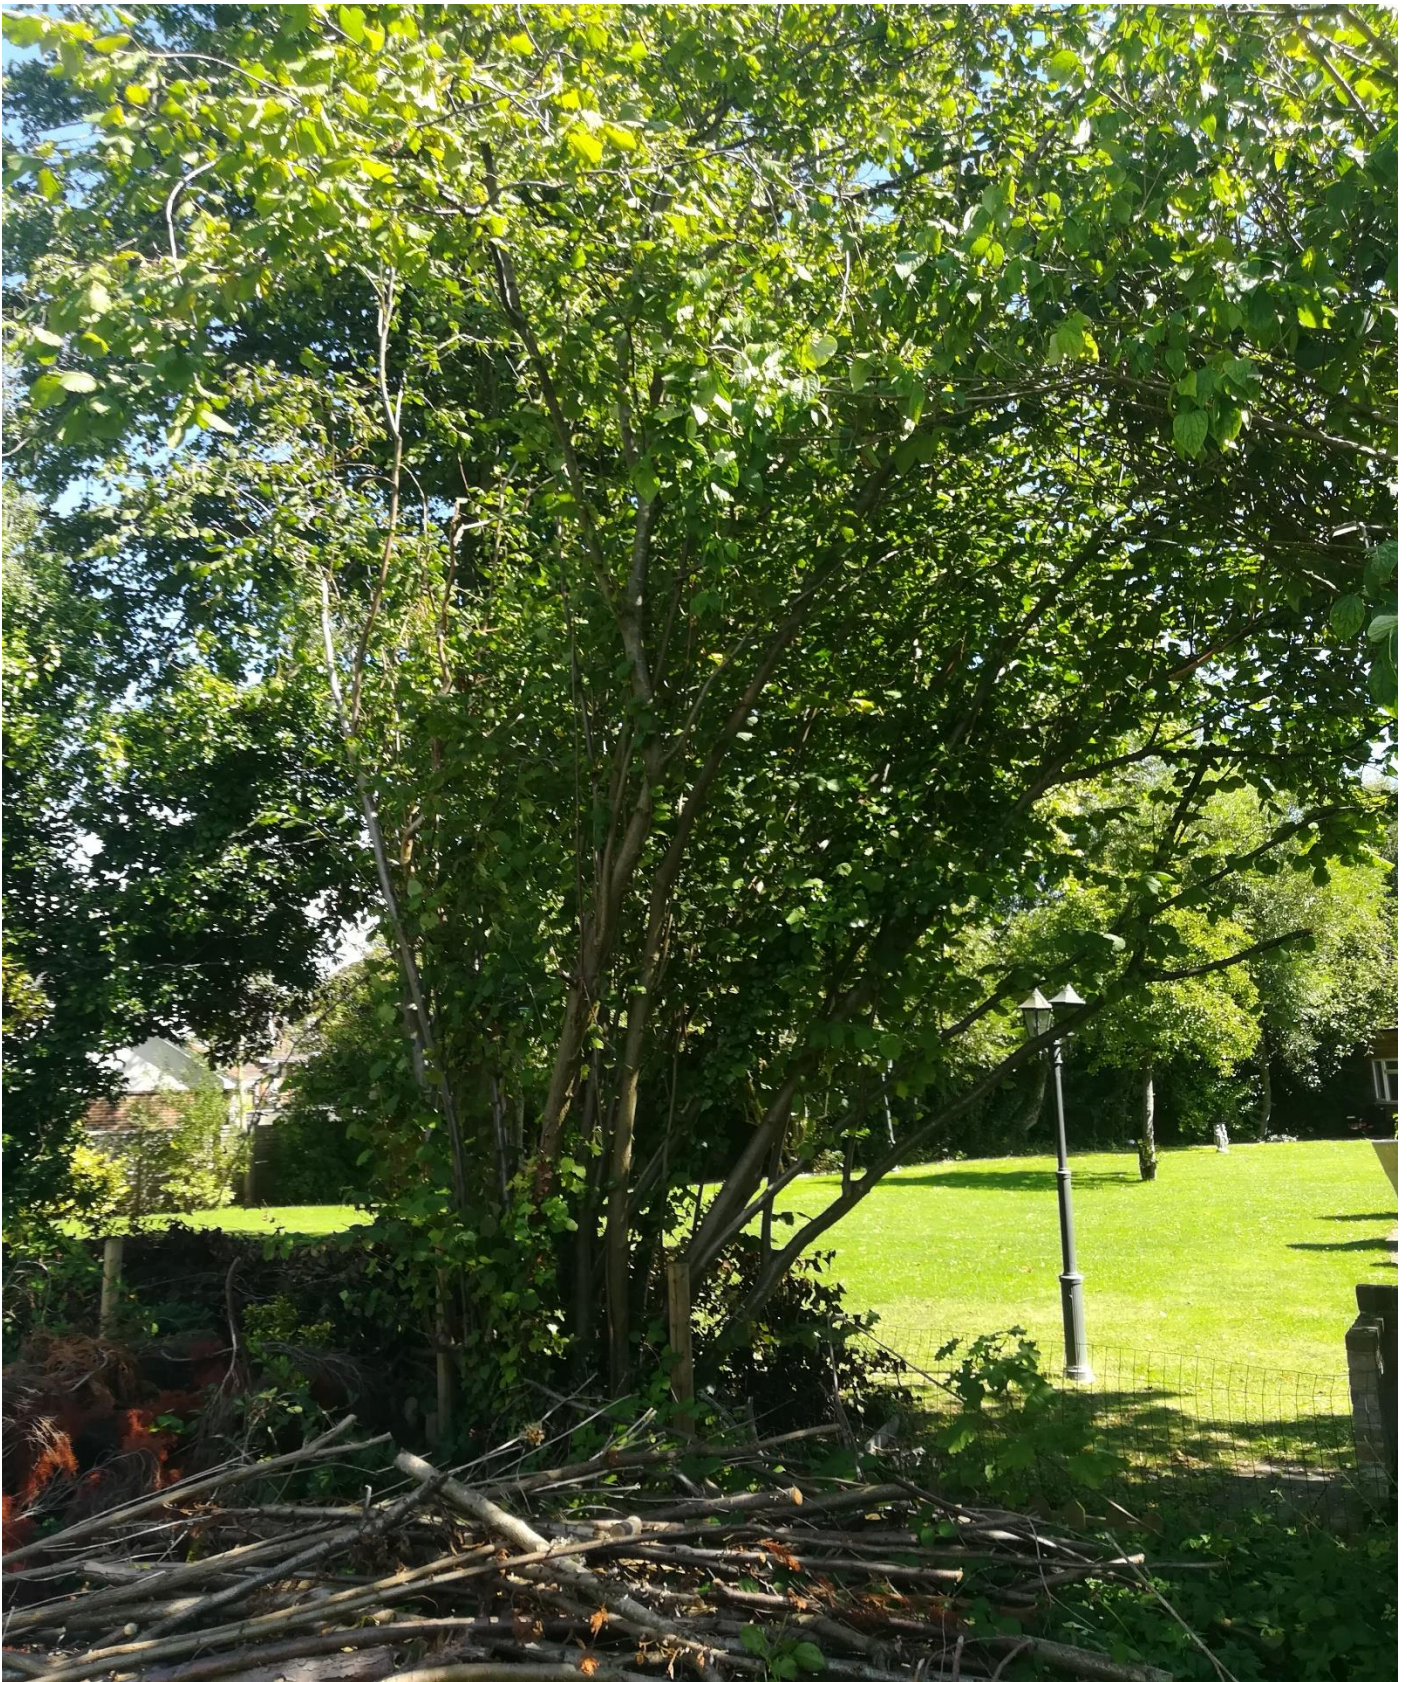
The Hazel coppice has also grown across the boundary line and is a further 7 metres from the proposed corner of the extension. The basal area of the coppice has been measured at 0.75msq as there are too many small stems to measure and I do not have access to the neighbouring property. See below.

The root protection area for this bush can be seen below. With the 20% offset a root protection fence can easily be erected to prevent damage to this bush. However, arboricultural work will have to be carried out in order to erect a new boundary fence, due to its increasing size and growth across the boundary line. It may be wiser to remove this coppice at this time.

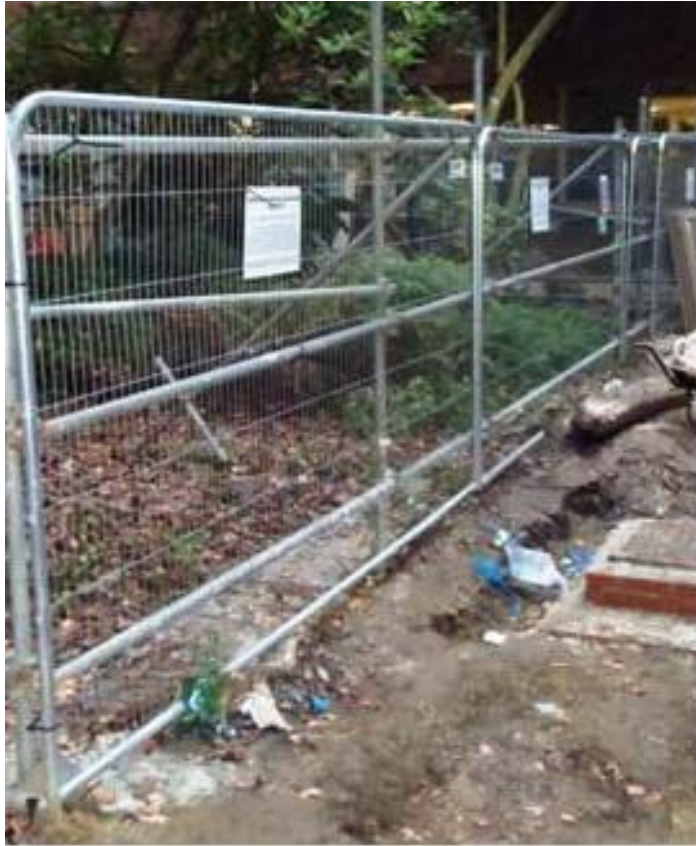
An example is shown below of root protection applied on another site. No construction materials should be stored in the area.

As this is not a commercial build I feel that 1.8m Herras fencing would be a little excessive. Orange plastic netting would be more than suitable to mark out the root protection area.
