**REPORT TO SUPPORT A TREE PRESERVATION ORDER  
APPLICATION**

LAND ADJACENT TO  
35A TOURNERBURY LANE  
HAYLING ISLAND  
HAMPSHIRE  
PO11 9DJ

FEBRUARY 2017

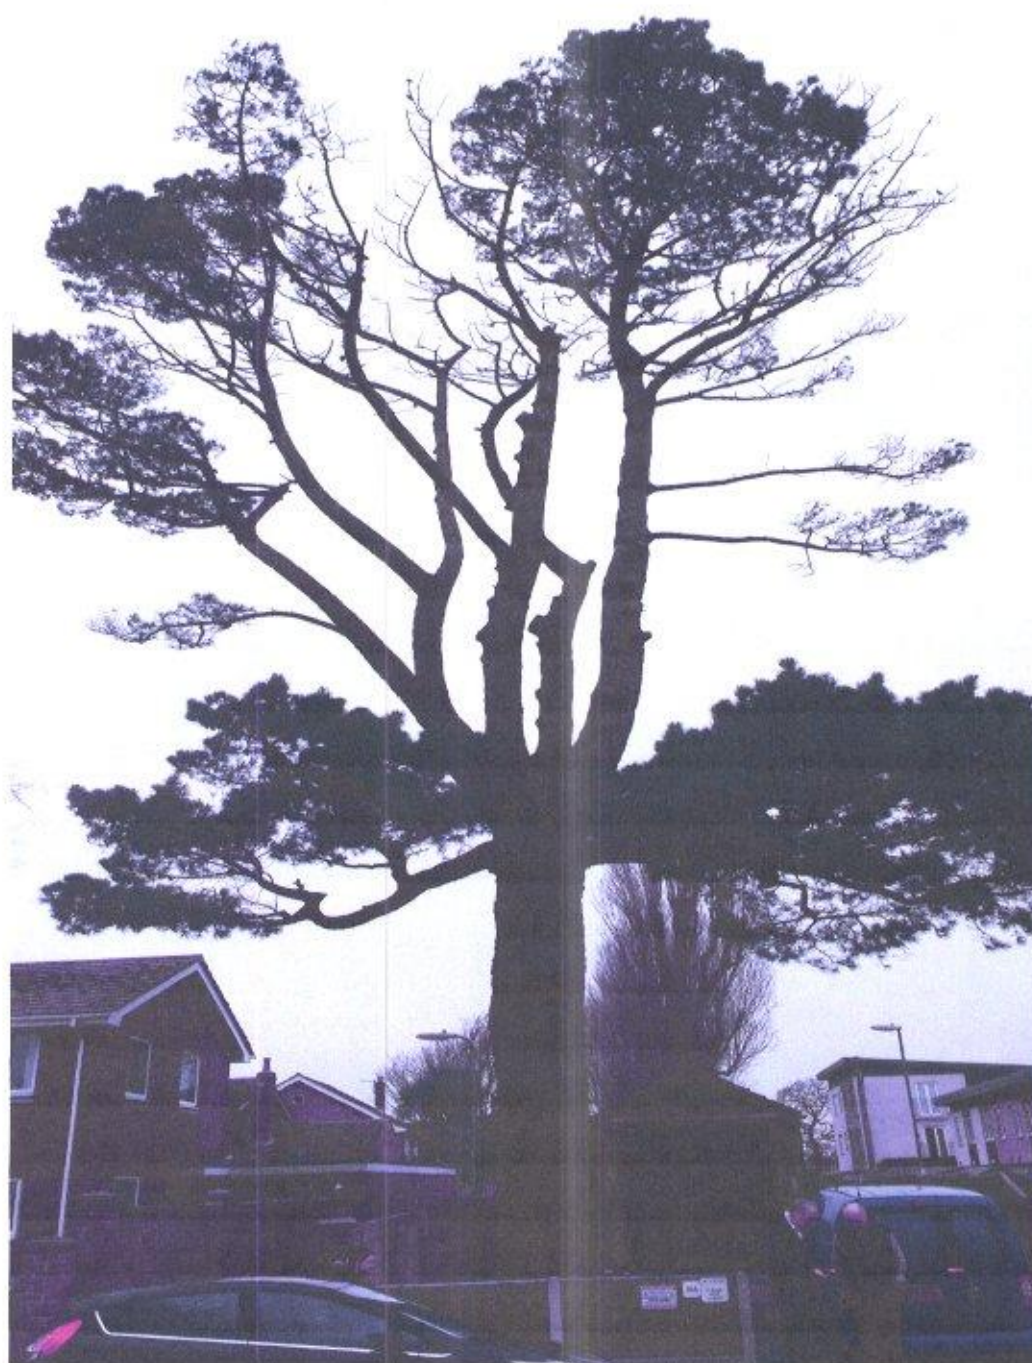
APPENDIX 2 PHOTOGRAPH TO SUPPORT TPO APPLICATION T17 MONTEREY PINE OF TPO 0872

This is an over-mature specimen in irreversible decline. It has suffered a lot of disturbance within its rooting area with a 30% lowering of soil level and continued soil compaction from vehicular access.

The damage within the rooting area is reflected within the crown by the dead scaffold and secondary branches and significant die back as well as sparse foliage with both chlorotic and necrotic patches.

The hazard rating of eleven out of twelve is well over the recommended threshold of six for taking remedial action. In this case it is considered the removal of the tree is the only viable option given concerns regarding potential hazards.

There are several targets that would be affected should the tree or some of its parts fail. These include three footpaths, a highway and residential properties. None of the targets can be moved or their use restricted.

| Tree Number | Proposed Work |
|---|---|
| T17<br>Monterey Pine | Fell at ground level and remove stump. Plant replacement tree. |
