## Global Tree Care Limited

### **Basic Tree Survey for Yacht Haven, Hayling Island. 14/11/2017**

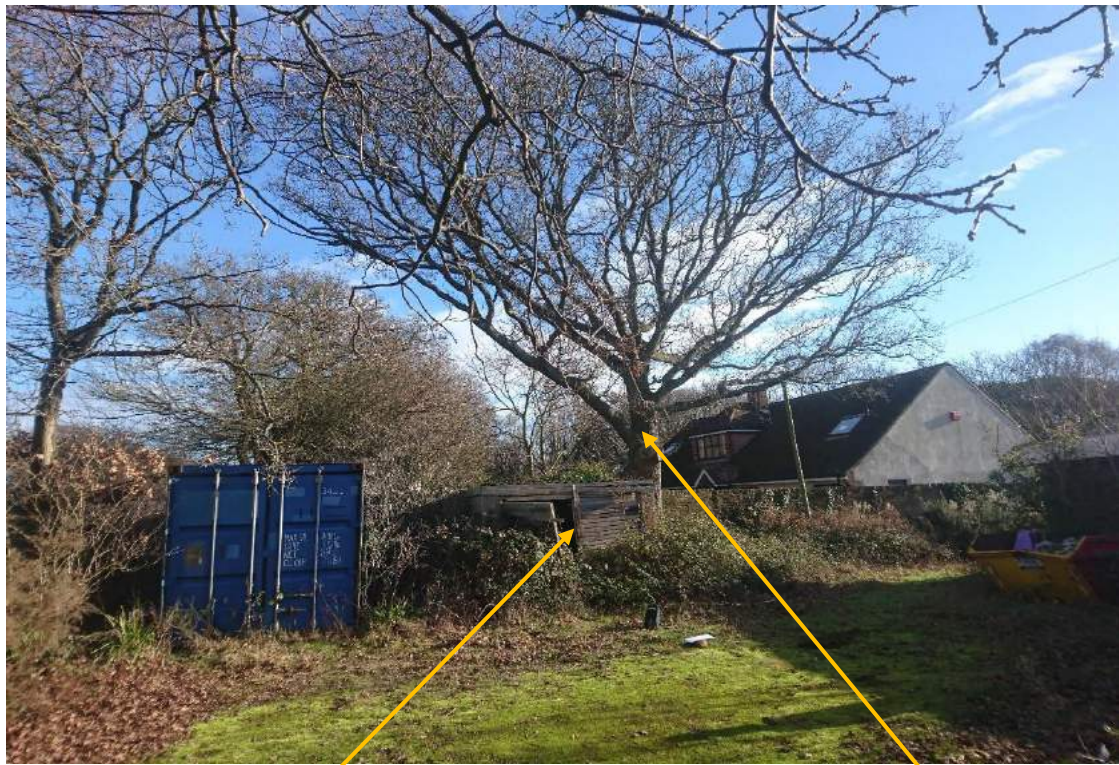
T. 22

The main tree in question is marked on the survey as T22. This is an oak tree which already has construction over the root area. See below.

Existing garage.

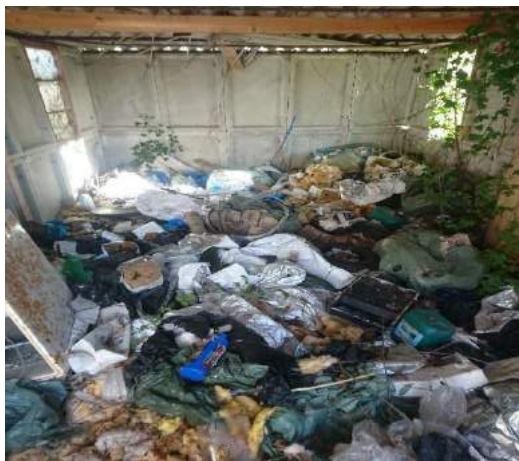
The existing garage floor is already concreted, restricting any precipitation or ground dew from penetrating through to the root system. See below.

Existing internal garage state.

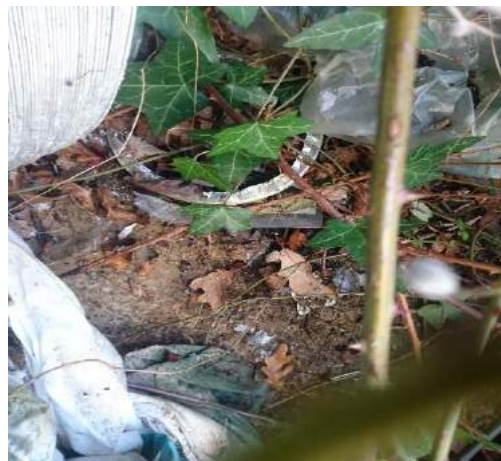
Concrete base showing after excavation.

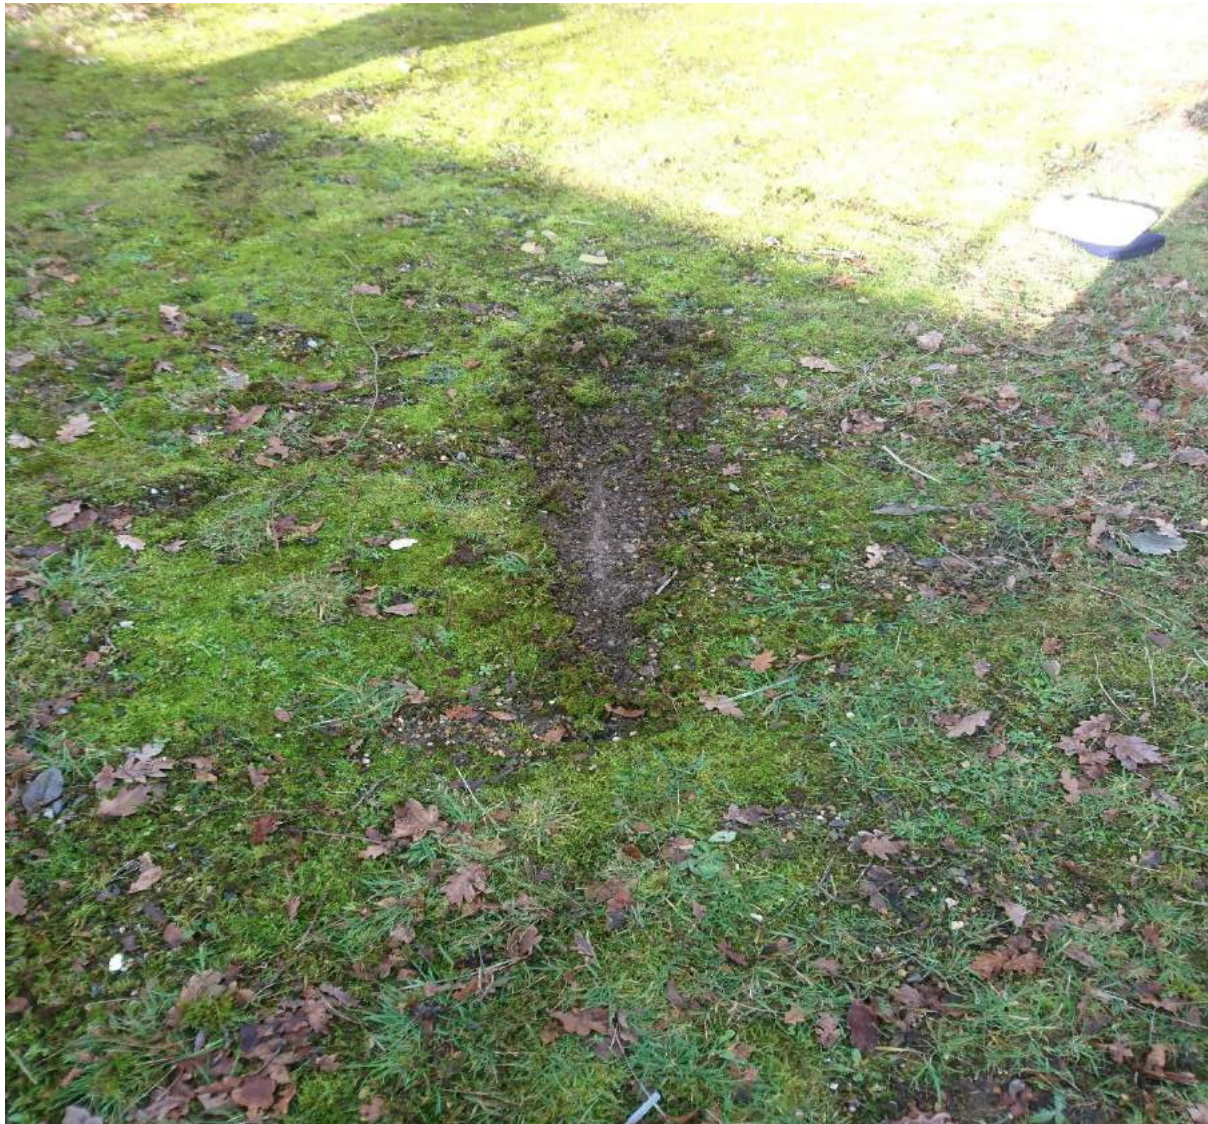
The existing driveway also extends over the root area and is made up of type 1 and gravel. Over the years of use this will have already compacted the soil over the root area of T22. Due to the existing garage and the driveway adding to compaction of the root area, and given the proposed plans, it is doubtful that T22 will suffer any significant root damage.

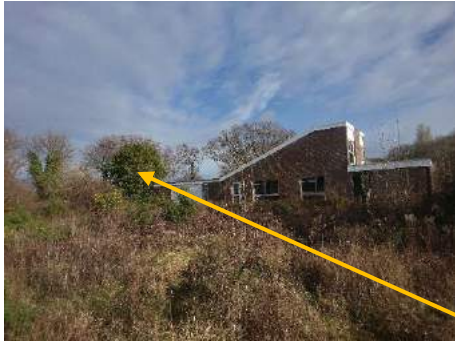
The Bay tree (as pictured below) is in fact an overgrown bush. It is obvious from the planting position and its structural growth that this was intended as a “feature”. There are no regulations as regarding overgrown bushes, (multi-stemmed).

Bay bush should be cut down to 60cm above ground and allowed to regenerate. When regularly trimmed tis will provide an excellent garden feature as well as providing very good cooking ingredient.
