**Arboricultural report for Mr. David Chisholm:**

14 Saint Hermans Road,  
Hayling Island,  
PO11 9NA

**Reason for report commission:**

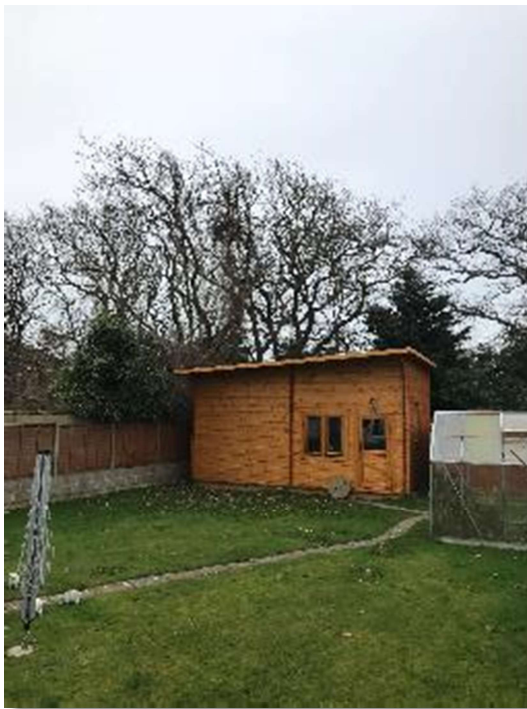
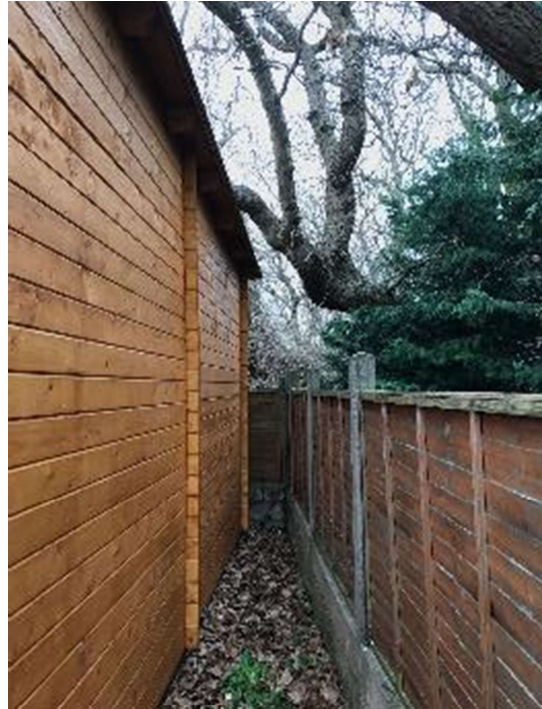
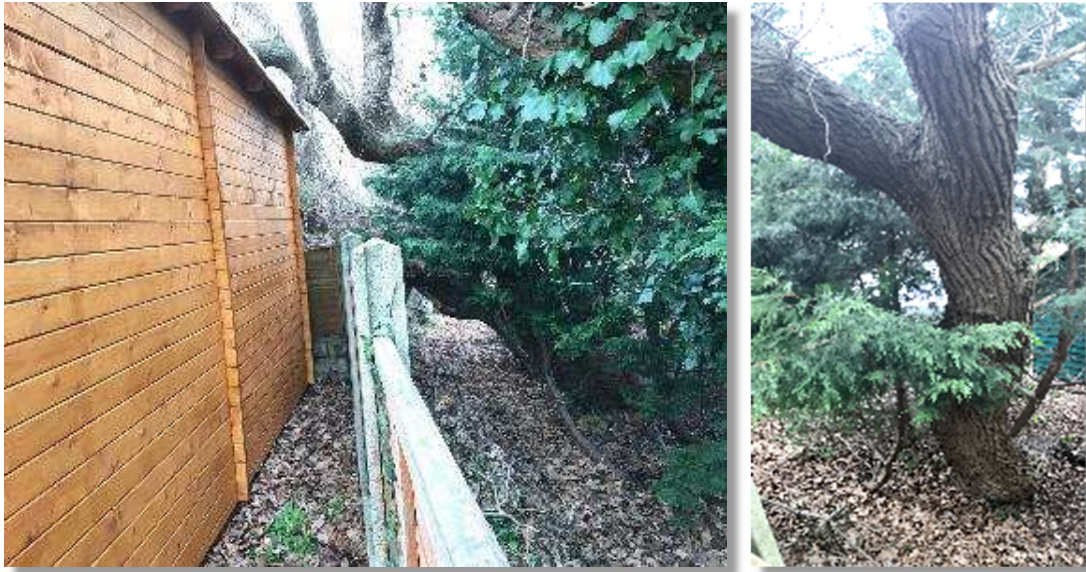
1. A mature tree, which can be described as lacking true Oak form, the tree has failed to reach its full potential and would appear to be in early stages of decline.
2. Height is estimated at circa 15 meters and spread at circa 14 meters.
3. The tree belongs to a 3<sup>rd</sup> party to the rear of 14 Saint Hermans road.
4. The tree has a growth pattern towards the SW, most of the growth is towards 14 and 16 Saint Hermans Road. The heavy lean to the North could suggest extensive root growth to the South to counter the lean effect, the area to the south is mostly an area of lawn. However, as the tree is growing amongst other trees rooting will likely be competitive, so there may be feeder roots if not structural roots to the north.

5. The crown is showing signs of die back with patchy deadwood visible (further observations would need to be made when the tree is in leaf to confirm extent). It is estimated that between 10% and 15% of the canopy is showing evidence of dieback, with the primary area of concern being branches of small to medium diameter.

7. The tree has a significant lean to the North of circa 30 degrees, off vertical. The tree has taken root into an old, low embankment (possibly an old track or boundary marker) and appears to have been growing this way for many decades. There is a possibility (unconfirmed) that trenching of roots growing to the North has occurred at some time in the past, as the bank on which the tree is rooted, appears to have been dug out at some stage.

9. There is an estimated 4 or 5 meters between the base of the stem and the shed of 14 saint Hermans Road.
10. The shed was only erected in October 2016 and as such it is unlikely the tree will have shown any adverse effects until this time.

The tree in question is rooted to the south and rear of the shed in the photo above

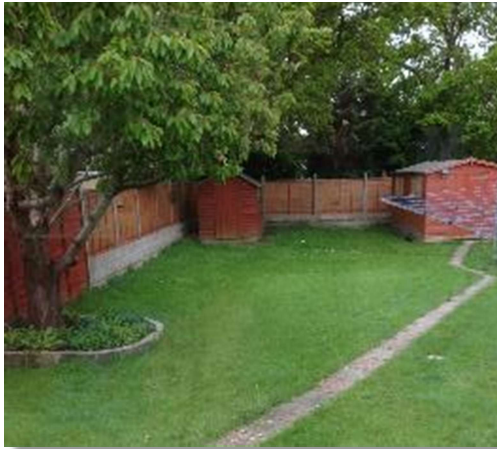
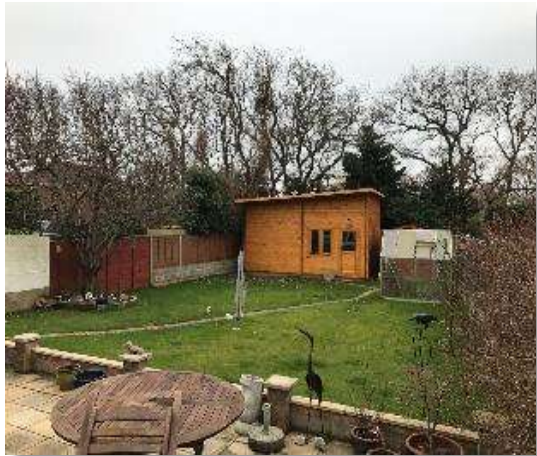
1. It is estimated (actual measurements were not possible, due to restriction of access) that the footprint of the new shed is currently occupying 20% of the Root Protection Area. The tree has been experiencing compaction in this area of the root zone for many years, due to the previous shed. As well as compaction, the RPA will also be experiencing a degree of rain shadow and thus have limited access to water.

3. The concrete base:
  - a. Constructed over, and encompassing a pre-existing concrete platform.
  - b. No pile foundations were constructed, so the potential for root damage is low. Whether footings were dug and how deep the slab is, is unclear. How much, if any damage was caused to the roots during construction could not be accurately assessed.

- c. The old base was circa 2/5<sup>th</sup> of the current base structure and occupied the NW portion of the new enlarged base.
  - d. The base structure is 4.5 x 6 meters.

- e. The pre-existing base was in place for over 10 years and was circa 2 x 3 meters.
  - f. Average crown spread is circa 12m x 14m = 168 meters' square, the shed occupies 4.5 x 6 = 27 meters' square, roughly 15% of the total Root area (to drip line).

Photos showing the old shed on its concrete base and the new larger shed.

4. The Implications of breaking up the concrete base, could in reality be more damaging than leaving the structure in place and monitoring the health of the tree. There are already signs of declining health, but a further assessment (when the tree is in leaf) would be required to make a more comprehensive assessment. Concerns with breaking up the structure:

- a. Damage or further damage to roots
  - b. Benefits would potentially be minimal.
5. There is evidence of very limited recent pruning, a discarded, cut branch was evident, as was a single pruning wound in the canopy the branch diameter was less than 50mm.

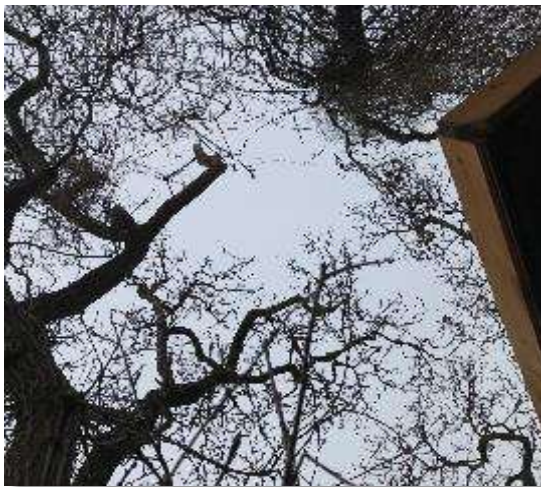
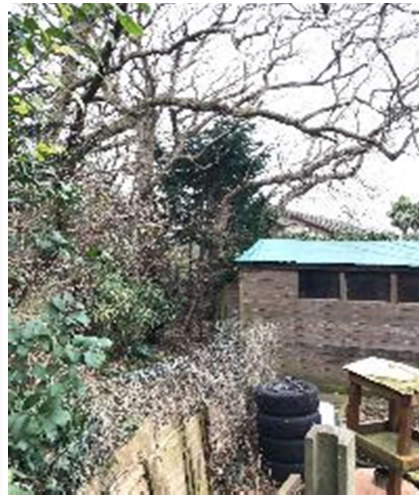
Further images showing significant areas of dead wood in the canopy and other areas of compaction locally.

- There should be no further tree maintenance work without consultation and relevant consent of the owners and HBC. Should overhanging branches require pruning, this, with consent would be perceived as reasonable, unless works are exempt, in which case pre-works notice should be given by HBC.
- Mr Chisholm, must also avoid any further actions that could wound or cause further stress to the tree.
- All efforts should be made to avoid all further compaction.
- The owners should take care maintaining the garden to avoid strimmer or mower damage.
- The tree would benefit from a maintenance schedule to include mulching and watering. This would require the owners, rather than Mr. Chisholm to take the required actions.
- A further assessment of the tree should take place when the tree is in leaf, Oaks can be late into leaf so July or August 2017 would be reasonable.

- g. An Air spade assessment of RPA which is still accessible would be useful to judge root health. However, consideration should be given to this action as further damage could occur during the operation.
- h. The planting of a successor tree would be a proactive and well received action, and would go some way to compensate for any amenity loss.
