**Tree Survey, Arboricultural Impact  
Assessment and Tree Method Statement  
To British Standard B.S. 5837: 2012  
“Trees in Relation to Design, Demolition and Construction –  
Recommendations  
For  
12 Magdala Road  
Hayling Island  
PO11 0BH**

**05 April 2017**

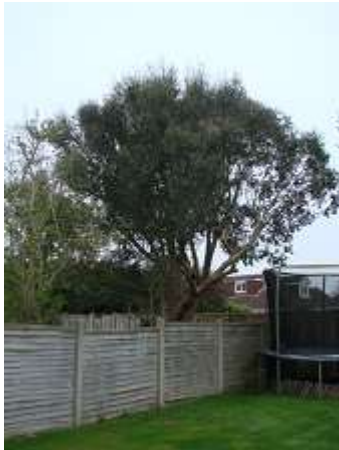
| Tree No | Species | Height M # | Dia at 1.5m (mm) | Crown Spread (m) | Crown Clearance (m) | Rad. of RPA (m) | RPA (M sq) | Age Class | Comments Structural and physiological condition | Preliminary Management considerations | Estimated remaining contribution (Years) | Category rating |
|---|---|---|---|---|---|---|---|---|---|---|---|---|
| T1 | Eucalyptus | #6m | #600 | #N 4<br>E 5<br>W 4<br>S 2 | #2 N | 7.20 | 163 | SM | Fair physiological condition<br>Fair structural condition | | 20+ | B |

14.1 The proposed new extension will encroach into the RPA of the tree T1 by an insignificant amount. Due to the site conditions ground protection measures will be required as outlined within the attached Method Statement Appendix 1 and 2.

- 3.3 The area as shown on the Tree Survey Plan 0447-17-NJT to be covered with a semi permeable membrane and covered with 100mm of bark chippings on which is laid the scaffold boards and this will remain in place for the duration of works. This is to stop undue compaction of the ground within the RPA of T1.

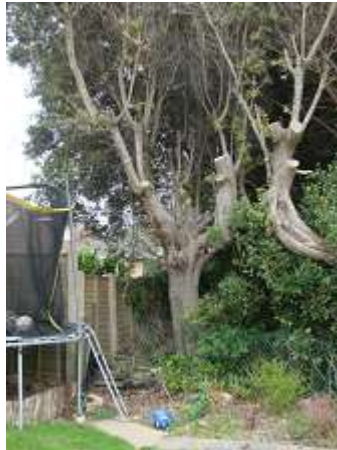
| Tree No | Species | Height M # | Dia at 1.5m (mm) | Crown Spread (m) | Crown Clearance (m) | Rad. of RPA (m) | RPA (M sq) | Age Class | Comments Structural and physiological condition | Preliminary Management considerations | Estimated remaining contribution (Years) | Category rating |
|---|---|---|---|---|---|---|---|---|---|---|---|---|
| T2 | Evergreen Oak | #5m | #400 | #N 3<br>#E 4<br>W 2<br>S 2 | #3 E | 4.80 | 72 | EM | Poor physiological condition<br>Poor structural condition<br>Badly pruned in past assume to clear overhanging branches into No12 | | 20+ | C |

13.2 T2 and T3 have been badly pruned in the past and one must assume this has been due to the fact that the braches overhung No 12. They have however re-grown and will require some attention in the future to ensure that they form a better shape not withstanding the outcome of a detailed inspection of T3.

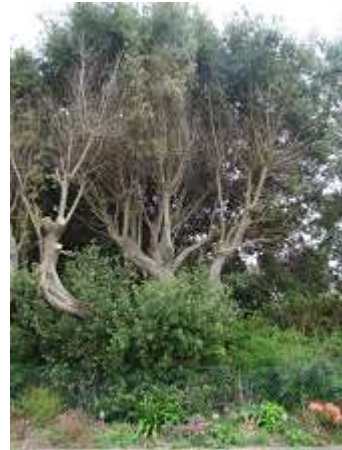
| Tree No | Species | Height M # | Dia at 1.5m (mm) | Crown Spread (m) | Crown Clearance (m) | Rad. of RPA (m) | RPA (M sq) | Age Class | Comments Structural and physiological condition | Preliminary Management considerations | Estimated remaining contribution (Years) | Category rating |
|---|---|---|---|---|---|---|---|---|---|---|---|---|
| T3 | Evergreen Oak | #5m | #600 | N 4<br>#E 5<br>W 2<br>S 4 | #3 E | 7.20 | 163 | EM | Fair physiological condition<br>Fair structural condition<br>Badly pruned in past above. Split trunk and showing signs of rot | Recommend further inspection | +10 | C |

13.1 All of the trees are in neighbouring properties and therefore I was unable to get to carry out a detailed inspection of each tree. However T3 an Evergreen Oak is split at base and shows signs of decay and a further inspection by the owners is advised.
