**1. Introduction**

- 1.1 Martin Dobson Associates Ltd was instructed by Lesley Severs on 07 September 2016 to carry out a safety inspection of one oak tree at the rear of 36 Gladys Avenue, Cowplain, PO8 8HS.

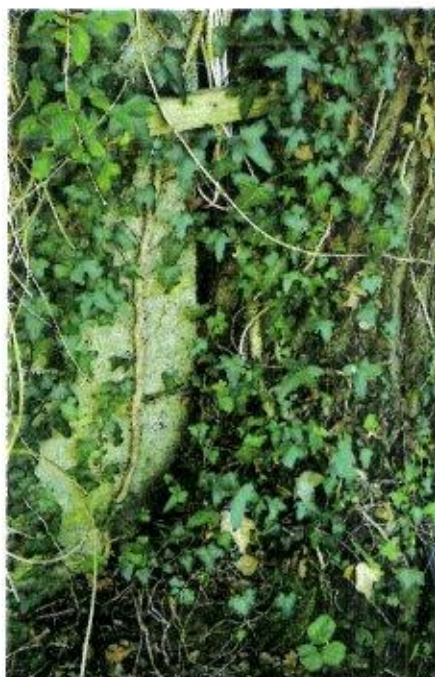
- 2.6 The boundary wall running to the east from the stem is hard up against the stem (Figure 1). This wall is constructed from breeze blocks to a height of 1800mm and the stem is compressed against it at 550mm and at the top. According to Mrs Severs the wall is over 30 years old.

**Figure 1.** Eastern aspect of the stem compressed against the wall.

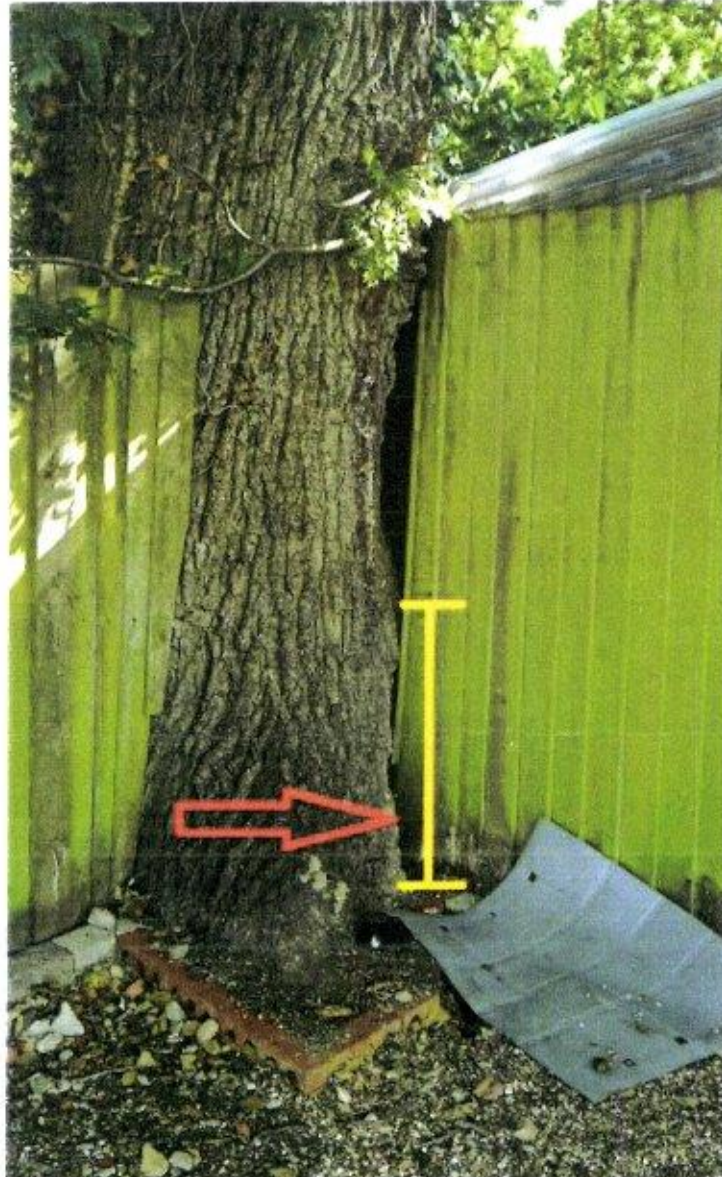
**Figure 2.** View of the stem from number 34 Gladys Avenue. The red arrow shows the start of the entrance to the cavity which opens into the next property. The yellow line shows the height of the cavity opening.

- 2.8 From this garden a large cavity is visible which extends from the south to the east into the inaccessible land. The opening to the cavity is 200mm wide at ground level tapering up to a height of 600mm. The depth of the open cavity extends horizontally into the trunk for 650mm in a northerly direction. Inside the cavity a measurement of 800mm was taken from the soil level inside to the top of the open void in the stem.
- 2.9 The wood inside the cavity was dry.

- 3.6 The tree should be felled and removed from the site to remove the risk of harm occurring to people of property as a result of its failure.
- 3.7 An application for works should be submitted to Havant Borough Council prior to any works being carried out together with a proposal for a replacement tree.

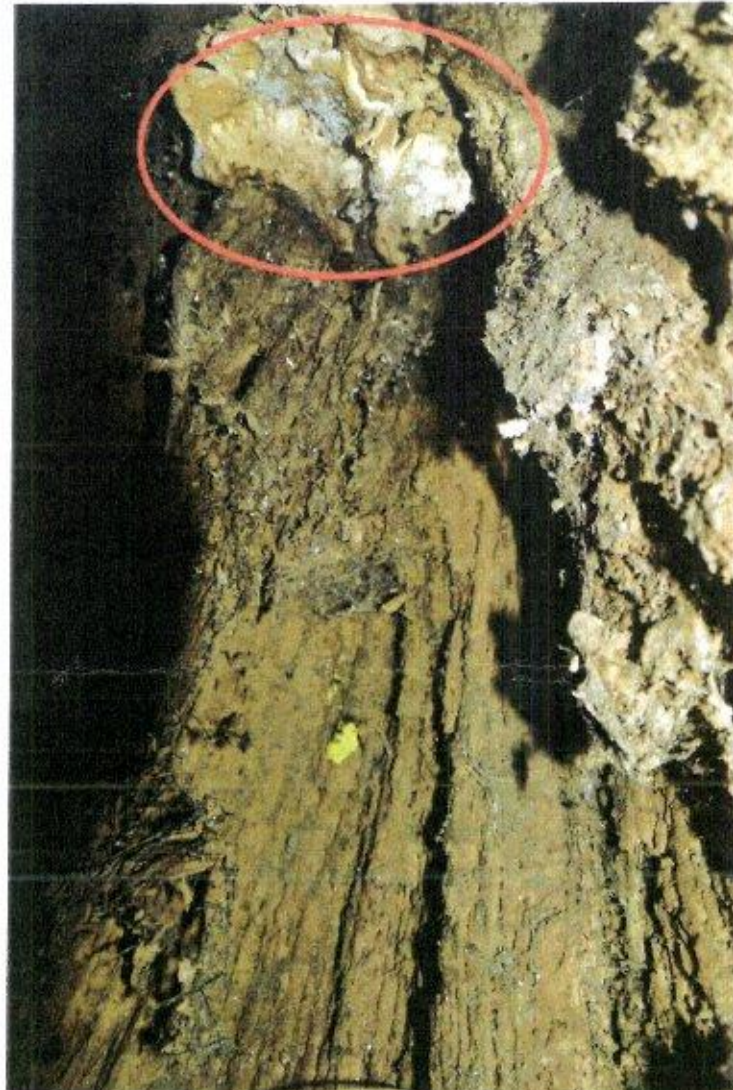
- 2.10 Desiccated remains of fungal fruiting bodies were located at the top of the internal wall of the cavity at 800mm (Figure 3). Identification of the fungus was made difficult due to its location and the dilapidated state of the fruiting body. In order to establish the species of fungus a sample would need to be sent to a specialist for identification. Fungal infection causes rot within the woody tissues of trees and this is likely to be contributing to the development and expansion of the cavity.

Figure 3. Looking up into the cavity showing the desiccated remains of a fungi at the top of the 800mm high cavity.

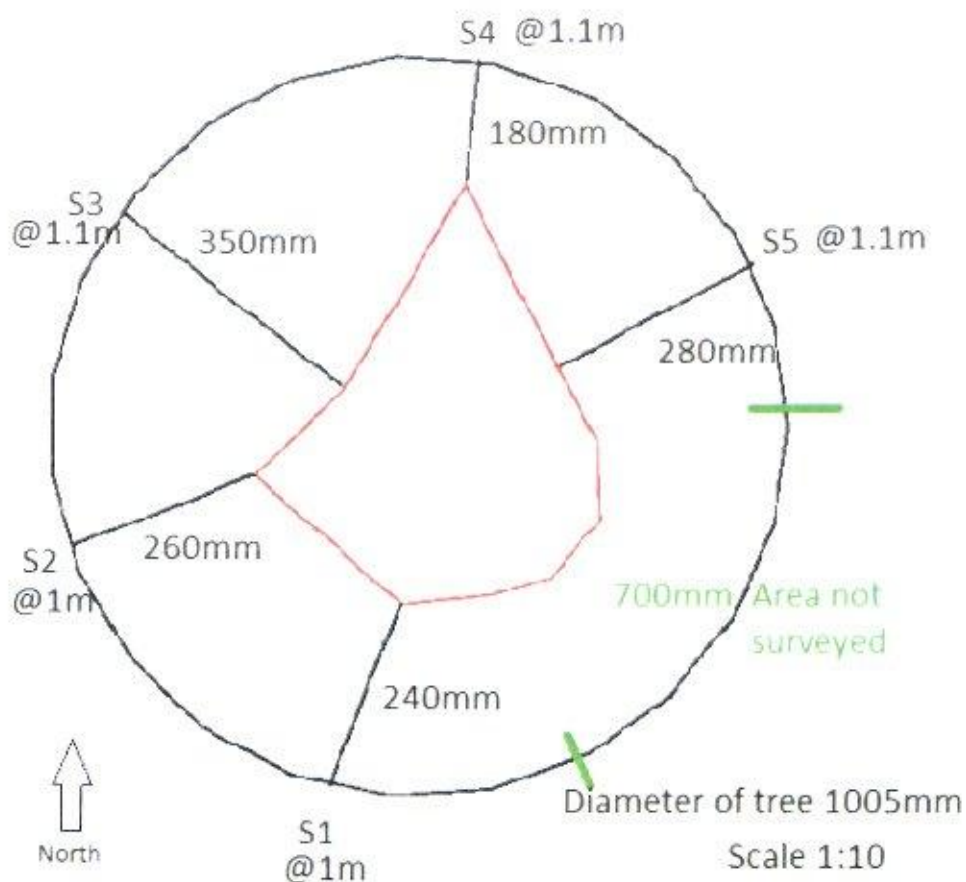
- 2.11 Two core samples were taken from the tree's stem in the garden of 34 Gladys Avenue at a height of 1m from the ground. The stem diameter at this point was 1005mm. A further three core samples were taken at 1.1m from ground level from the garden of 36 Gladys avenue.
- 2.12 The reason for the difference in height from ground level of these measurements is the 100mm difference of ground level between the two gardens. It therefore achieved a level cross-sectional reading of the sound woody tissues within the tree's stem.

- 2.13 At the time of inspection it was not possible to measure the diameter of the stem at the standard 1.5 m from ground level as the wall prevented the tape from being passed around the stem.
- 2.14 Core samples from the remaining segment of the stem were not taken as I was unable to gain access to the garden in which it is situated.
- 2.15 Three core samples were taken from a height of 500mm. The one sample from the garden of number 34 was taken above the large buttress root in the only area where a reasonable sample could be taken, this was found to have 350mm of sound wood before decay was encountered. The two further samples taken at 500mm in the garden of number 36 and returned results of 340mm and 330mm of sound wood.

**Figure 4.** A scale diagram of a cross section of the tree stem at 1 – 1.1m from ground level showing the depth of sound wood remaining as constructed from core samples taken S1 – S5. The red line indicates where the sound wood finishes and decayed wood starts.

- 2.22 Although there is sufficient sound wood at the level where the core samples were taken to maintain the tree in its current state, there is the unexplored factor of the quality of the woody tissue at the inaccessible segment of the stem, which I believe to be the area of greatest significance at this level of the stem due to the poor quality of the wood on sounding. In my opinion it is likely that the decay in the centre of the stem extends outwards towards the bark in this sector.

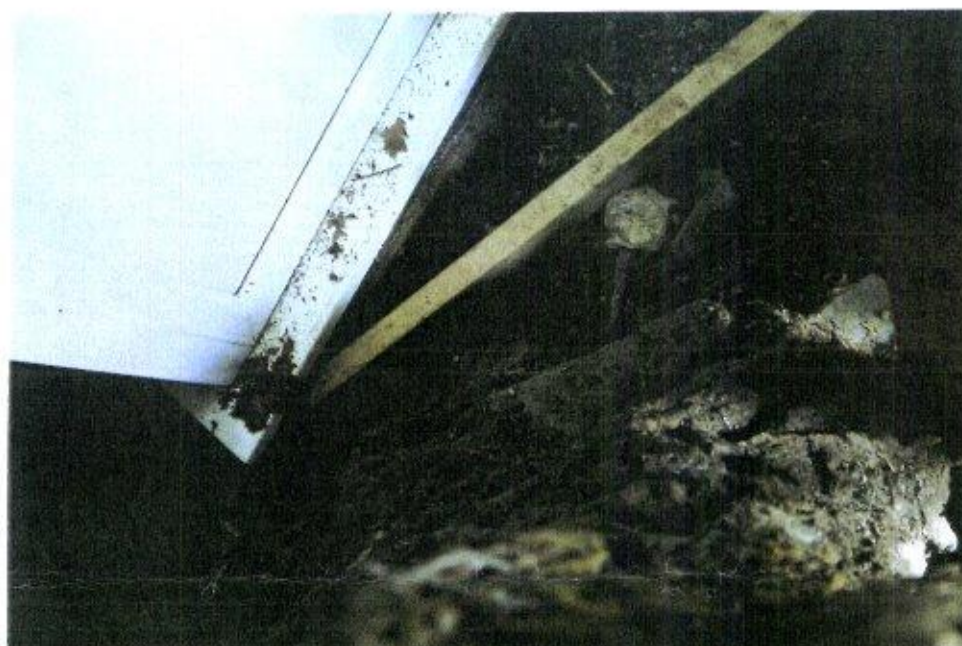
- 2.18 Sounding of the stem from the garden of 34 Gladys Avenue indicated that a cavity is present between ground level and 1400mm from the ground at which point sound wood was encountered.
- 2.19 Sounding of the section of stem in the region which I was unable to access fully due to garden boundary fencing revealed wood to be of poor quality. This matched the observations of the bark quality as made through a gap in the fence (Figure 5). Evidence of old building damage to the buttress roots in this area (pre dating the recent structure shown in the picture) was also observed.

**Figure 5.** Looking down at the section of stem in the third property which could only be sounded with a mallet.
