# Tree Inspection Report

BELLWAY HOMES  
HALYARDS  
BEECH GROVE  
HAYLING ISLAND  
PO11 9DP

Author: J. Green | 23<sup>rd</sup> November 2016

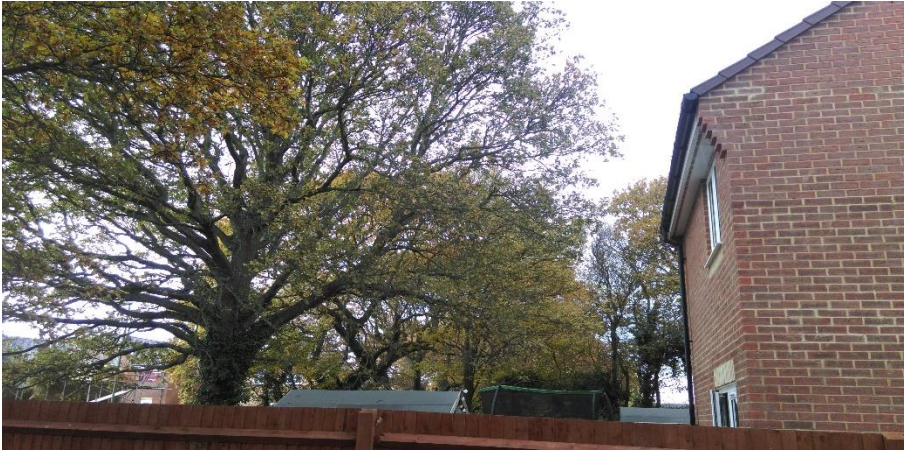
T55 is located to the rear boundary of 28 Windsurfing Place and there is significant lower canopy overhang into the properties' rear garden to the North. The upper crown is also excluding light from the garden and rear of the property. A number of included branch unions were observed but their severity cannot be concluded from a ground based visual inspection.

T55 Northern Crown Spread

T55 would also benefit from a light Crown Reduction of up to 2m to alleviate forces at the fulcrum of included branch unions and to lessen the "wind sail" area. Of secondary benefit would be the resultant increase in light level to the affected property. This should be carried out by the pruning of secondary & tertiary branches only and leaving an even, flowing branch line as a result.

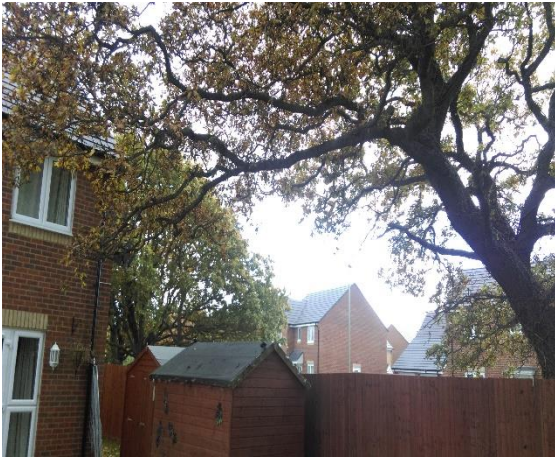
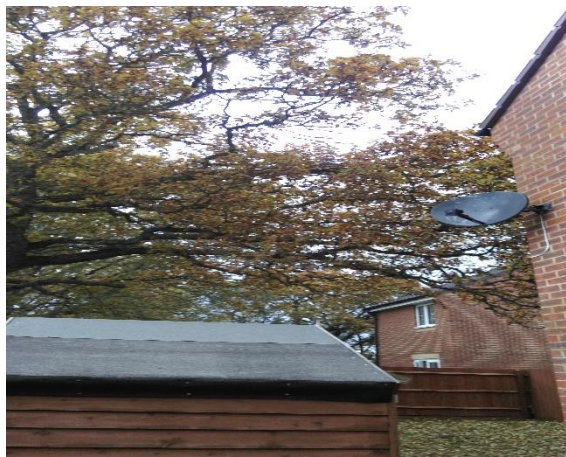
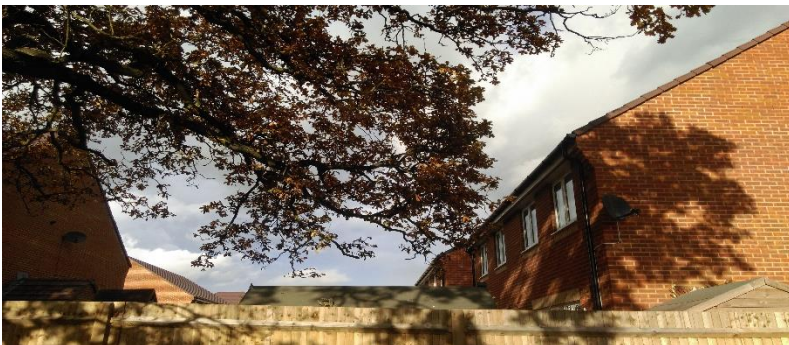
T56 is located to the rear boundary of 14 Windsurfing Place and again there is significant lower canopy overhang into the properties' rear garden to the North. Said lateral overhang is close enough to contact the adjacent building. A number of included branch unions were observed but their severity cannot be concluded from a ground based visual inspection.

The canopy appears to have undergone historical suppression to the South and as a result the crown is significantly biased towards the North.

T56 Northern Crown Spread / Proximity to Building

T56 would require some remedial pruning by up to 2m to the Northern lateral crown spread to attempt to stimulate the tree to redress uneven crown bias. This in turn would provide statutory clearance from the adjacent residential building and alleviate forces exerted on scaffold branch union fulcrum. This should be achieved by pruning secondary & tertiary branches only to ensure that the diameter of pruning wounds would not be excessive.
