## Photo Survey

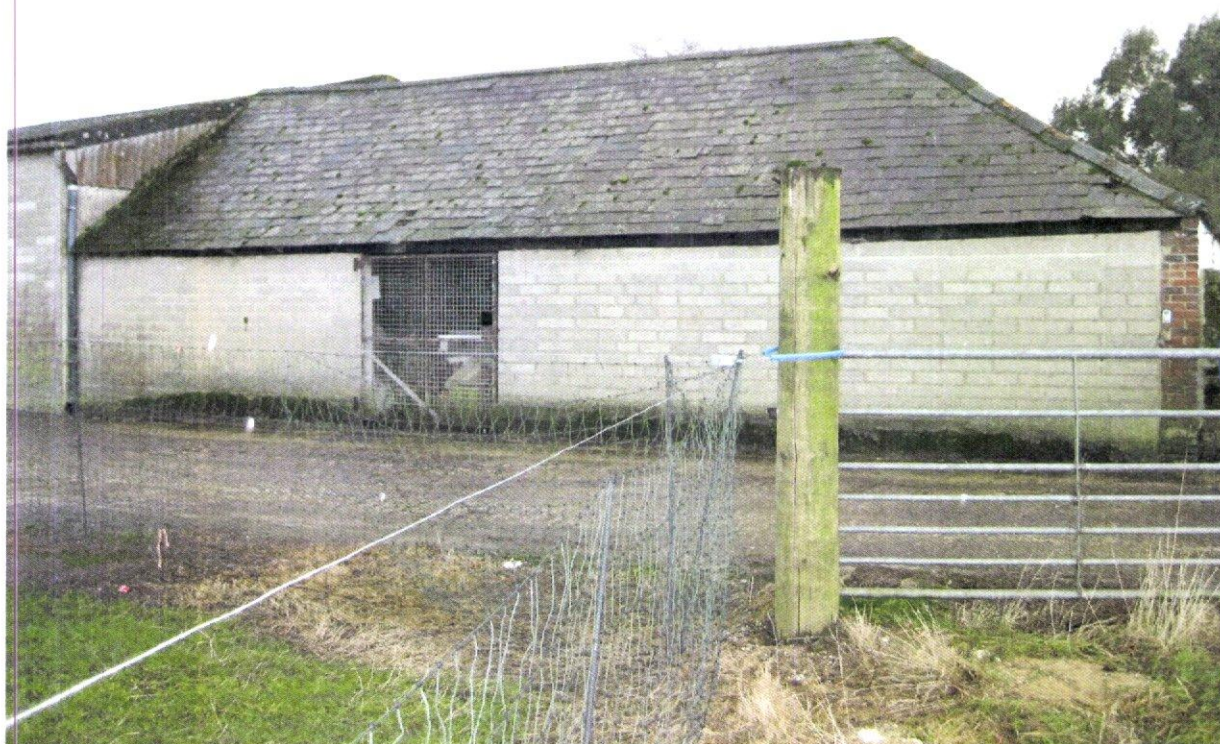
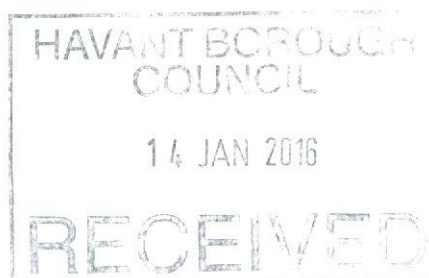
### North Elevation

This elevation was originally open sided as a cart shed but was bricked up in approximately 1960 to allow more secure storage of farm goods. The ventilated door is secure but left as a wire mesh gate to allow airflow to assist the fan in drying the crops stored in the adjacent barn.

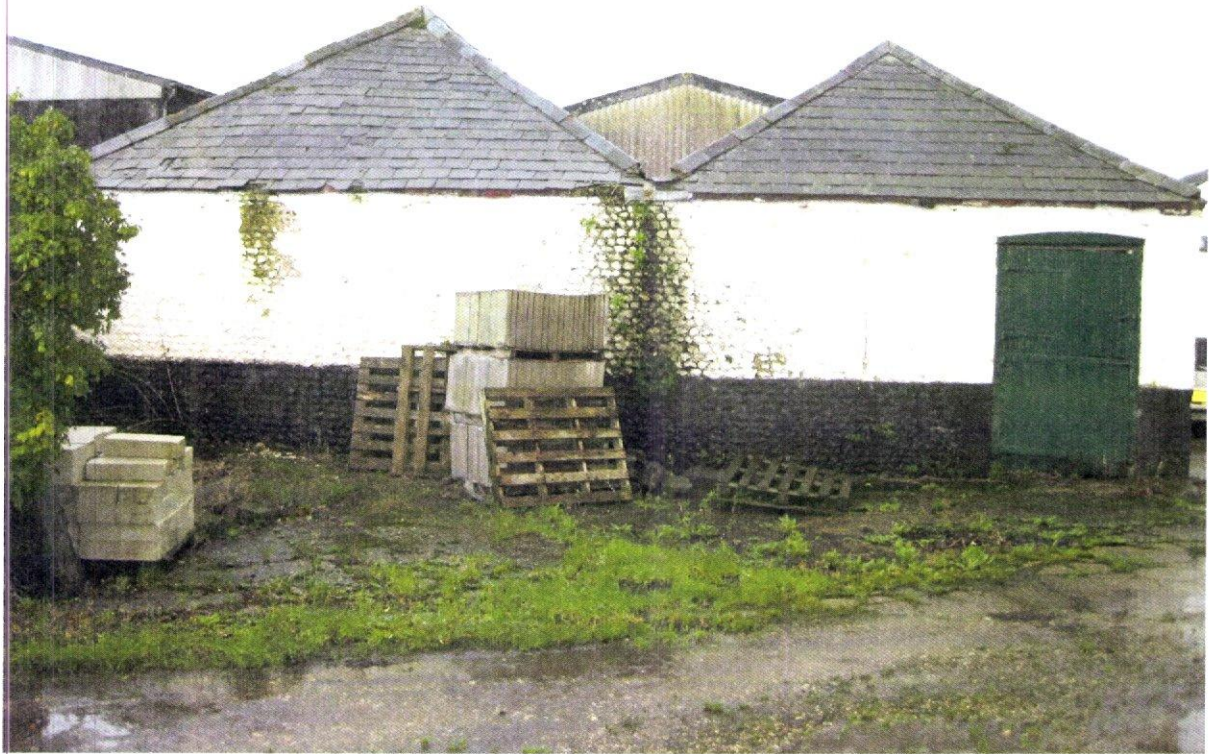
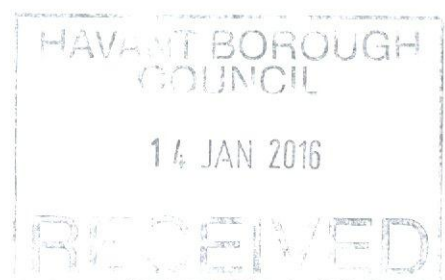
### West Elevation

This elevation boasts a well built flint wall. It has an outlet from the valley which is in need of repair. There is a stable door to the right. There is also a drain for rainwater.

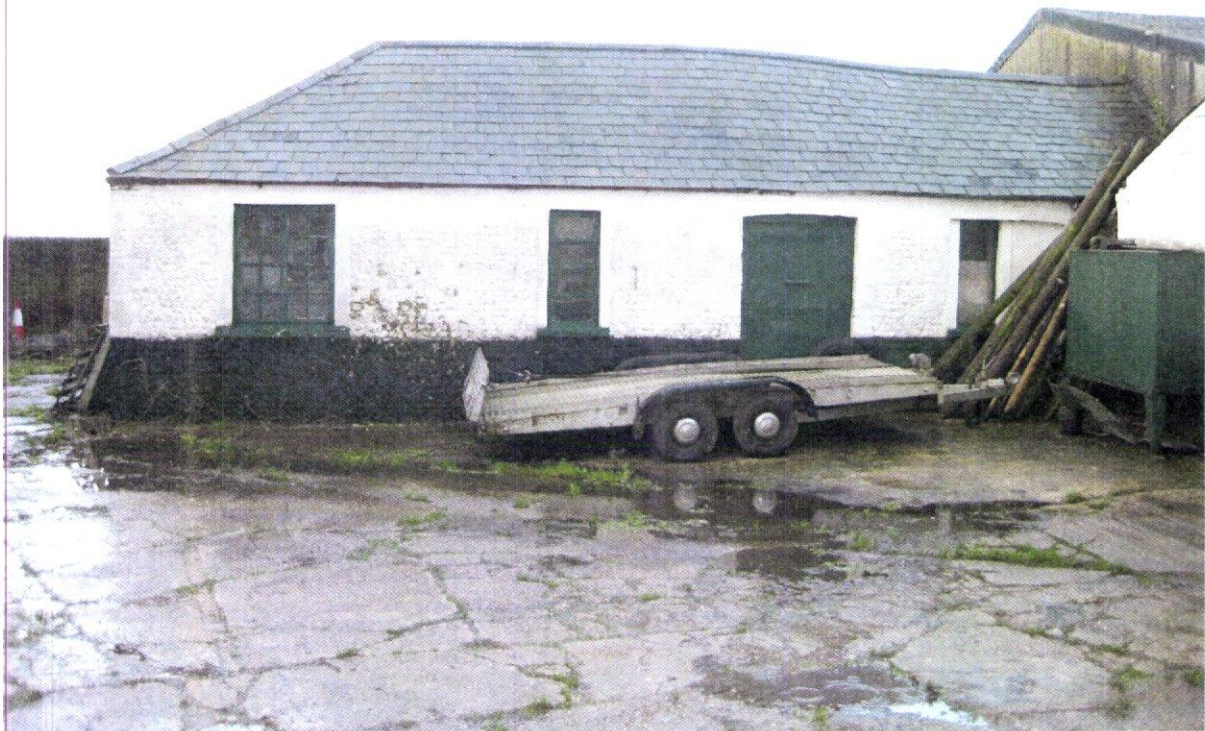
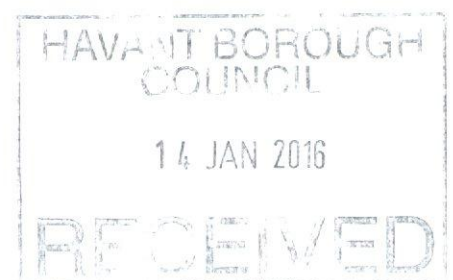
### South Elevation

The elevation has 3 windows 1 large and 2 smaller. It has a large stable door. This elevation faces a courtyard area.

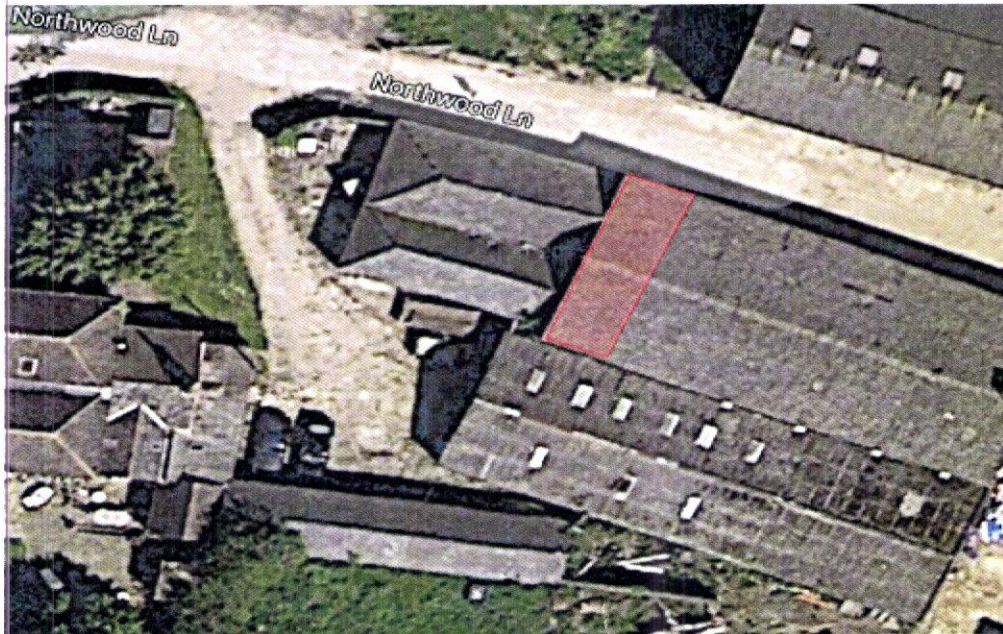
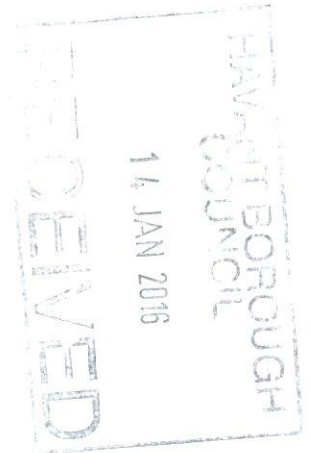
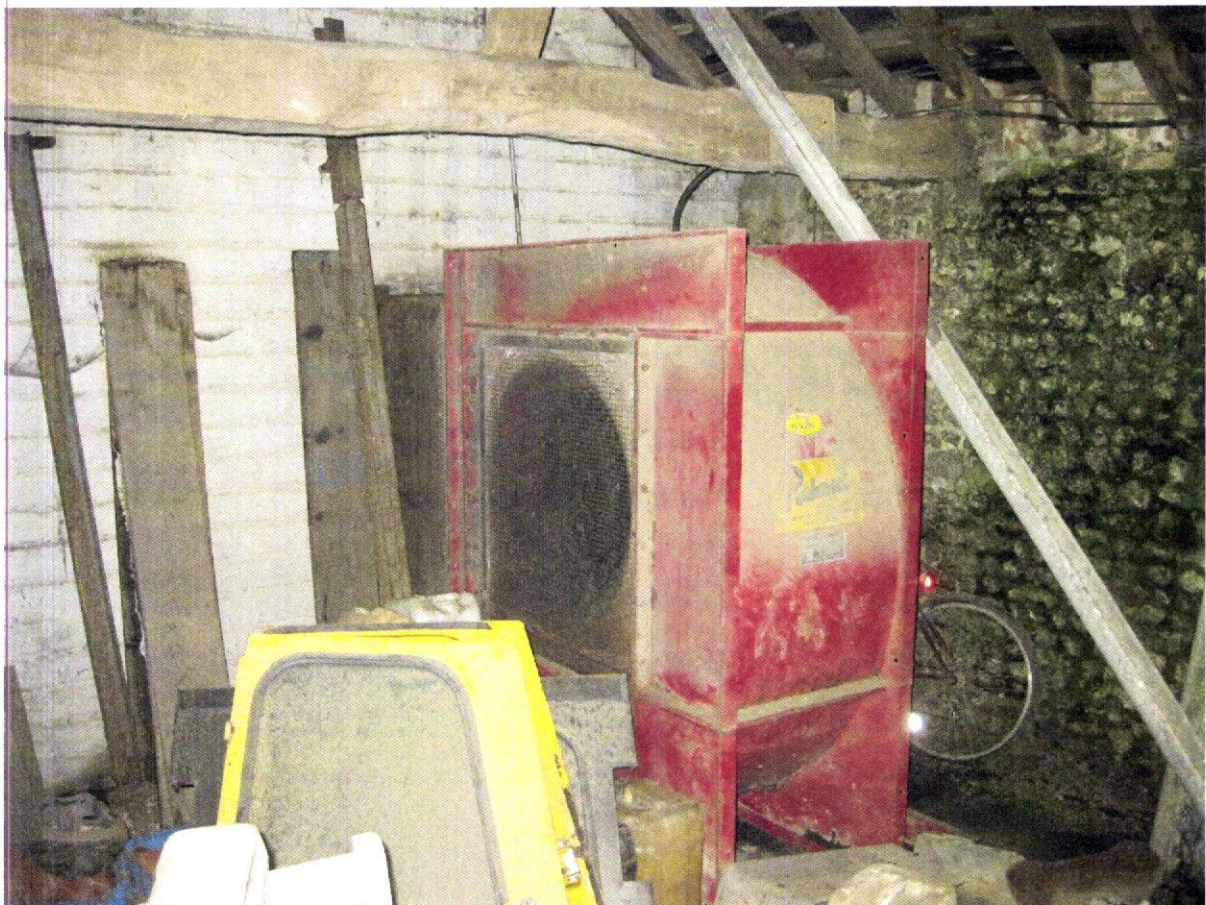
### West Elevation

The west elevation is currently a 9 inch block wall of a grain store. It is intended to remove the section outlined in red which will mean the dairy will be fully detached from any building and will allow a court yard area as the wall to the north will be retained.
