Contamination Report for

**"The Dairy"**

Northwood Farm Northwood Lane Hayling Island.

May 2016

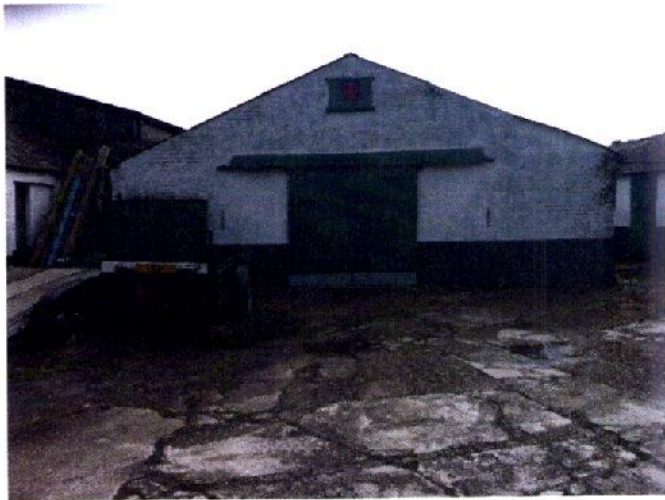
The yard area shows a well cracked concrete base presumably laid on a base of crushed brick rubble.
