# Global Tree Care Limited

## Arboricultural assessment BS5387 report for:

Mr & Mrs Walters  
Yacht Haven  
Hayling Island  
Hampshire.

Surveyed by Ian Lansley 19/2/2017

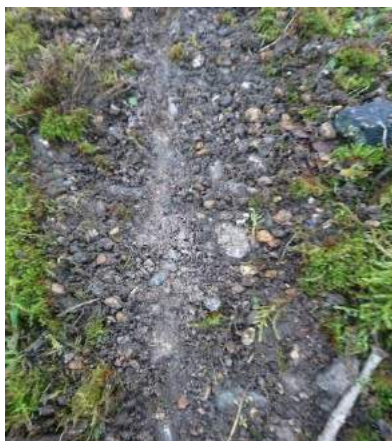
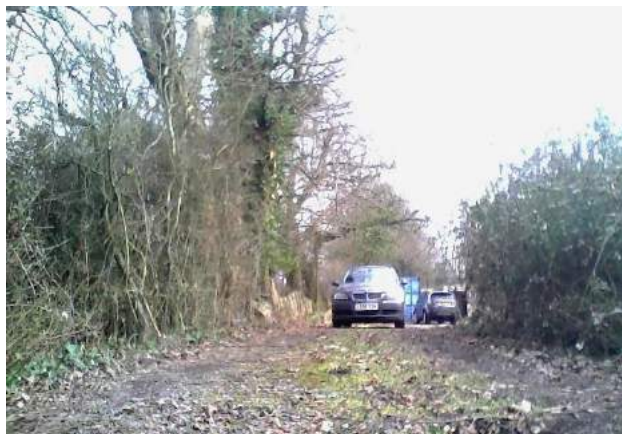
The site at the above address is very flat and level, being a coastal property. There is a house on site which is now dilapidated and dangerous. Access to the site is by a well compacted driveway constructed of type 1 aggregate and topped with road planning's. As shown below.

This road has been used for the duration of the previous occupation. This has resulted in the usual compaction of ground along the site access. This runs along the TPO group to a distance of 1.5 to 3 .0 meters.

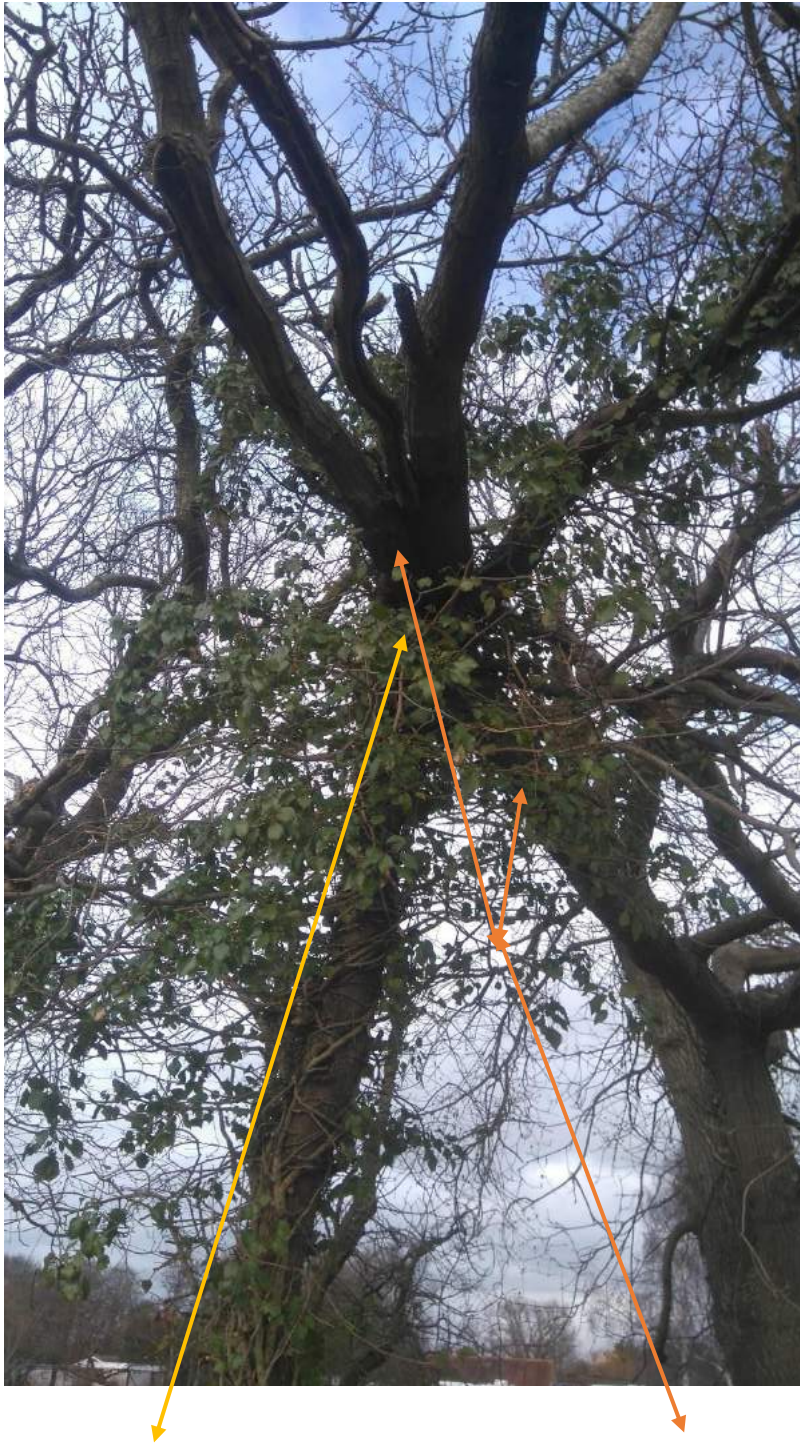
T6 *Acer campestre* (Field Maple). As can be seen from the below photograph T7 has a large and friction bearing branch growing through the fork of T6. Due to this problematic growth, I would recommend the removal of T6 as it is now misshapen, well over shaded and now has growth problems due to the large oak branch. Over time this will continue to weaken the fork and result in failure at the fork point for T6.

Fork of the small Field Maple (T6)

Large branch from Oak (T7)

I would also recommend that this branch on T7 be pruned back, as its growth has been supported and may well fracture with the removal of T6. T7 has been pruned in the past, shows good health and recovery.

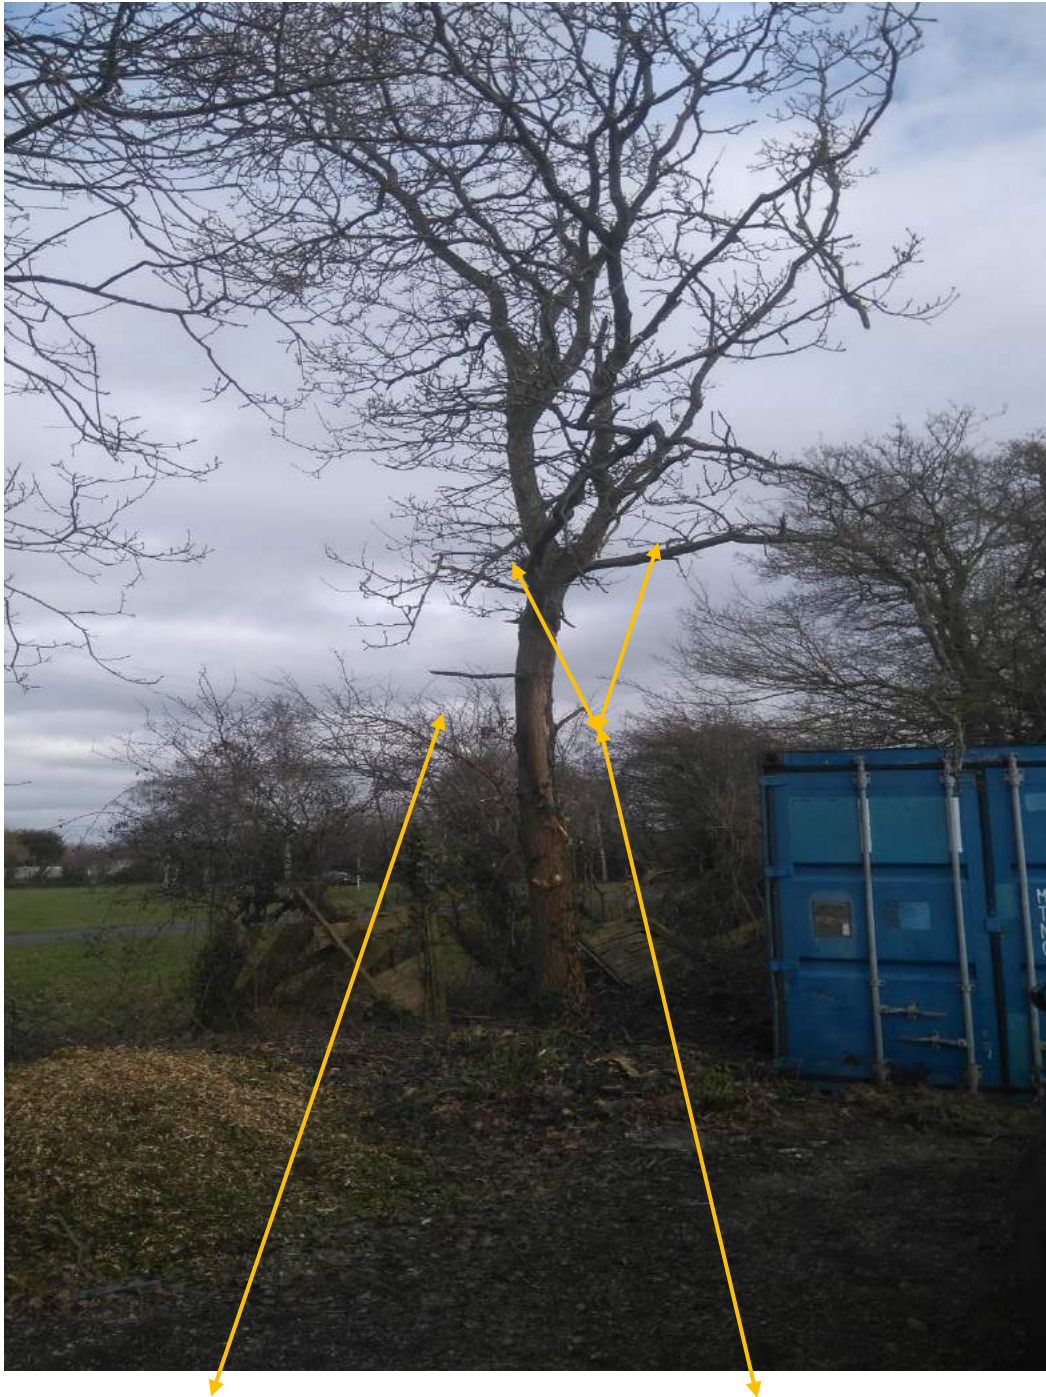
T8. This tree falls within the proposed area for the boathouse. It measures 29cm at 1.5m and has a height of 9.8m and has already suffered damage from the placement of the blue container already on site. See below.

Severe bark scrape showing poor healing.    Bark scrape, limb in poor condition.

This damage due to previous poor care, this tree is not in the best of health and will deteriorate further over time. There is already evidence of crown dieback. The owners of the property request the removal of this tree (T8), and have already stated they would like to replant with more Oak trees along their boundary after the completion of works.

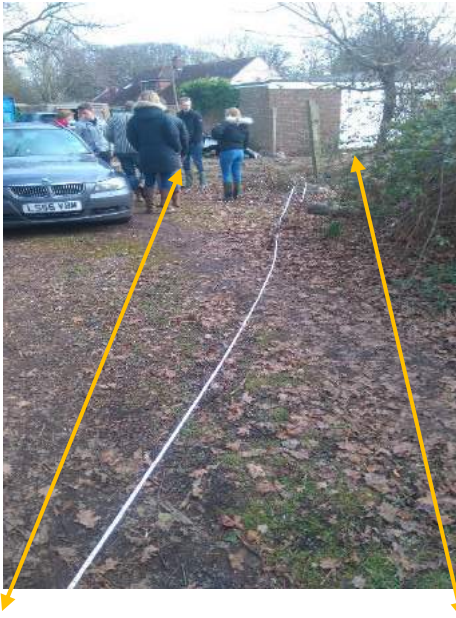
Recommended site access.

The recommended sit access will allow construction traffic to evade the root protection area which can be fenced off as above. The proposed construction material storage will also be well away from the protected Trees (T1 – T8).
