**Trees to the rear of 97 Lovedean Lane, Lovedean - TPO 1641**

I refer to our site meeting on Thursday 24<sup>th</sup> September when we met with the owners of 3 & 4 Woodbury Grove and inspected the following trees:-

Having reviewed the health and safety of these trees (access permitting) you have asked that I advise you on a management strategy and any recommended tree works to satisfy complaints received from the two house owners in Woodbury Grove. I understand that it is your intention to submit this report in support of a TPO application to Havant Borough Council.

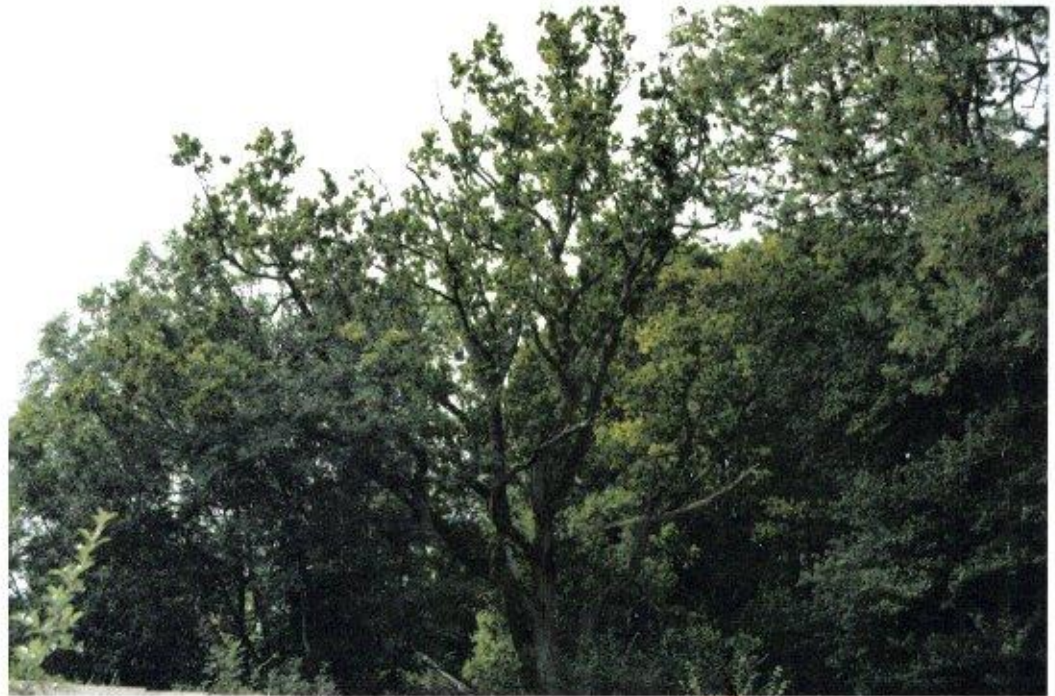
**Oak (TPO T4)**

- This mature Oak is in a state of decline with a crown full of tip dieback and large diameter dead branches.
- I was unable to inspect the basal area of the tree because of the dense Brambles and undergrowth – thus I cannot confirm whether it is safe or what fungal pathogen might be attacking the root system. *clearance inspection to be done immediately*

Recommendations:

- The immediate risk is to the owners of No 93 Lovedean Lane as some very large diameter branches precariously overhang their rear garden. I would recommend that your tree surgeon removes the dead branches to make the crown safe – this does not require consent or notification to the Council.
- I recommend that you also have the dense undergrowth cleared away around the base of this tree and then have it fully inspected by an arboricultural consultant – preferably between Oct and March when fungal brackets and toadstools will be most evident – please ask whoever is doing the work to progress with care around the base of the tree as they may destroy any evidence of fungus that may be present. *Consent to be visited*

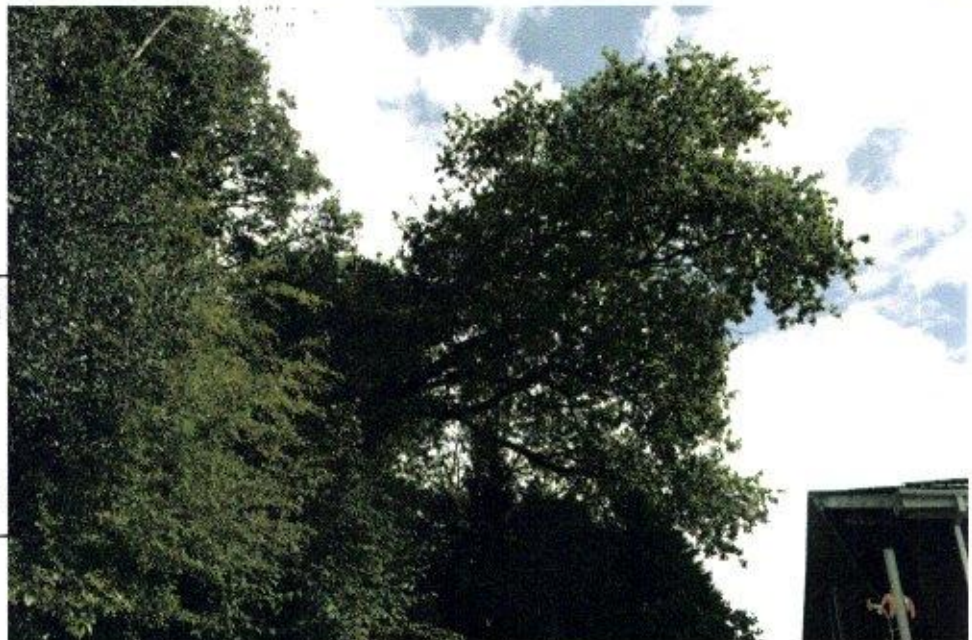
Oak (TPO W1)

- This semi mature Oak tree is growing out of the woodland towards the roof of the house at No 3 giving the owner cause for concern - as other trees have failed and fallen within the woodland in this vicinity.
- I inspected around the base of this tree and found no evidence of fungal decay or anything that might suggest the lean was anything but natural caused by pressures from other trees and the propensity for the tree to present the fullest crown to the south facing side although it does have a very heavily weighted arching crown to the south side.
- This is also an Oak which is noted to be a deep rooted tree and the trees which have fallen are all Cherries.
- However, the crown of this tree is heavily weighted towards the house and I advise that some pruning works would be prudent to address this issue and they would not affect this trees amenity value.

Recommendations:

Works advised are:-

1. Reduce the lateral spread to the south side only by 2m to 2.5m overall making all final cuts adjacent to living growth points in accordance with BS3998.

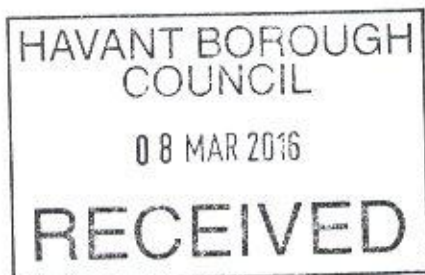
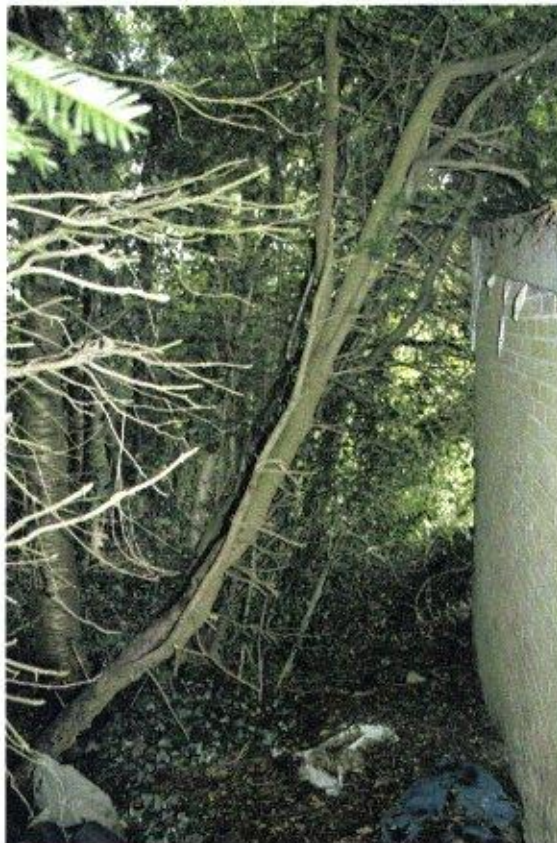
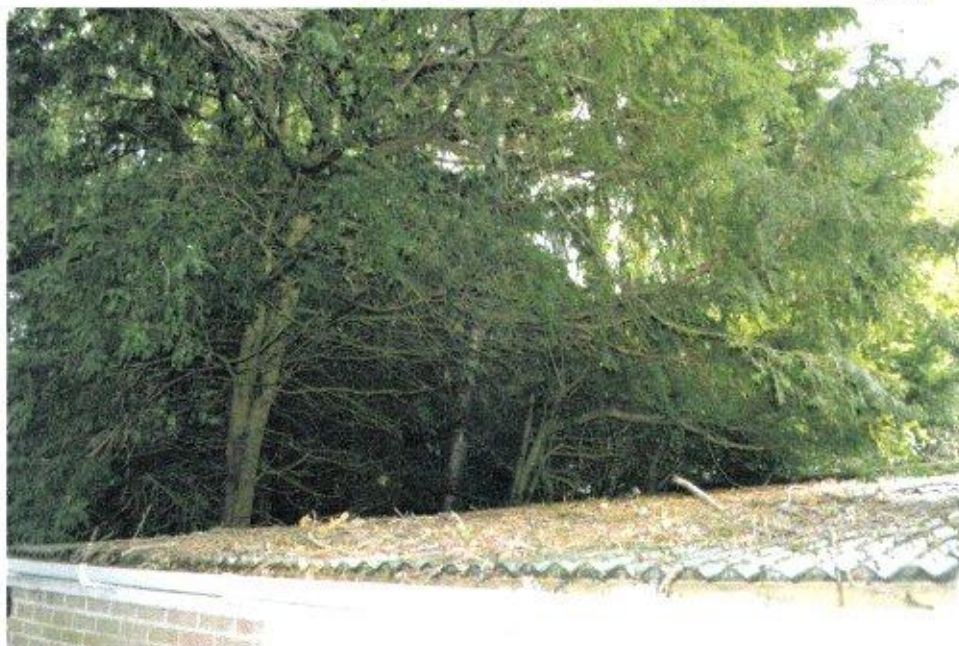
Yews/Hazels (TPO W1)

- These small trees have been suppressed by more dominant woodland trees behind them and as a result they grow out to the south side underneath the canopies of the larger trees to achieve maximum light for their own crowns.
- This brings them into contact with the roof of the garage which the owner now needs to have repaired and maintained.

Recommendations:

Works advised are:-

1. Prune the Yews and Hazels in such a way that they are crown lifted and a 1m clearance is achieved above the garage roof and away from the sides of same - making all final cuts adjacent to living growth points in accordance with BS3998.

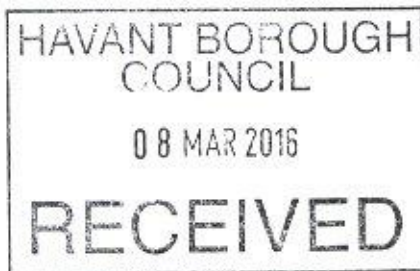
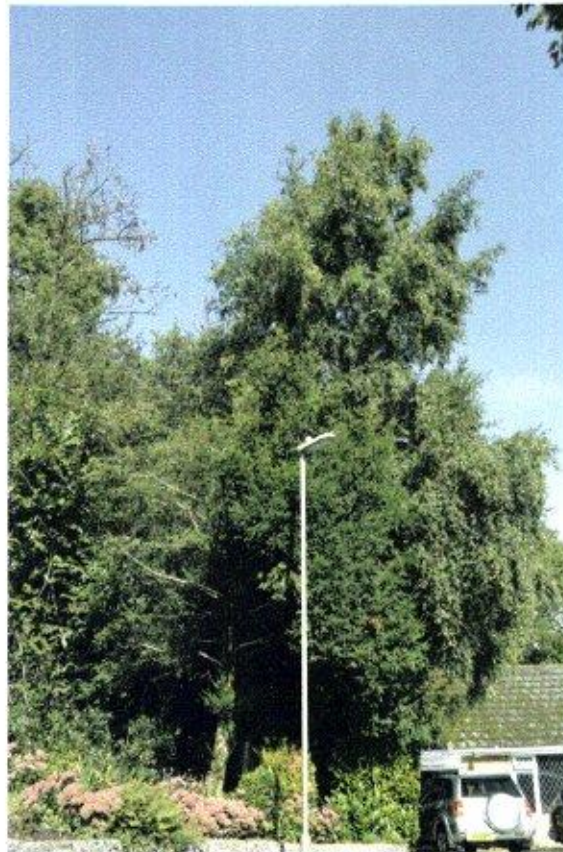
**Birch (TPO W1)**

- This tree was once multi-stemmed but only one stem remains which accounts for its leaning habit to the east side as it was previously competing for air space for its crown with the other stems.

- The owner of No 4 advised that one of the stems failed recently and showed me the remains of the cut sections of wood and these revealed that it had failed around a point of fungal decay - but the final cut close to ground was made through sound wood.

- There was no evidence of a fungal pathogen around the base of the tree and the crown of the remaining stem is full and healthy.
- I tapped the basal area with a sounding mallet but there were no hollow soundings produced.

- I probed the tight forks with an auger but there was no sign of decay pockets.
- There is no option to use electronic decay detection equipment because the tight forks will distort the readings.

- Whilst it is never possible to be absolutely certain that a tree is safe as it is a living organism and situations can therefore change radically as it grows I can only assert that at the time I inspected the tree there was no reason to suspect that it is anything but sound and healthy.

- This does not address the concerns of the owner of No 3 who is alarmed by the lean and weighting of the crown and would prefer to see it crown reduced and reshaped. I would not advise this course of action as this is a mature tree and Birch does not respond well at this age to heavy pruning. Plus once you start down the road of pruning works you can actually create a situation (as with the Cherries in TPO W1) where topping out creates problems that were not there before by promoting growth from weak points of attachment around the old pruning wounds and then you have to repeat the pruning operations on a cyclic basis every 3 to 5yrs.

Recommendations:

Works advised are:-

1. No tree works are advised at this time.
2. Re-inspect this tree in 12 months time.

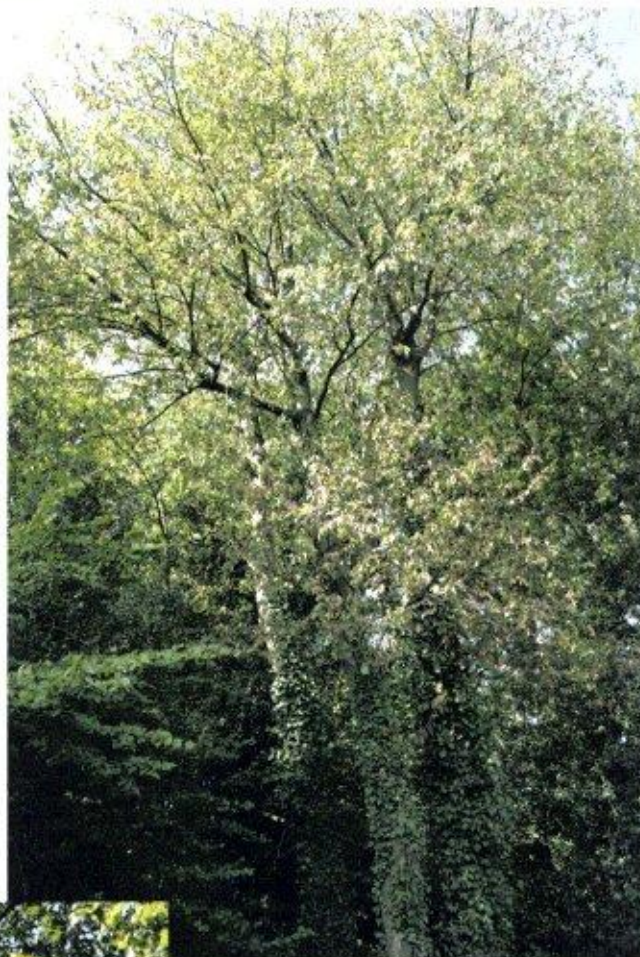
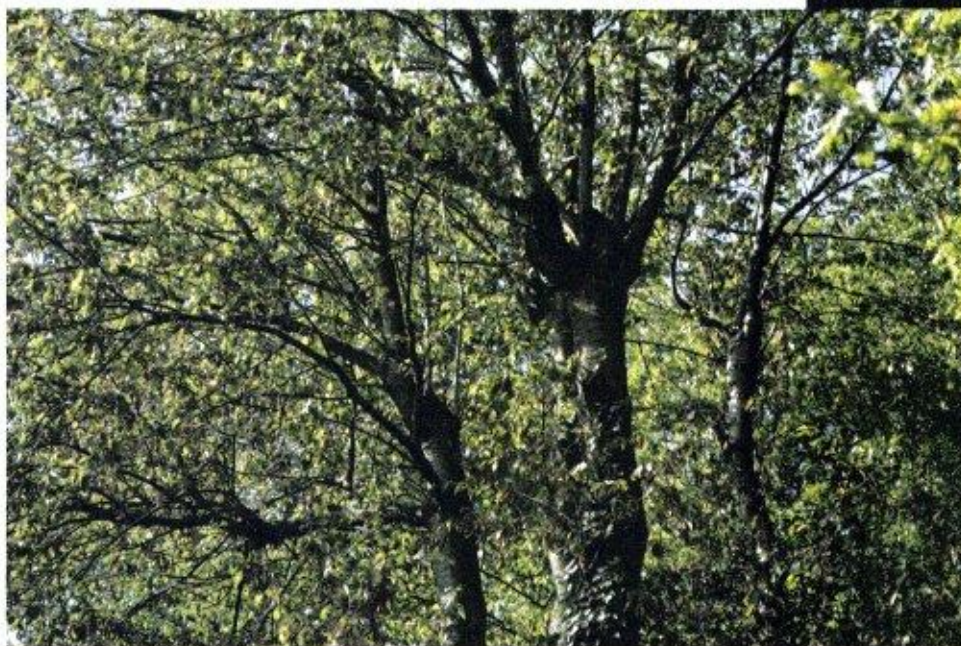
Cherries (TPO W1)

- These mature trees have been heavily reduced and reshaped in the past leaving large open wounds from which a mass of new stems have arisen around each pruning wound and some decay pockets are visible.
- These new stems have weak points of attachment and there is with this species of tree a high risk of failure of these stems in high winds.

Recommendations:

Works advised are:-

1. Reduce these trees back down to the old pruning points unless there is decay noted in same in which case cut just below this into sound wood.

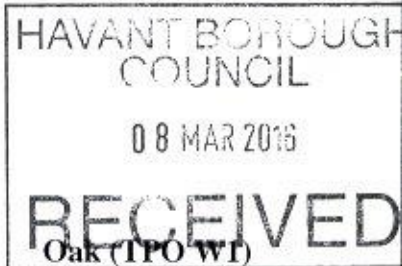
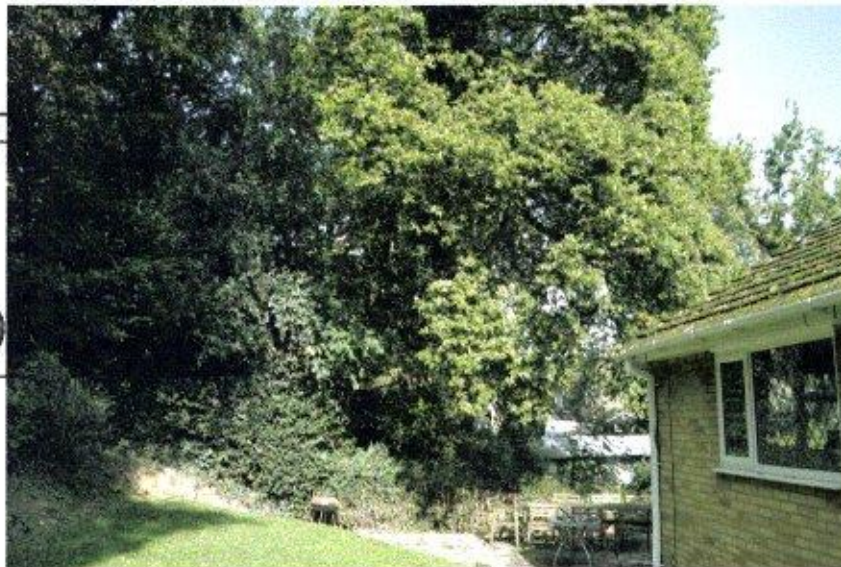
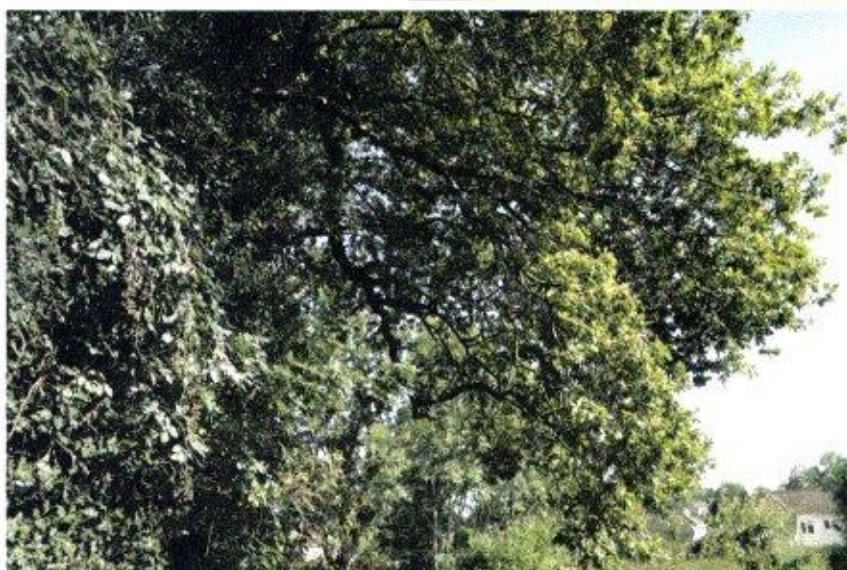
- This mature tree has a low spreading canopy which overhangs the rear garden of this property casting shade and leaf fall on same.
- The owner asked me if this tree could be topped out or removed to solve this problem – my response was that this tree was TPO'd and thus the Council would resist its removal as there are insufficient grounds for same. Similarly no topping out would be permitted because it would achieve nothing given that this tree is at the edge of a mature woodland and the trees behind it would still cast shade and leaf fall over the garden.
- I advised that the best course of action would be to apply for some crown lifting works to clear the low overhang and provide some relief for the owner.

Recommendations:

Works advised are:-

1. Crown lift by removing the 'dropper branches' of less than 70mm diameter from the undersides of the main limbs – to achieve a ground clearance above the garden of between 3m to 4m.
