Our Ref. 2844

4<sup>th</sup> May 2010

Re: **86 West Street, Havant, Hampshire.**  
**Existing Front South Elevation.**

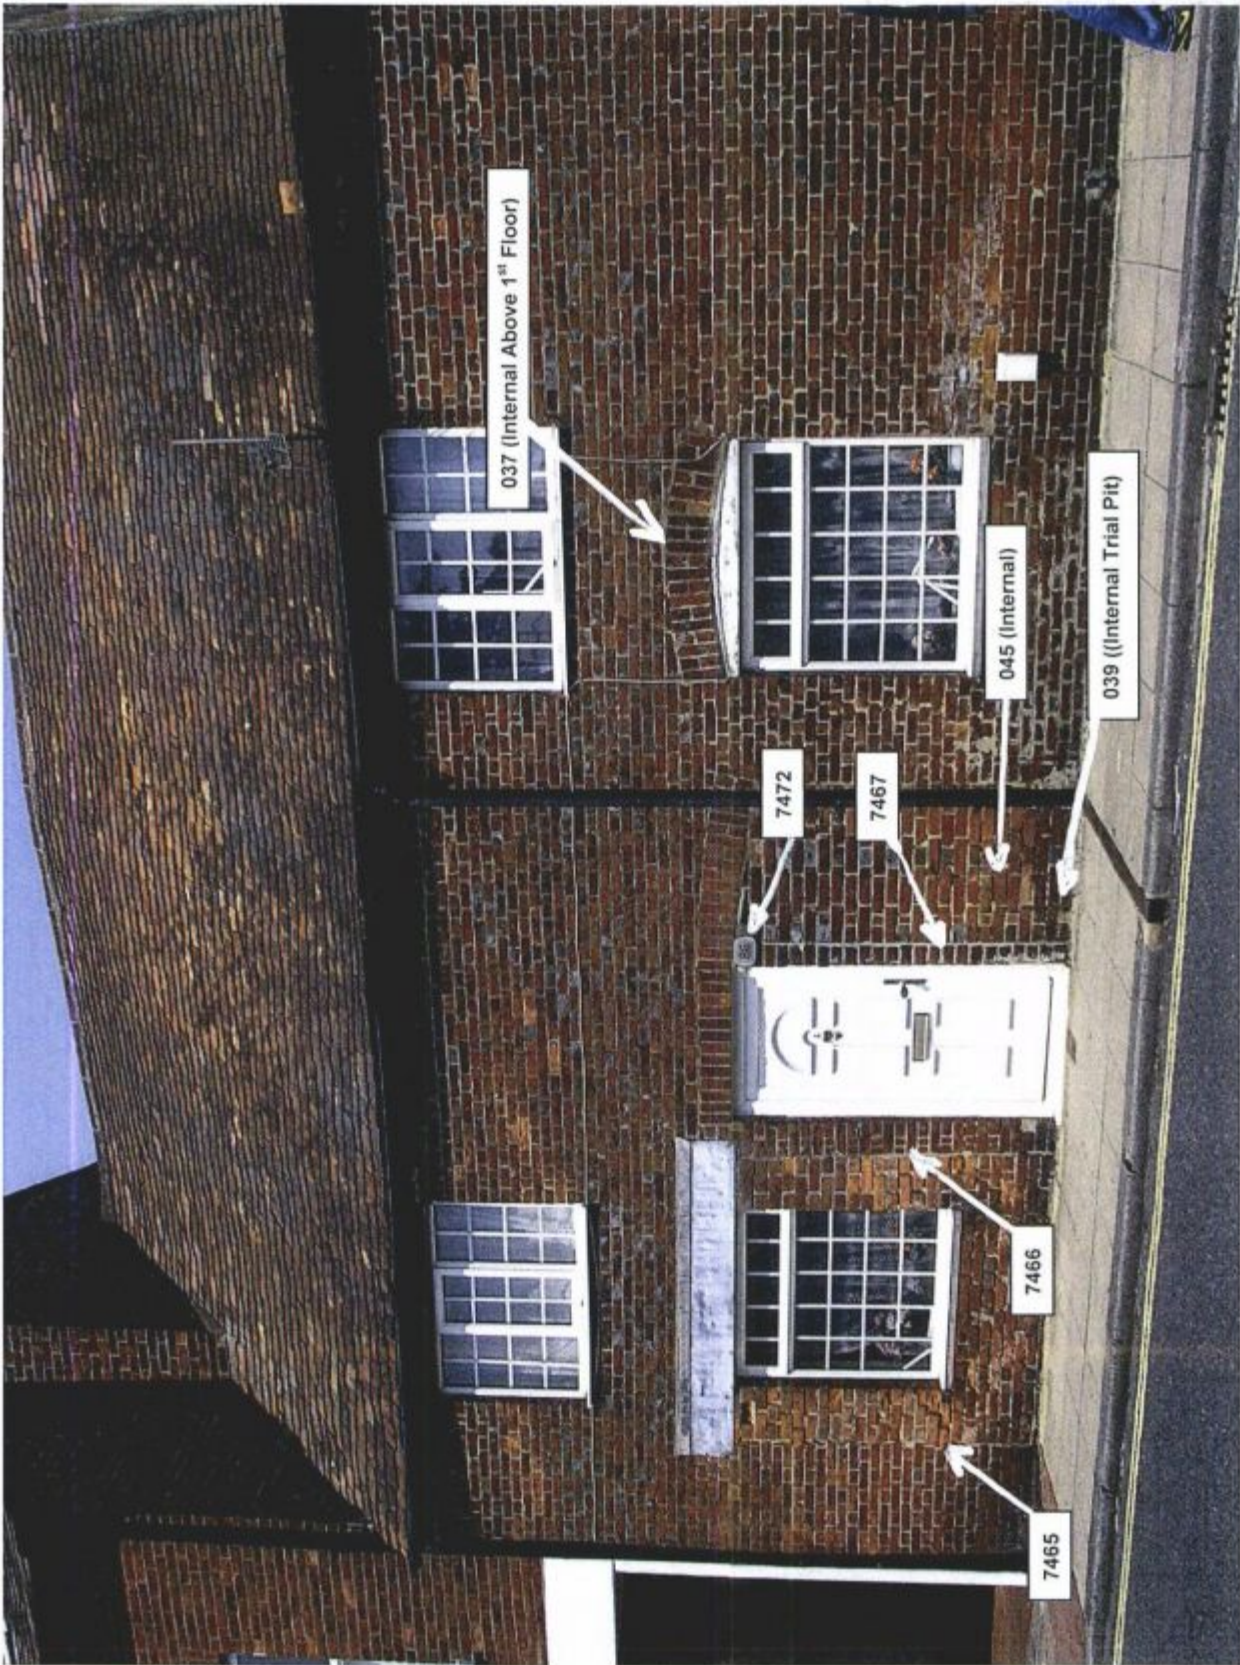
Photo No. 06.03.09/005

- The existing western ground floor window is housed within an original large square opening, (possibly an earlier shop front) that has been infilled.

The bricks and coursings to the infill do not match the original Flemish bonded work and are straight jointed at the abutments. **(See Photo Nos:- 06.03.09/005, 7465 & 7466.)**

These unconnected straight vertical joints occur, not surprisingly, at the positions of worst vertical distortion and where the first floor joists have completely lost their bearings as a direct result.

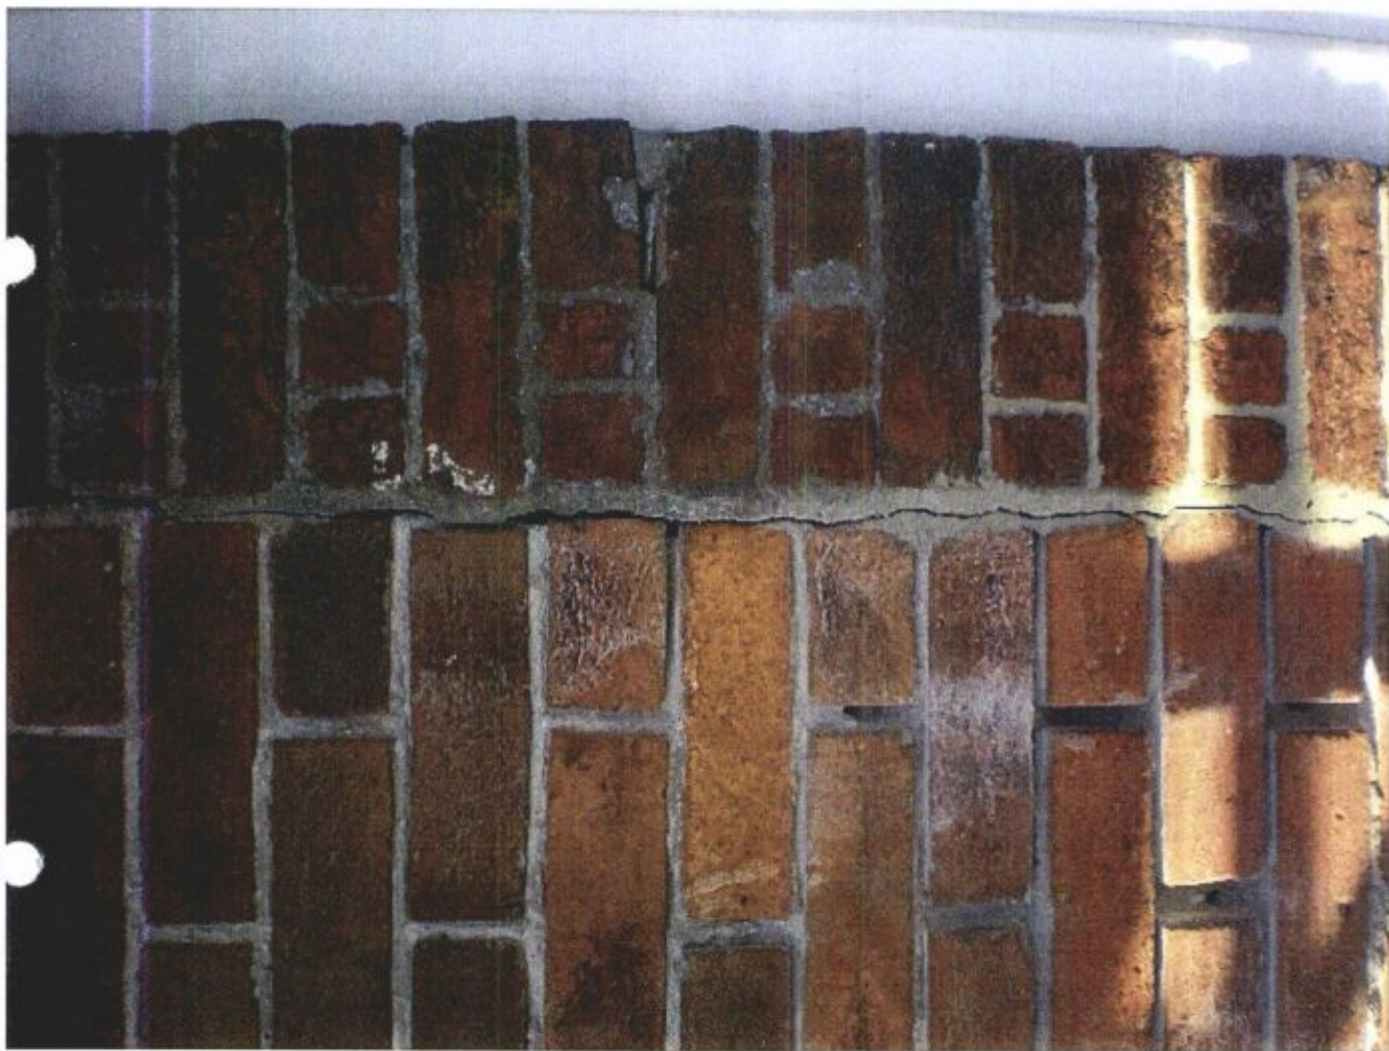
Photo No. 7466

- The brick pier between the existing ground floor western window reveal and the adjacent door is only 215mm wide. **(See Photo No. 7466.)**

Internally, it abuts, but is no longer connected to, a returning timber framed corridor wall.

The separation at this point is 66mm maximum internally.

The pier leans outwards at first floor level by 70mm.

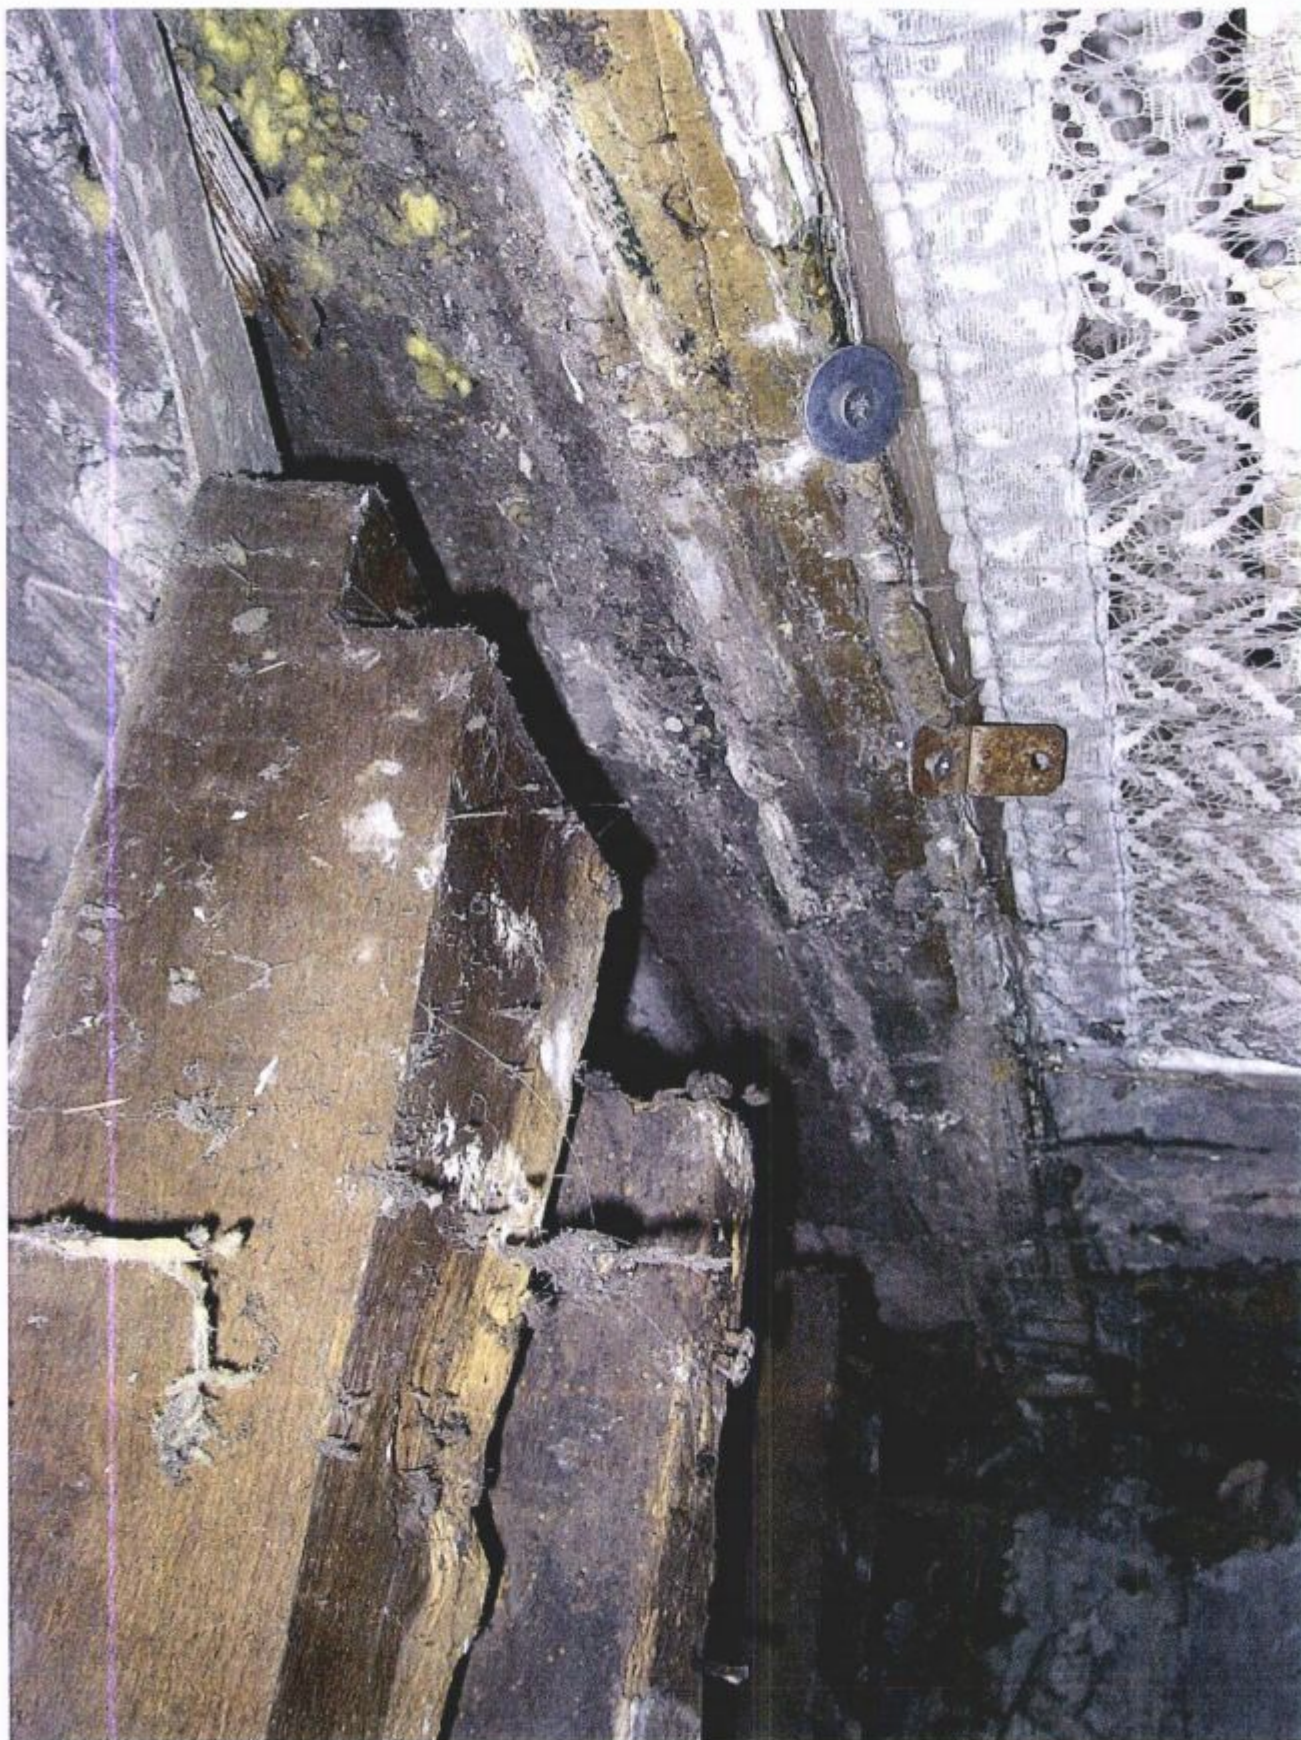
Photo No. 09.30.09/48

There are buried timbers over the window-head internally, which are suspect and which require to be replaced. [ 2/ 75 x 150 outer under flashing, 1/ 120 x 100 inner. All with worm infestation]. **(See Photo No. 09.30.09/48.)**

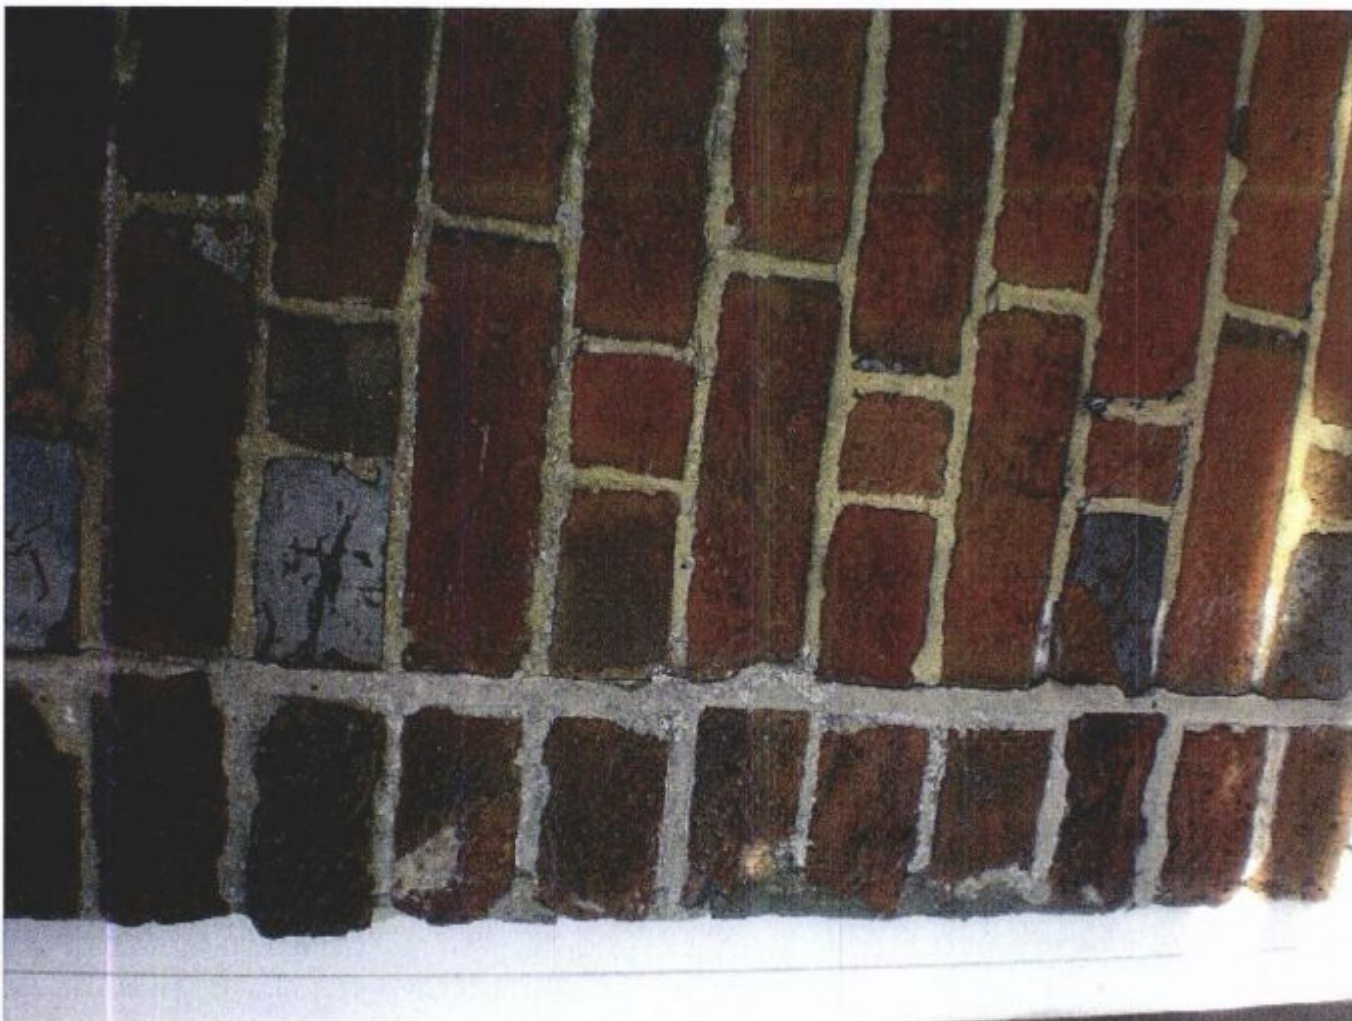
Photo No. 7467

The lintel over the present door is horizontal soldier coursed brickwork externally, which then adjoins the previous crown of a soldier coursed segmental brick arch at the east to a previous doorway.

The eastern bearing is only 102mm wide brick on end and straight jointed to the previously infilled opening. **(See Photo No. 7467.)**

- The old infilled doorway is to be re-opened, which will dictate widening of the opening to accommodate the party wall construction between the two doorways and the replacement of the existing lintel and partial segmental brick arch.

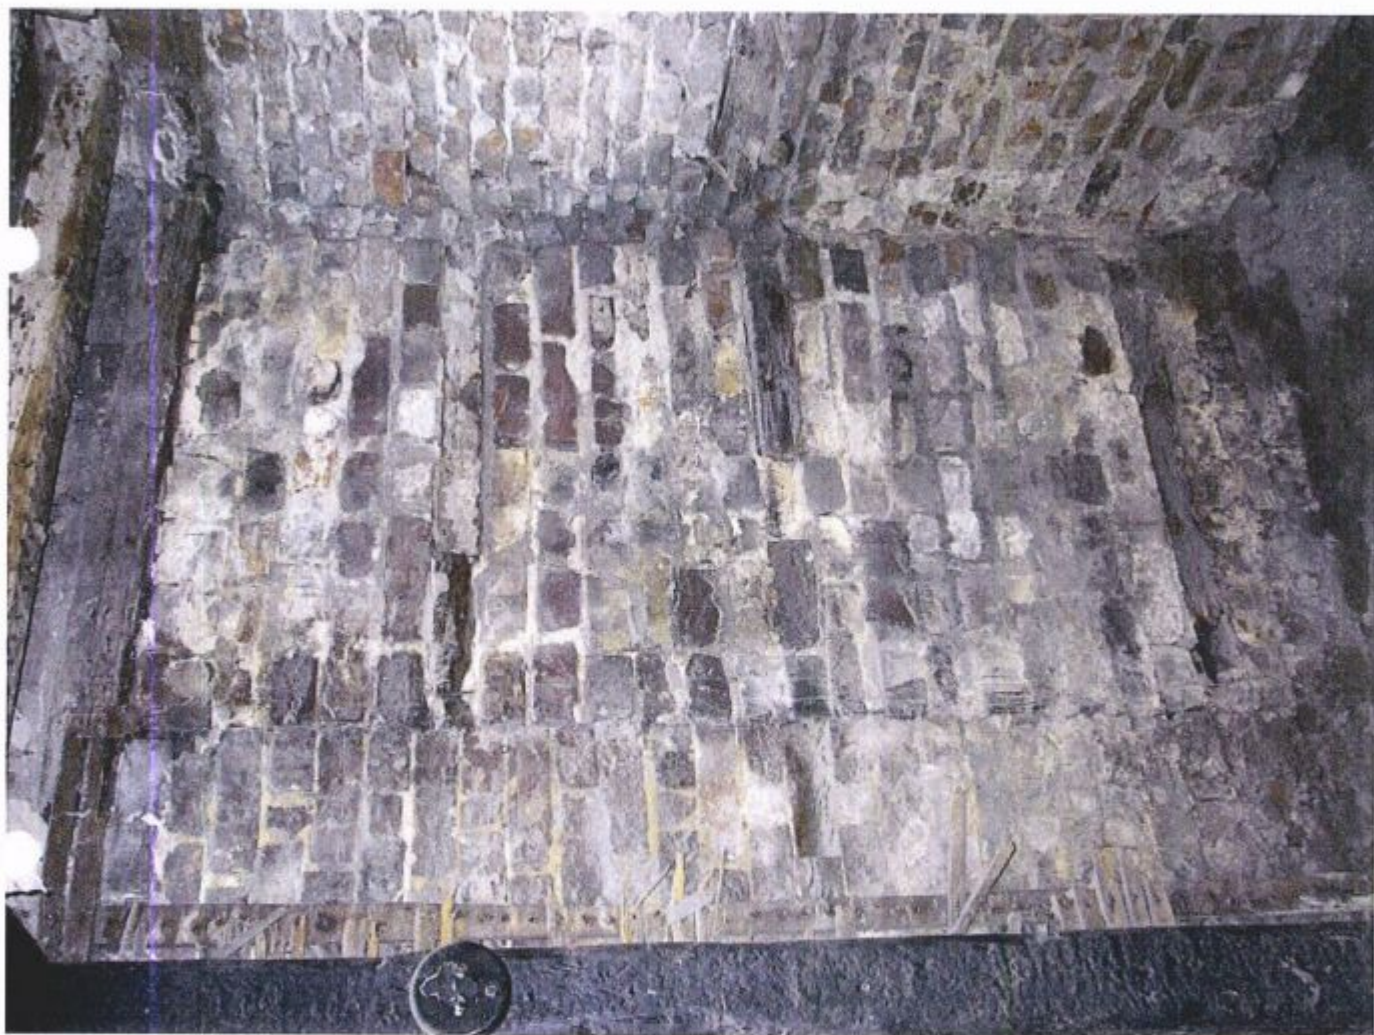
Internally, the infilled doorway has a buried timber lintel above and timber plates within the panel; all of which are suspect. **(See Photo No. 09.30.09/045 which shows the infilled panel and timber plates and see Photo No. 09.30.09/044, which shows the abutting 100mm infilled stud wall to the corridor and the outward lean to the front wall at the junction.)**

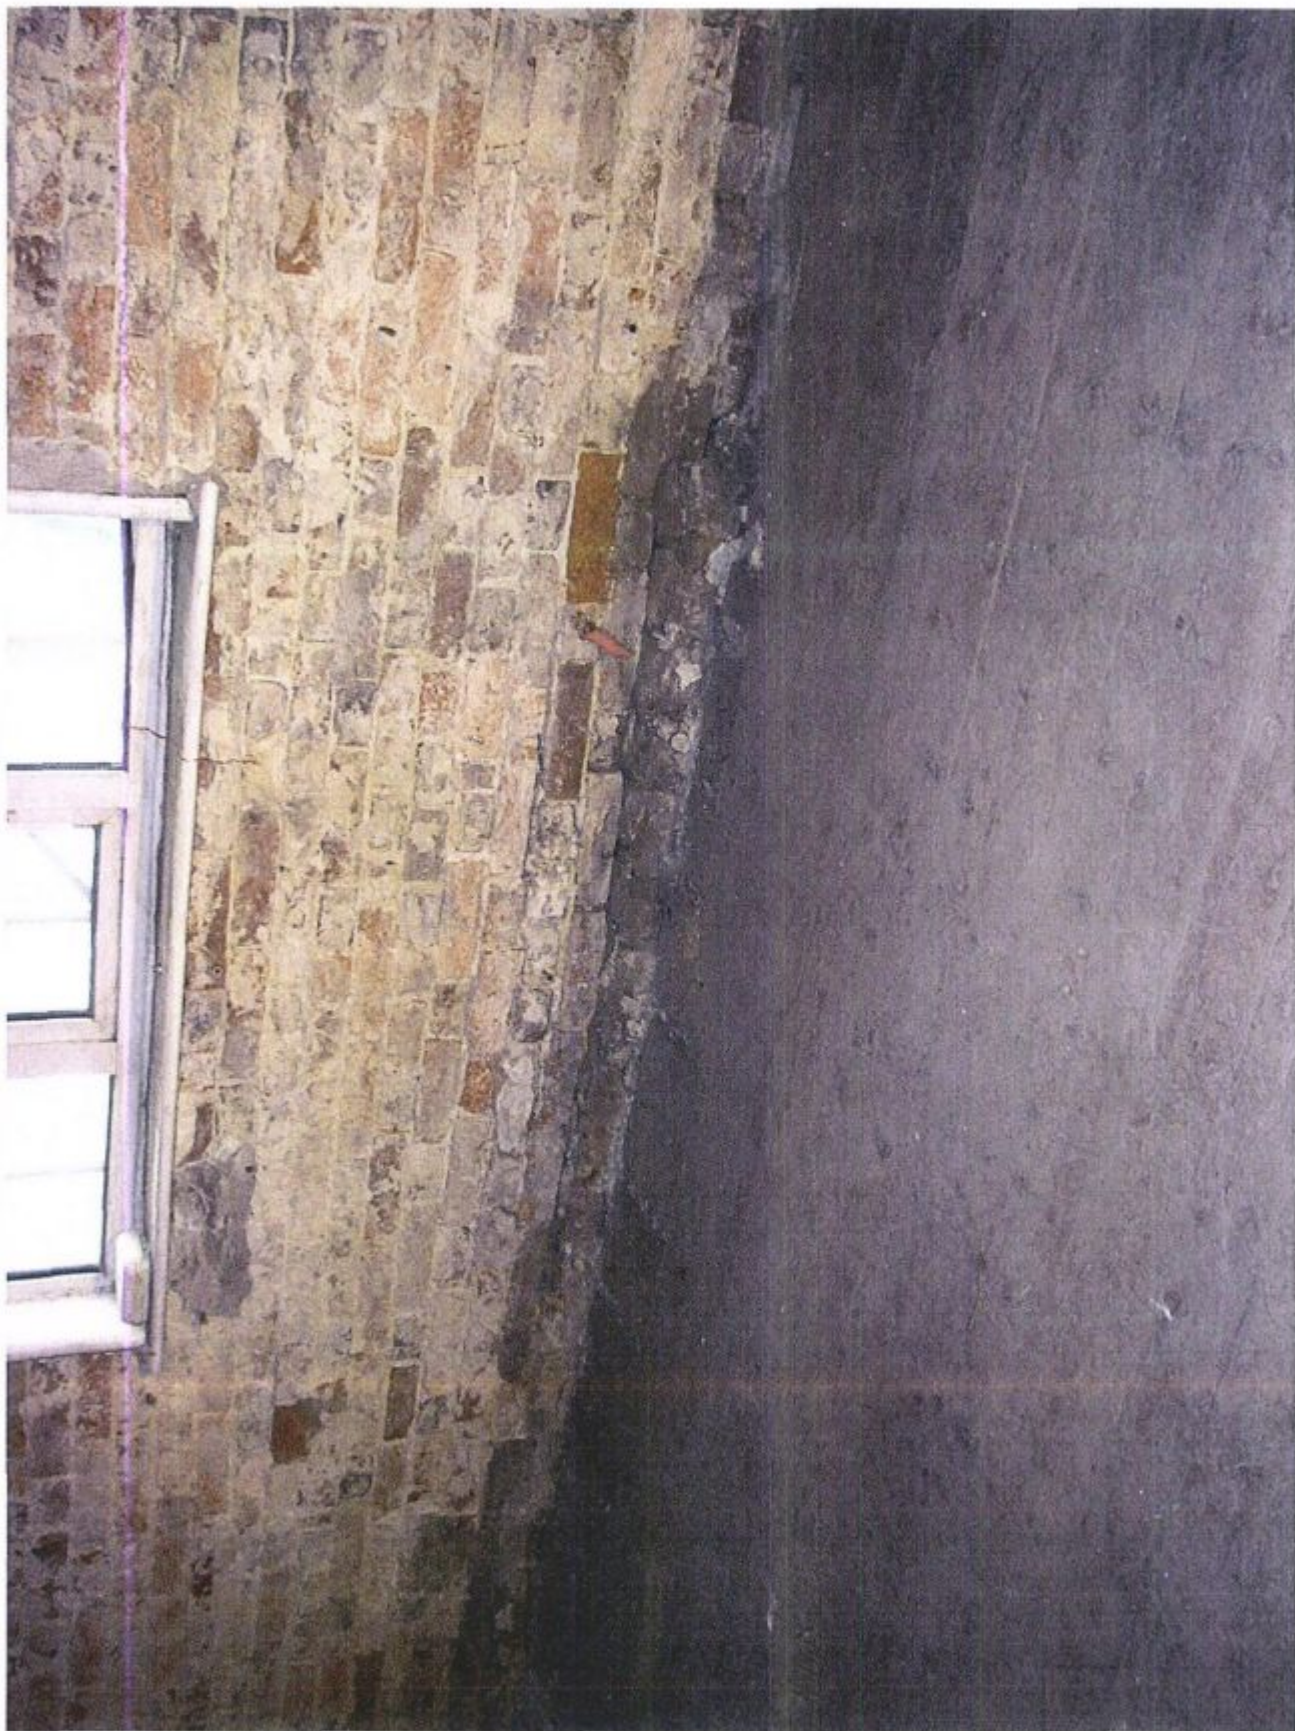
Photo No. 09-30-09/037

- Bedrooms 1 & 2 timber window lintels show pronounced deflection and are both suspect.
- Bedroom 2 shows a considerable length of loose/missing masonry below the window at first floor level. (**See Photo No. 9.30.09/037.**)

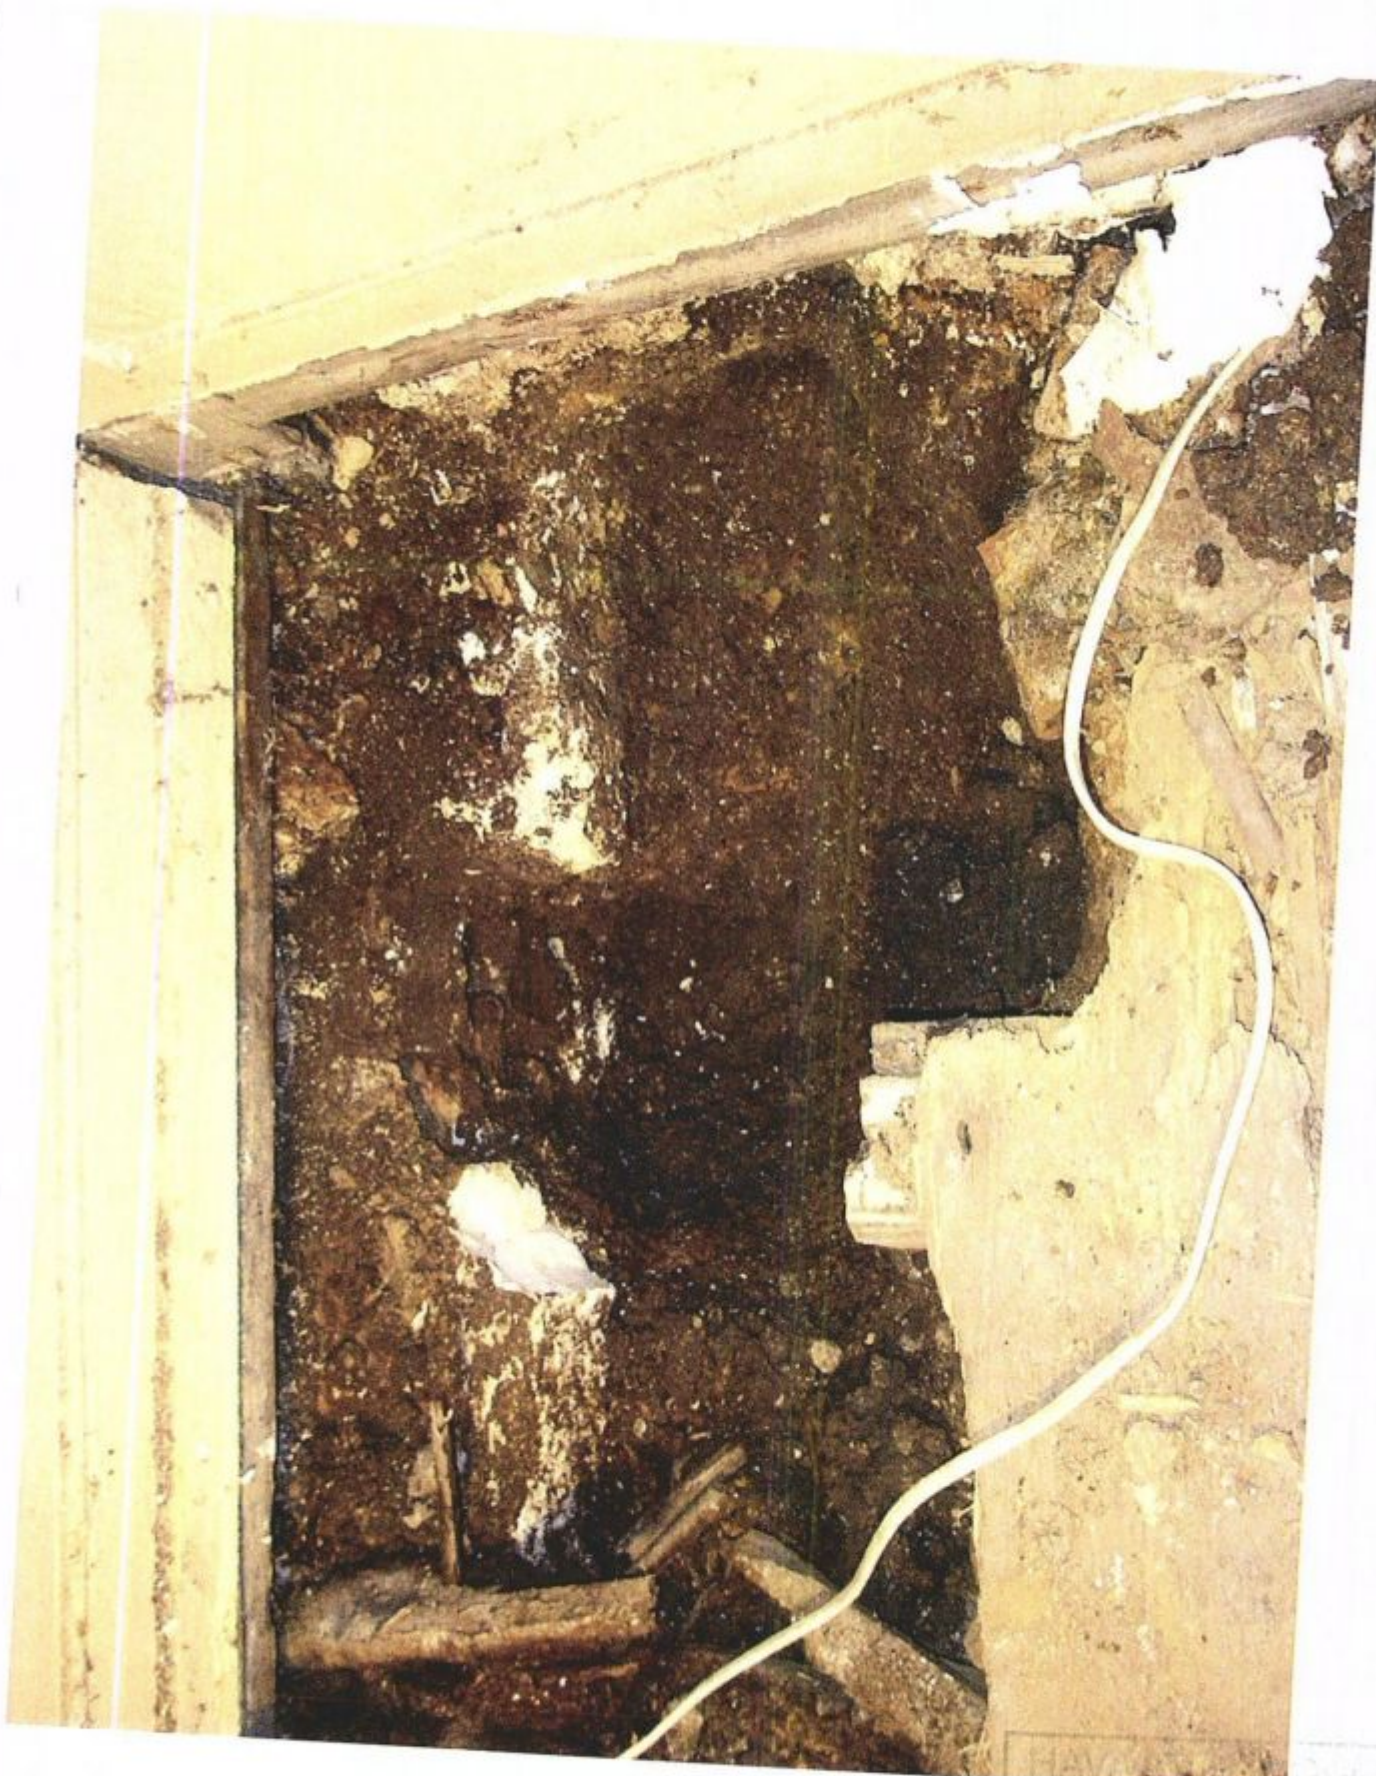
Photo No. 07-15-09/039

- The internal lintel to the eastern window is 120mm deep, worm infested and should be Replaced.
- A small trial pit undertaken internally adjacent to the infilled doorway and abutting the corridor wall (**see Photo No. 07.15.09/039**) though curtailed due to the fragility of the wall, suggests that there is very little by way of a foundation to the front or internal corridor walls.

Consequently, the whole front elevation will require a new foundation and dpc to suit the ground floor construction.

This would dictate underpinning over the complete wall length.

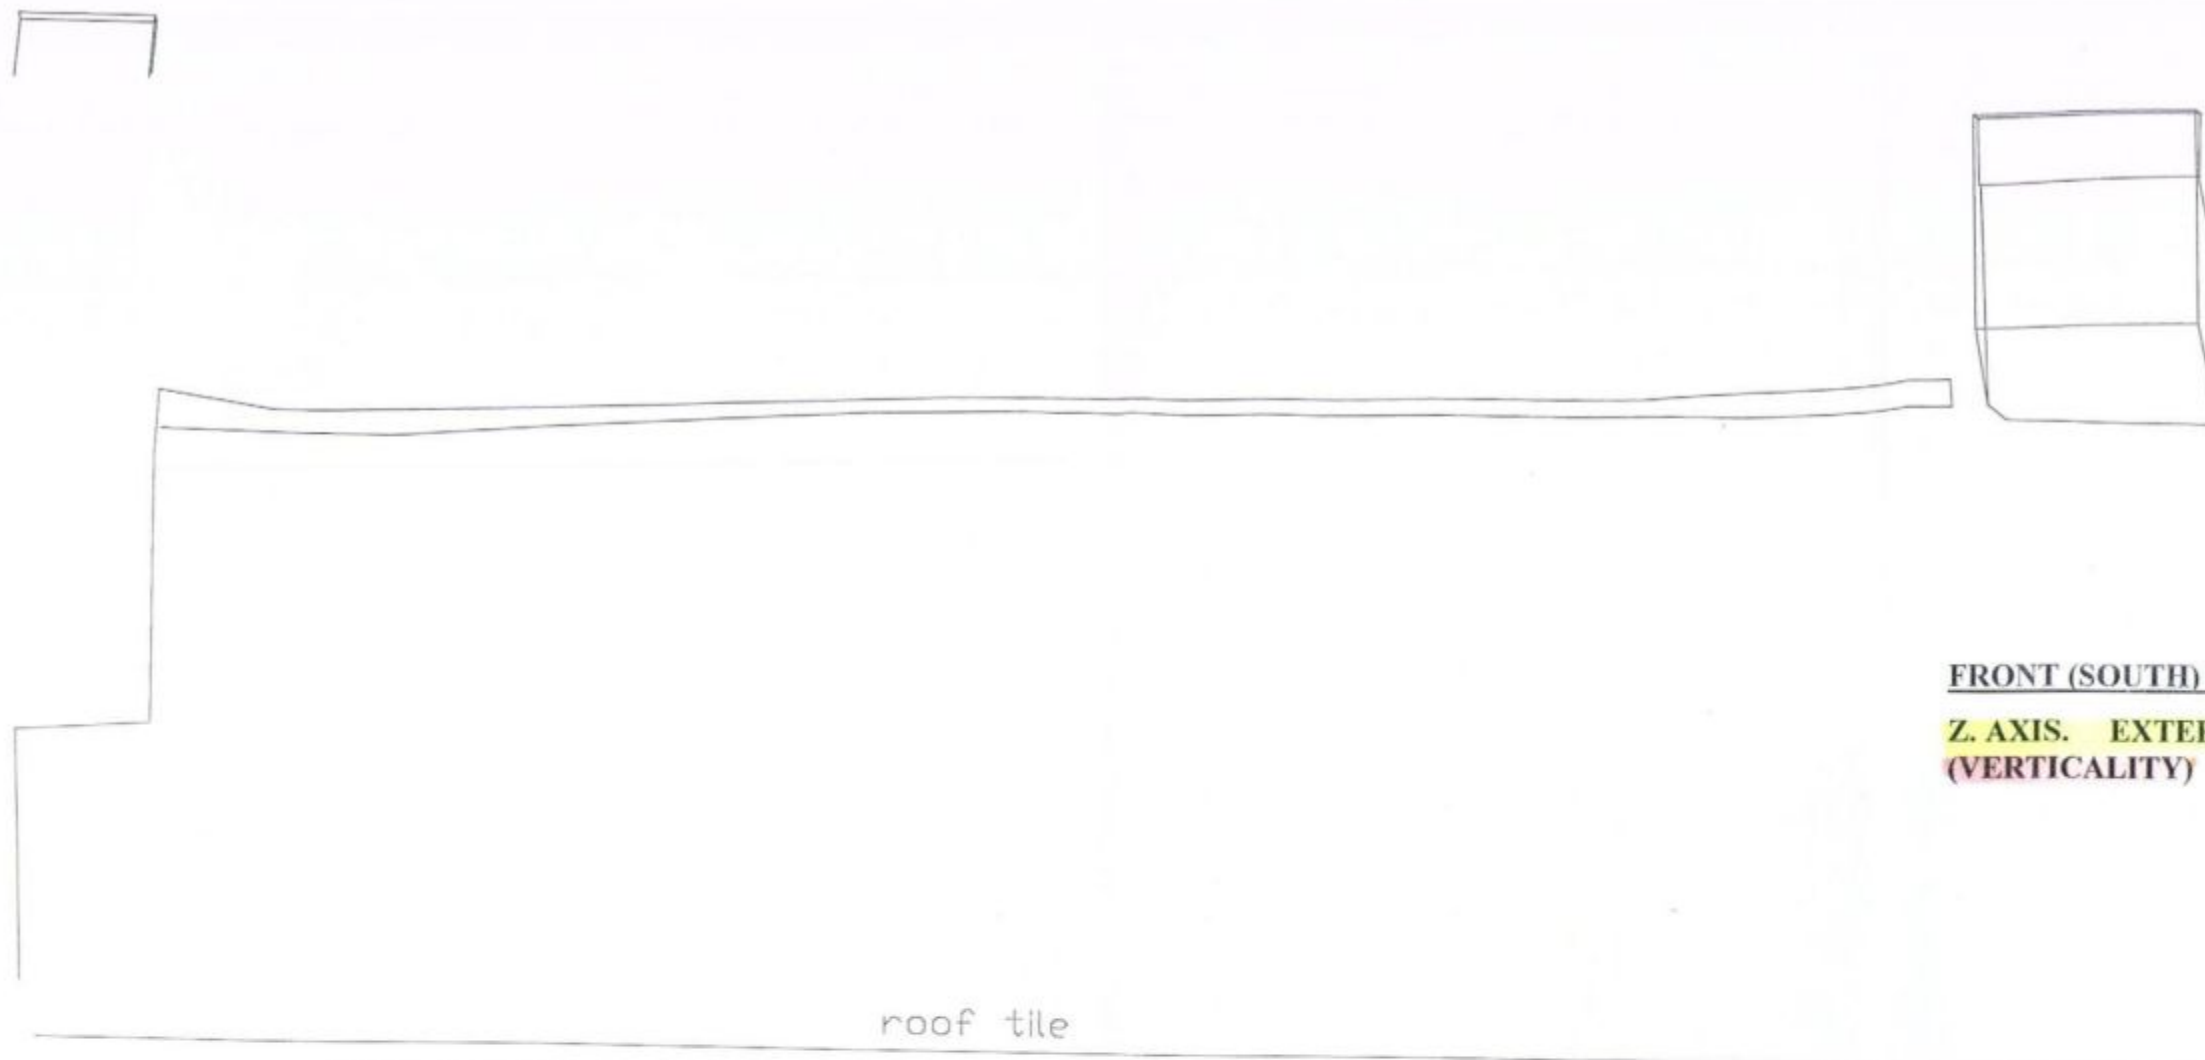
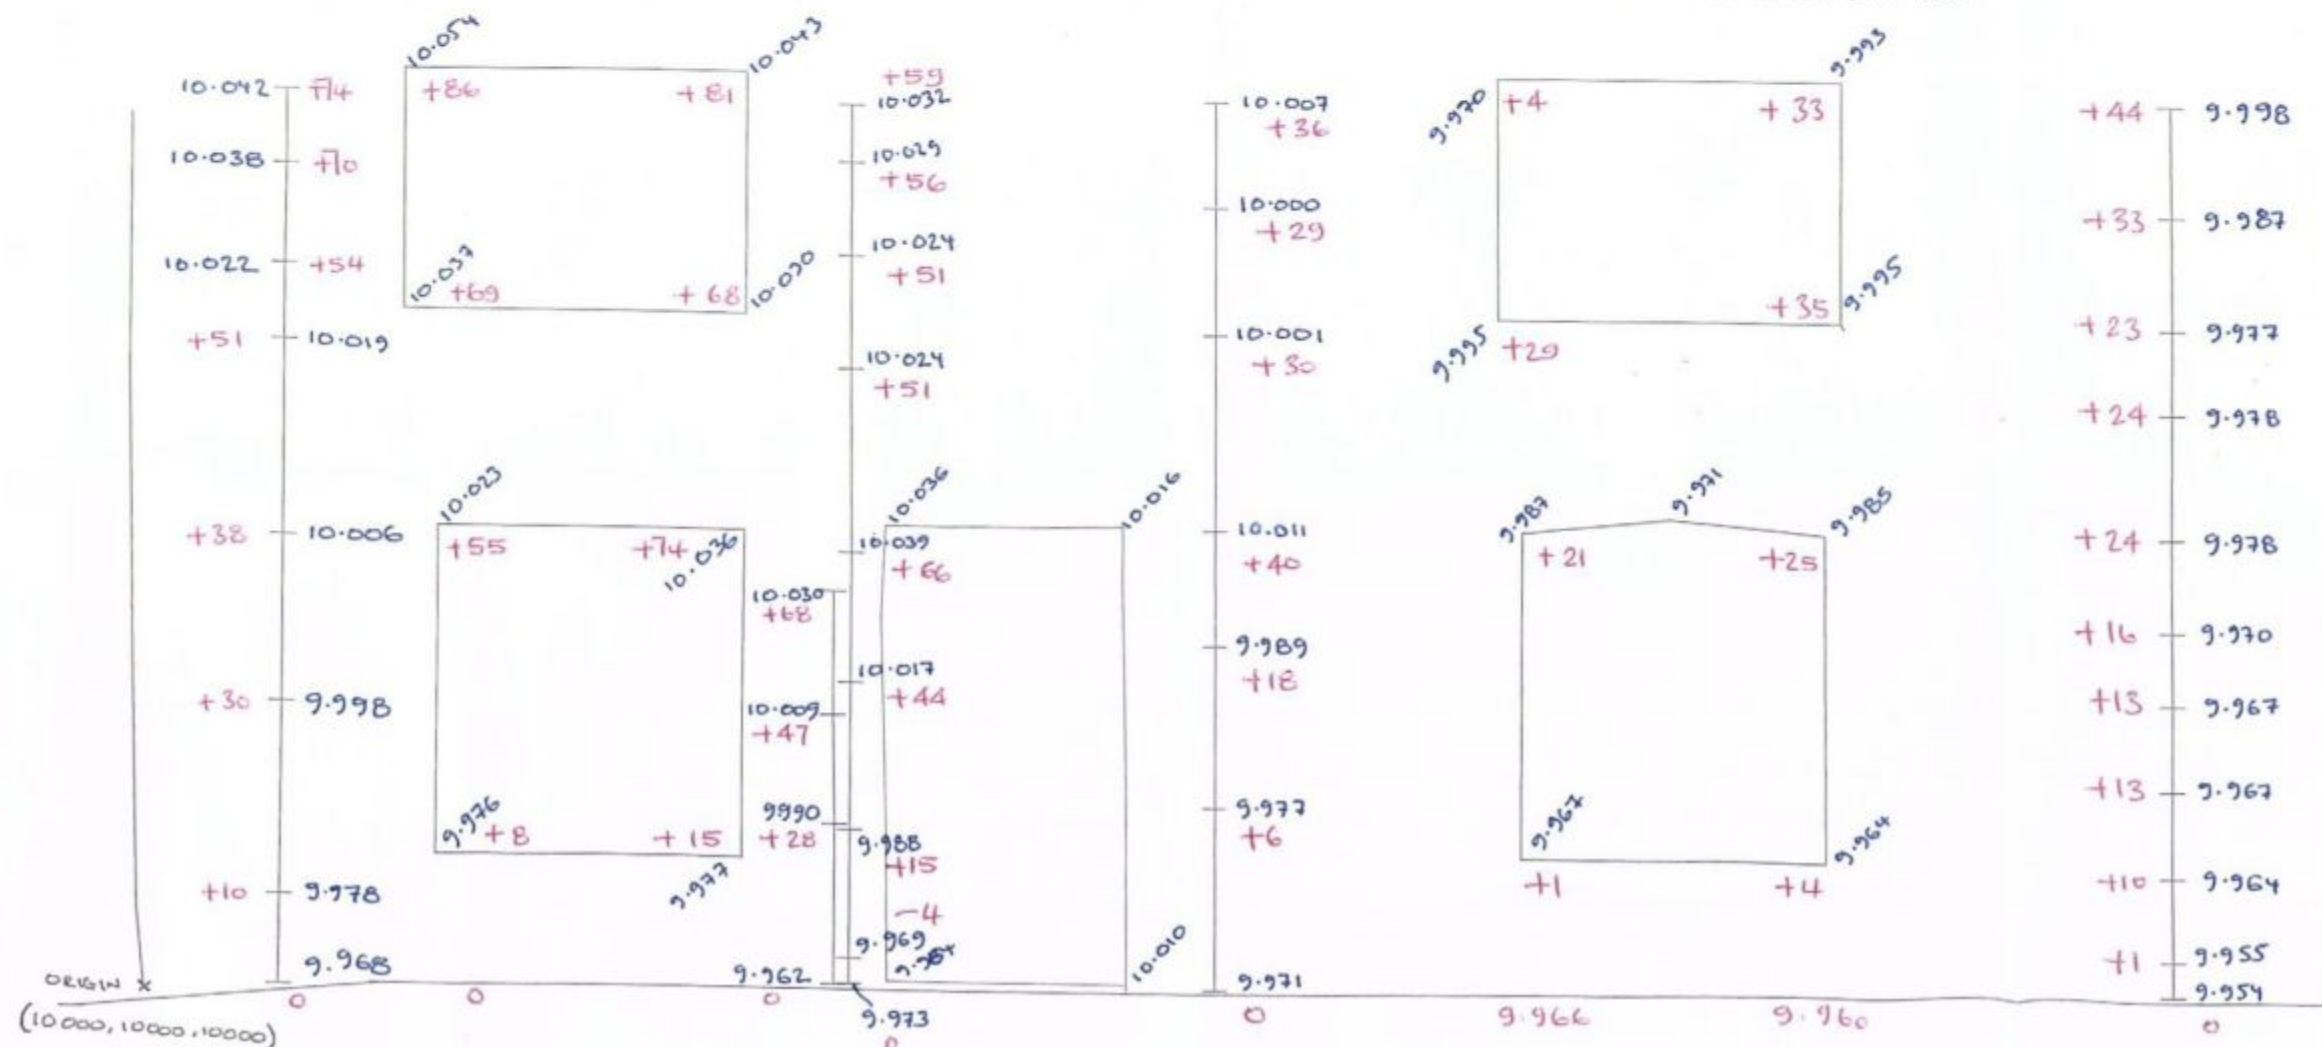
2844/S/01

The external distortion over the height in relation to the base of the wall is at its worst at the west, varying from 44mm at the east to 86mm at the western window-head externally and 93mm at plate level, internally at a similar location.
