# ADDENDUM TECHNICAL REPORT ON A SUBSIDENCE CLAIM

97 Sutton Road  
Waterlooville  
Hampshire  
PO8 8PT

# TECHNICAL REPORT ON A SUBSIDENCE CLAIM

## SITE INVESTIGATION REPORT

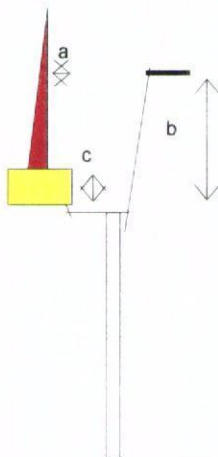
Foundation Details

A trial hole was excavated to expose the foundations - see site plan for location (labelled EH1) and the diagram below for details. Trial Hole 1 on the rear right hand corner of the rear extension revealed a concrete strip footing founded at a depth of 1m below ground level which bears onto firm brown slightly sandy CLAY. Root activity of live appearance was noted to the underside of the foundations.

| No. | Borehole Depth | Footing (a) | Underside (b) | Thickness (c) |
| TH1 | 3.00 m. | 100 mm. | 1,000 mm. | 400 mm. |

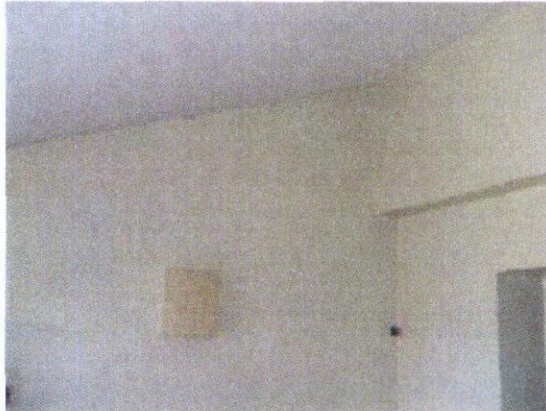
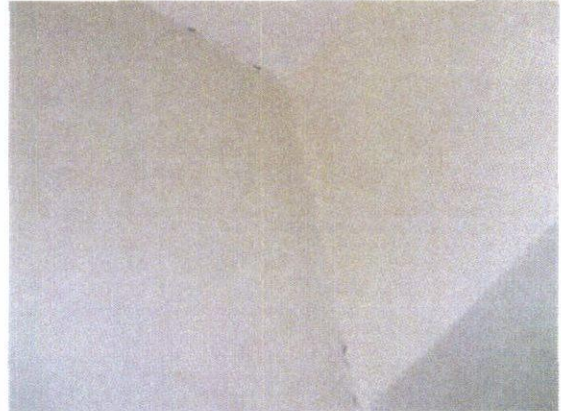
Rear addition

There was evidence of movement at the junction of the house and rear addition on the right side junction. There was no evidence of movement on the left side junction. There was also a very slight crack on the outside wall of main house close. The crack widths were up to 1mm.

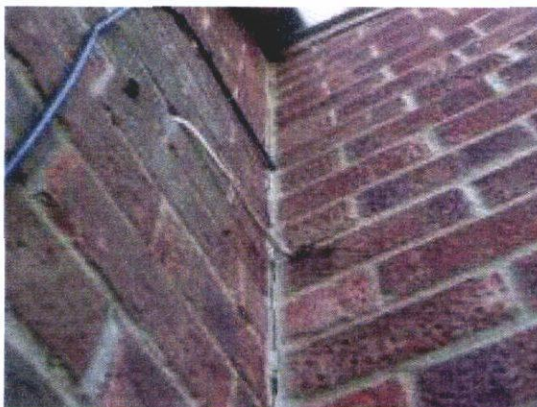
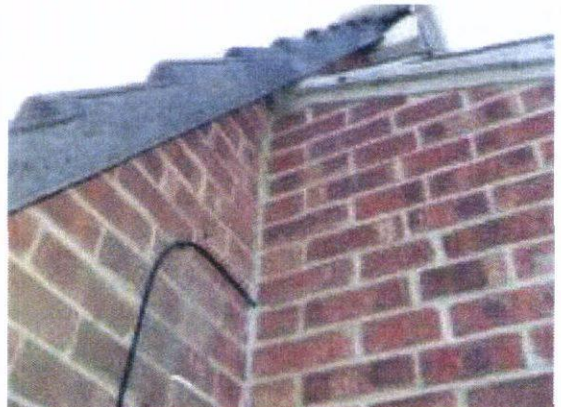
There was evidence of movement at the junction of the rear addition and house. The separation gap was no larger than 2mm.

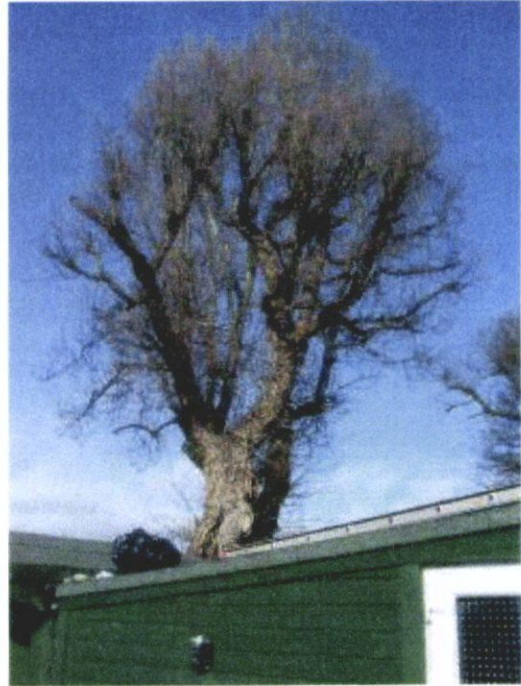
T1

Marishal Thompson have implicated the Oak and Ash trees T1, T2 and T4 as the cause of the claim, based on their proximity to the trees, size and the species. They have recommended the felling of the trees to bring about property stability.

An application shall be submitted to reduce the Oak and Ash trees as an attempt of mitigation over tree felling. Tree reduction will generate relative property stability. If tree reduction is refused then partial underpinning will be needed which will escalate the claim reserve from £1k to £40k.
