**GROUND INVESTIGATION REPORT**

**WOODCROFT FARM PHASE 3,**

**LOVEDEAN, HAMPSHIRE**

| Reference: | GE20772-GIR-DEC23 |

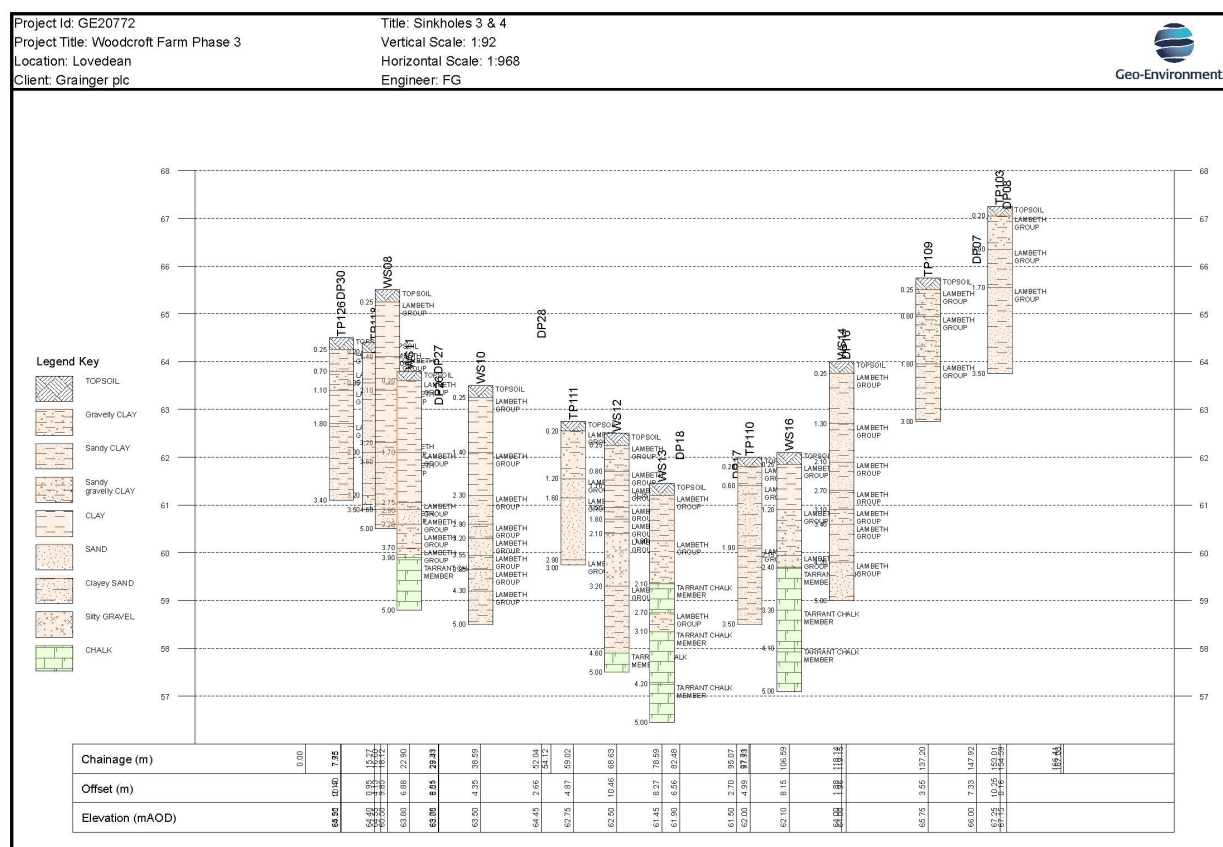
### Plot 1 Ground model section through Sinkholes 3 and 4

As noted above, the ground conditions were observed to vary over relatively short distances, i.e. within the extent of some of the exploratory holes. In addition, the depth to the Chalk was observed to vary significantly such that whilst Chalk was encountered at relatively shallow depth in some of the exploratory holes, it was not encountered in others. These variations in depth to the Chalk are considered characteristic of karstic weathering, but also reflect the site's location on the 'feather edge' of the junction between the Lambeth Group and underlying Chalk, with the thickness of Lambeth Group cover increasing towards the north and north-east.

A ground model section from west to east through Sinkholes 3 and 4 is presented below and presents a graphical illustration of the variation in topography and underlying ground conditions.

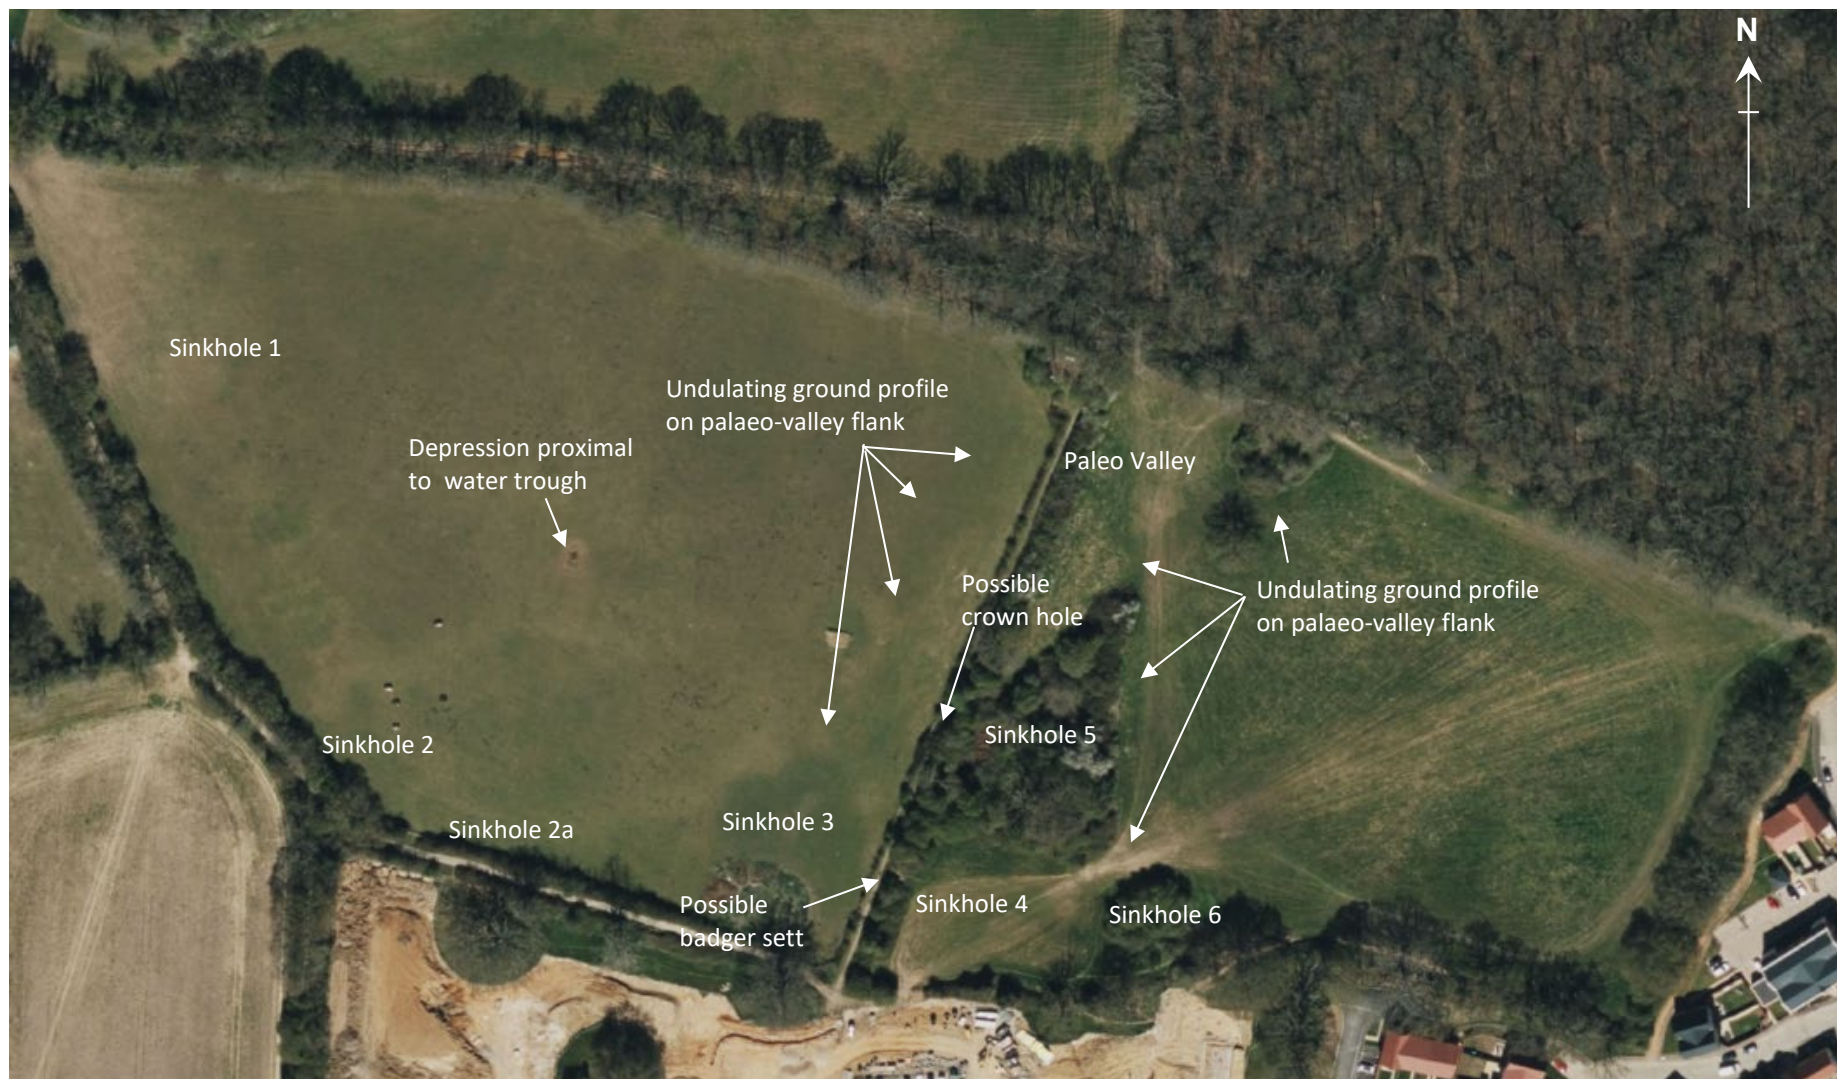
The ground surface on the western field generally fell from north to south. Four depressions/sinkholes were noted within the field (Sinkhole 1, 2a, 2b and 3). Sinkhole 1 was located within the north west of the western field and comprised a surface depression that was wholly within the grassed field. Sinkholes 2a and 2b were located in the south west of the western field and comprised two adjacent depressions that were also part of the grass field but extended to the field boundaries. Sinkhole 2a correlated with Sinkhole 2 as described in the 2015 report. Sinkhole 3 was located in the south eastern portion of the western field and comprised a grassed depression which extended to the southern and eastern boundaries of the field. In addition, the ground around and between sinkholes 1, 2a, 2b and 3 was observed to undulate and slope away in a general southeasterly direction. Figure 4 shows the locations of these identified geohazards.

In addition to the valley features, three sinkholes (Sinkhole 4, 5 and 6) were noted to be located within the western portion of the eastern field. Sinkhole 4 was located in the far southwestern corner of the eastern field and comprised a grassed depression. Sinkhole 5 was located to the north of Sinkhole 4, i.e. in the more densely vegetated portion of the valley-like feature. Sinkhole 6 was located to the east of Sinkhole 4 along the southern boundary of the eastern field. This sinkhole was also densely vegetated with mature trees, shrubs and undergrowth. Ground levels varied significantly between Sinkhole 4 and Sinkhole 6, the latter being at a higher elevation, i.e. on the shoulder of the valley-like feature and two step changes in slope level and profile were observed between Sinkhole 4 and Sinkhole 6. Figure 4 shows the locations of these identified geohazards.

| <b>Project:</b> | Woodcroft Phase 3, Lovedean | | | <b>Title</b> | Geohazrd Features Plan | |

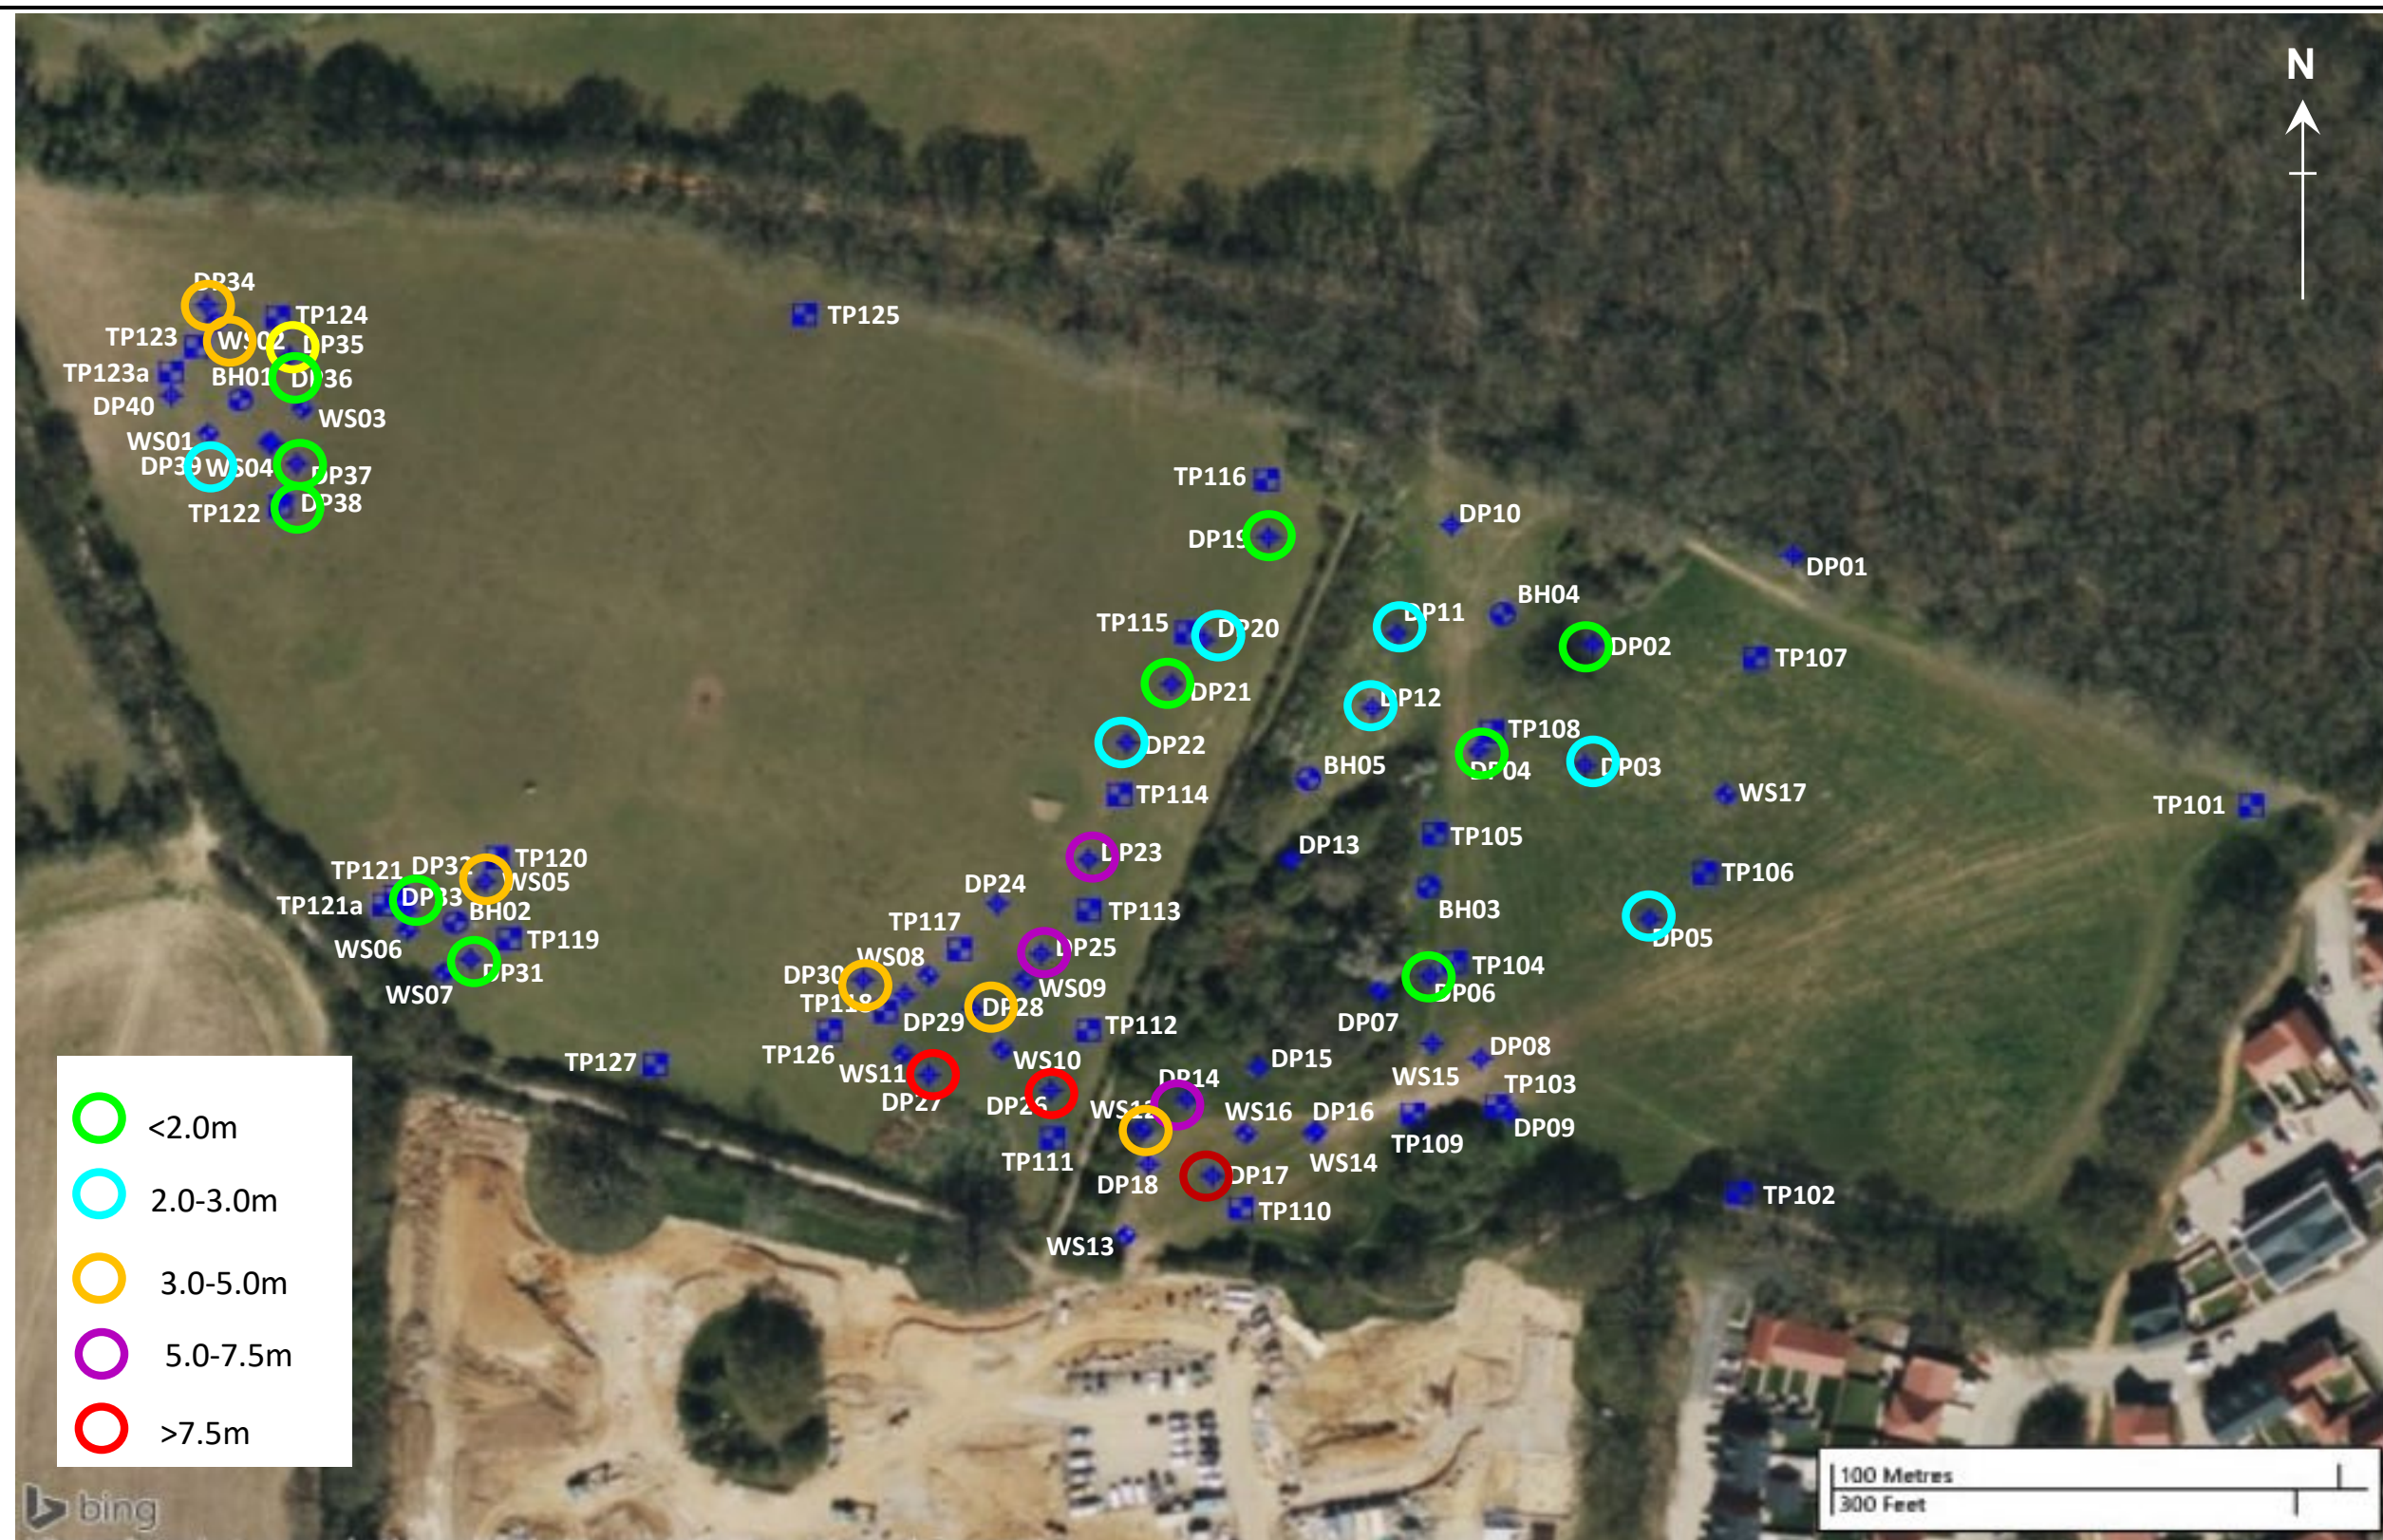
As shown in Figures 4-7, the depth of loose and/or potentially voided zones varied within location even within specific sinkholes. This variation was spatial across a sinkhole area and also variation in depth at which the loose or voided ground was encountered. Table 4.2 summarises the exploratory holes where loose or voided ground was indicated by investigation undertaken.

| <b>Project:</b> | Woodcroft Phase 3, Lovedean | | | <b>Title</b> | Locations where DP values of 0 (zero) were recorded (incl SPT N=0) | | |

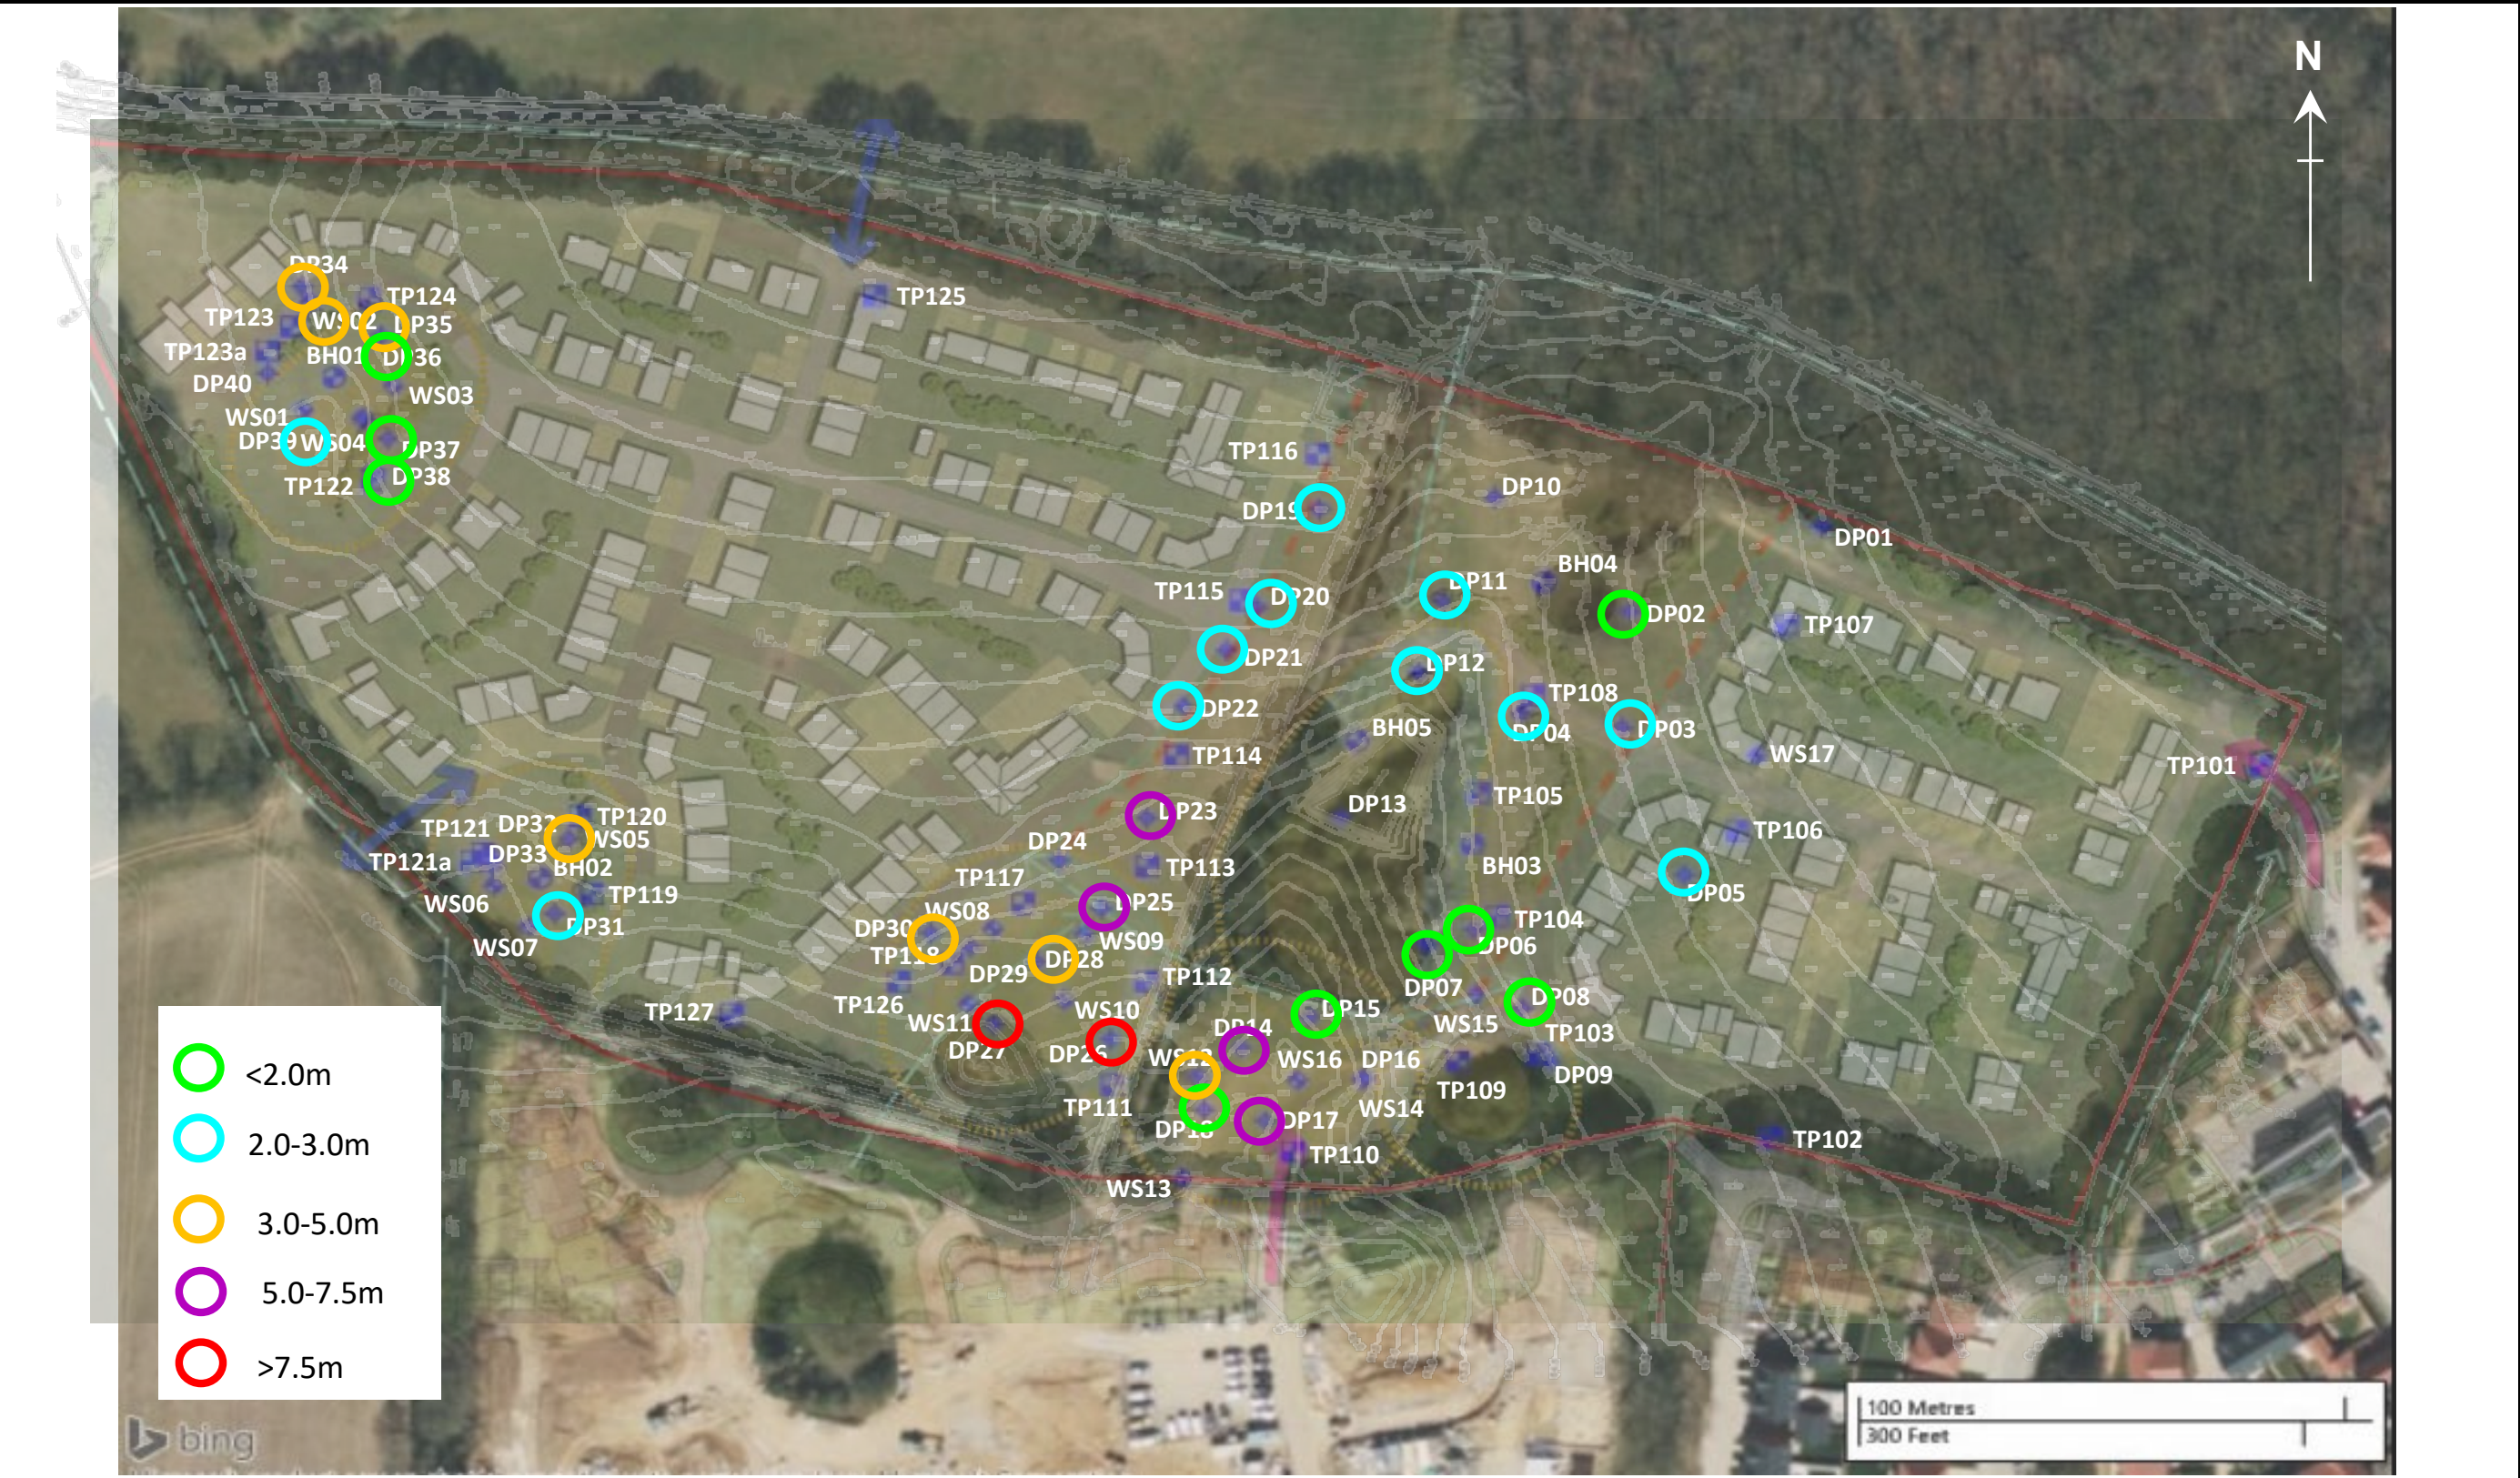
| Project: | Woodcroft Phase 3, Lovedean | | | Title | Locations where DPSH N values of <3 were recorded (incl SPT N=0) on layout | | |

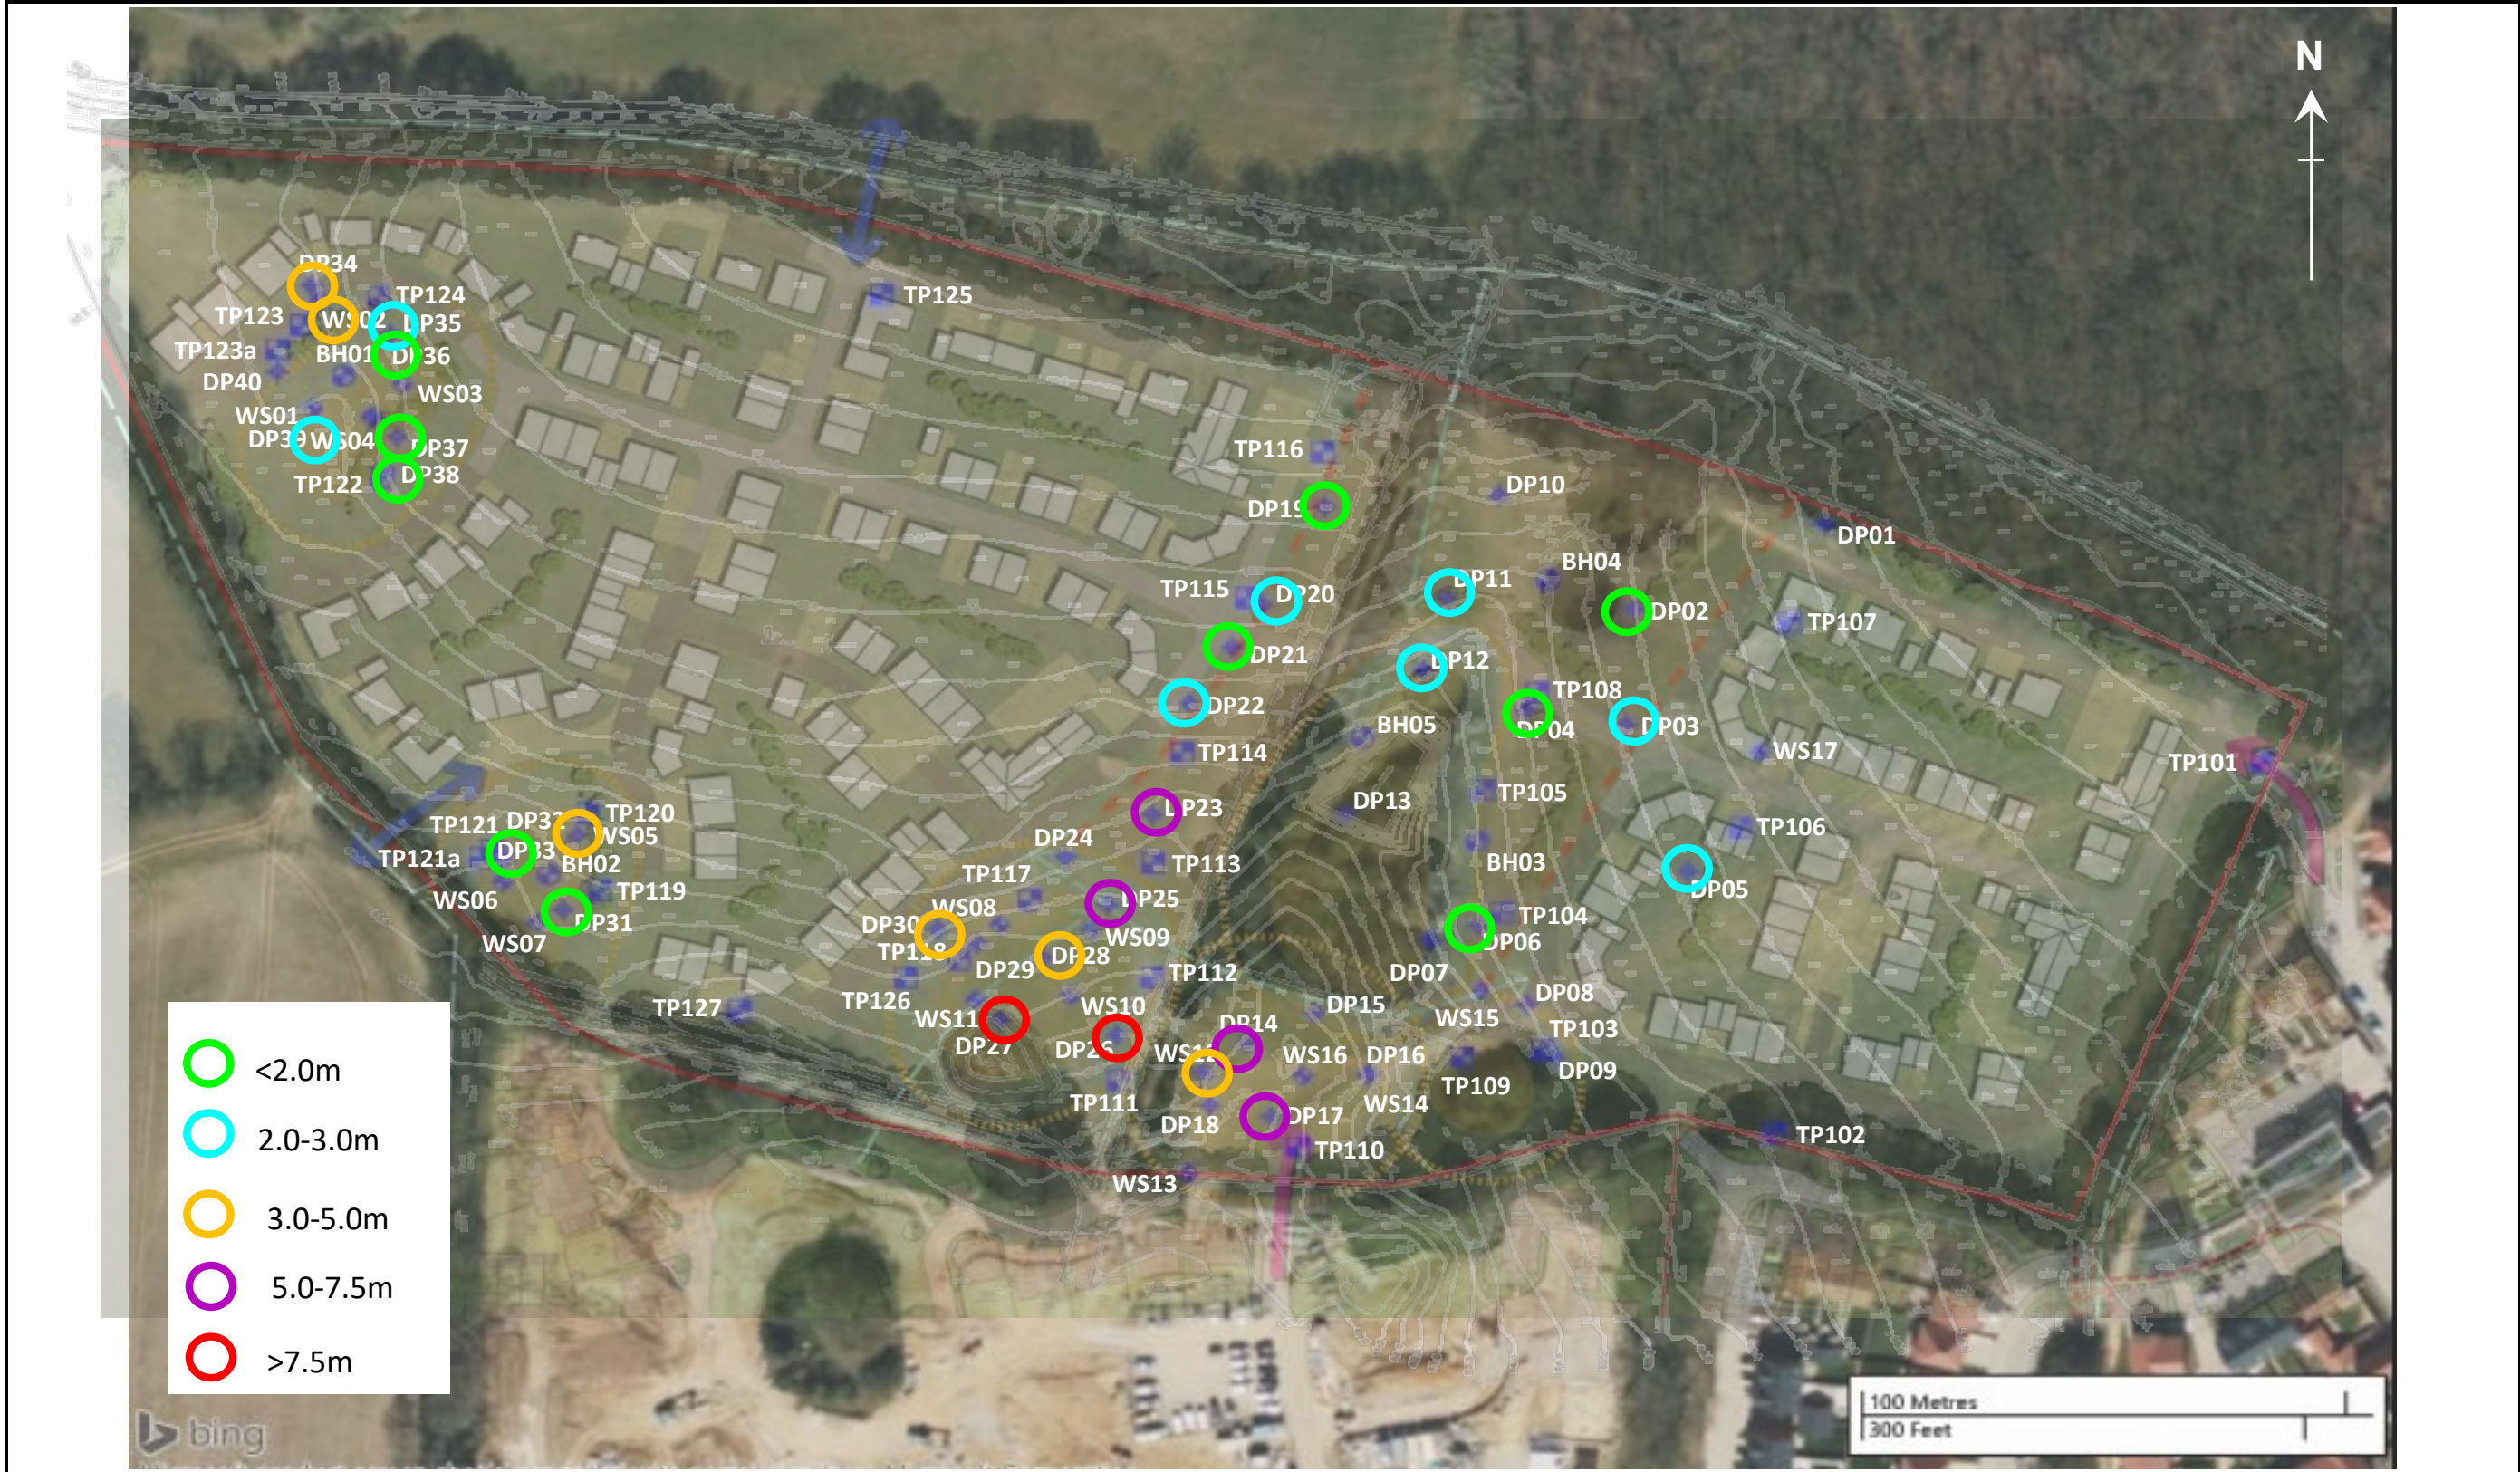
| Project: | Woodcroft Phase 3, Lovedean | | | Title | Locations where DP values of 0 (zero) were recorded (incl SPT N=0) on layout | | |
