## ECOLOGY PRA TECHNICAL NOTE

| <i>HCCET reference</i> | 24.0148 | <i>Client reference</i> | P13926 |
| <i>Site</i> | Staunton Farm –<br>Gothic Library, Middle<br>Park Way, Havant,<br>PO9 5HB | <i>Client</i> | Hampshire County<br>Council – Property<br>Services |
| <i>Survey dates</i> | PRA: 13 March 2024 | <i>Report date</i> | 20 November 2024 |

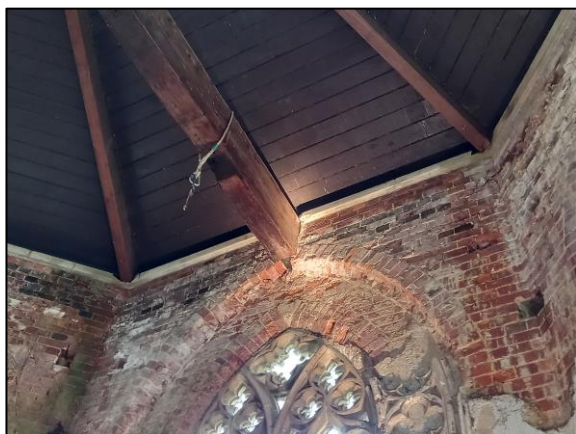
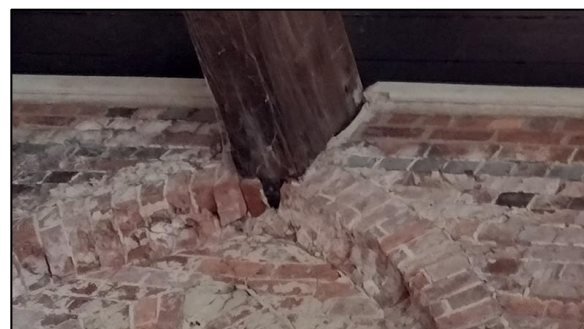
brickwork (Photos 5 and 6). There are gaps in the brickwork with missing bricks and/or missing sections of mortar (Photos 10 – 12). Some of these are openings to cavities within the wall, and were accessible these were examined with torch and endoscope. No bats or evidence of bats were found within, although the cavities are suitable for crevice dwelling bats and may be suitable for hibernation.

**Photo 5** Main beam as it ties into wall

**Photo 6** Main beam as it ties into wall

- Roof structure:
  - Designed timber propping to the high-level octagonal plate. – *No gaps suitable for bats.*
  - Steel brackets to the main roof beam. – *The roof beam is still in the same location, the timber has not been altered and gaps in brickwork have not been filled in.*

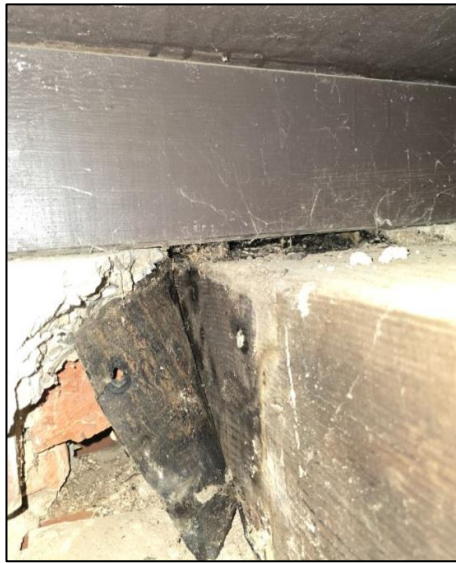
**Photo 7** Bricks removed to inspect beam decay

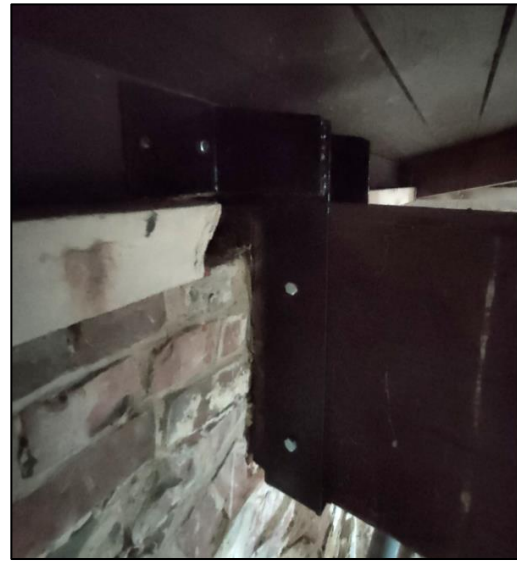
**Photo 8** Bracket in place, wrapping around beam end and bolted into timber wallplate

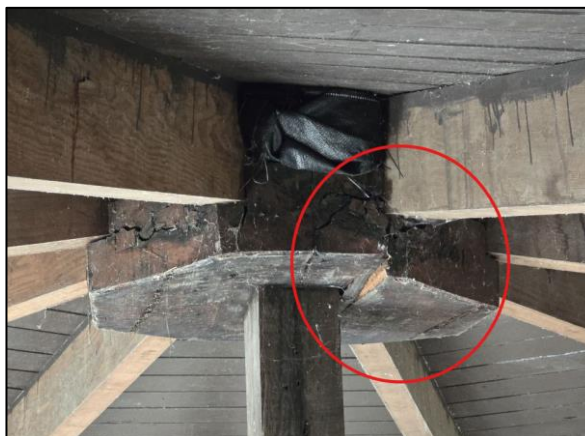
There is no internal void to the roof. The interior of the structure is a single room, open to the apex of the roof with bare brickwork with patches of plasterwork, stonework window frames with leaded windows (Photos 3 and 4). The ceiling is timber lined with exposed beams and a central octagonal roof plate (Photo 7). The roof plate had a displaced section of wood, but no suitable gaps for bats. The main beams tie into the

**Photo 9** Split timber at central octagonal roof plate

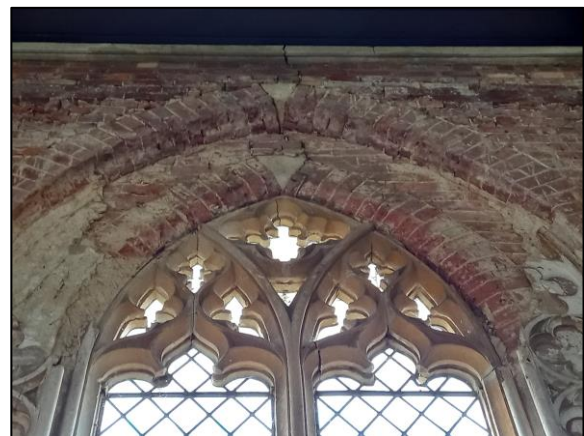
**Photo 10** Brickwork above window

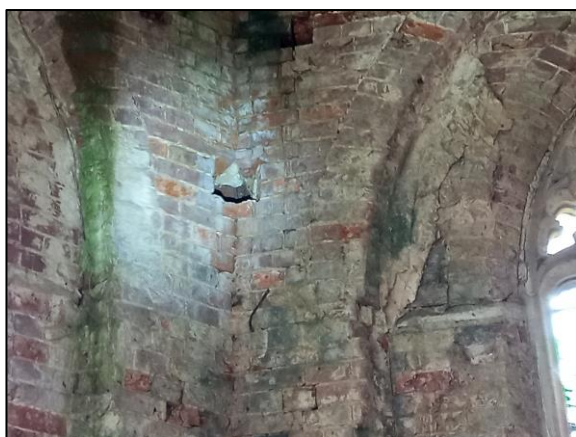
**Photo 11** Missing and crumbled brickwork in interior

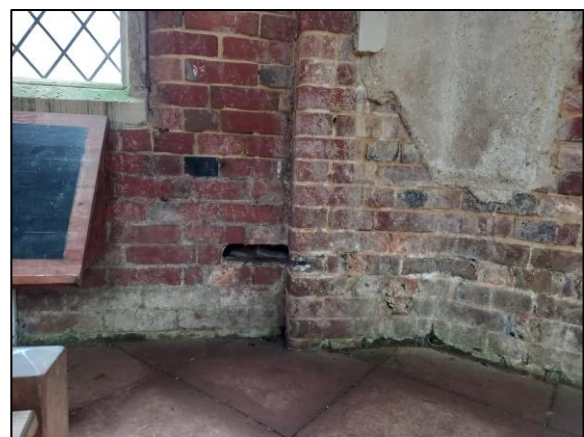
**Photo 12** Missing bricks in interior wall

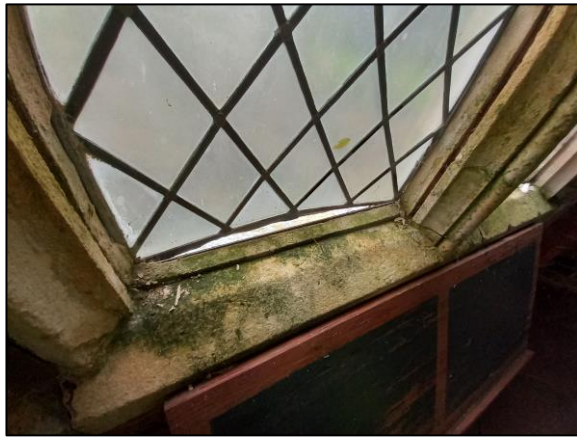
Access points into the interior of the structure are the door which did not appear to have significant gapping around the frame or between the door and the frame. The door is open during the daytime and closed at night. The windows are closed and do not open, and all but one was well-sealed with leadwork around the frames. One of the windows has a gap at the bottom of the frame (Photos 13 and 14). There are no curtains on the windows and the interior is well lit with natural light.

The gap in the window frame is unlikely to be suitable access/egress into the interior for bats due to the low location and position over a flat surface.

**Photo 13** Interior image of gap to bottom of window

- Secure loose glass windows using lime mortar putty. – *Gap not suitable for bat access.*

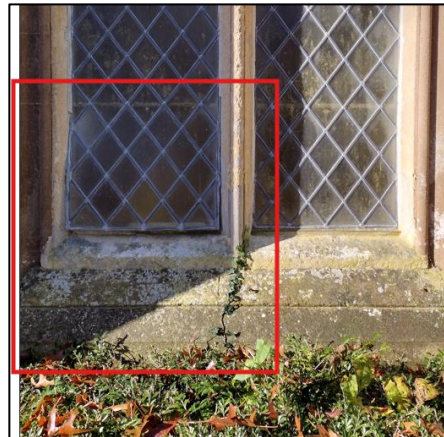
The building is brick with render on some of the sections (Photos 1, 2 and 15). The brickwork is generally in good condition and there are some cracks in the render (Photos 15 and 16), although this appears too small to support roosting bats. There is a crenelated masonry parapet feature around the top of the building and single brick and render chimney. The leadwork around the windows is well sealed apart from one with gapping at the bottom (Photo 14).

**Photo 14** Exterior image of gap to bottom of window.

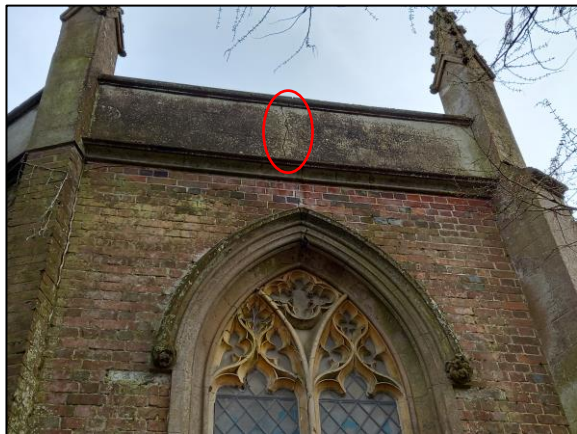
**Photo 15** Exterior showing brickwork and render sections and crack at upper level

- Fabric:
  - Like for like localised conservation and repairs of loose render to reduce the risk of falling masonry, and to reduce water ingress which may lead to further decay to the fabric. – *Cracks in render and masonry on exterior unsuitable for roosting bats.*

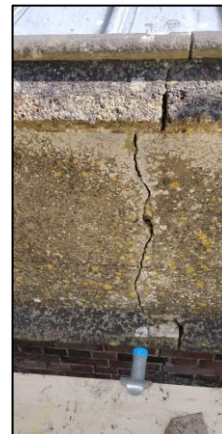
**Photo 16** Crack in high level masonry for repair – Face 2

- Masonry:
  - Structural repairs to a crack to Face 2 parapet wall. – *The crack was small and unsuitable for bats*
- Chimney:
  - Adapt chimney capping to prevent water ingress and promote water run-off. – *The chimney was not suitable for roosting bats due to exposure, damp and vegetation. Capping has vents which may allow access/egress to bats (see Photos 22 and 23).*

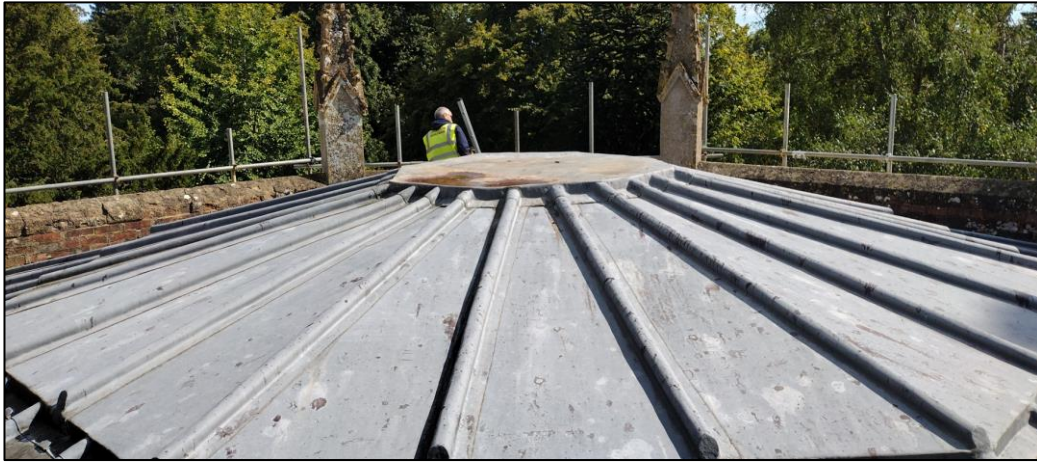
The photographs and drone imagery show that the roof of the octagonal structure is covered with lead which is rolled and folded with no gaps for ventilation (Photos 17 to 19). There is a gutter around the edges between the end bottom of the lead and the parapet walls. The chimney was uncapped, and the interior brickwork appeared to be filled with moss and vegetation (Photos 20 and 21).

**Photo 19** *Lead roof covering, rolled and folded with no ventilation*

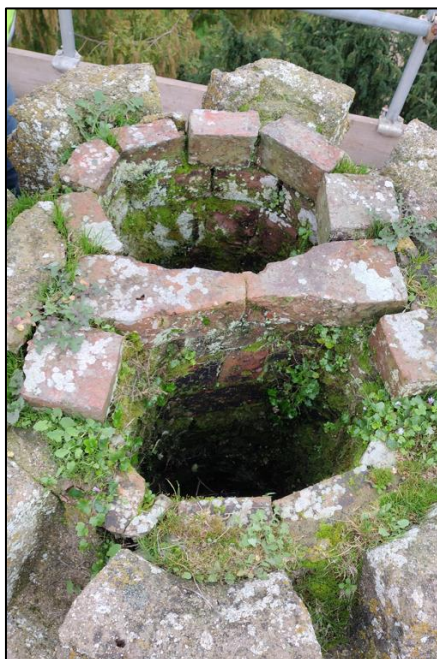
The exterior of the structure appears to have little in the way of suitable crevices with well-sealed bricks and stonework and cracks in the render that are too small to support roosting bats. The chimney – prior to capping, was exposed to the elements with a damp and vegetated interior not suitable for roosting bats. The leaded roof has no suitable features for roosting bats.

**Photo 20** *View of uncapped chimney*

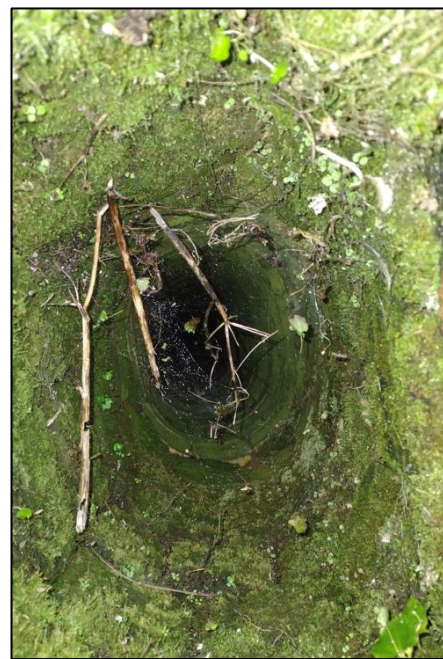
**Photo 21** *Interior of chimney*

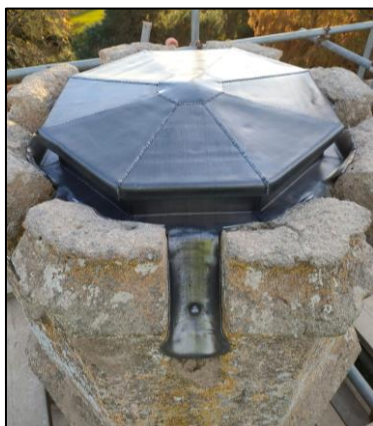
**Photo 22** *Chimney capping*

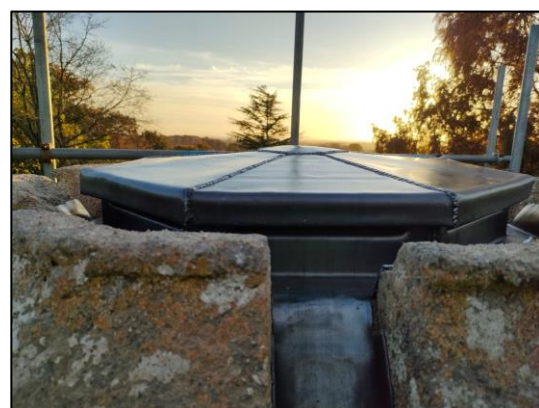
**Photo 23** *Ventilation feature in capping – approximately 200 x 20mm*
