## ARBORICULTURAL TECHNICAL NOTE (Updated 22.10.24)

Date: 24<sup>th</sup> March 2022  
To: Tilly Whinshaw – Redrow – Head of Planning  
From: Stefan Kowalczyk – RPS – Senior Arb Consultant  
Pages: 8 inc. this page  
Regarding: Tree Protection Fencing at Camp Field, Havant  
Updated: 22 October 2024 – Ross Carthew - RPS Senior Arb Consultant

### Inspection of Tree Protection Fencing at Camp Field, Havant

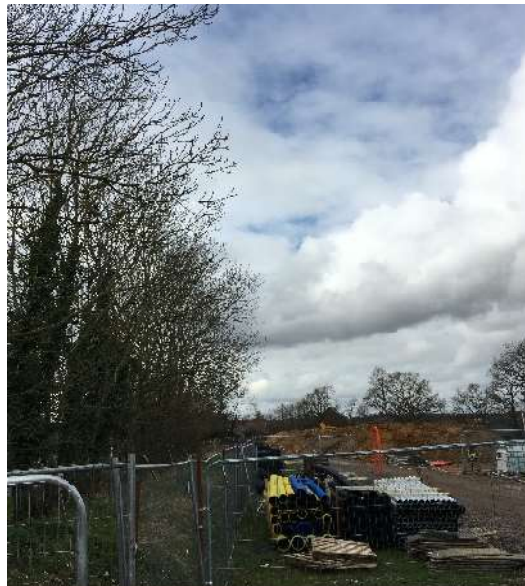
Trees in this section are relatively low quality and located on the southside of a pre-existing bund. Therefore, rooting activity to the north is likely to be restricted.

The Tree Protection Fencing (TPF) looks to be slightly closer to the tree stems than specified on the Tree Protection and Removal Plan.

However, given the quality of trees (Category C) and their situation – on the southside of an existing bund, retaining the TPF in its current location is low risk and similarly, adequate to protect the likely rooting area of the relevant trees.

Figure 1. View looking westwards. Bartons Rd to the left.

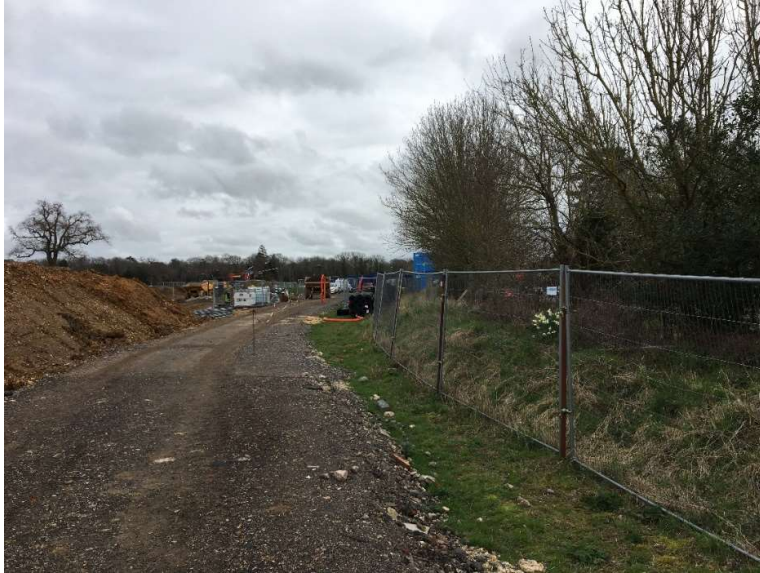
Figure 2. View looking eastwards. Bartons Rd to the right.

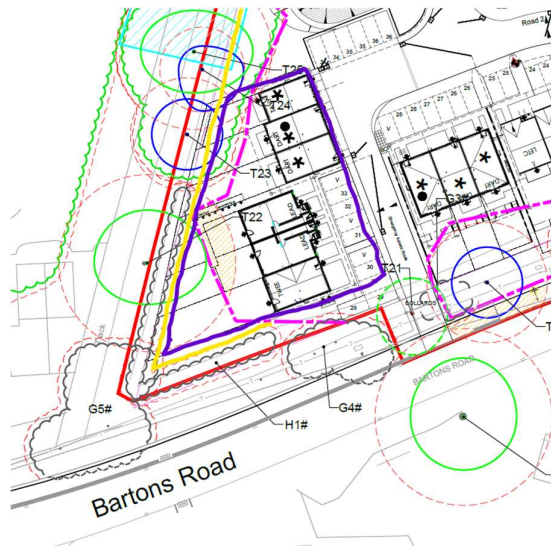
G4# and H1# is a continuation of the southern boundary tree line and is of no particular merit. T22, Oak, on the other hand is a high-quality tree with a large RPA located on the western boundary. TPF is currently positioned incorrectly and a materials storage compound has been erected in this area with “pilling mat” surfacing, a concrete slab supporting 3 mortar silos and an external wooden fence.

- 1) Yellow line represents the current location of TPF.
- 2) Pink/Magenta (dash dot) line represents the approved location of TPF.
- 3) Purple line represents the approximate extent of the existing compound.

Figure 3. Snapshot of approved Tree Protection Plan with approximate current compound location added.

The construction of the compound does not align with the approved TPP and any damage resulting from its development has already occurred. Fortunately, the impacted trees are situated behind an established drainage ditch, constraining potential root interference to the East and, consequently, mitigating the extent of potential damage.

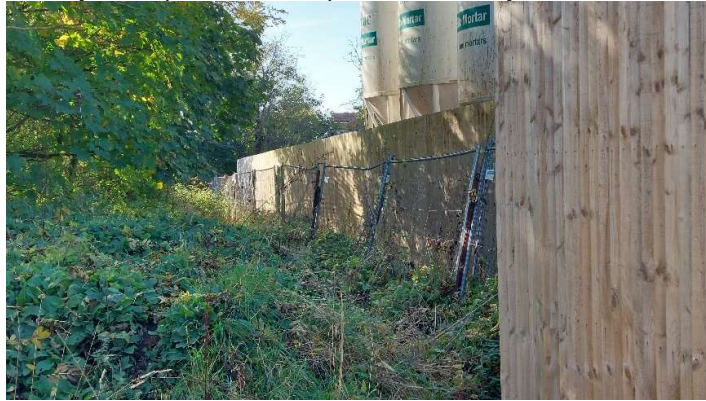
Additionally, the Tree Protection Fencing running adjacent to H1# looks to be in poor condition and possibly a little closer to the trees than it should be. There is however a close board fence erected behind this which currently forms part of the compound which may be used as Tree Protective Fencing.

Figure 4. View looking westwards. G4 on the left side of the picture.

- 1) Notices should be placed at regular intervals, along the compounds south and west close board fencing, to denote that this fencing is to be considered Tree Protection Fencing (See examples in Appendix 1). This fencing should then remain in place until all other work are completed. The Heras fencing should also remain in situ until build is complete.
- 2) Area should be returned to soft landscaping immediately after the construction yard is removed.
- 3) Monitor the ongoing health of T22. June 2024 photograph shown below.

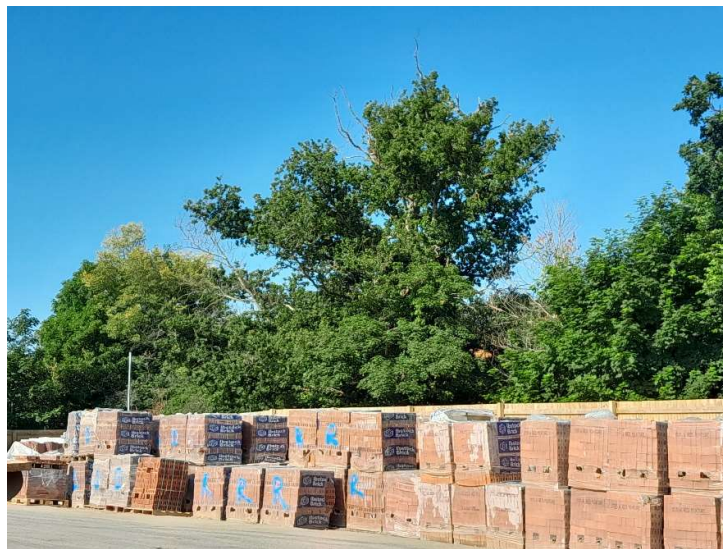
Figure 5. View looking westwards. T22 on the right side of the picture.

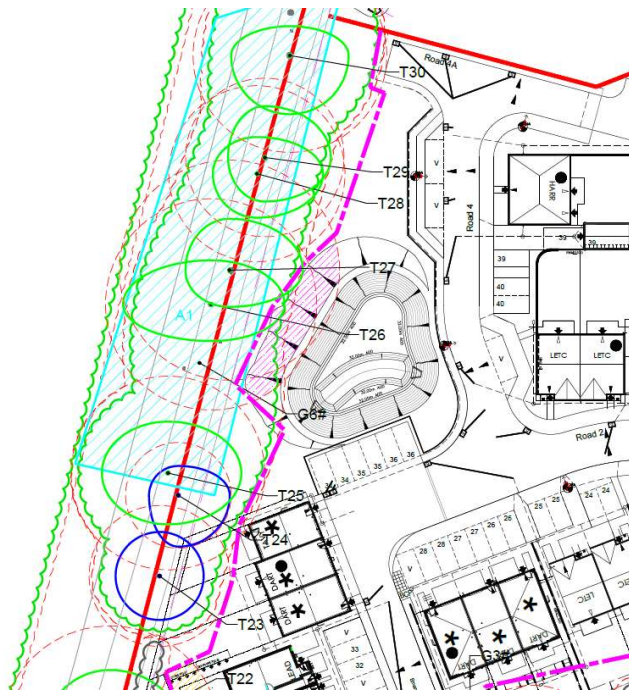
TPF is currently located in an adjusted location to that found on site previously and is now nearer to the approved location as detailed on the Tree Protection Plan. The TPF broadly follows the canopy extent or 'drip line' of the mature Oak trees.

There is an existing ditch within the RPA on the eastern side of the stem which may limit shallow rooting to the east somewhat. However, given the age and stature of these trees it is highly likely that roots have occupied the land east of the existing ditch.

Stored topsoil within the RPA has been removed back to the existing fencing line. Some minor levels of spoil / sub-soil still lie inside of the newly established CEZ, however the depth and extent of these materials would not appear to be significant.

Figure 6. Tree Protection Plan showing trees along western boundary

- 1) Remove remaining spoil from construction exclusion zone back to existing levels. This should be done using appropriate hand tools. Where possible, the use of machines with a long reach should be favoured, if they can work from outside of the RPA. Removal of the spoil shall occur in strips working from the undisturbed surface, working in a retreating manner away from the retained tree. No reduction in levels of the underlying soil surface shall occur with RPA's.
- 2) Once the spoil has been removed sub-soil aeration will be carried out by an approved contractor using compressed air to decompress soil. This will be done at 1 meter centres along the area previously covered with spoil.
- 3) During the decompaction process, soil amelioration will be undertaken by injecting bio char, mycorrhizal fungi and/or tree fertiliser and bacteria into the soil, along with the air.

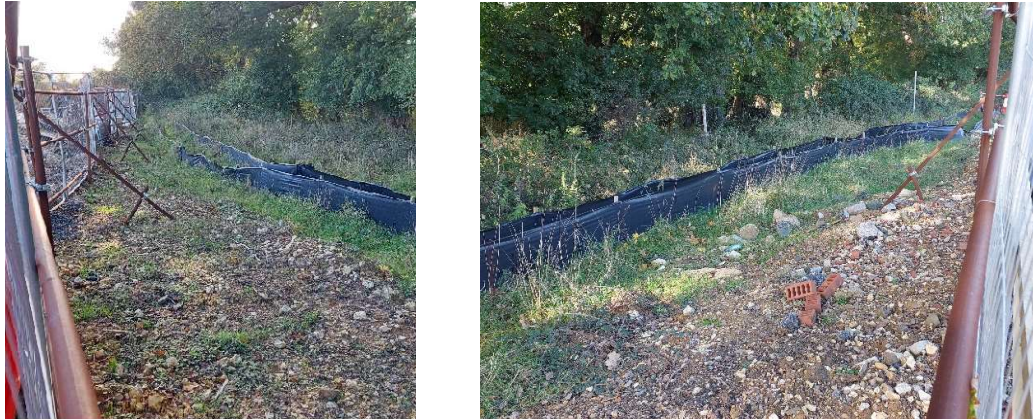
Figure 7. View looking south and north. Western site boundary of the development.

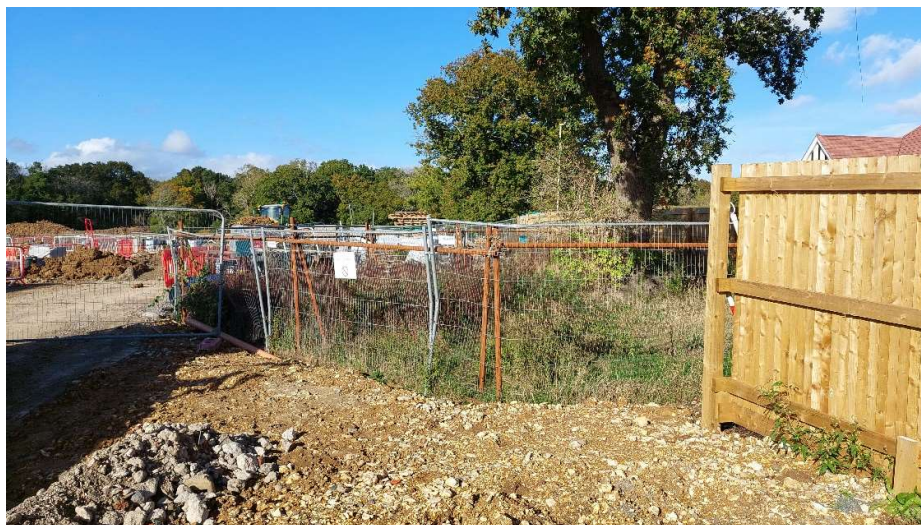
A large mature (TPO'd) Oak located within the central part of the site. TPF looks to be inadequate to protect the RPA and the outer edges of the RPA have been built up to form temporary construction access. This has then been compacted by site traffic. The newly constructed cycle path to the east of the tree was also supposed to be "No-Dig" construction and does not appear to be.

Figure 8. T22 - view looking north

- 1) Tree Protective Fencing position to be checked and realigned in line with the approved Tree Protection Plan.
- 2) The built-up temporary access track within the RPA shall be manually broken up and removed from the RPA using appropriate hand tools. Where possible, the use of machines with a long reach should be favoured, if they can work from outside of the RPA. Removal of the spoil shall occur in strips working from the undisturbed surface, working in a retreating manner away from the retained tree. No reduction in levels of the underlying soil surface shall occur with RPA's.

- 4) Once the spoil has been removed sub-soil aeration will be carried out by an approved contractor using compressed air to decompress soil. This will be done at 1 meter centres within the RPA.

- 5) During the decompaction process, soil amelioration will be undertaken by injecting bio char, mycorrhizal fungi and/or tree fertiliser and bacteria into the soil, along with the air.

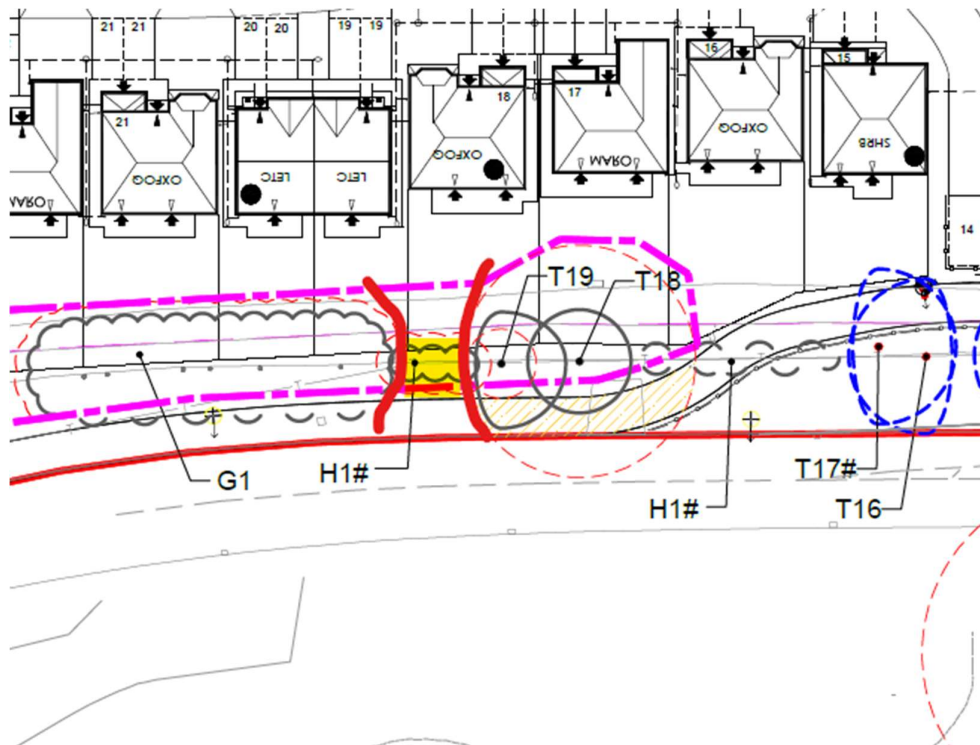
A section of H1# has been removed and an access road has been installed in its place. This detail was not included within the Tree Protection Plan however, the impact to existing trees is likely negligible. Exact impact to the east end of G1# is however unknown – tree roots could have been severed and/or negatively impacted without prior consideration due to the excavation and installation of a subbase.

Figure 9. Section of H1 removed highlighted in Yellow and approximate location of installed access road shown with red lines.

TPF has not been installed in accordance with the Tree Protection Plan however, it is generally adequate for the same reason expressed within section 1.1 of this note.

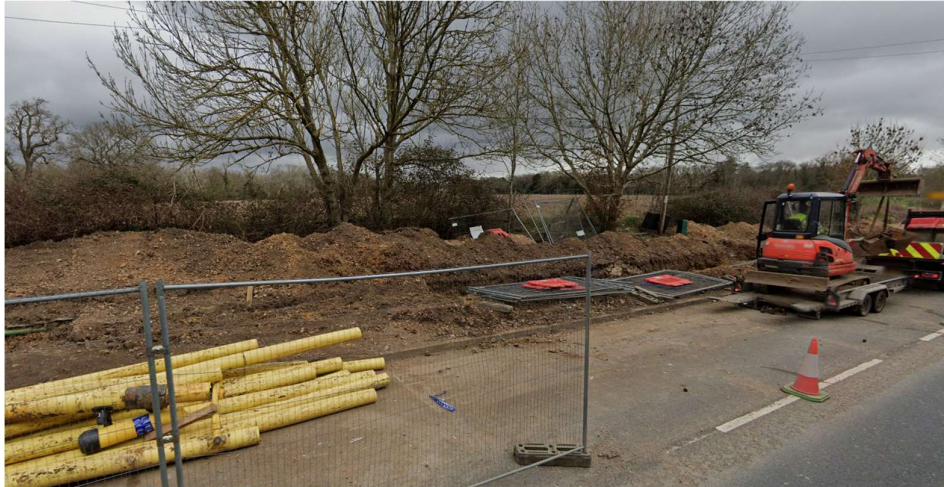
Figure 10. Image taken from Google Streetview showing previous utility works.

This work will have severed the roots of T18 & T19 back from the proposed cycle path negating the need for “No-Dig” construction, additionally T18 was highlighted for removal following the works, due to concerns over its future stability with the utility works having affected a large amount of its southern RPA, and has now been felled. These changes to the design and construction of the cycle path were picked up in a separate, cycleway specific, AIA (JSL3850\_781A) and shown on its accompanying Tree Protection Plan (JSL3850\_715A), as shown below:

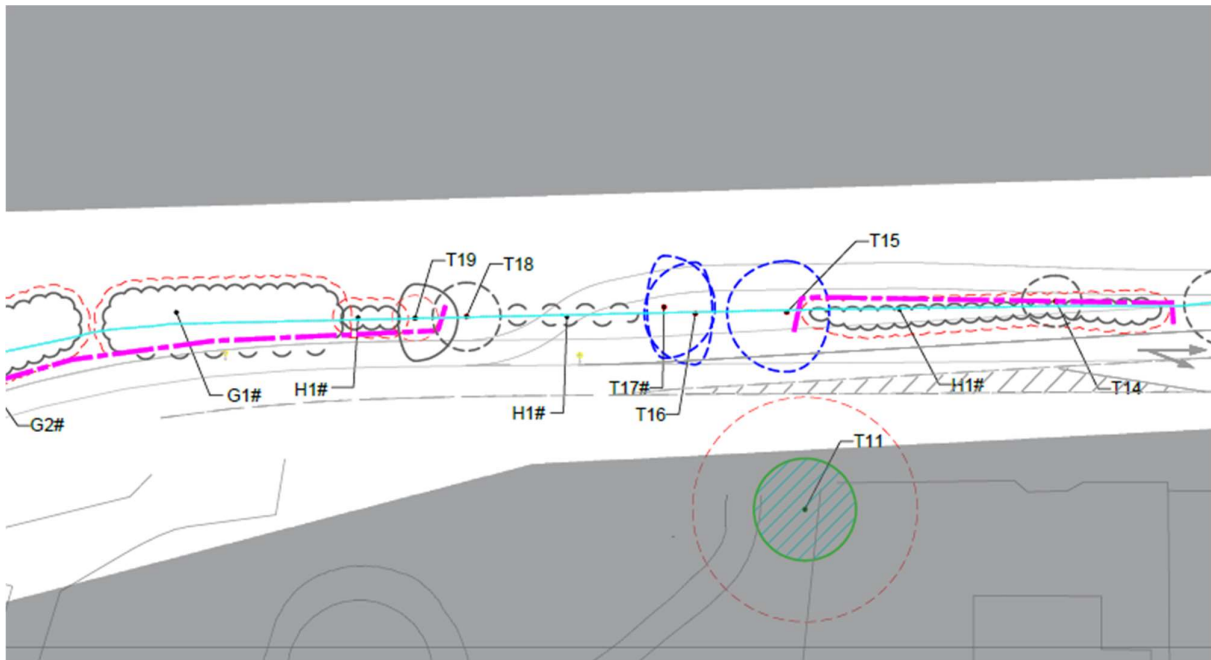
Figure 11. Extract of JSL3850\_715A showing revised tree protection/ removals proposed for cycle path construction.

Hedgerow H1# shown in Figure 11 above has been removed. Redrow have proposed the replanting of this hedgerow to the council and are in discussions with Highways.

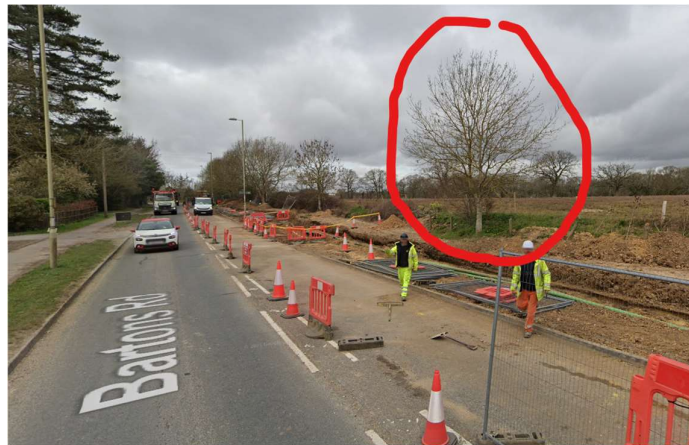
T13 has been removed. There is no remaining evidence of the tree other than its roots. The stump has been removed. Ownership of this tree was initially unclear; the tree has since been confirmed as within Highways Authority land. It was initially discussed that the tree may have been felled without consent and that it may have required a retrospective CAVAT assessment. On further investigation, this tree was shown to be removed in the planning-approved documents as well as the agreed S278 designs. It was removed in line with the planning approval and s278 agreement, therefore, no commuted sums should be payable.

Figure 12. Google St view, Mar 2021, showing T13

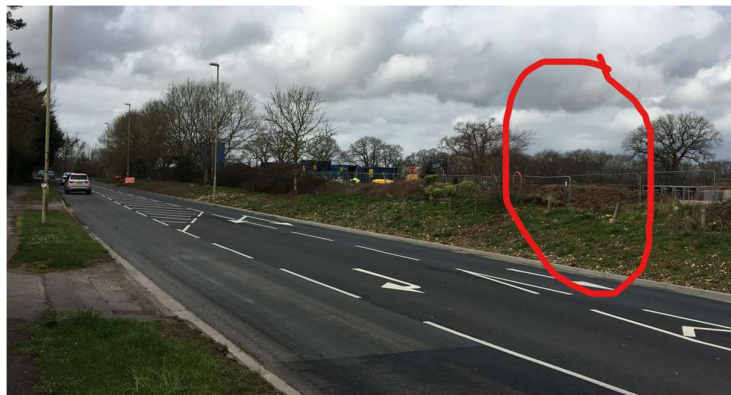
Figure 13. Current image taken 14th Mar 2022. T13 missing
