## **Visual Tree Assessment Report (VTA)**

**LAND AT MONTEREY DRIVE,  
HAVANT, HAMPSHIRE**

**PERSIMMON HOMES SOUTH COAST**

**Report Number: MB221111**

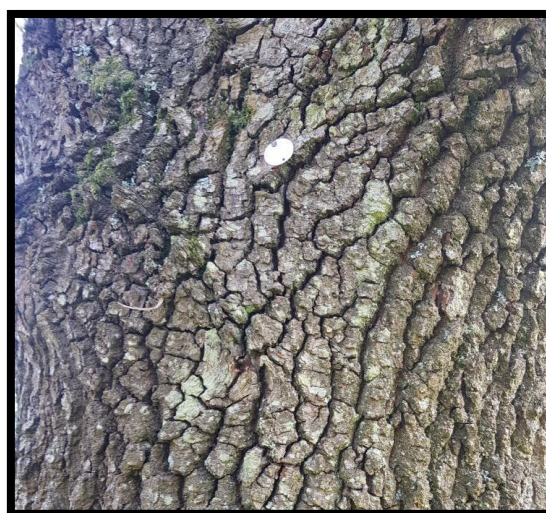
**Plate 1: Tag nailed to stem.**

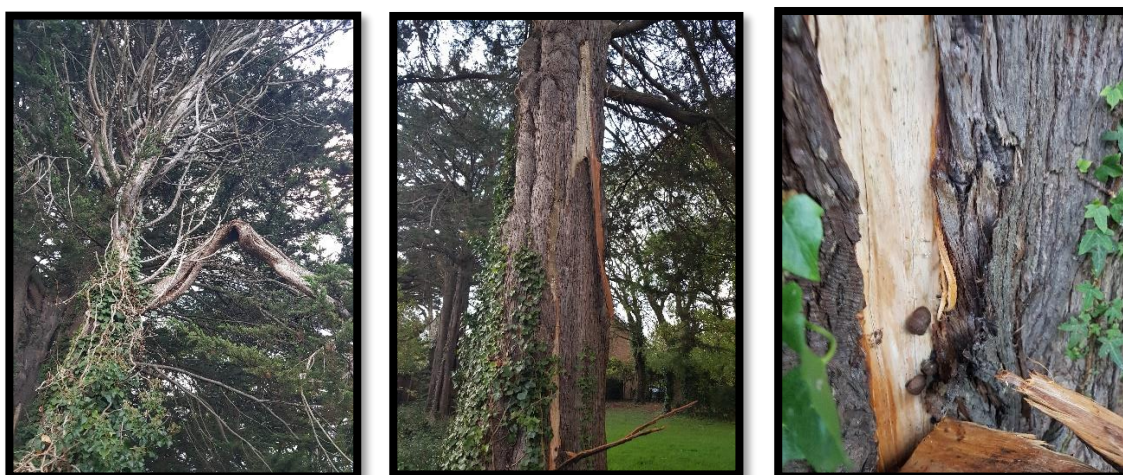
**4.1.6** All of the trees exhibited storm damage with stress fractured branches, suspended branches and major hanging deadwood. In addition, one tree was observed to have shed bark and a stress fracture of the stem was recorded. Two trees have been identified for removal due to their condition. The remaining trees all require remedial work to remove the dead, and dangerous branches. A montage at Plate 2 indicates some of the work required.

**Plate 2: Montage of storm damage.**

The works to make these trees safe are exempt a Planning Application for trees that are subject of a Tree Preservation Order as they are deemed dangerous.

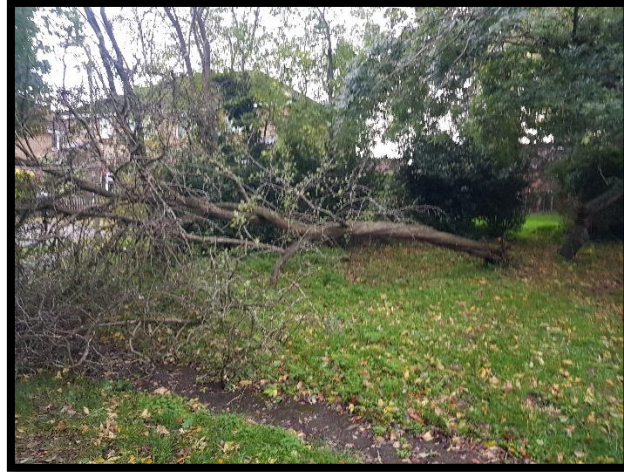
**4.1.7** A cursory inspection of the trees surrounding the park recorded a windthrown tree that was obstructing a footpath. This should be removed. It is deemed safe and not urgent.

**Plate 3: Windthrown tree.**
