# **Gristwood & Toms Tomograph Decay Investigation Report**

**T001: Mature Oak  
St Marys Car Park  
Hayling Island  
PO11 9BY**

**15<sup>th</sup> April 2024**

**Author: Jim Mead Tech Cert (Arb) FdSc (Arb)  
MArborA.**

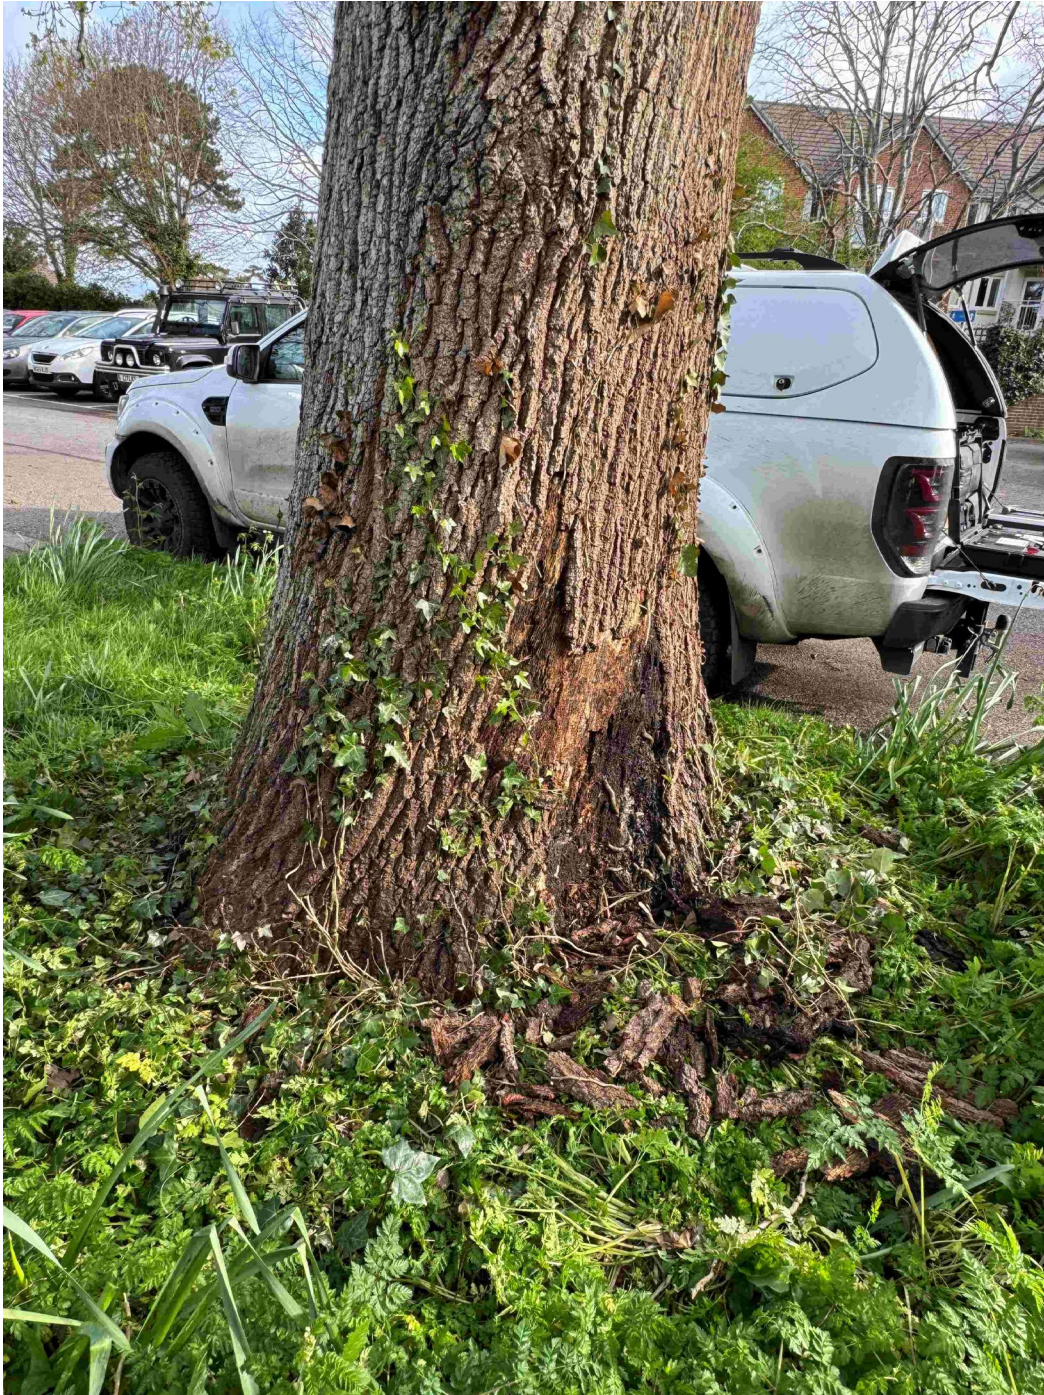
Mallet sounding of the trees stem confirms extensive bark delamination and necrotic cambial tissue throughout the southern elevation, exceeding 1.5m wide at ground level and extending up to in excess of 2.5m. There are small areas of dark staining/exudation, consistent with colonisation by *Armillaria* spp. (Honey Fungus) decay pathogen, along with significant frass, from boring insects colonising the dead bark.

**Fig. 9: T001 Stem viewed from the south.**

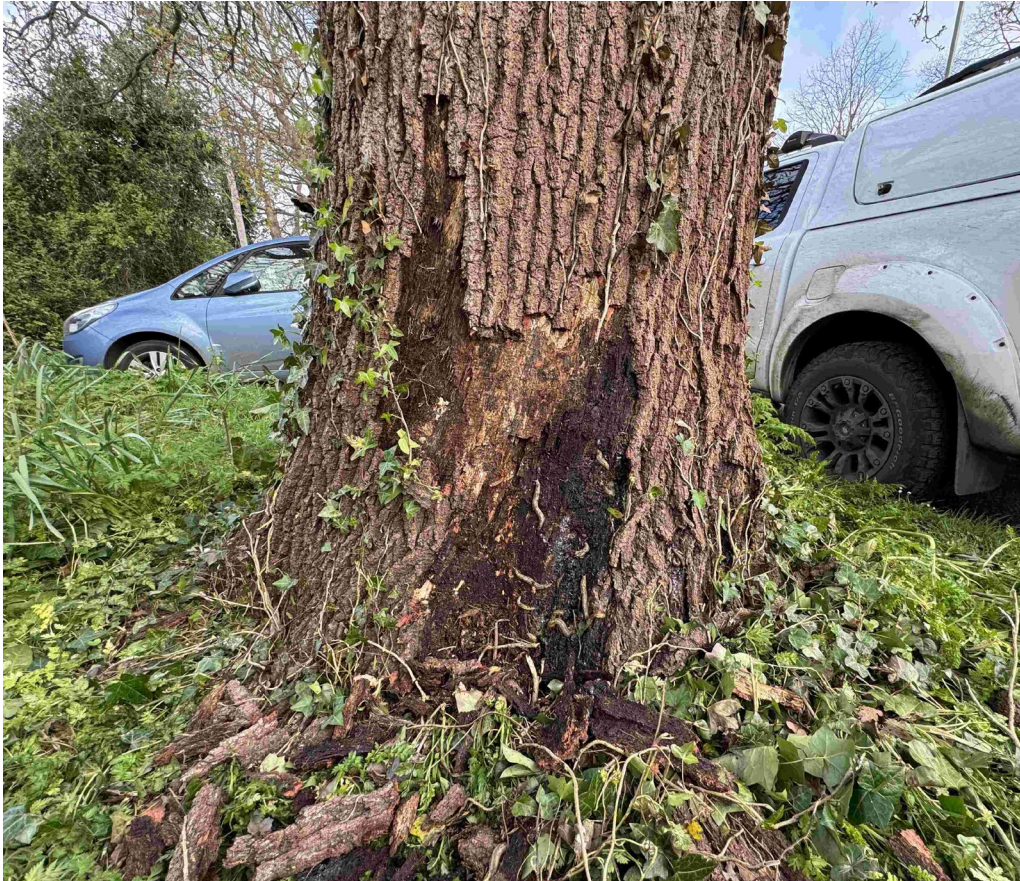
Removal of an area of the dead bark to the tree's southern quadrant, exposed significant necrotic cambial layer along with Rhizomorphs and Mycelial layers. The exposed heartwood was all confirmed to be solid. Probing into the soil around the base of the tree did not indicate the presence of any subterranean decay, or basal cavity.

**Fig. 11: T001 Area of removed dead bark.**

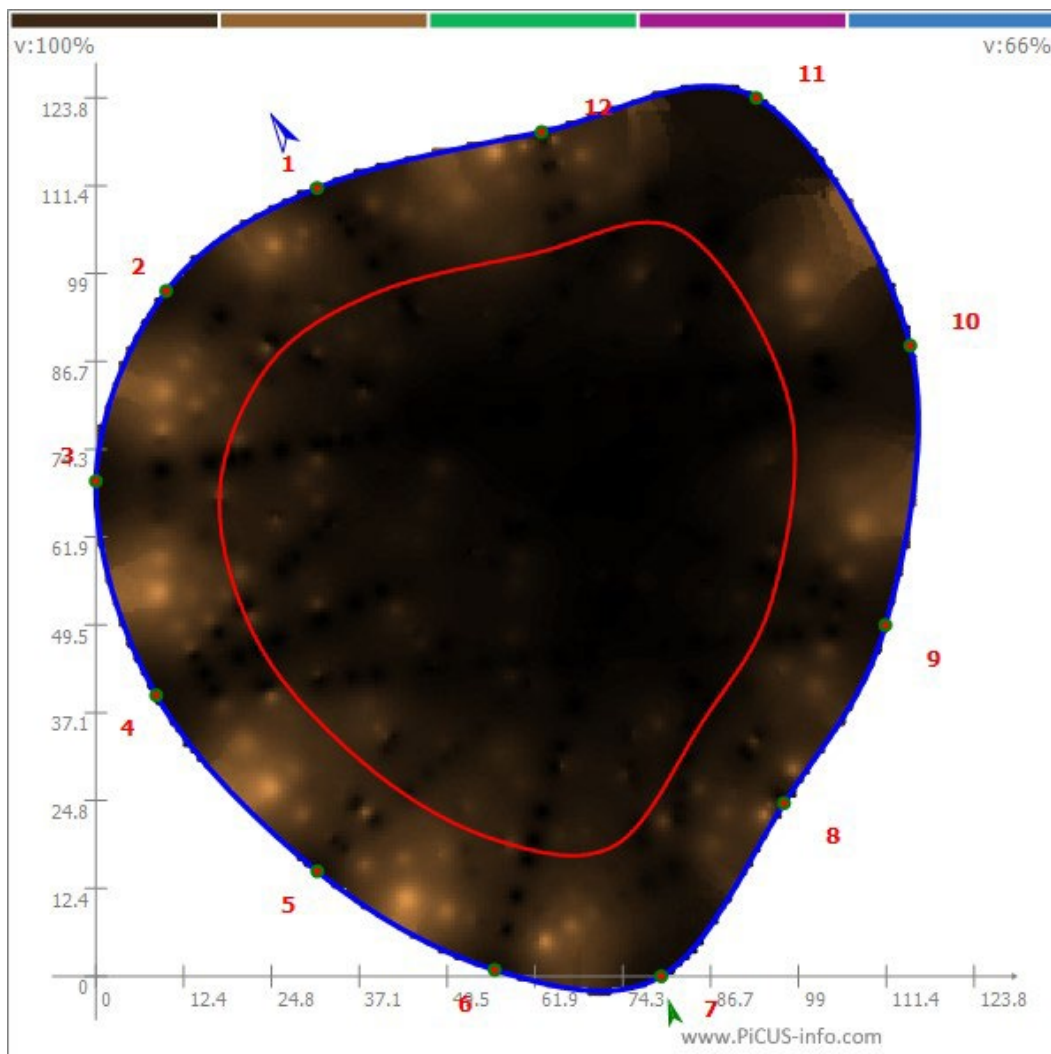
Fig. 17: T001 Tomograph at approx. 10cm above GL.

Neither of the subject tree's test levels depicted any discernible decay, and I saw no evidence to suggest that further Ultra-Sound and or Micro Drill testing would be of benefit. The acceptable residual wall thickness is intact throughout the stem radii at each level, with no indication of compromised structural integrity due to decay.

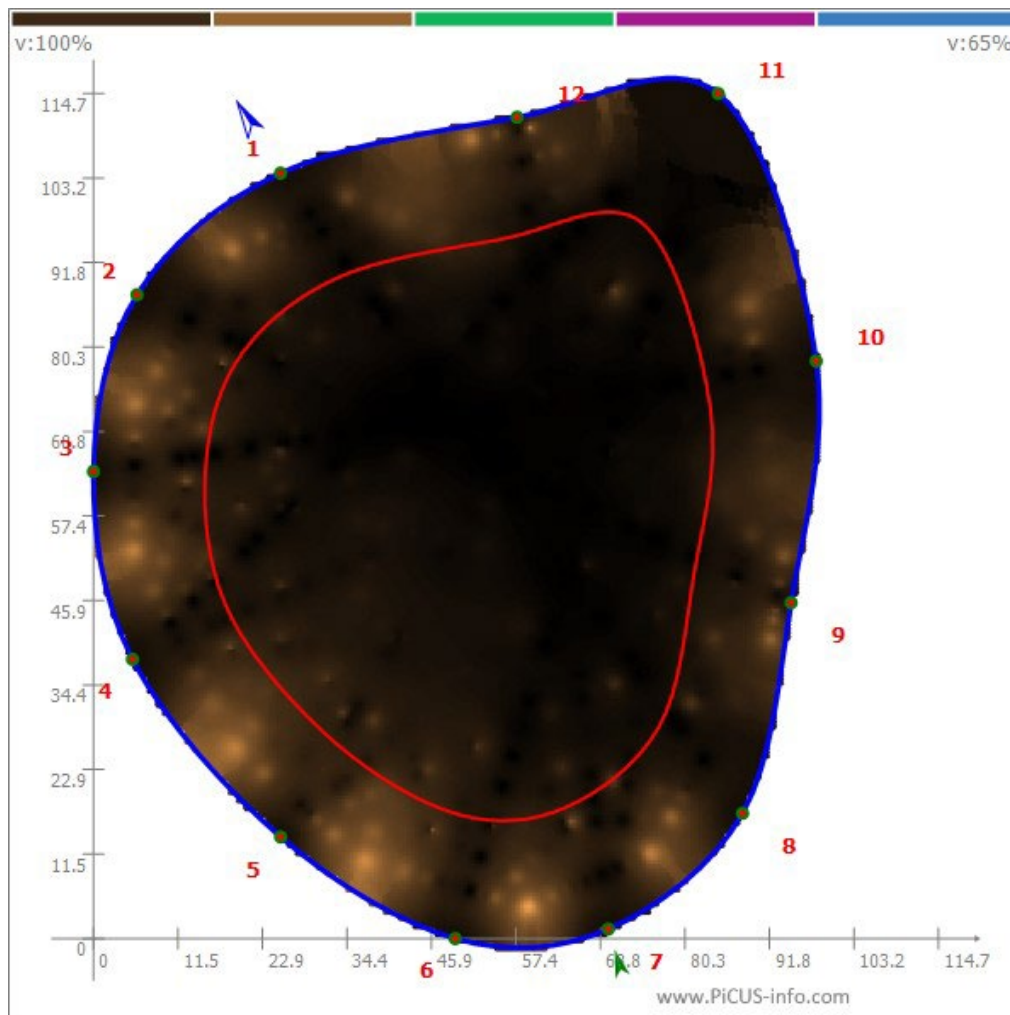
**Fig. 18: T001 Tomograph at approx. 25cm above GL.**
