## **Resistograph Tree Report**

**Vivid Housing Limited**

**Rear of 22-34**

**Prepared by  
Richard Daubeney Our Ref 0624-RD  
12th of June 2024**

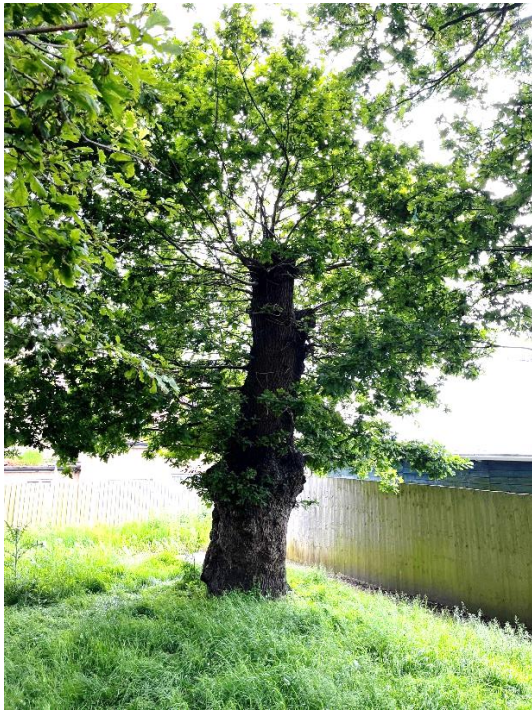
- 5.3 T3172 English oak tree, following the testing carried out to the tree, the results show that there is major hollowing within the central area of stem, however, reading 3 and 4 showed some moderate areas of live sound wood still present. The tree has fruiting body *Laetiporus sulphureus* (Chicken of the Woods) located on the stem to the East side at 20cm above ground level. The fungus is known for stem hollowing and can lead to brittle fracture. The tree has been heavily pollarded, resulting a significantly reduced stem, this in turn is reducing the risk to the immediate area. However, the tree has put on significant dense regrowth throughout, likely a response growth since the pollard was carried out.

**T3172 English oak looking South.**

- 6.1 Following the results of T3172, T3173, T3174, T3177, T3178, T3179 English oak trees mentioned within this report, we now provide our conclusions.
- 6.2 The testing to T3172 English oak tree has shown that there is a significant hollowing present within the stem, however with there are areas of sound wood present within the heavily reduced stem, including the noted fruiting body of *Laetiporus sulphureus* (Chicken of the Woods) located within the cavity. The risks have been reduced due to the historic pollard. Therefore, based on this information, and targets such as buildings, public footpath all within striking distance of tree, we advise that the tree is repollarded with removal of all

growth. Once completed, this can then be continually managed as a low pollard and monitored again as part of the next inspection to ensure no change to health or condition.

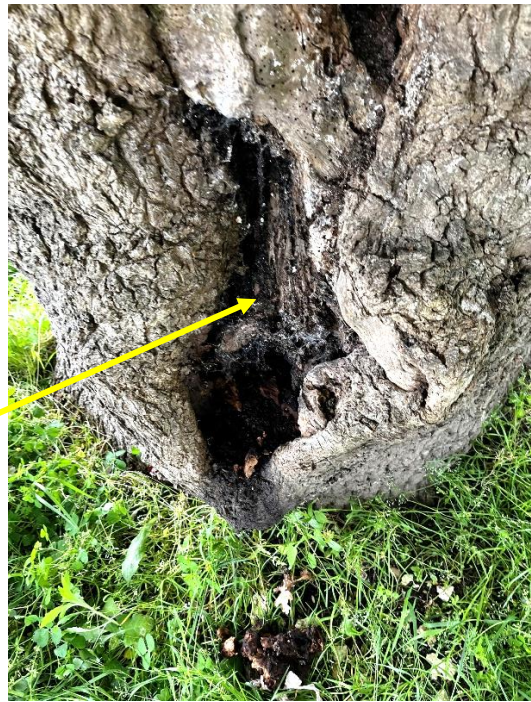
**T3172 English oak tree looking to West towards cavity location.**

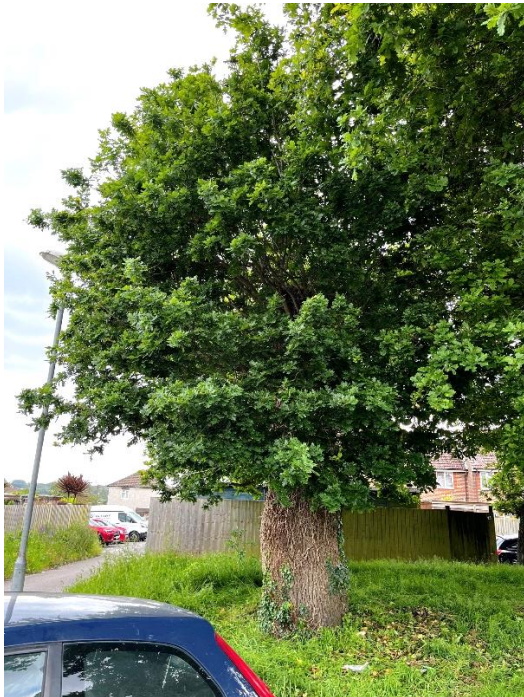
- 5.4 T3173 English oak tree following the testing carried out to the tree. This was found to have advanced decay within the stem, the presence of Fruiting body *Laetiporus sulphureus* (Chicken of the Woods) was noted to the West side of the stem, this is likely linked to the internal decay present within the stem. The stem has significant hollowing similar to T3172, with minimal residual wood remaining. However again similar to T3172, T3173 has dense coverage of regrowth formed all round. The tree has been historically and heavily pollarded, which in turn has reduced the risk to the immediate area of the tree.

**T3173 English oak looking West**

- 6.3 The testing to T3173 English oak tree highlights significant hollowing within the stem and including the fruiting body of *Laetiporus sulphureus* (Chicken of the Woods) attached to the stem cavity area. As the tree has produced significant regrowth, and with target area of car park and public footpath within striking distance of tree. It is recommended a repollard is carried out to 5m above ground level. This will ensure that the tree has no further additional pressure added to the lower section of the stem and rooting area. This can then be monitored as part of next inspection to ensure there is no change to health and condition.

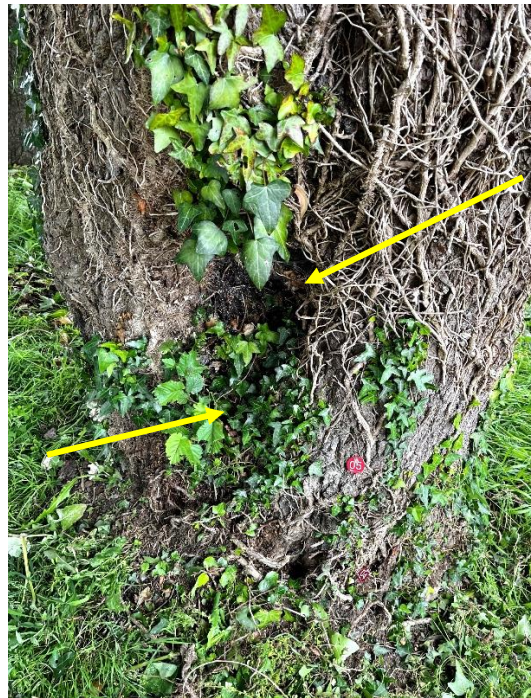
**T3173 English oak Looking East towards cavity**

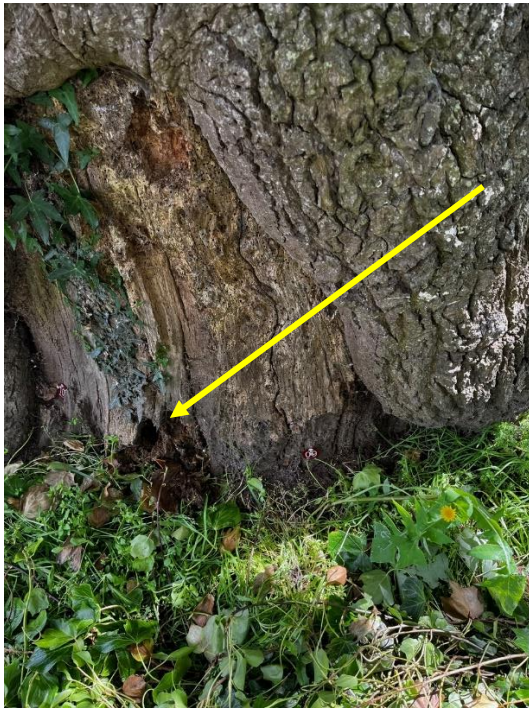
- 5.5 Following the resistograph testing of T3174, it is noted that there is column of decay and cavity within the central area and towards the North and West sides, which in turn link with the external wounds to the stem. Since the last testing was done on this tree, the decay present within the stem has not deteriorated significantly. The remaining sound live wood is moderate within the stem. The tree has had a reduction to the crown following the previous testing on this tree, which has shown to have good coverage of regrowth formed from the previous pruning points.

**T3174, English oak looking South towards basal cavity**

- 6.4 Following testing of the T3174 English oak tree, it is concluded that there is suitable live sound wood present within the stem. However, the large basal cavity located to the Northeast side of the stem is of an ongoing concern, and this is applying pressure to the rooting area of the tree. Although testing has been previously carried out on this tree, and the tree has responded well following the crown reduction. It is recommended that a further crown reduction is completed back to the previous pruning points of previous reduction, this would enable to keep the English oak tree at reduced height and limiting the risk to the immediate area.

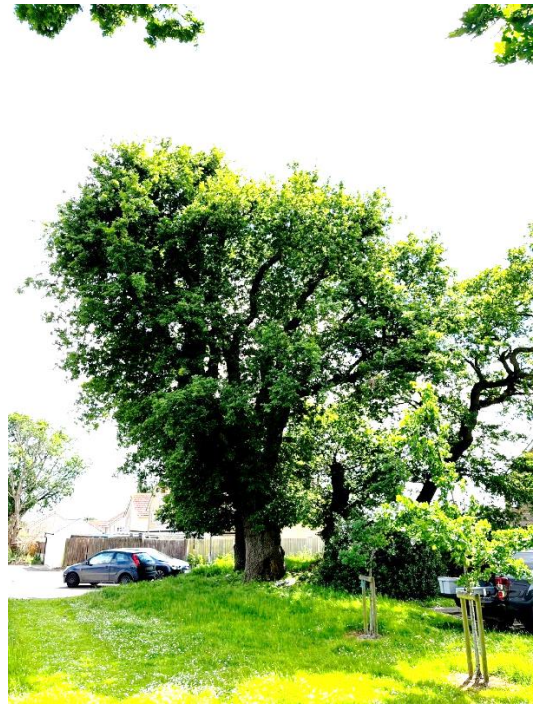
**T3174 English oak tree looking South.**

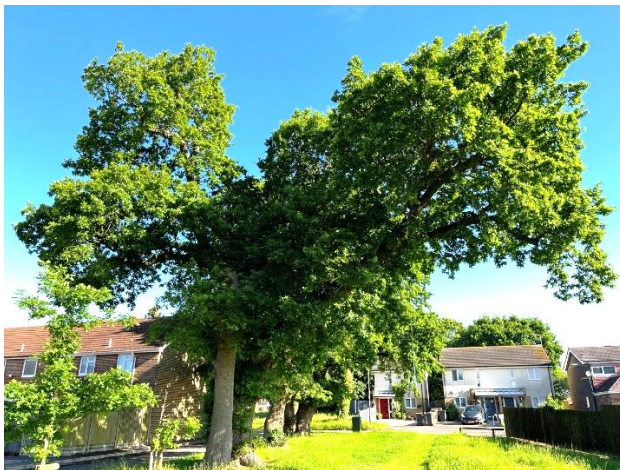
- 5.6 T3177 Mature English oak is twin stemmed at ground level. Both stems have large basal wounds to the West side, the Stem to the South has extensive column of decay, this is linked to the basal wound to the West following the testing. The tree has been previously tested and the tree was crown reduced as a result. The secondary stem to the North side, this was also tested and found that although there is a large basal wound to the West, the remaining stem surrounding the wound was found to have sufficient sound live wood present, with good areas of reaction wood noted within the readings. The tree is currently shown to have an unbalanced crown, with noticeable extensive stem leading out to the East side. The stem to the North has noticeable bleeding to the East side, this is likely to be considered bacteria related, however this is not significant at this stage, but will need to be monitored as part of the next inspection.

**T3177 English oak looking North.**

- 6.5 Following the testing on T3177, it is shown there is significant decay present within the secondary stem to the South side. This has been historically and heavily reduced in height following the previous testing of the tree. The other stem to the North side was shown to have basal wound to the West, although there is still suitable live holding wood present. When looking at the tree from a distance, it is noted the crown is heavily weighted towards the East side, this is applying pressure to the main stem. The tree is within target area of access road and buildings. Therefore, based on the information provided, we recommend that a crown reduction by 3m is carried out to the North side, the secondary pollarded stem to the South side requires a further reduction in height by 3m only. In doing this works will ensure that pressure is reduced to the lower section of the stem and rooting area.

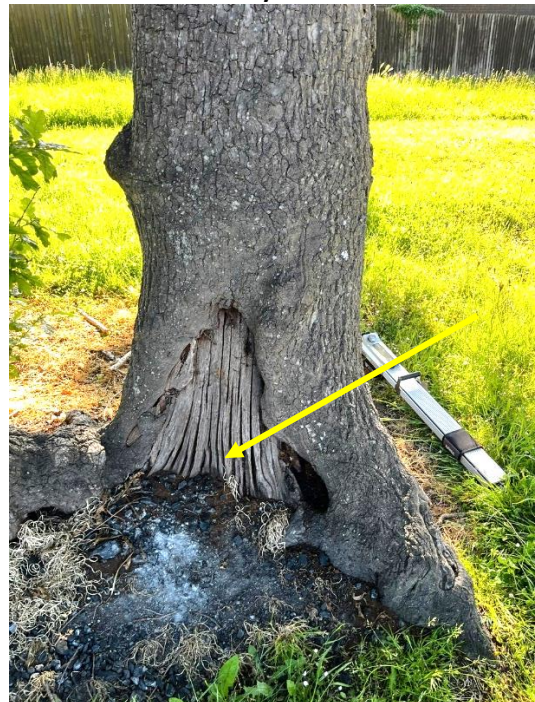
**T3177 English oak Looking East towards basal cavity area.**

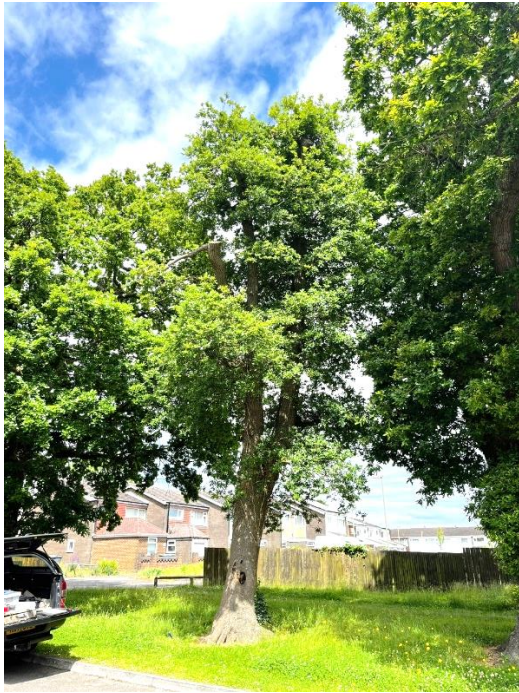
- 5.7 The results of the testing of T3178 English oak tree show that there is advanced decay present within the stem, as shown with readings 2 and 3, the decay is linked to the cavity based to the South side at 1.13m above ground level. The tree previously has been tested and the current results show moderate live sound wood remaining surrounding the cavity. The tree has previously been reduced in height.

**T3178, looking Northeast**

- 6.6 Testing to T3178 English oak has shown the condition of the tree focusing around the cavity on stem at 1.13m where there is a significant area of decay present. There is a further basal cavity to the North side but was found to have sufficient sound live wood surrounding the cavity from the results of the testing. The tree has been historically reduced in height following the previous testing in 2021, however consideration needs to be given for the tree location, with targets such as buildings, access road all within striking distance of the tree. Therefore, we recommend that a further crown reduction by 3m is carried out to height only, by doing so will continue to provide a staged and managed reduction process to the tree in height to limit the pressure to the cavity area and lower stem. We also recommend that the ivy is severed at ground level, to ensure future inspections of the stem can be carried out.

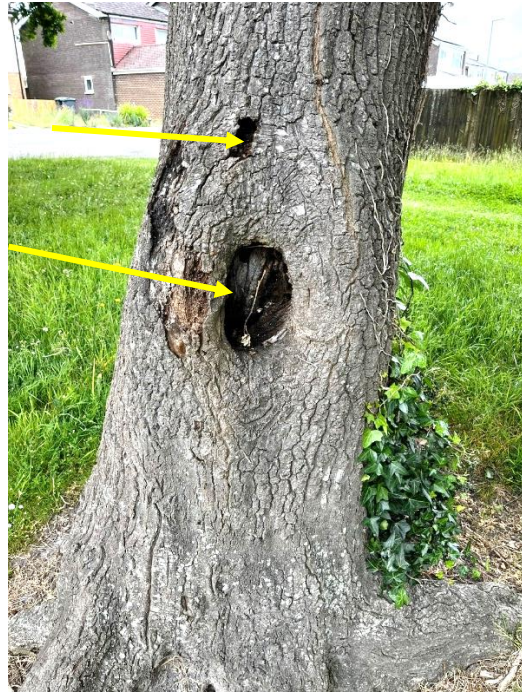
**T3178 English oak tree looking East towards cavity location on stem.**

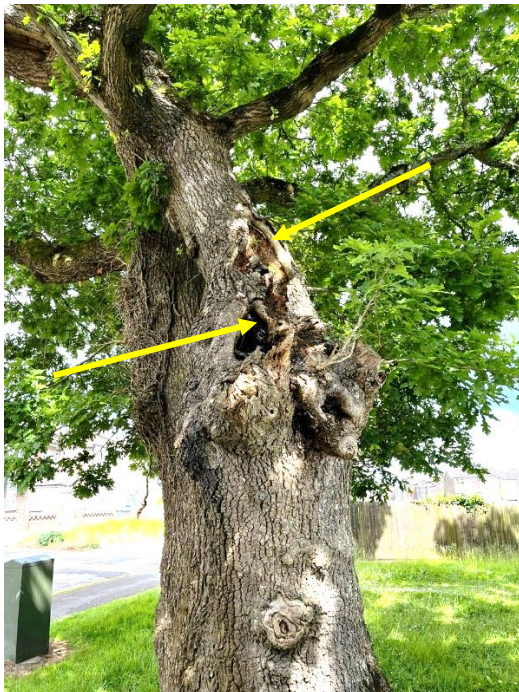
- 5.8 Based on the testing of T3179 Mature English oak tree, the results concluded were focused on the secondary stem to the West side above the main union, multiple cavities were noted on this stem with the main cavity at 2.5m with advanced decay noted. The testing showed moderate sound wood present within this stem, the decay is linked to the large, exposed cavity. The stem has grown out laterally to the Northwest side, which in turn has put increased pressure around the cavity areas on the stem. The remaining other large stem to East side and below the main union showed minor decay is present, the stem to the East is heavily weighted due to the formation of the two canopies growing together.

**T3179 English oak looking Southeast**

- 6.7 T3179 English oak tree has shown from the results, there is significant decay present within the secondary stem to the West, and the remaining other stem to the East is heavily weighted towards East side. The tree is within an area of targets such as main road, access road, public footpath all within striking distance. We recommend, based on this information, the following works, reduction to stem to West side by 4m. The stem to the East to be crown reduced by 2-3m all round. We also recommend the removal of the deadwood throughout the canopy, including the crown lifting over the main road to 6m above ground level. In carrying

out the reduction to the tree will reduce the pressure to the stem with the cavity, and the reduction to the other stem will ensure that the tree retains a balanced canopy.

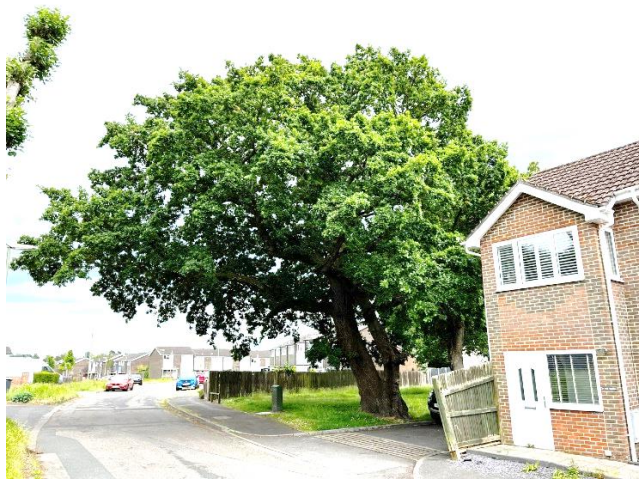
**T3179 English Looking North**

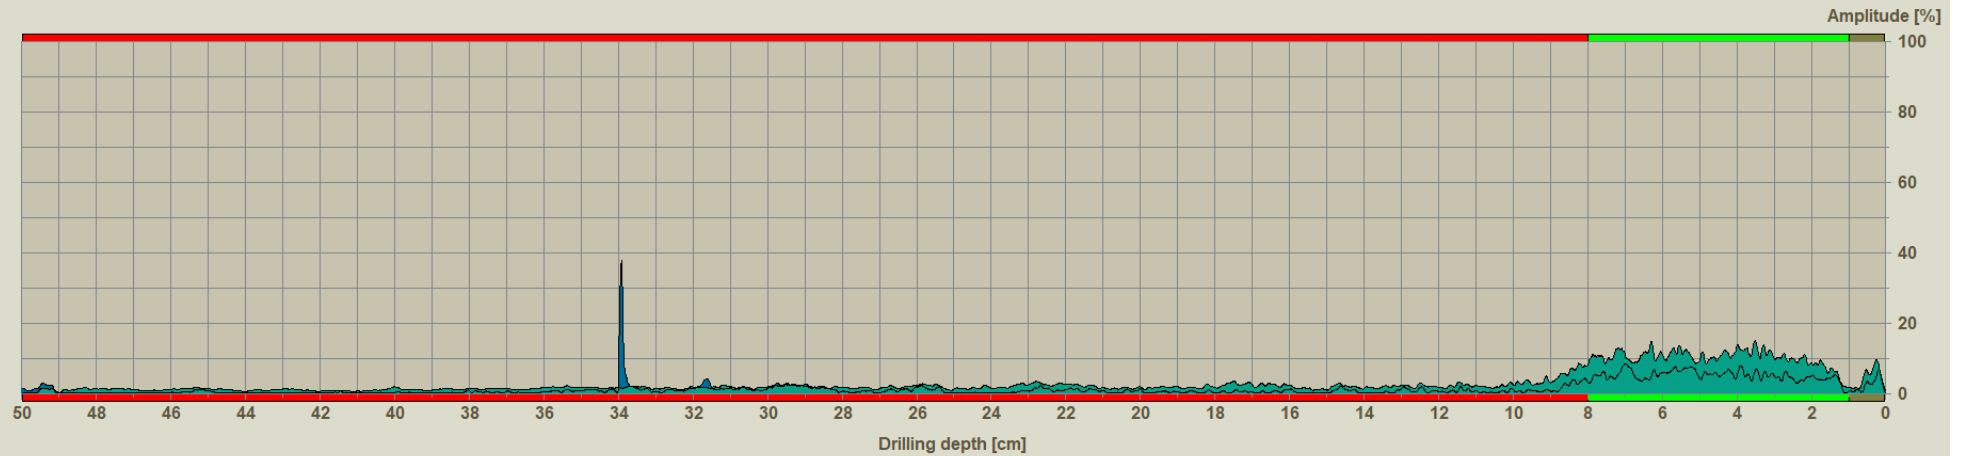
### T3172 English oak measurement 1

| ■ | From 0,00 cm to 1,00 cm | : Bark |
| ■ | From 1,00 cm to 8,00 cm | : Sound wood |
| ■ | From 8,00 cm to 50,00 cm | : Decay |

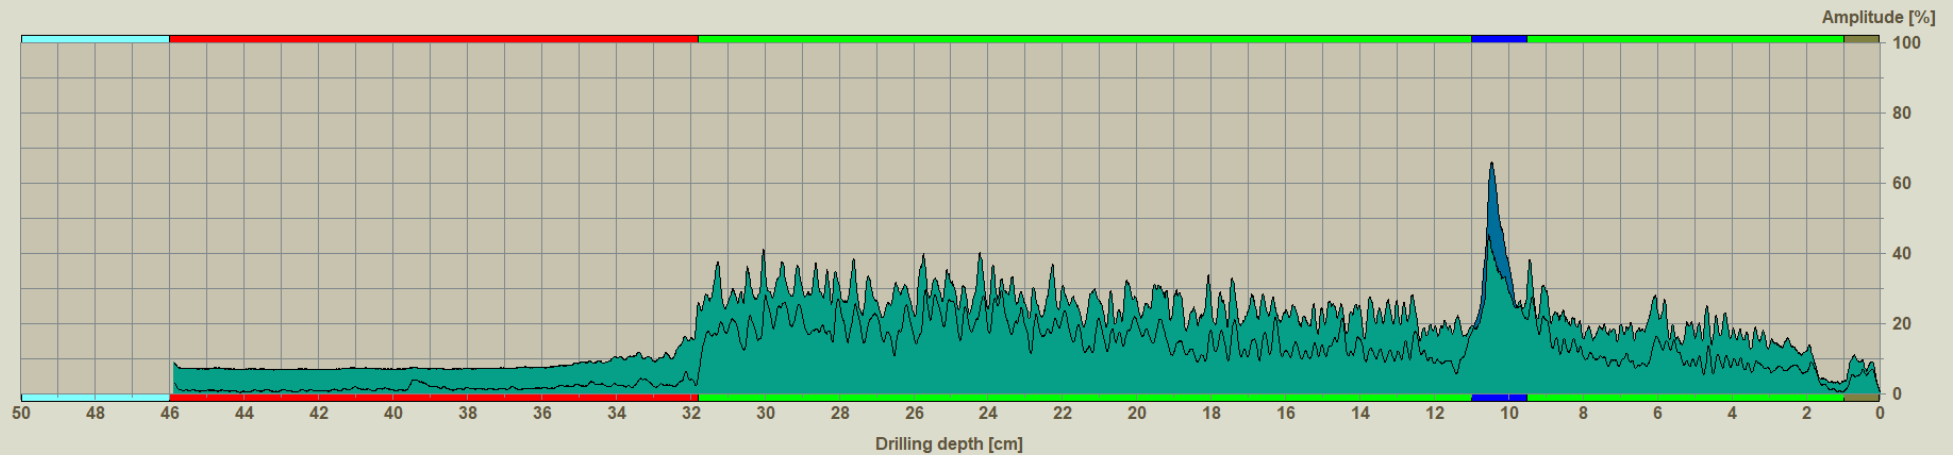
T3172 English oak measurement 2

| From 0,00 cm to 1,00 cm | : Bark |
| From 1,00 cm to 9,50 cm | : Sound wood |
| From 9,50 cm to 11,00 cm | : Reaction wood |
| From 11,00 cm to 31,80 cm | : Sound wood |
| From 31,80 cm to 46,00 cm | : Decay |
| From 46,00 cm to 50,00 cm | : Cavity |

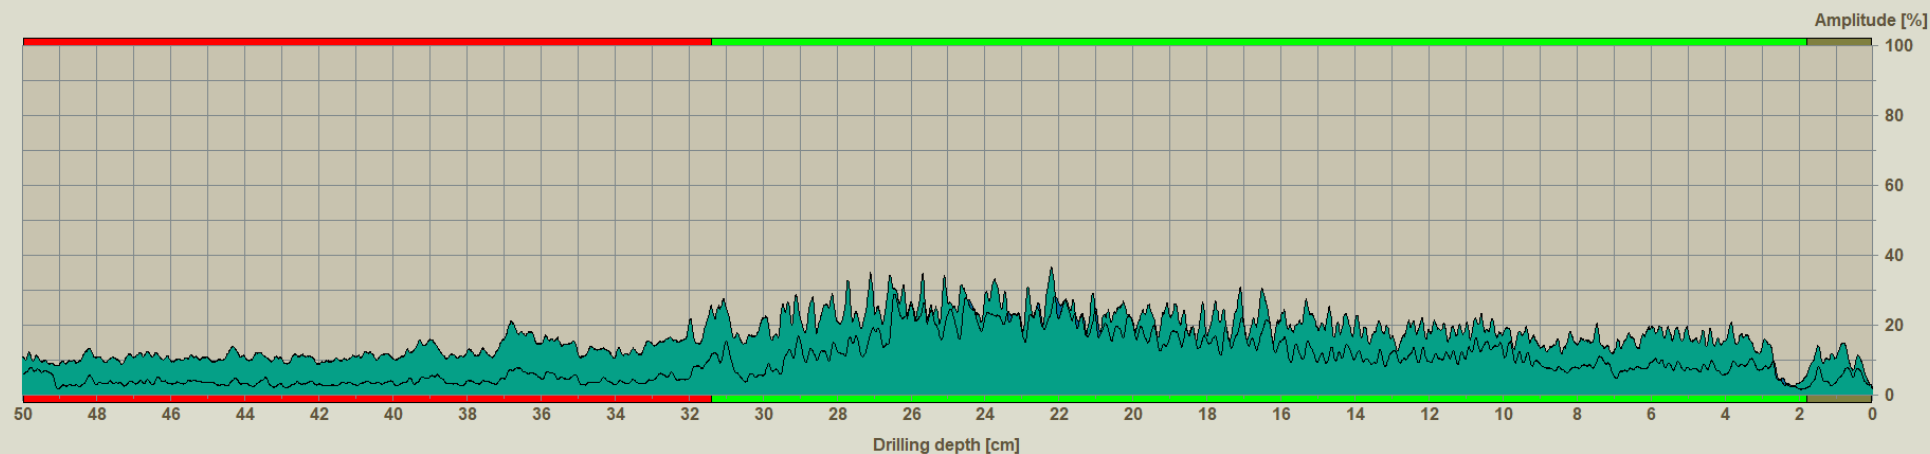
T3172 English oak measurement 3

| From | 0,00 cm to | 1,80 cm | : Bark |
| From | 1,80 cm to | 31,40 cm | : Sound wood |
| From | 31,40 cm to | 50,00 cm | : Decay |

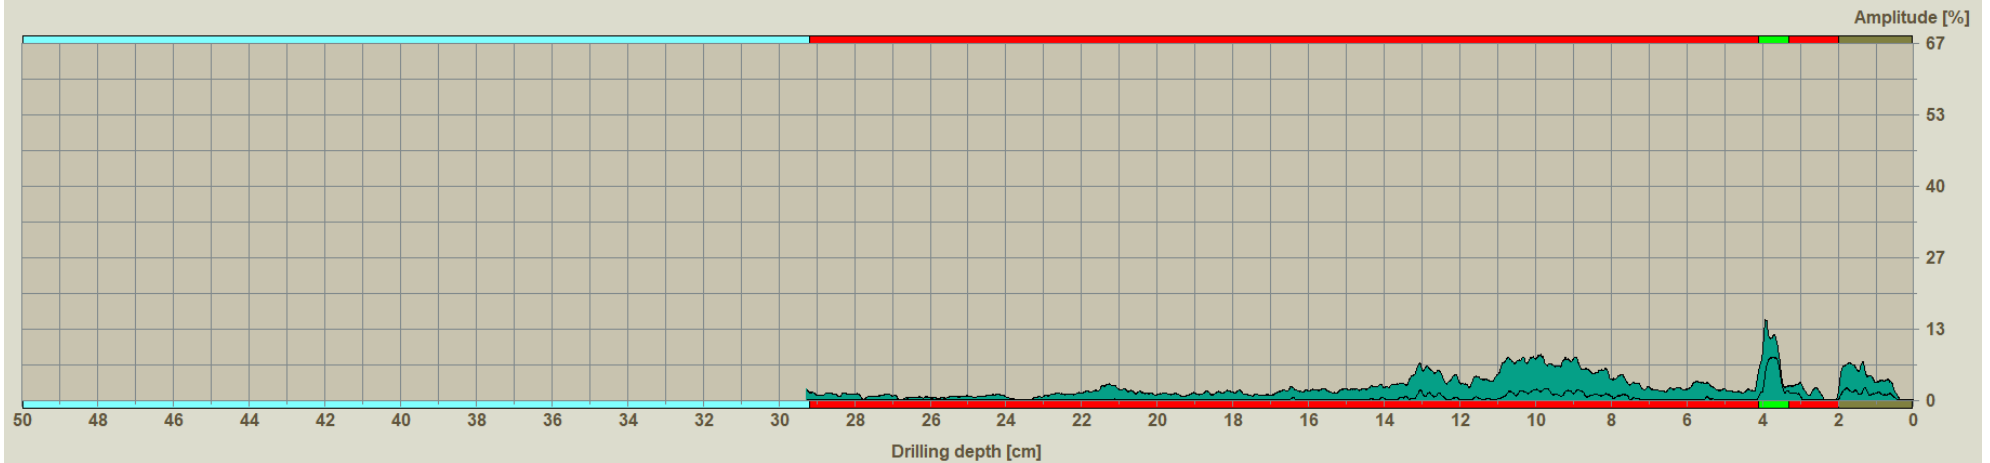
T3173 English oak measurement 1

| From | 0,00 cm to | 2,00 cm | : Bark |
| From | 2,00 cm to | 3,30 cm | : Decay |
| From | 3,30 cm to | 4,10 cm | : Sound wood |
| From | 4,10 cm to | 29,20 cm | : Decay |
| From | 29,20 cm to | 50,00 cm | : Cavity |

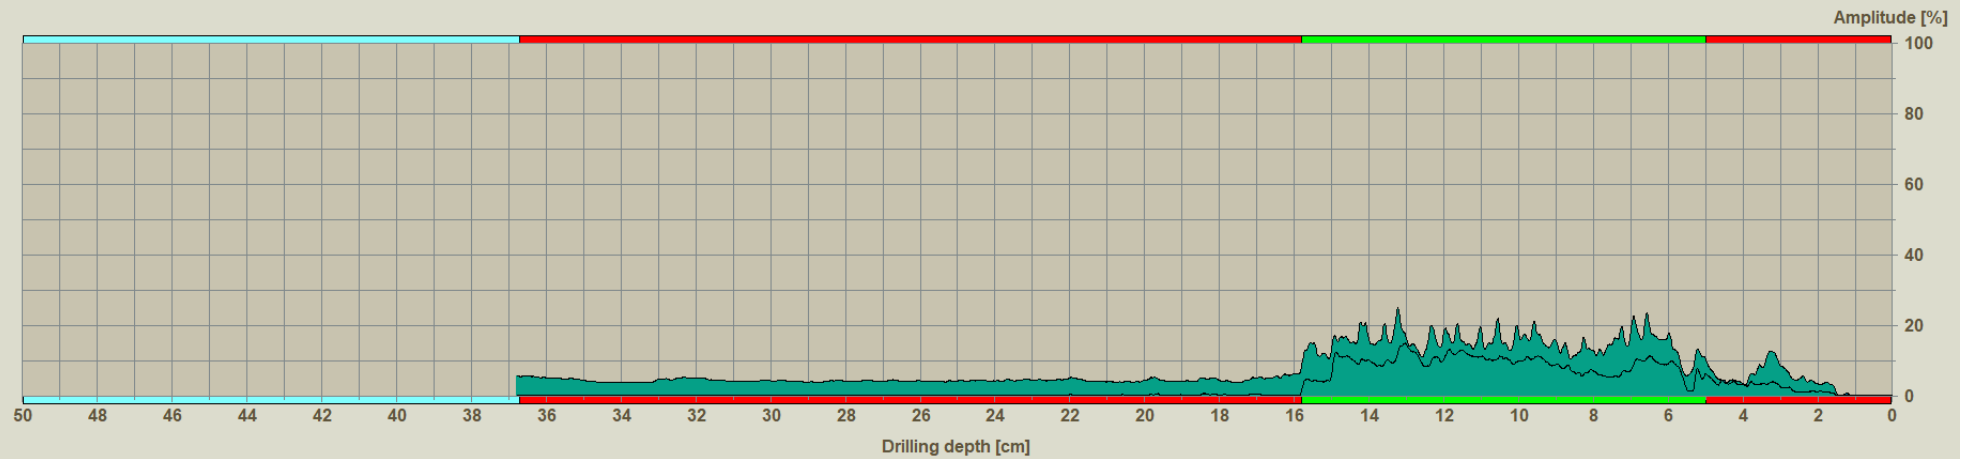
T3173 English oak measurement 2

| From | 0,00 cm | to | 5,00 cm | : | Decay |
| From | 5,00 cm | to | 15,80 cm | : | Sound wood |
| From | 15,80 cm | to | 36,70 cm | : | Decay |
| From | 36,70 cm | to | 50,00 cm | : | Cavity |

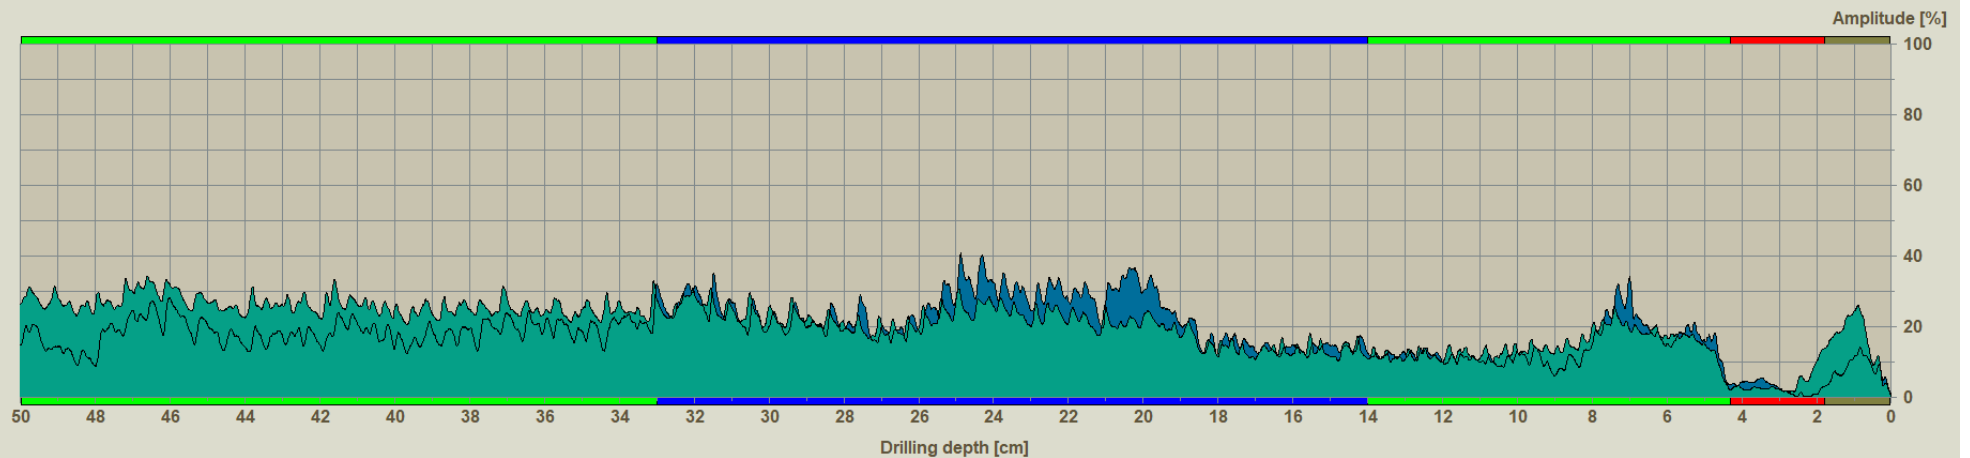
T3174 English oak measurement 2

| From | 0,00 cm | to | 1,80 cm | : | Bark |
| From | 1,80 cm | to | 4,30 cm | : | Decay |
| From | 4,30 cm | to | 14,00 cm | : | Sound wood |
| From | 14,00 cm | to | 33,00 cm | : | Reaction wood |
| From | 33,00 cm | to | 50,00 cm | : | Sound wood |

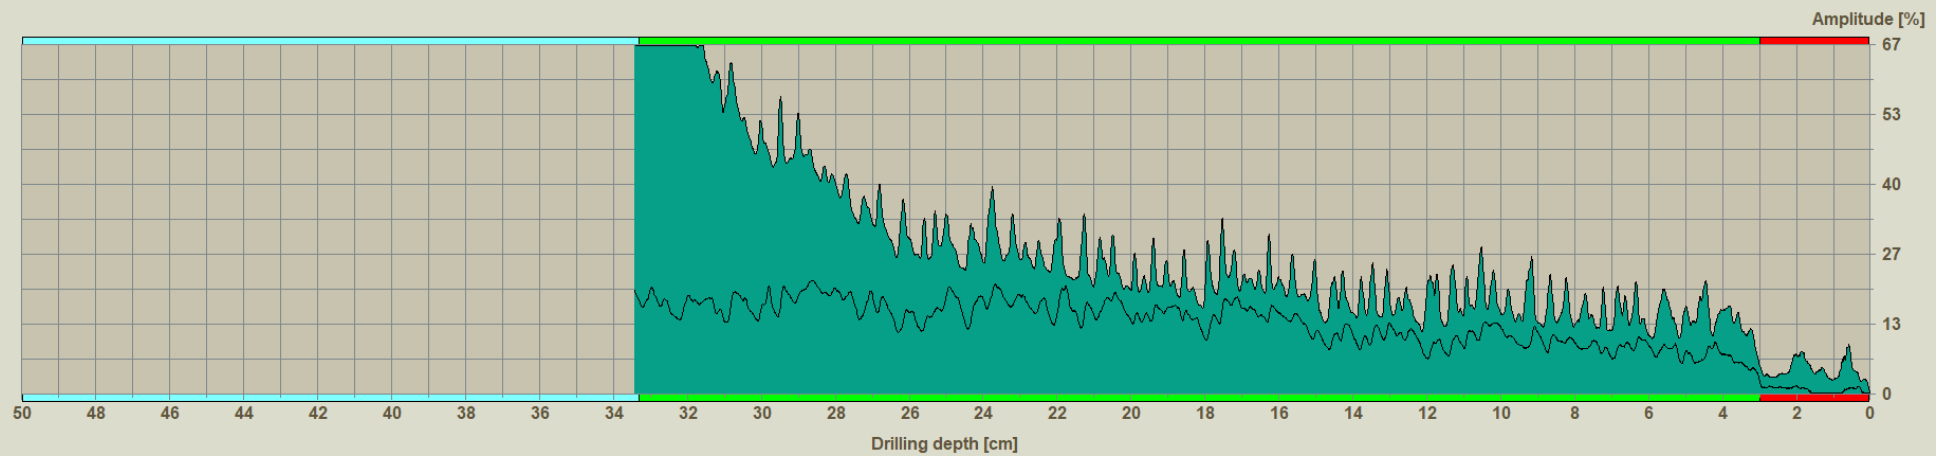
T3174 English oak measurement 3

| From | 0,00 cm to | 3,00 cm | : Decay |
| From | 3,00 cm to | 33,30 cm | : Sound wood |
| From | 33,30 cm to | 50,00 cm | : Cavity |

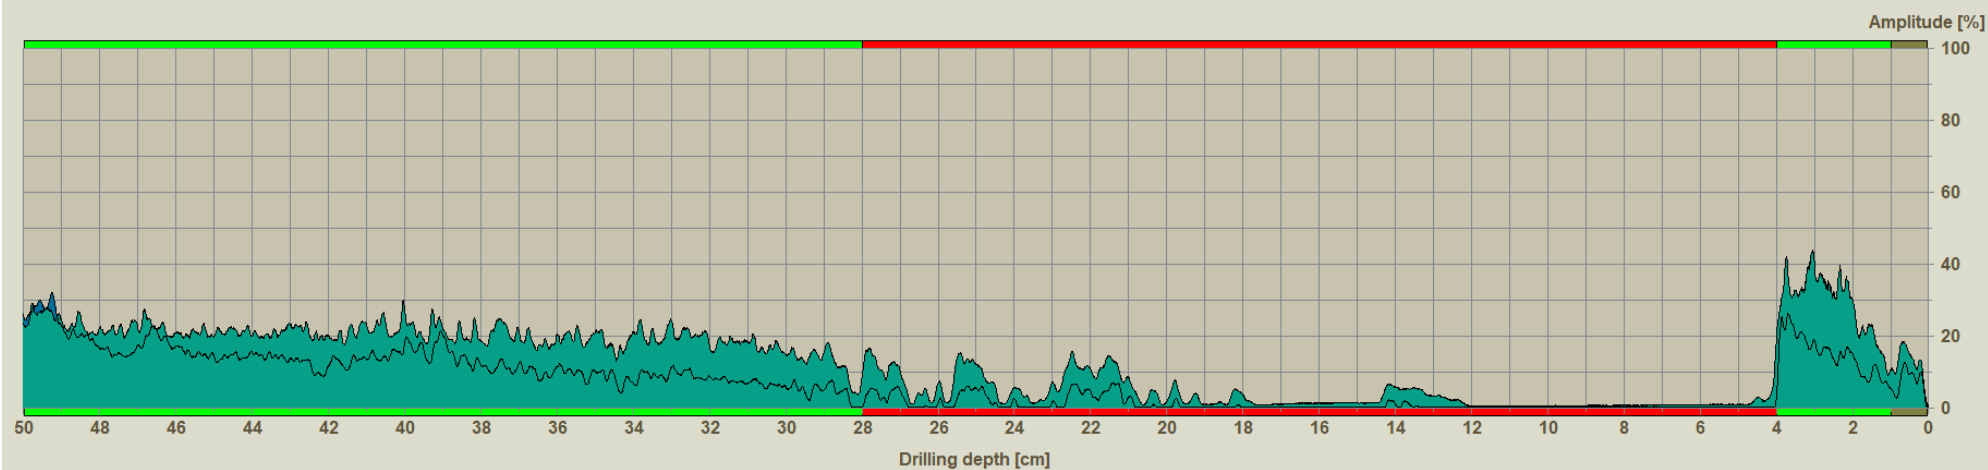
T3177 English oak measurement 1

| From | 0,00 cm to | 1,00 cm | : Bark |
| From | 1,00 cm to | 4,00 cm | : Sound wood |
| From | 4,00 cm to | 28,00 cm | : Decay |
| From | 28,00 cm to | 50,00 cm | : Sound wood |

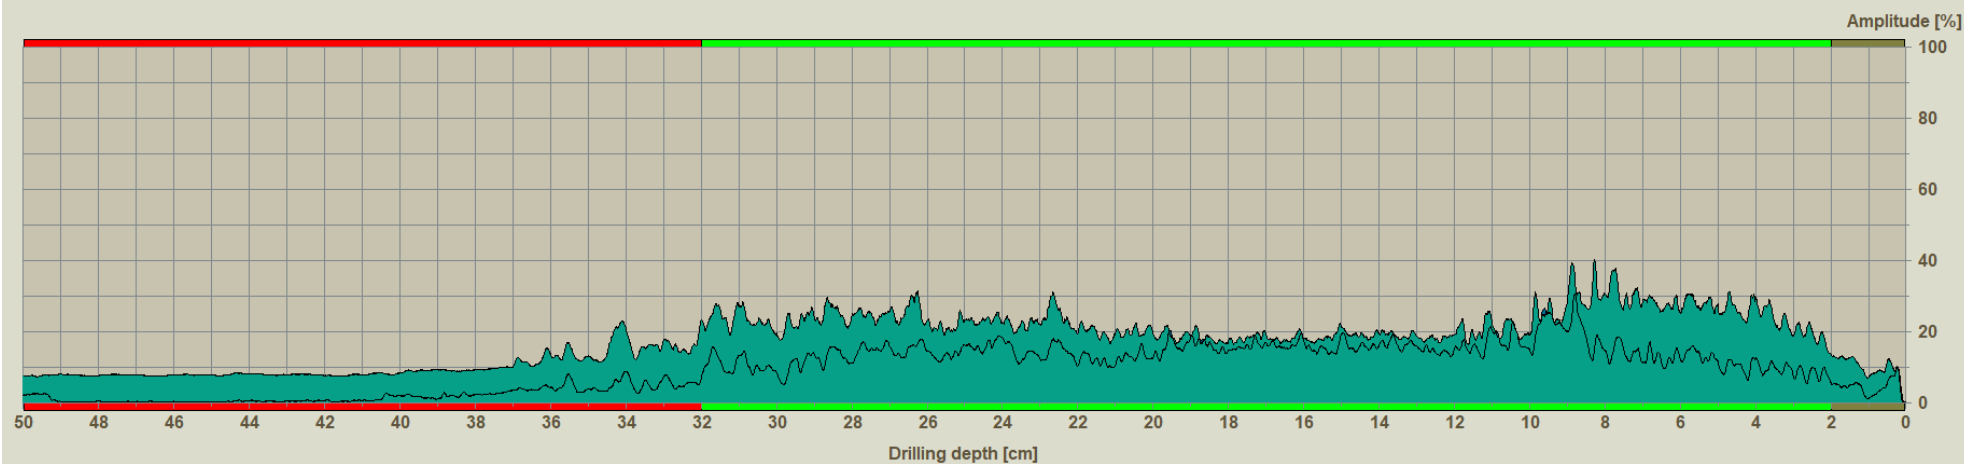
T3177 English oak measurement 2

| From | 0,00 cm to | 2,00 cm | : Bark |
| From | 2,00 cm to | 32,00 cm | : Sound wood |
| From | 32,00 cm to | 50,00 cm | : Decay |

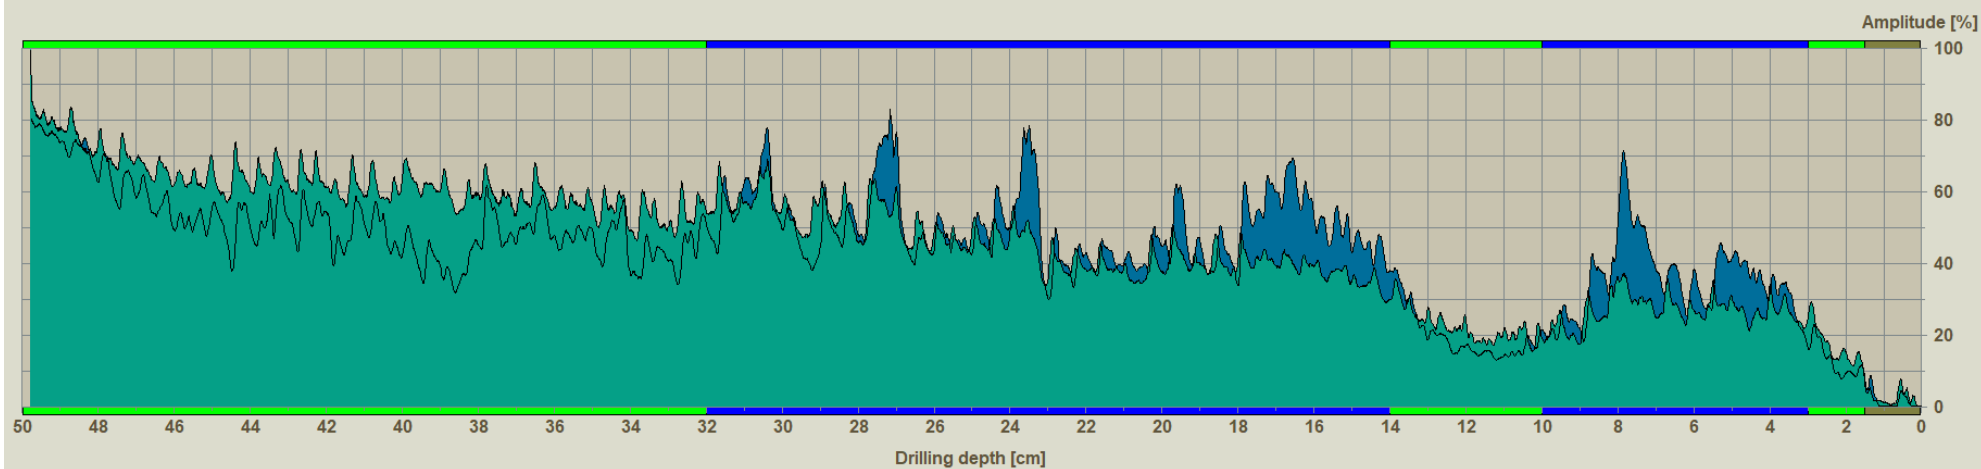
T3177 English oak measurement 3

| From | 0,00 cm to | 1,50 cm | : Bark |
| From | 1,50 cm to | 3,00 cm | : Sound wood |
| From | 3,00 cm to | 10,00 cm | : Reaction wood |
| From | 10,00 cm to | 14,00 cm | : Sound wood |
| From | 14,00 cm to | 32,00 cm | : Reaction wood |
| From | 32,00 cm to | 50,00 cm | : Sound wood |

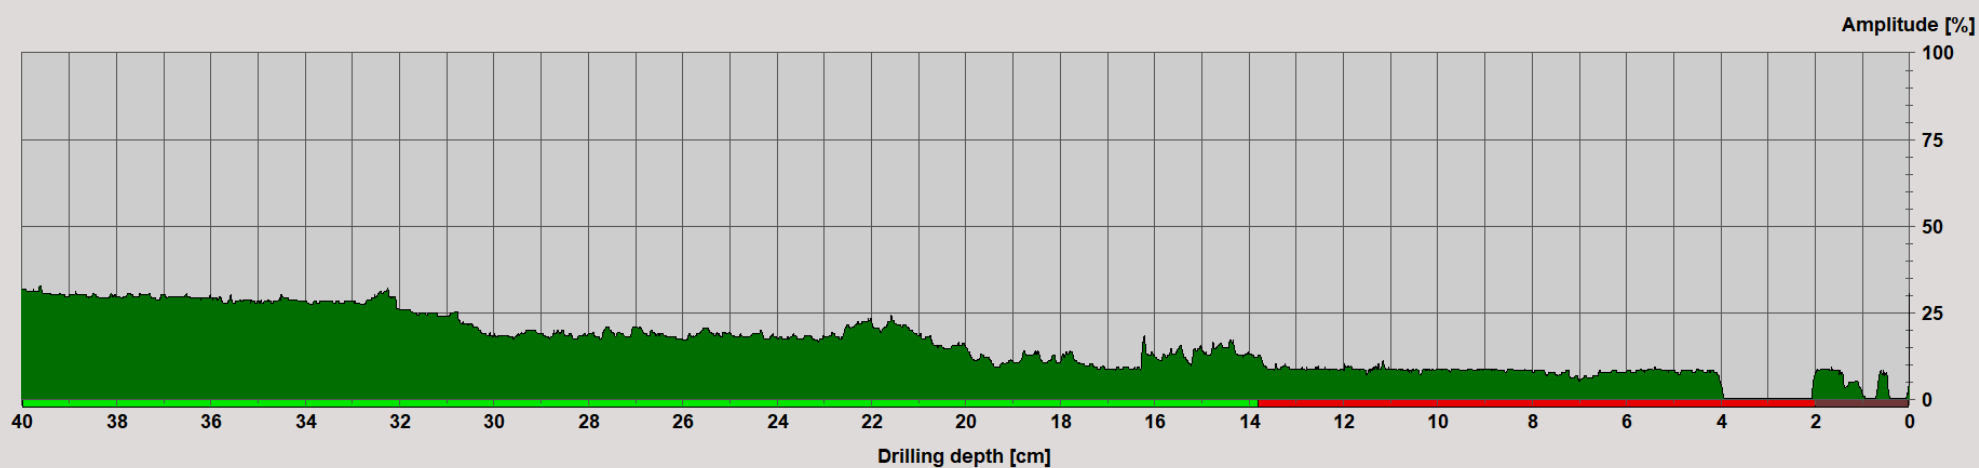
T3179 English oak measurement 1

| From 0,0 cm to 2,0 cm : | Bark |
| From 2,0 cm to 13,8 cm : | Decay |
| From 13,8 cm to 40,0 cm : | Sound wood |

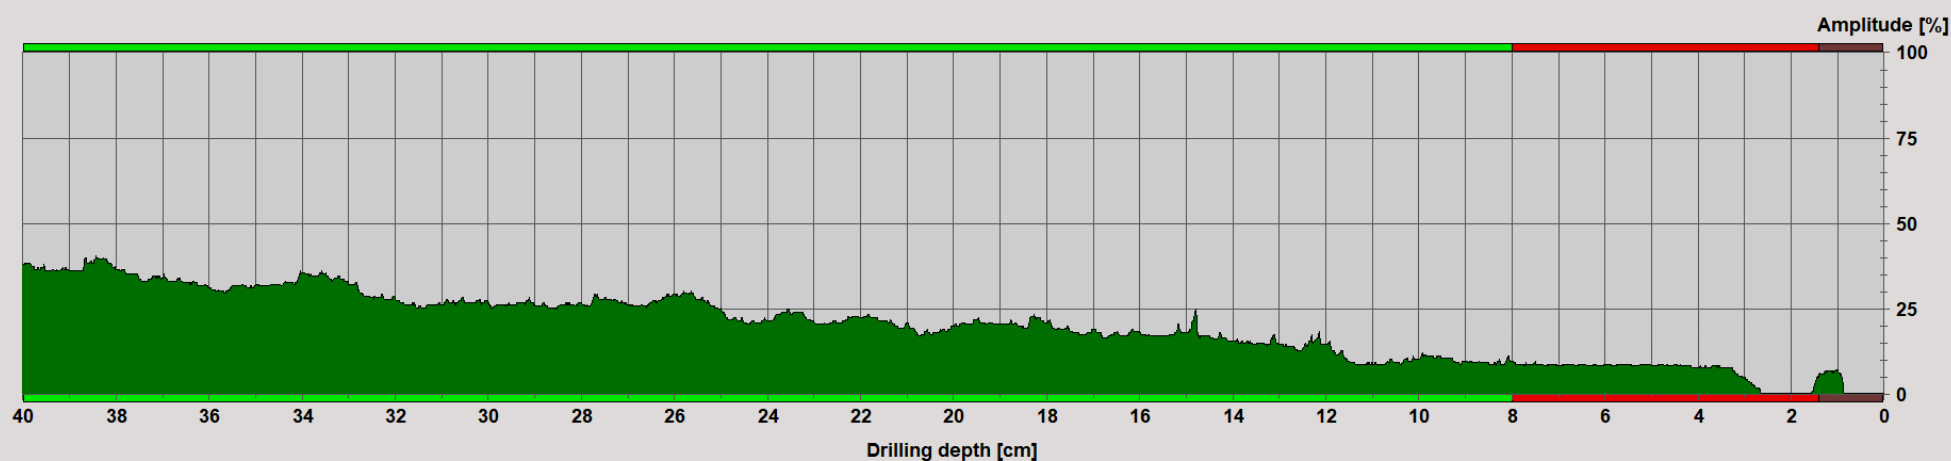
T3179 English oak measurement 2

| From 0,0 cm to 1,4 cm : Bark |
| From 1,4 cm to 8,0 cm : Decay |
| From 8,0 cm to 40,0 cm : Sound wood |

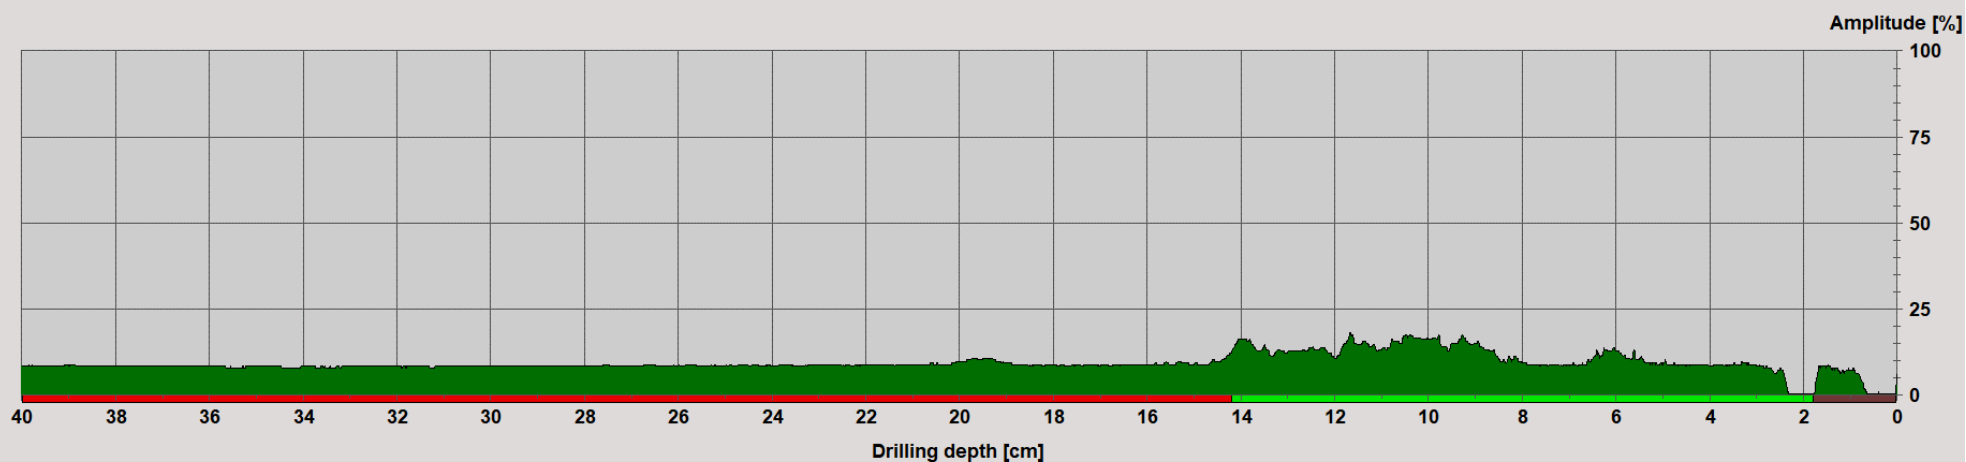
T3179 English oak measurement 3

| From 0,0 cm to 1,8 cm : | Bark |
| From 1,8 cm to 14,2 cm : | Sound wood |
| From 14,2 cm to 40,0 cm : | Decay |

T3179 (Secondary stem to West side)
