## WINDOW CONDITION ASSESSMENT

32 High Street  
Emsworth  
Hampshire  
PO10 7 AW

Project: Conversion into residential use.

Date: February 2024

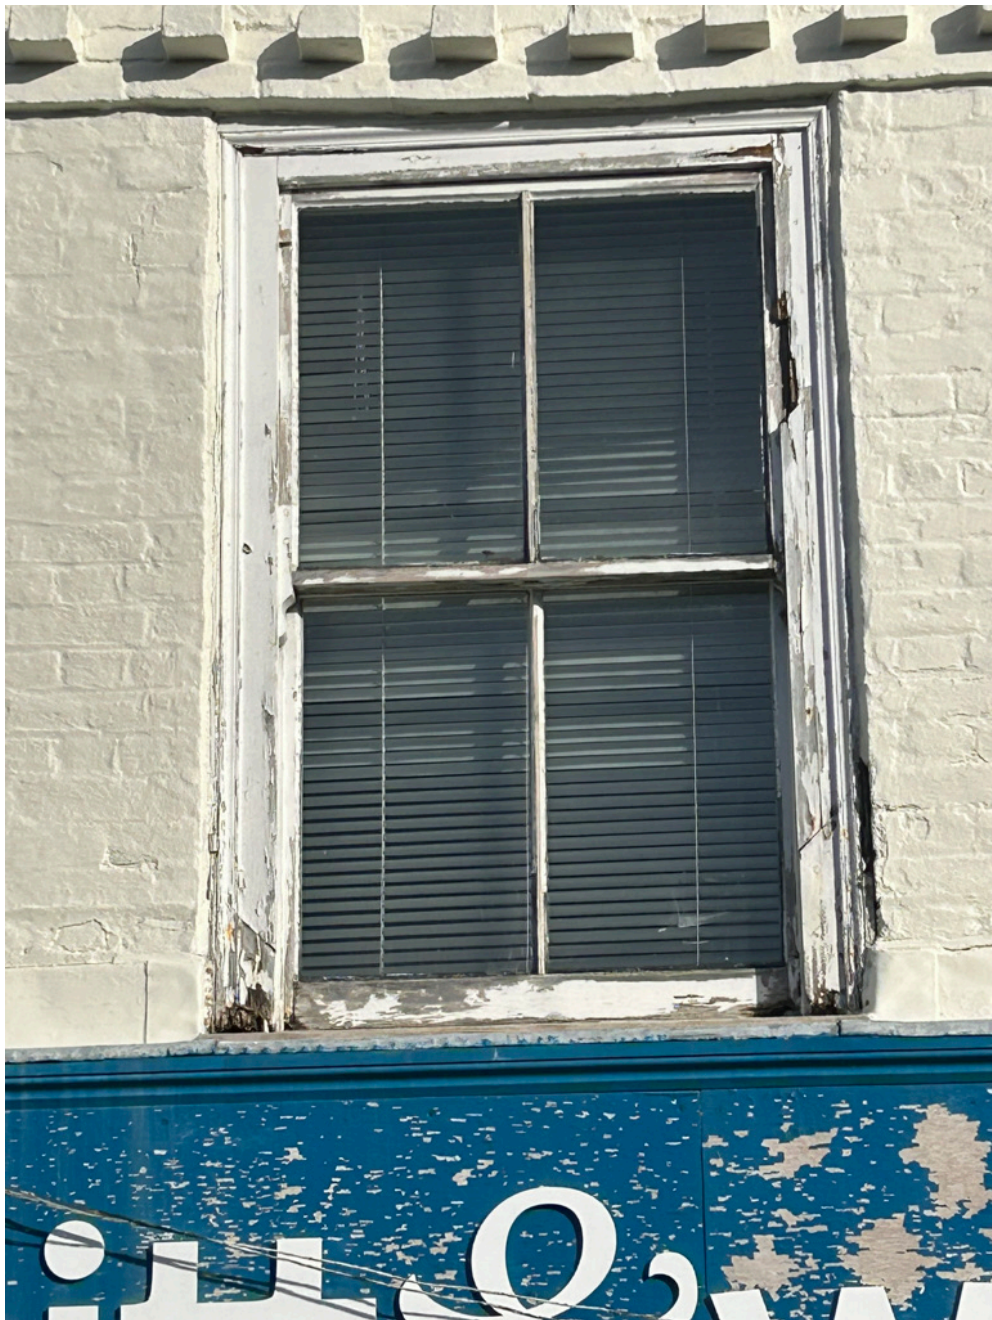
2.1. Window no: W1

Location: front elevation

Type: sash

Period: 20<sup>th</sup> century replacement

Material: timber painted white

Glazing: plate, single

Condition: frame and cill rotten; sashes heavily weathered

Advice: a modern window that is not worthy of repair. An improved replacement could enhance the building.

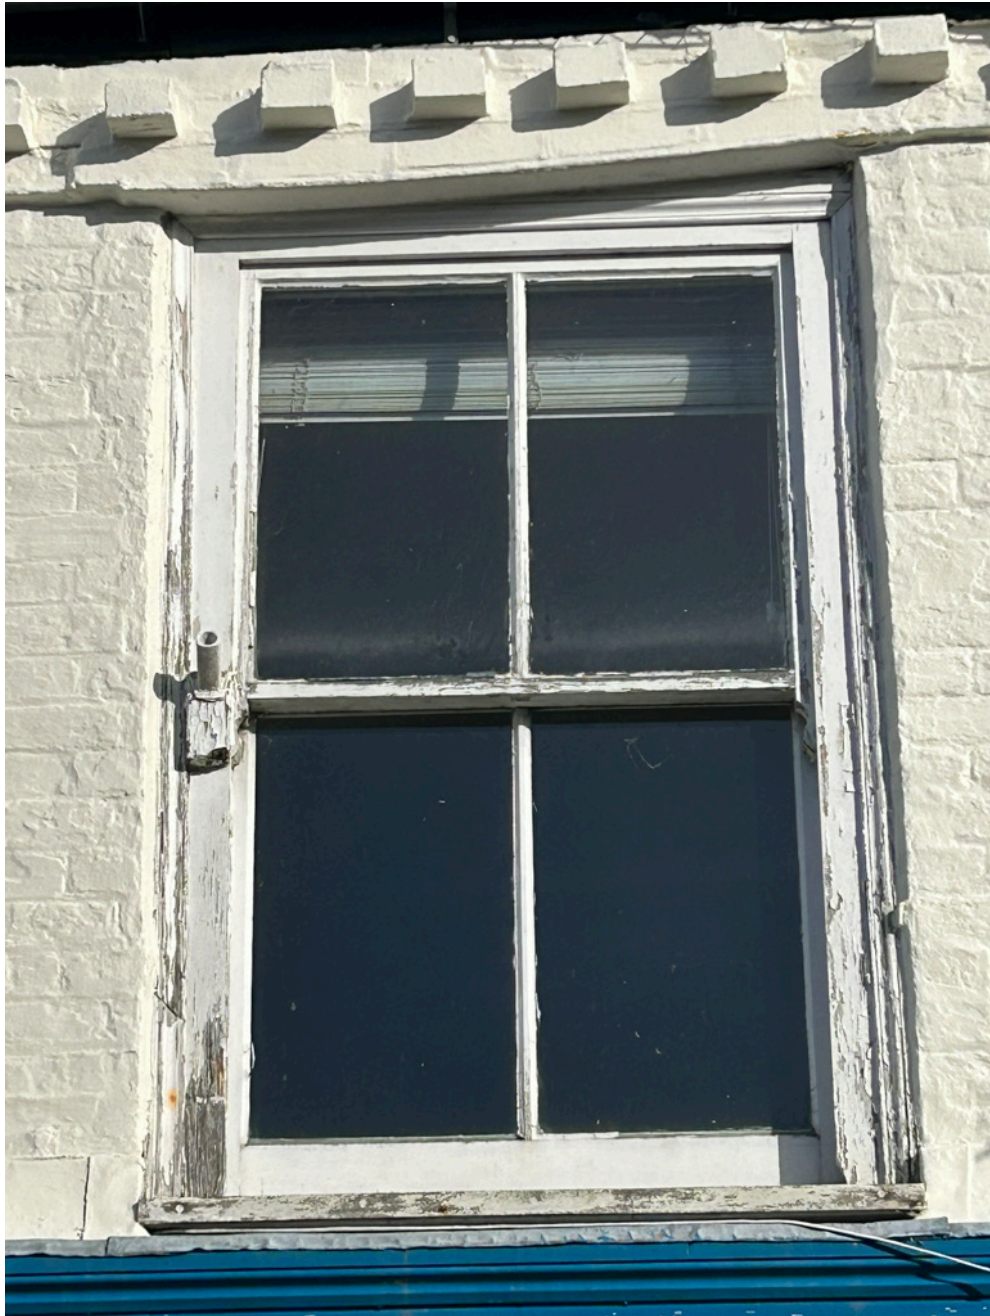
- 2.2. Window no: W2  
Location: front elevation  
Type: sash  
Period: 20<sup>th</sup> century replacement  
Material: timber painted white  
Glazing: plate, single  
Condition: sashes okay, though frame decayed at low level  
Advice: repairable, however could be replaced and enhanced as modern.

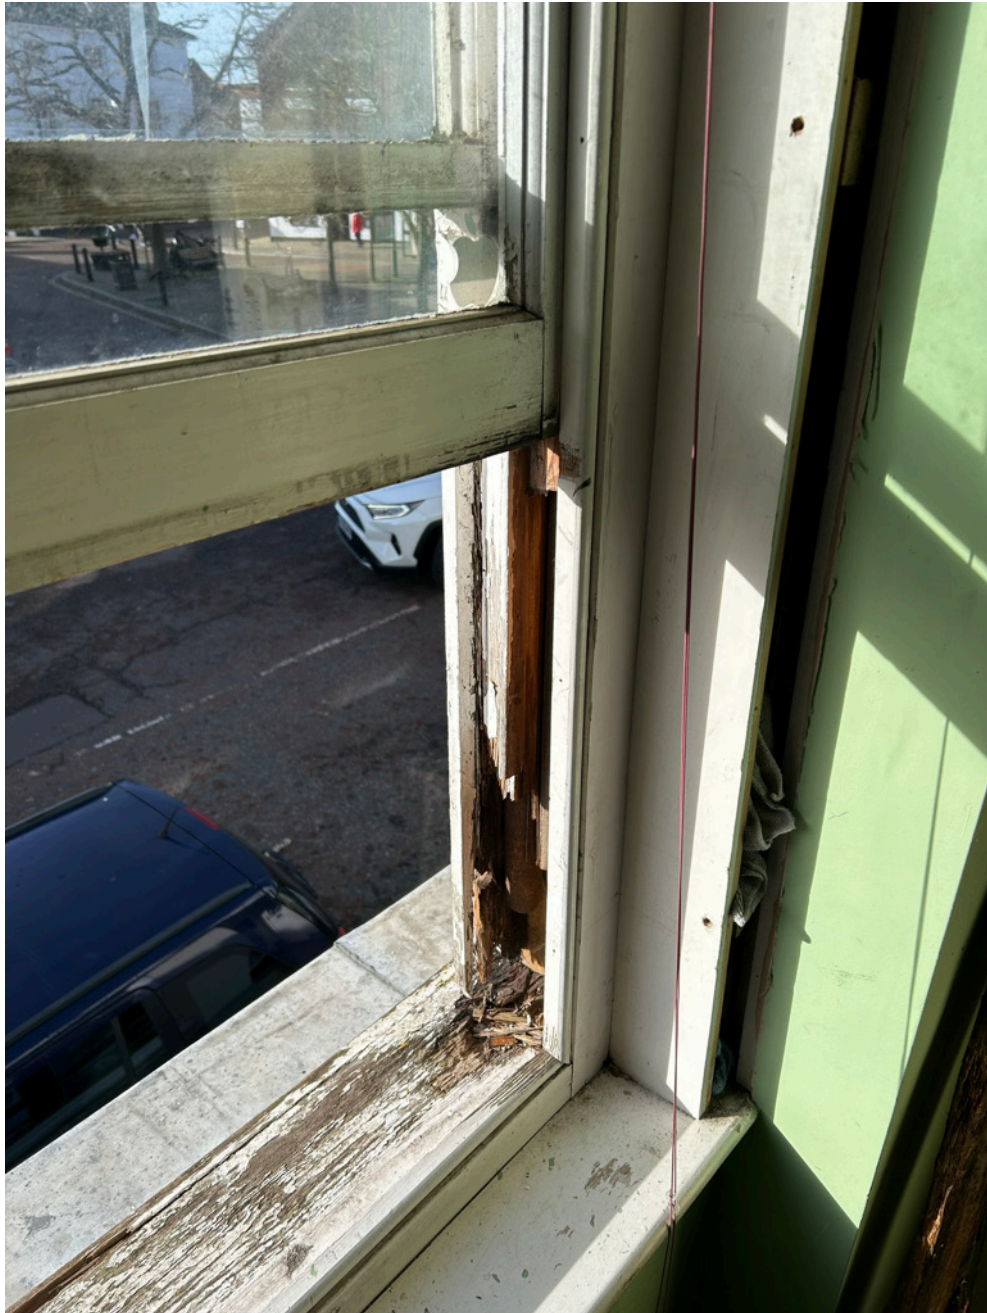
- 2.3. Window no: W3  
Location: front elevation  
Type: sash  
Period: 20<sup>th</sup> century replacement  
Material: timber painted white  
Glazing: plate, single  
Condition: frames rotten at lower level and bottom sash in poor condition  
Advice: repairable, however could be replaced and enhanced as modern.

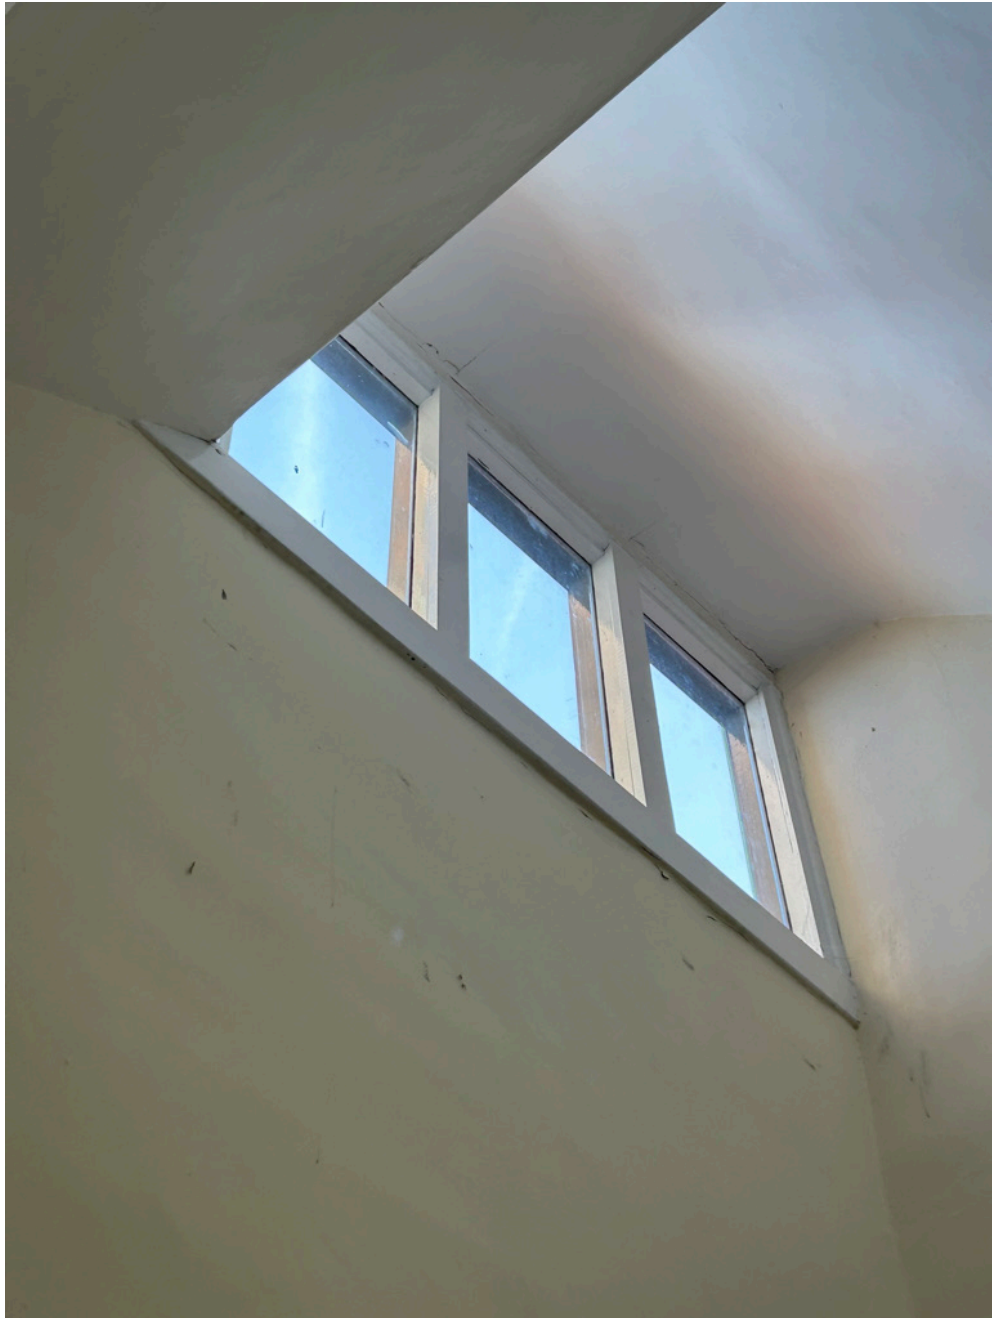
- 2.4. Window no: W4  
Location: rear elevation of original building  
Type: static, multi-paned  
Period: 20<sup>th</sup> century  
Material: timber  
Glazing: plate, single or double-glazed  
Condition: good, from a slightly distant inspection (see photo)  
Advice: modern window that could be replaced if necessary.

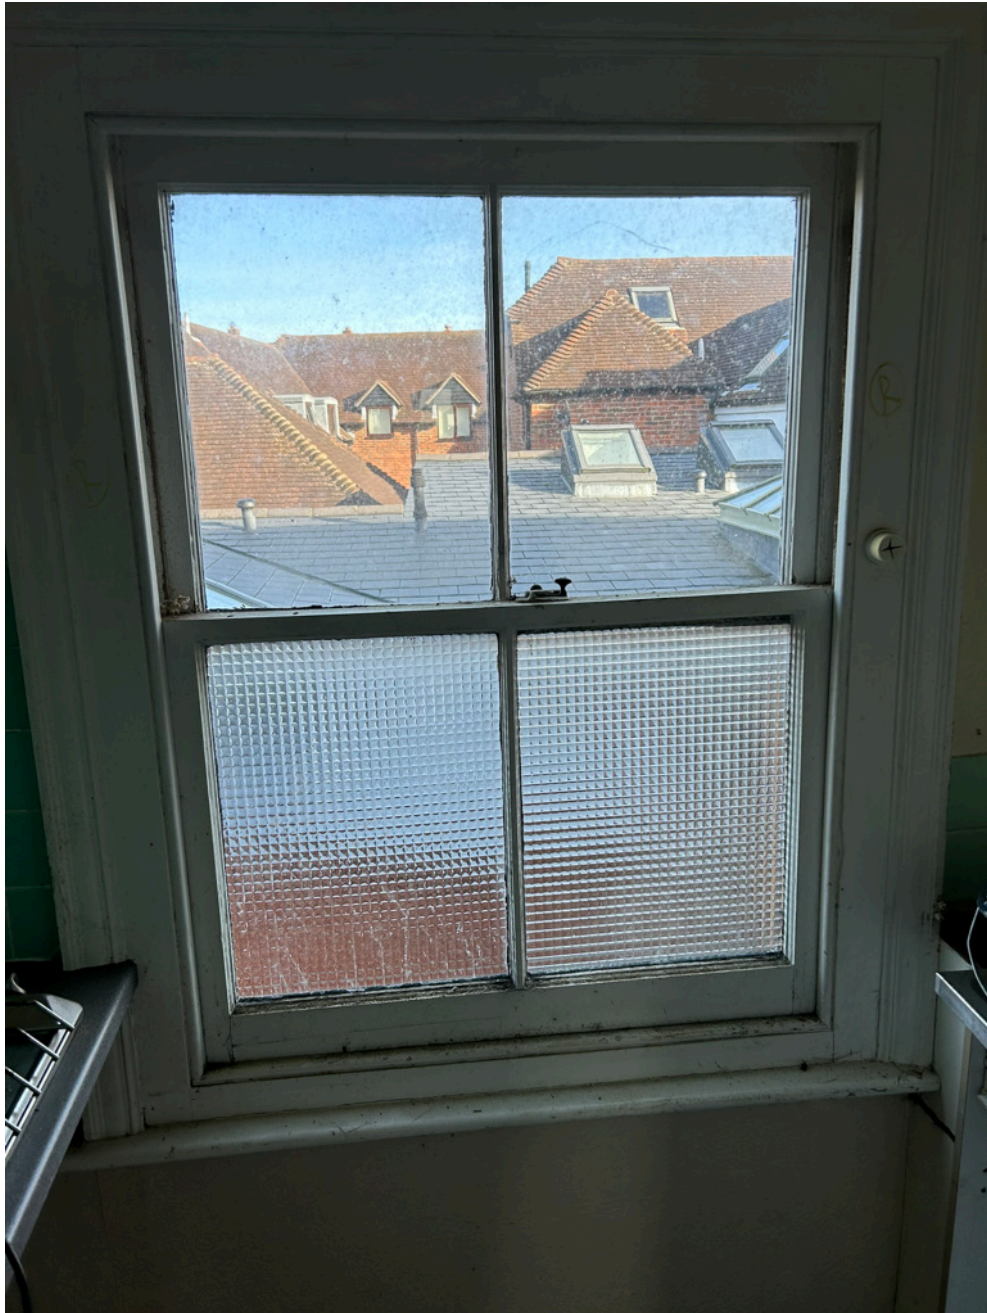
- 2.6. Window no: W6  
Location: rear elevation  
Type: casement  
Period: late 19<sup>th</sup> or early 20<sup>th</sup> century  
Material: timber painted white  
Glazing: upper sash crown (historic); lower sash modern plate  
Condition: solid and repairable, though requires redecoration and new sash cords  
Advice: repair and replace glazing in lower sash.

- 3.1. Whilst 32 High Street is a listed building, only windows W6 and W10 contain historic fabric. In our opinion this is late 19<sup>th</sup> or early 20<sup>th</sup> century in date and largely repairable. The exception may be W10 where some of the glazing bars have begun to deteriorate and feel soft in places and the LPA may want to take a view on this.
- 3.2. The remaining windows, with the exception of W14, are all very modern with many being of poor construction and design. These carry no significance and should be capable of replacement with a view to enhancing the appearance of the building.
- 3.3. The three front windows are all modern replacements and should be replicated again, but ideally with more sympathetic glazing bars.

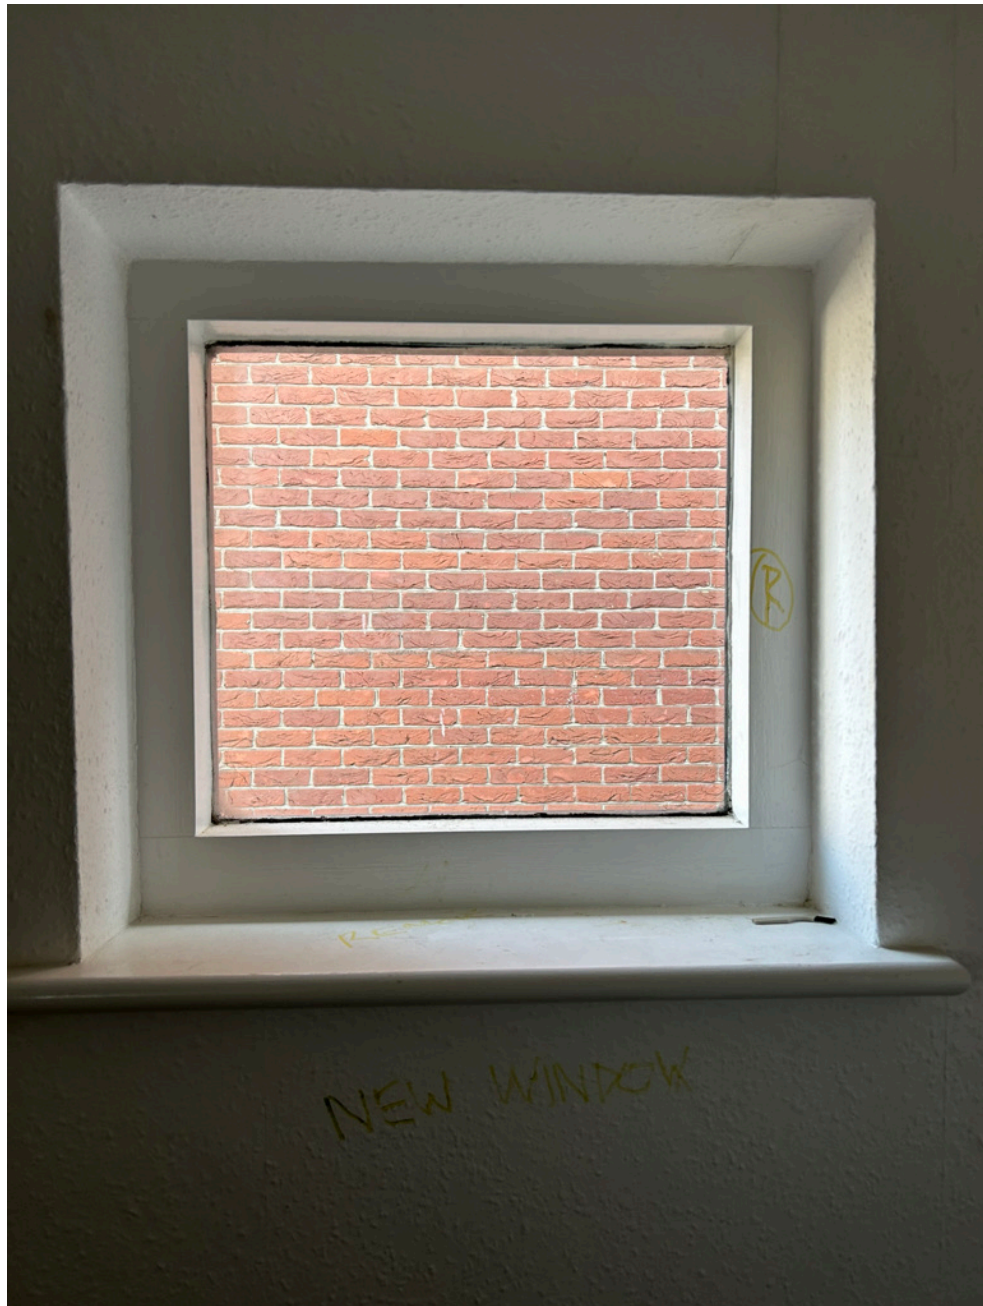
- 2.7. Window no: W7  
Location: side elevation  
Type: static  
Period: 20<sup>th</sup> century  
Material: timber  
Glazing: plate  
Condition: good  
Advice: modern window so can be retained or replaced.

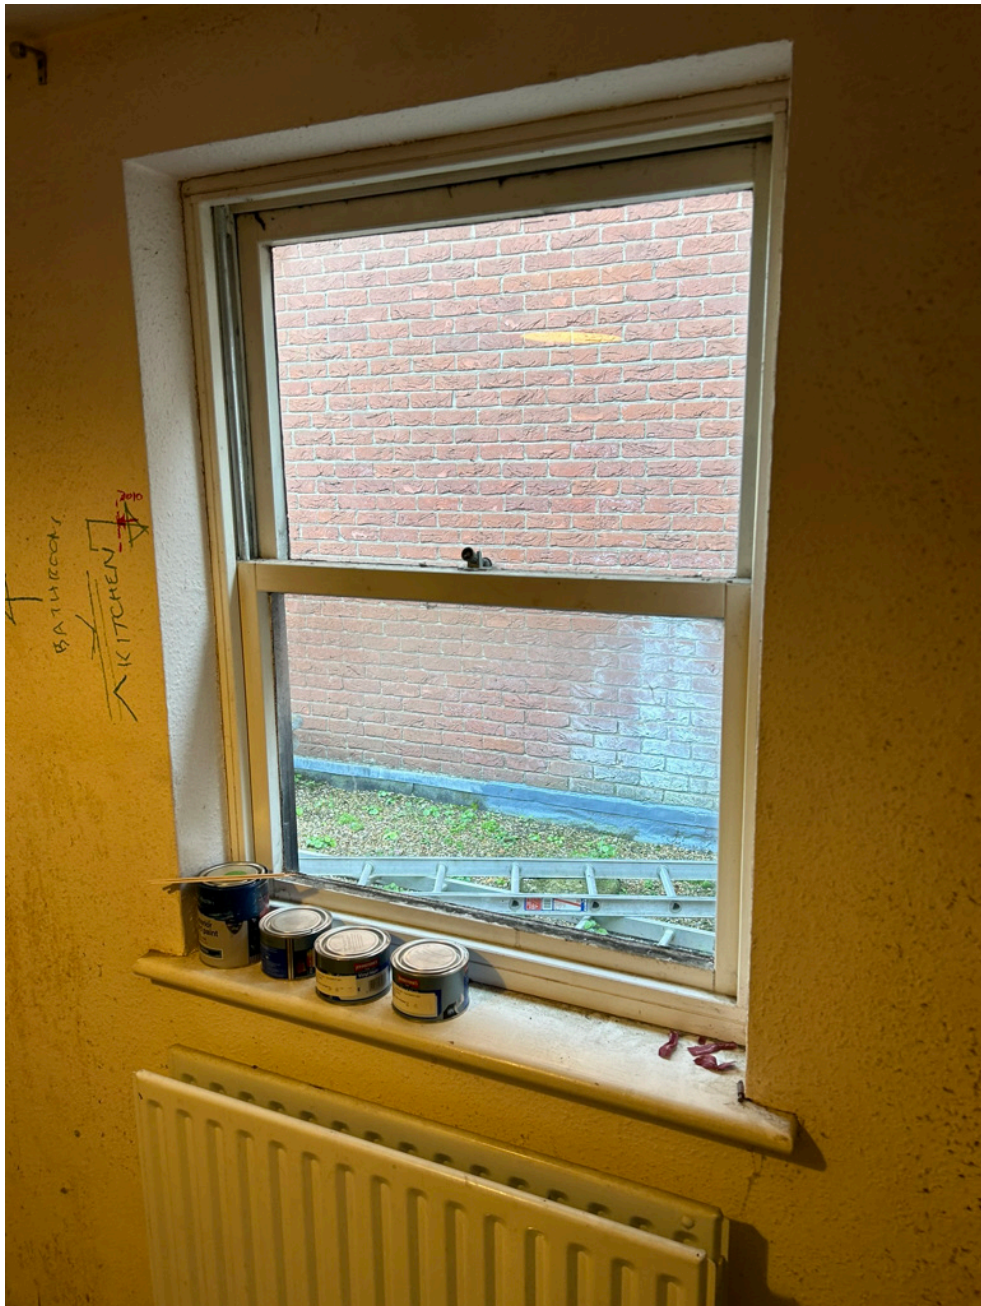
- 2.8. Window no: W8  
Location: side elevation  
Type: sash  
Period: 20<sup>th</sup> century  
Material: timber  
Glazing: modern plate  
Condition: poor model and construction  
Advice: replace with improved design.

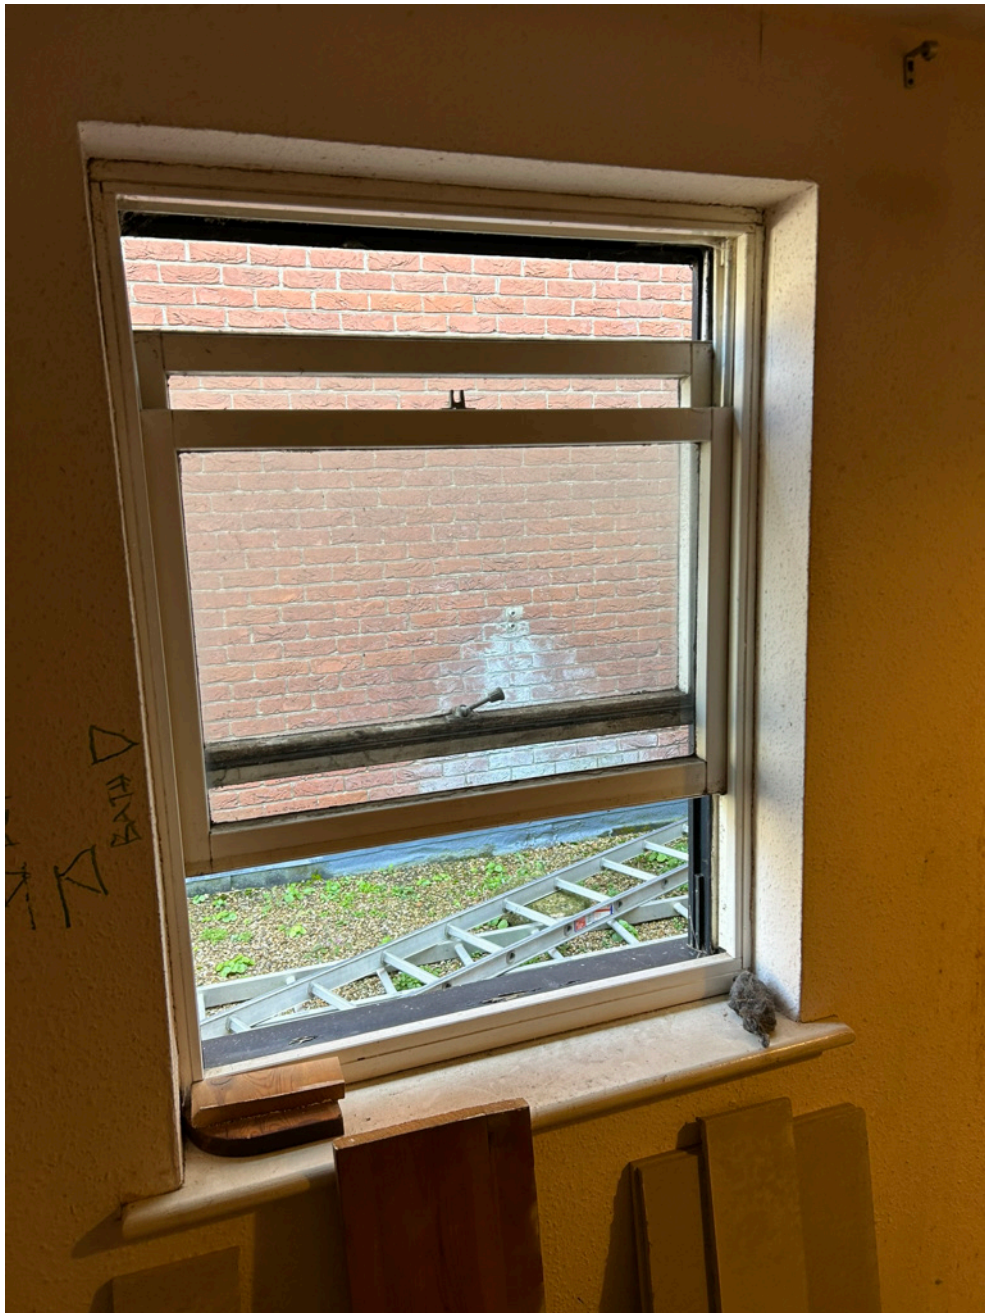
- 2.9. Window no: W9  
Location: side elevation  
Type: sash  
Period: 20<sup>th</sup> century  
Material: timber  
Glazing: modern plate  
Condition: poor model and construction  
Advice: replace with improved design.

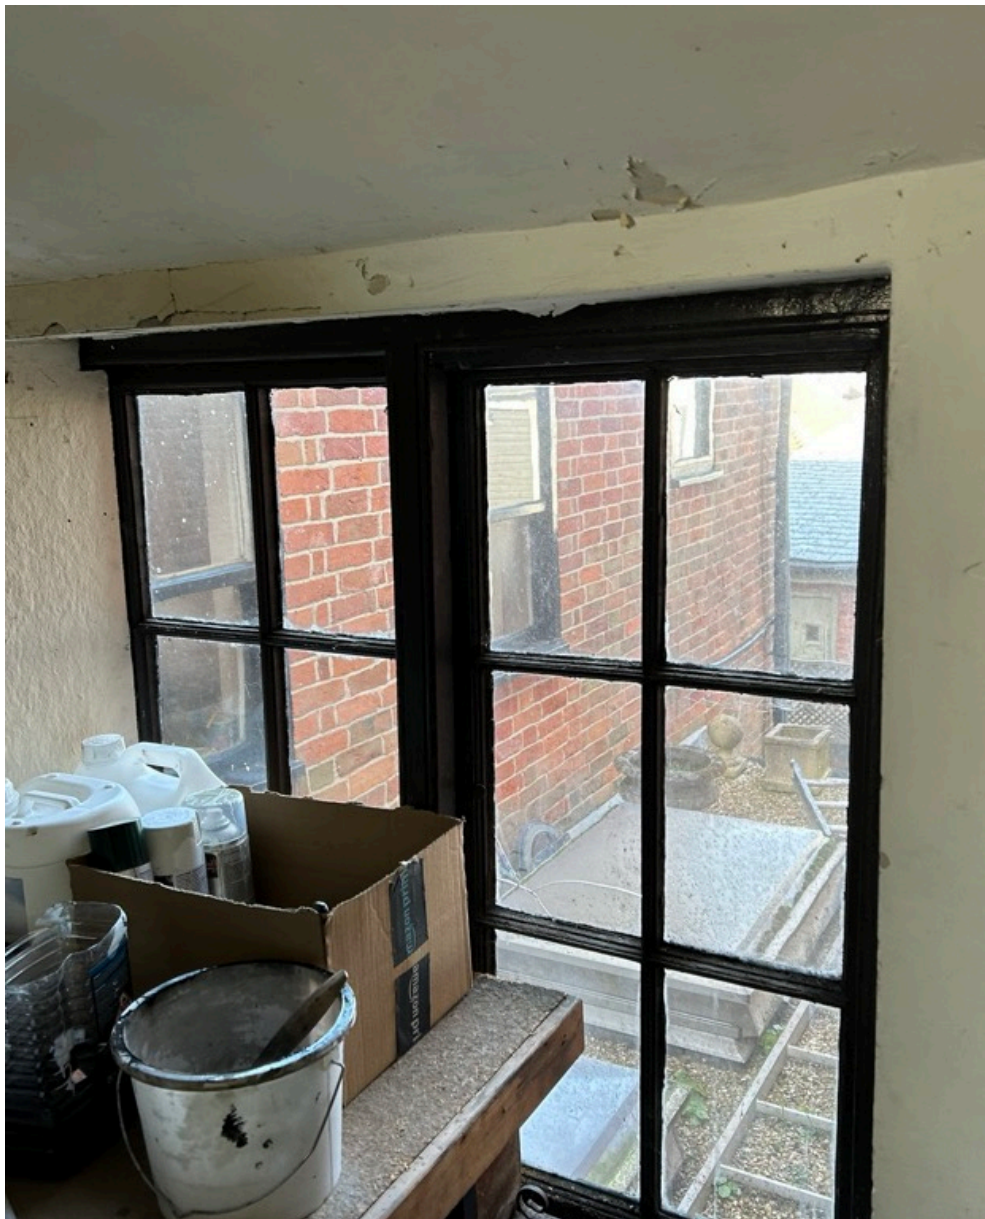
- 2.10. Window no: W10  
Location: rear elevation  
Type: casement  
Period: late 19<sup>th</sup> or early 20<sup>th</sup> century  
Material: timber painted black  
Glazing: crown (historic)  
Condition: frame good, though casements with signs of water damage and glazing bars beginning to deteriorate in places.  
Advice: retain frame; retain casements, if possible, though replicate if timber proves to be failing; glazing could be re-used.

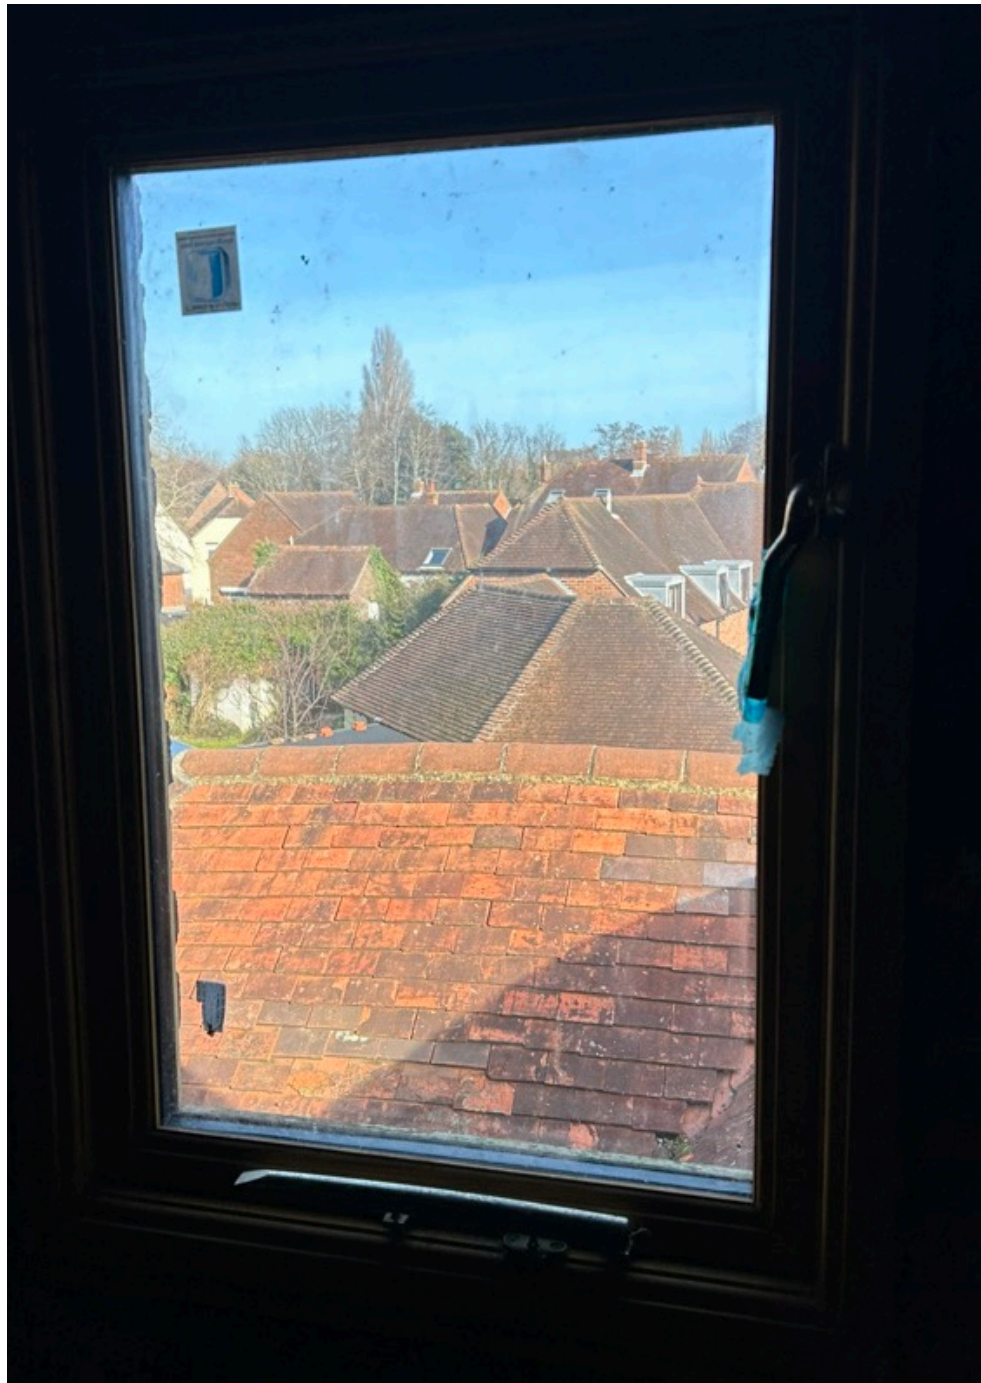
- 2.11. Window no: W11  
Location: rear elevation (gable)  
Type: casement  
Period: 20<sup>th</sup> century  
Material: timber, varnished  
Glazing: double-glazed  
Condition: okay, but inappropriate modern design  
Advice: replace.

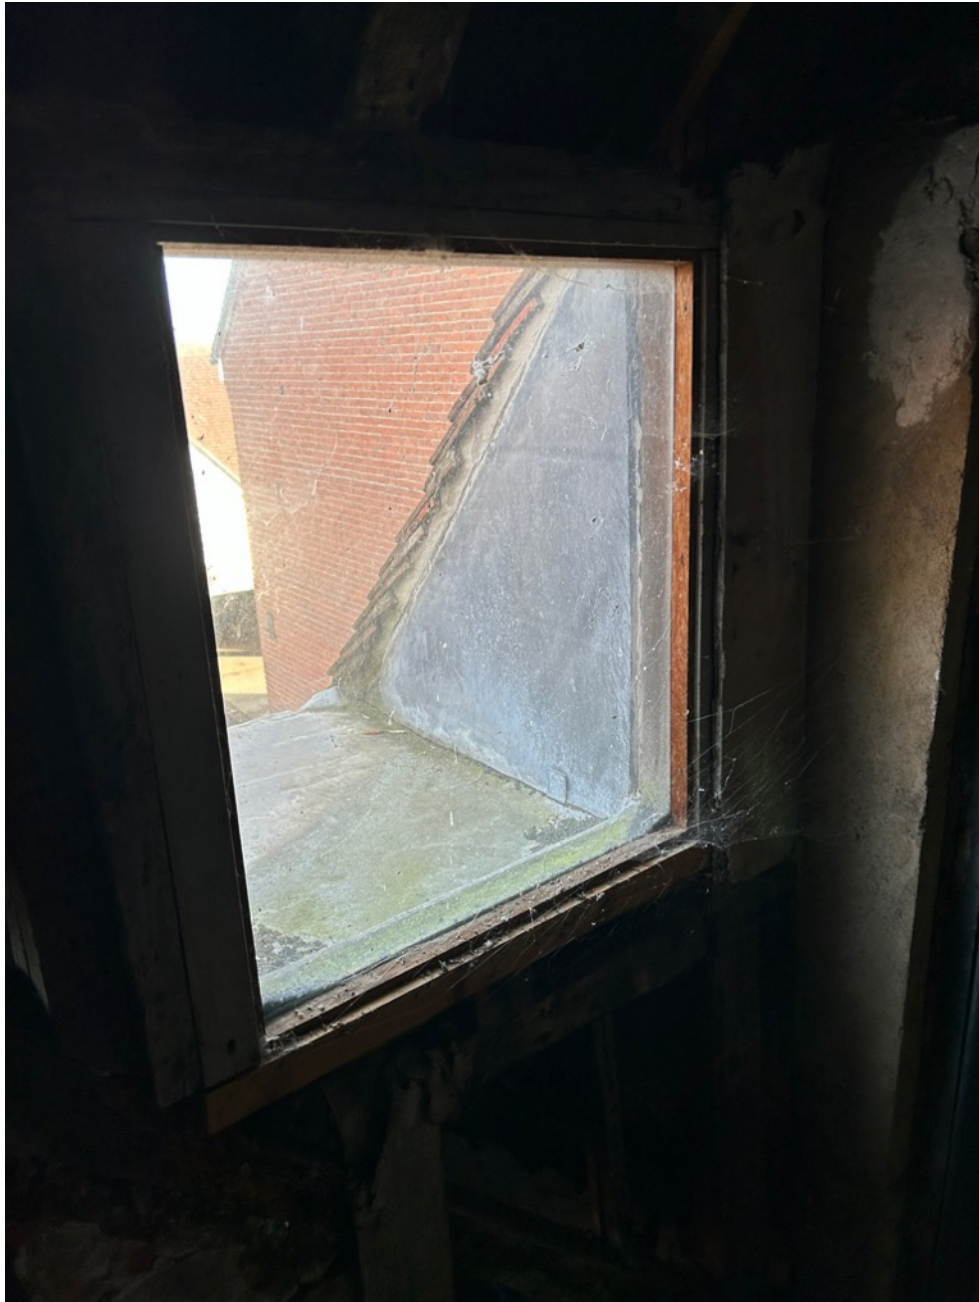
- 2.12. Window no: W12  
Location: rear  
Type: static  
Period: 20<sup>th</sup> century  
Material: timber  
Glazing: plate  
Condition: okay, but poor construction  
Advice: replace with more sympathetic design.

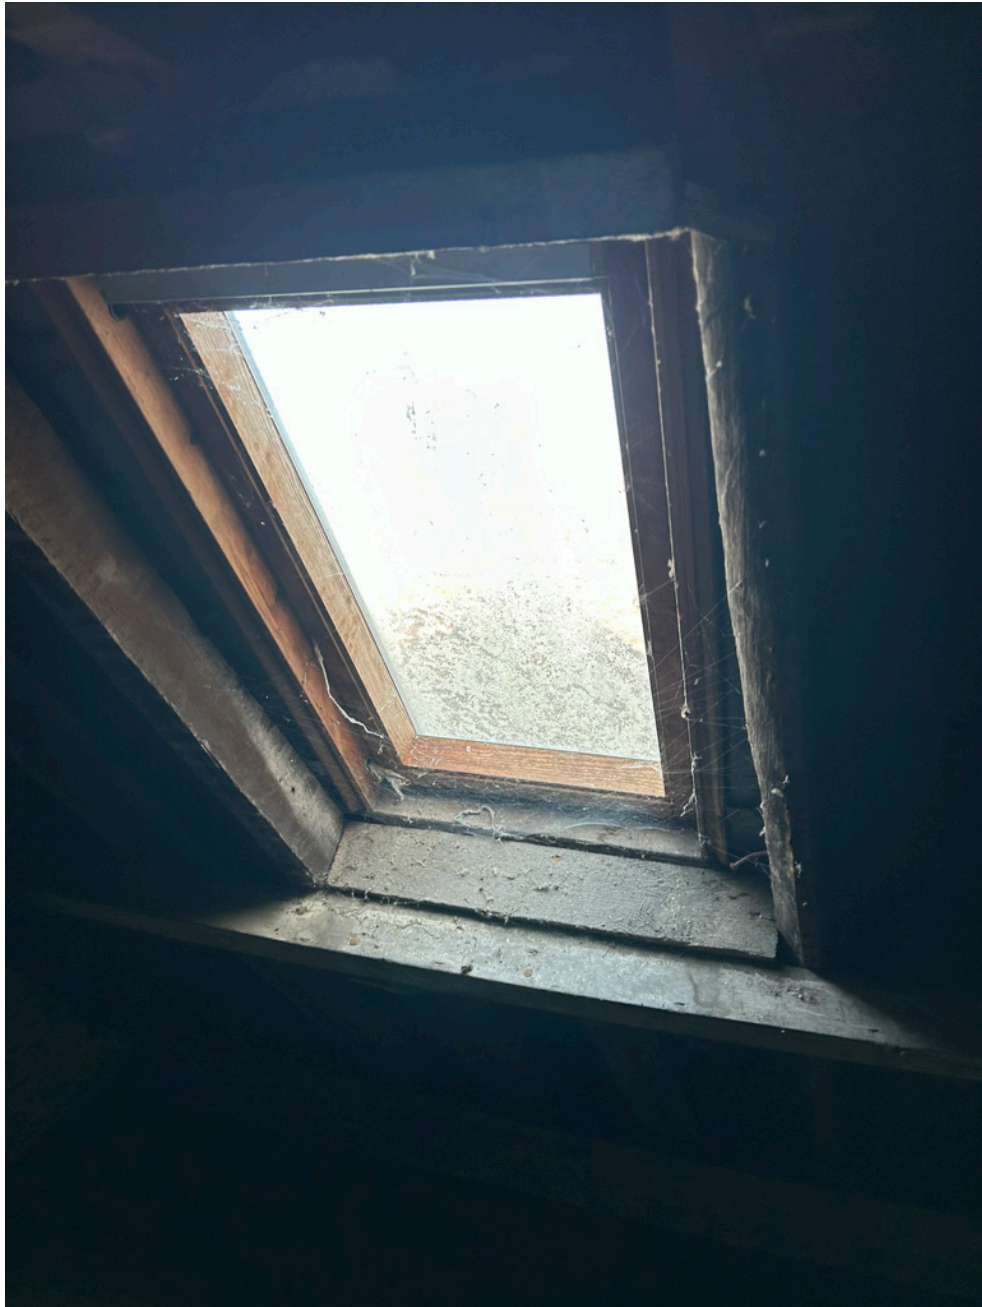
- 2.13. Window no: W13  
Location: rear roof slope  
Type: rooflight  
Period: 20<sup>th</sup> century  
Material: timber, unpainted  
Glazing: plate  
Condition: okay, but could be improved  
Advice: replace.

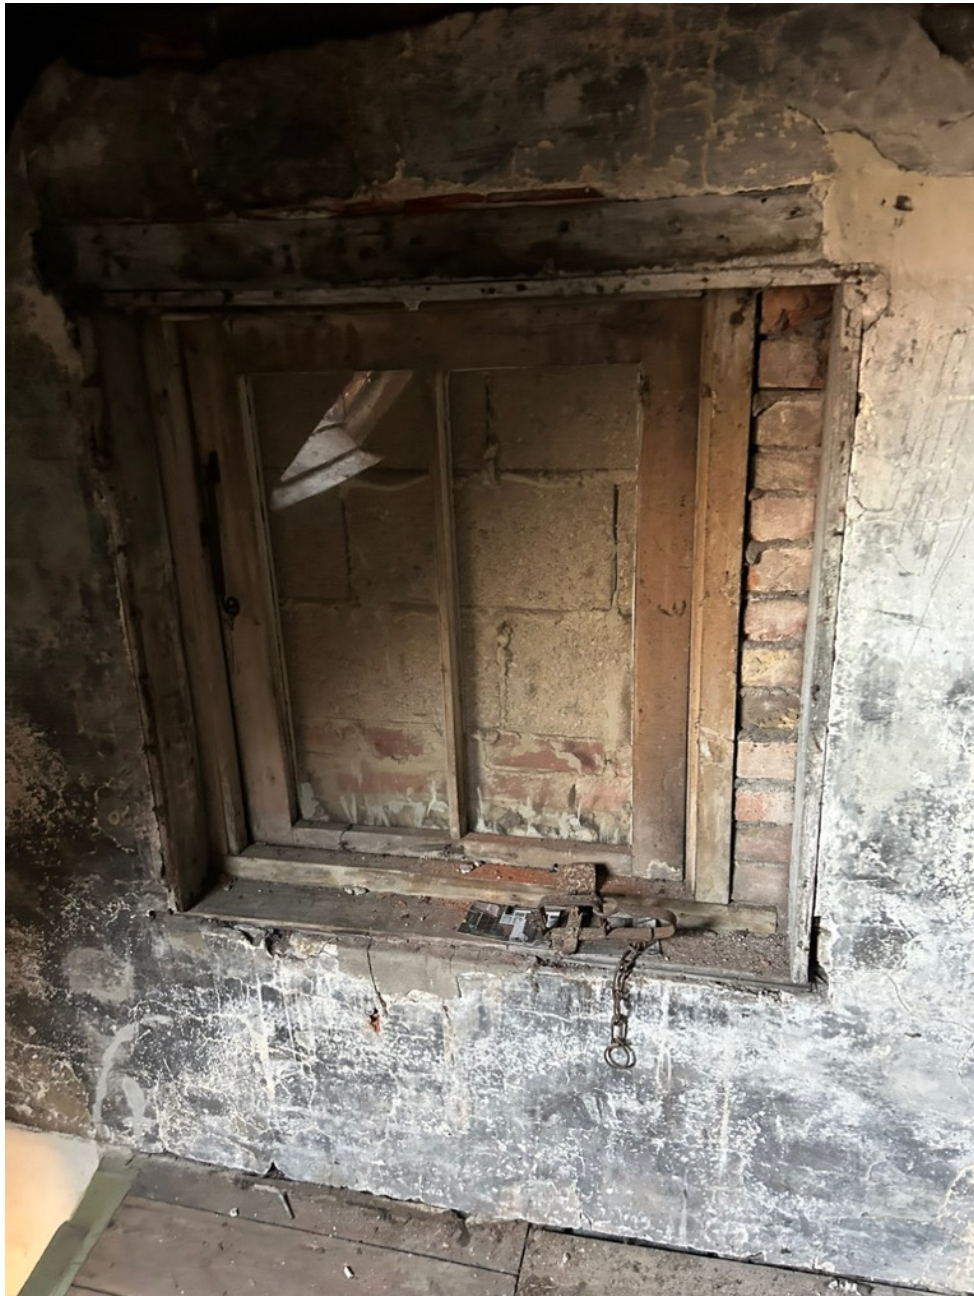
2.14. Window no: W14

Location: side elevation, though now blocked in

Period: late 19<sup>th</sup> or early 20<sup>th</sup> century, with older aperture partly infilled

Material: timber

Glazing: possibly plate

Condition: good but blocked in.

Advice: window can be blocked in, though should be retained in the wall and the aperture expressed internally.
