**21720**  
**Langstone Lodge**  
**1 Langstone High Street**  
**Langstone**  
**PO9 1RY**

**Condition.**

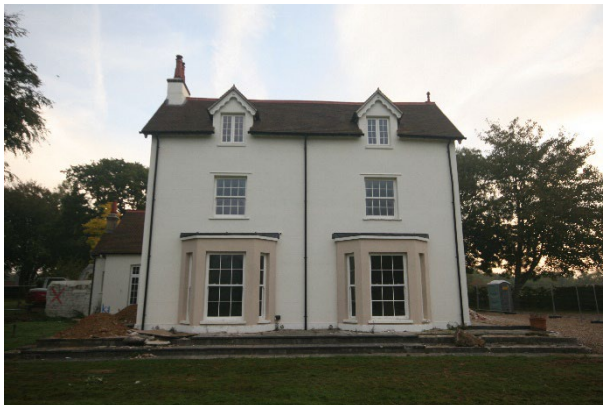
The front elevation has had a significant number of structural repairs including stitching to masonry and render consolidation and replacement.

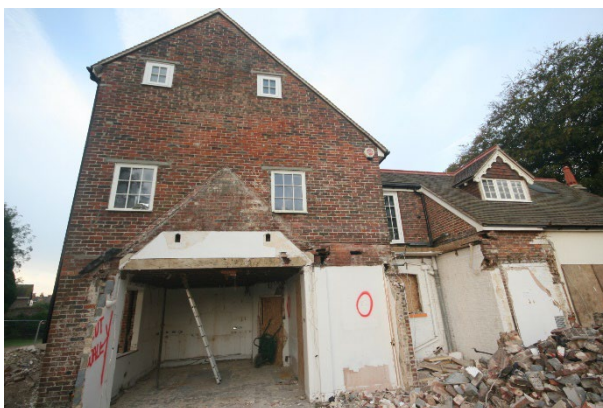
The rear elevation exhibits a significant number of interventions to the masonry with cracking, discontinuity and bulging clearly evident. Bonding is poor and erratic, and the inserted steelwork is poorly supported and restrained. Large elements of the masonry are loose and can be freely moved.

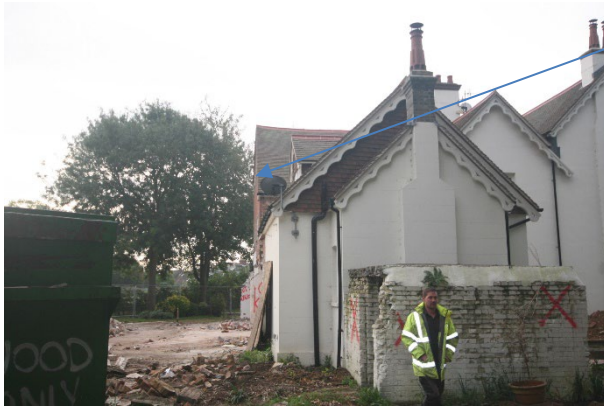
Bulging to the masonry is clearly evident externally and is mirrored internally. Bonding is poor with open joints and variations in brick size. Cracking is clearly evident in a number of locations and the masonry can easily be moved by hand.

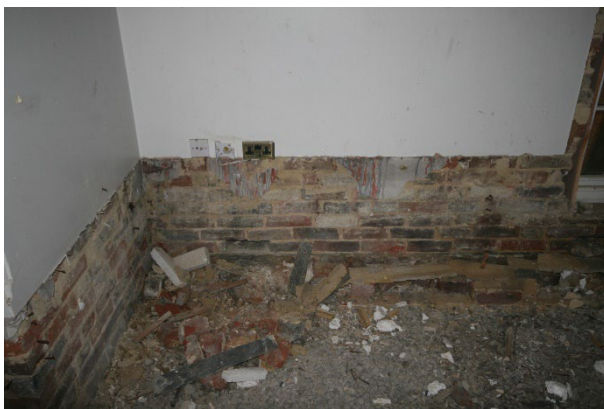
Brick bonding is poor throughout structure and varies from course to course. Mortars are erratic and vary from cementitious to lime based in an apparently random manner. Bricks are mixed with blocks showing the various phases of intervention.

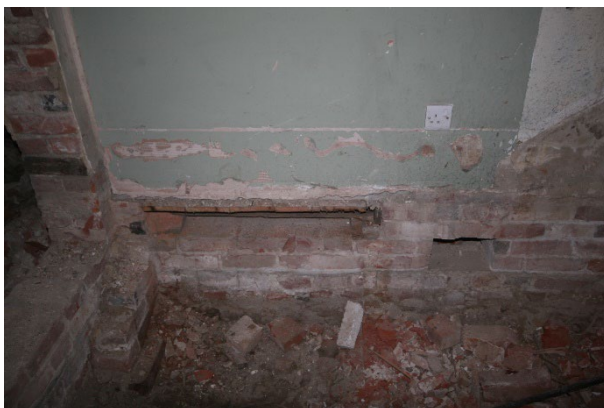
A number of random voids have been discovered within the building leaving elements poorly supported and lacking coherent restraint.

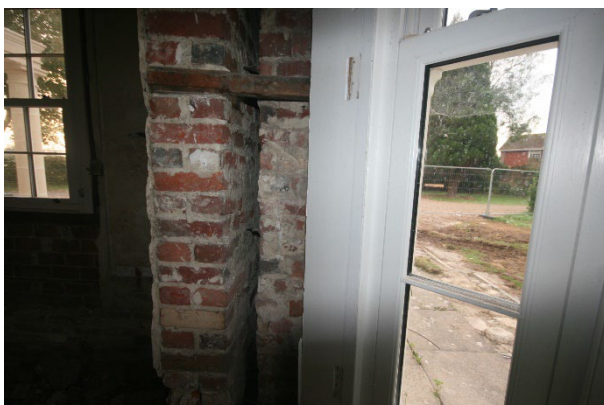
Some external walls have been discovered to be two skins of 9" masonry with a cavity and minimal ties. The ties are in poor condition and insufficient to properly restrain the masonry skin to skin.

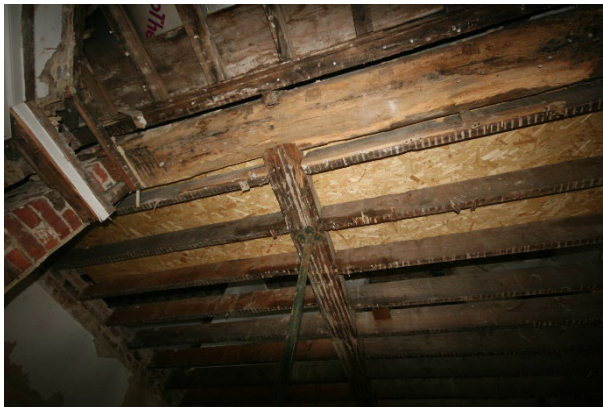
A significant number of timber elements have been found to be decayed and defective with corroded and poor connections. Timber elements supporting masonry above are decayed with wet rot.

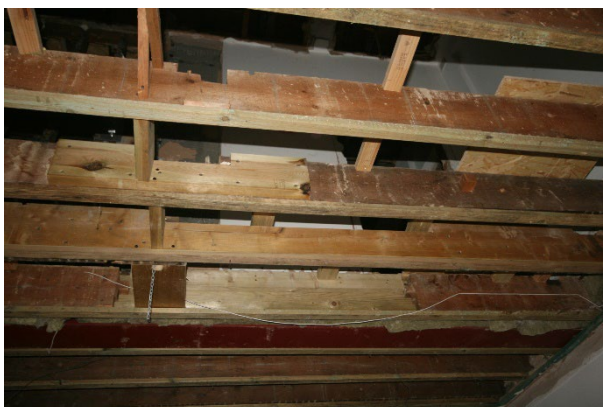
A number of existing joists to the first and second floor have been severely notched in various locations, assumed to be facilitate service installation routes resulting in excessive loss of section and now require strengthening or replacement.

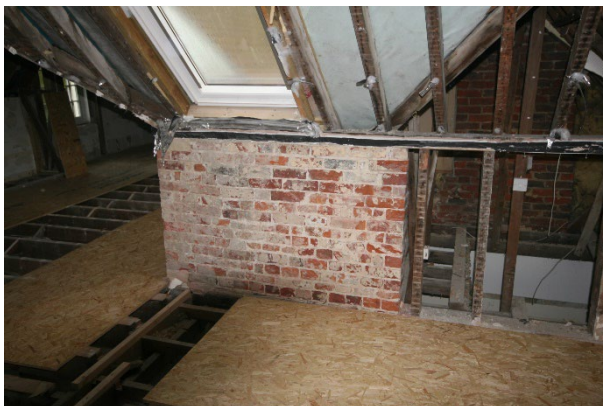
The dwarf walls supporting the roof are poorly bonded, distorted and leaning as a result of the lateral forces exerted by the unrestrained roof structure. These walls are not capable of providing the lateral restraint required for the roof in its current condition.

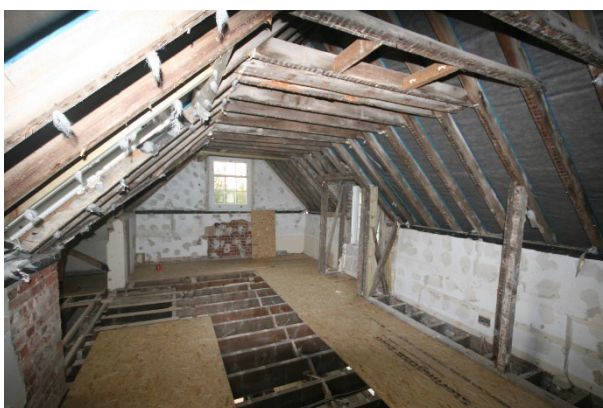
The roof structure has been previously stripped of all viable support and is now entirely reliant on the stability of the dwarf walls for lateral and vertical support. The form of the roof, with its high collar and long sarking, results in high, unresolved, horizontal loads at rafter bearing level. The

dwarf walls supporting the plates do not have sufficient lateral resistance to contain these forces and are deforming as a result. Also, the roof is constructed from minimal timber sizes with little capacity to resist these forces.

The roof structure and the supporting masonry needs to be fully reordered and strengthened to provide a competent structural solution with lateral loads fully accommodated and to negate the horizontal element as much as possible.

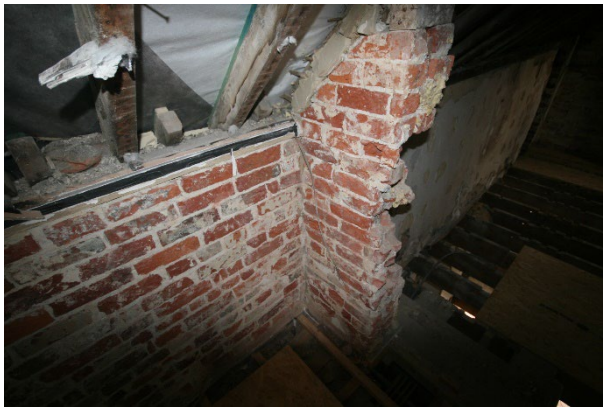
The dwarf walls supporting the roof are poorly bonded and distorted and previous openings have been poorly formed with all previous lateral restraint effectively removed leaving the walls as free-standing cantilevers with insufficient form, mass and strength to resist the overturning moments resulting from the lateral forces exerted by the roof structure. These walls require substantial reconstruction and strengthening to ensure their effectiveness or for the lateral forces to be resolved elsewhere, such as the insertion of a substantial steelwork structure to competently and fully support the roof.
