# Fallen&Found Arboriculture Ltd

## Professional Tree Inspection

Q2029\Carter\PTI\2022\_V1

**147**  
**Brook Gardens**  
**Emsworth**  
**Hampshire**  
**PO10 7LL**

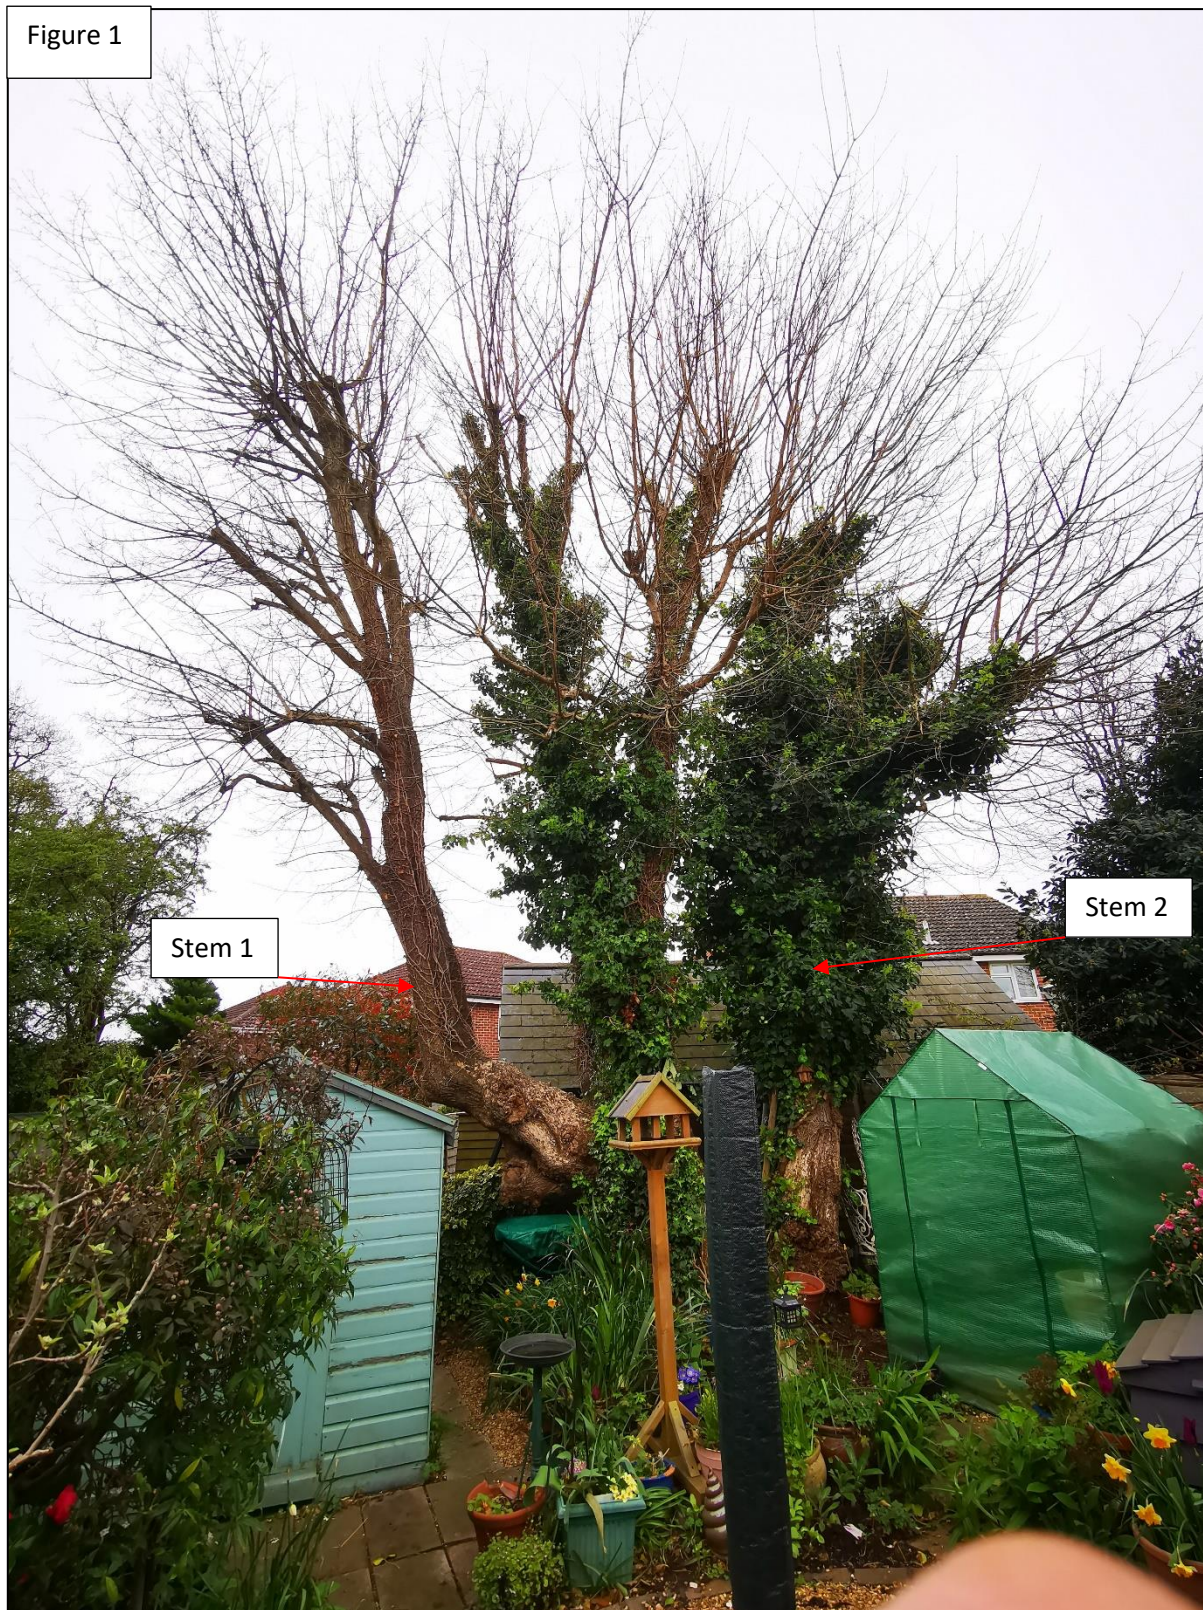
Figure 1

3.2.1. The subject tree is medium sized with a canopy which has been previously reduced multiple times. After inspecting the growth extension associated with regrowth emanating from pruning wounds on the tree, I perceive the last crown reduction operation to have taken place within the last five years<sup>1</sup>. The tree has two main stems which originate from the same point at ground level. Ivy has colonised the western most stem and proliferated upwards into the tree's canopy. The tree is located within striking distance of numerous above ground targets and areas of high-moderate occupancy from property owners.

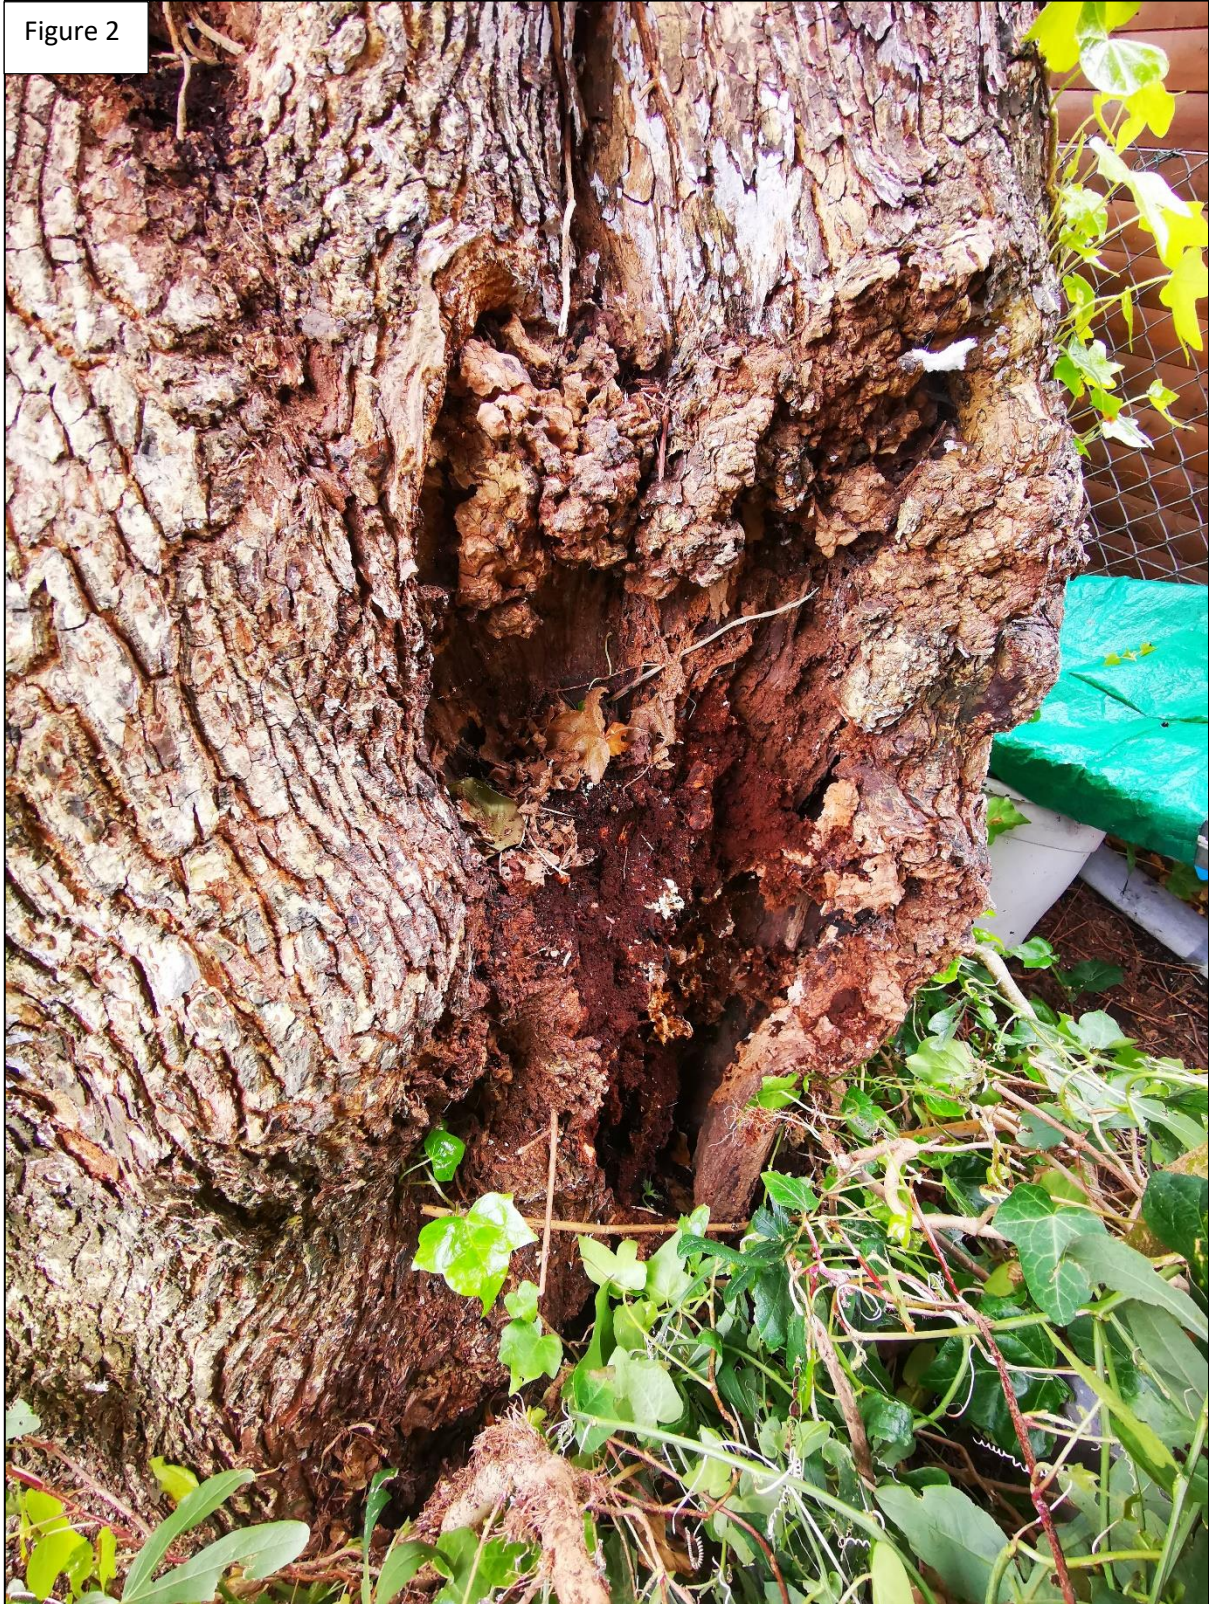
Figure 2

3.3.3. The two main stems of which the tree comprises appear to originate from a common coppice stool. A large decay cavity is located close to ground level on the western side of the stem 1 (easternmost)<sup>2</sup>. A probe can be inserted to an approximate depth of one metre at an oblique angle into the cavity. The decayed area surrounding the basal cavity measures 400mm wide and 1000mm in height. The decayed heartwood at this location has a dry crumbly texture and is dark red in colour<sup>3</sup>. Another area of decay is present on the adjacent stem located to the west of stem 1 at approximately the same height.

The decay and subterranean cavity discovered during the inspection indicates the presence of a now fully decayed and no longer existent central stem which was historically located between the two surviving main stems which the tree comprises of.

The subject tree should be removed by being sectionally felled to ground level as soon as practicable.

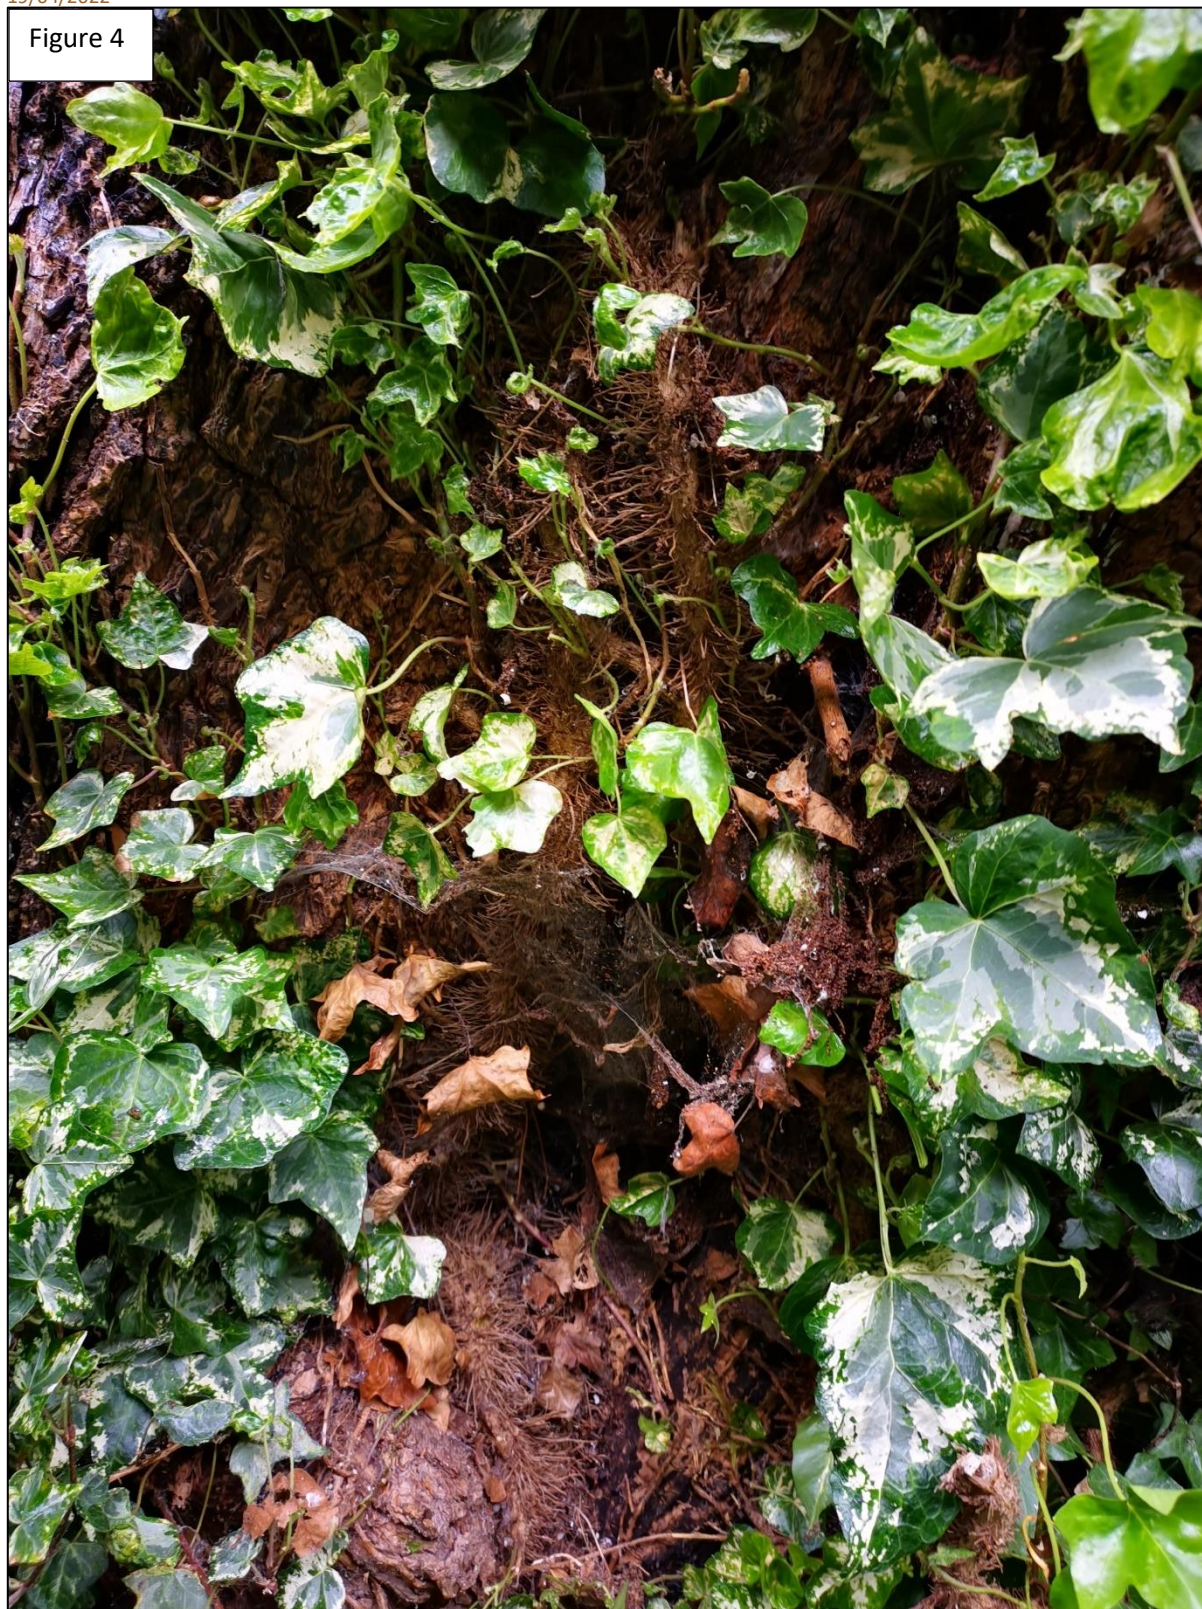
3.4.1. An old desiccated fungal fruiting body was present on the south-eastern side of stem 1 located beneath some ivy at an approximate height of 400mm above ground level. A photograph of this area can be viewed in Figure 4 of Appendix A within this document. Further heavily decayed fruiting bodies were also present upon the floor beneath this area. I inspected the fungal fruiting body which I removed from beneath the ivy. Although old and desiccated it is obvious to me that this fruiting body belongs to the known heartwood decay pathogen Beefsteak Fungus (*Fistulina hepatica*)<sup>4</sup>.

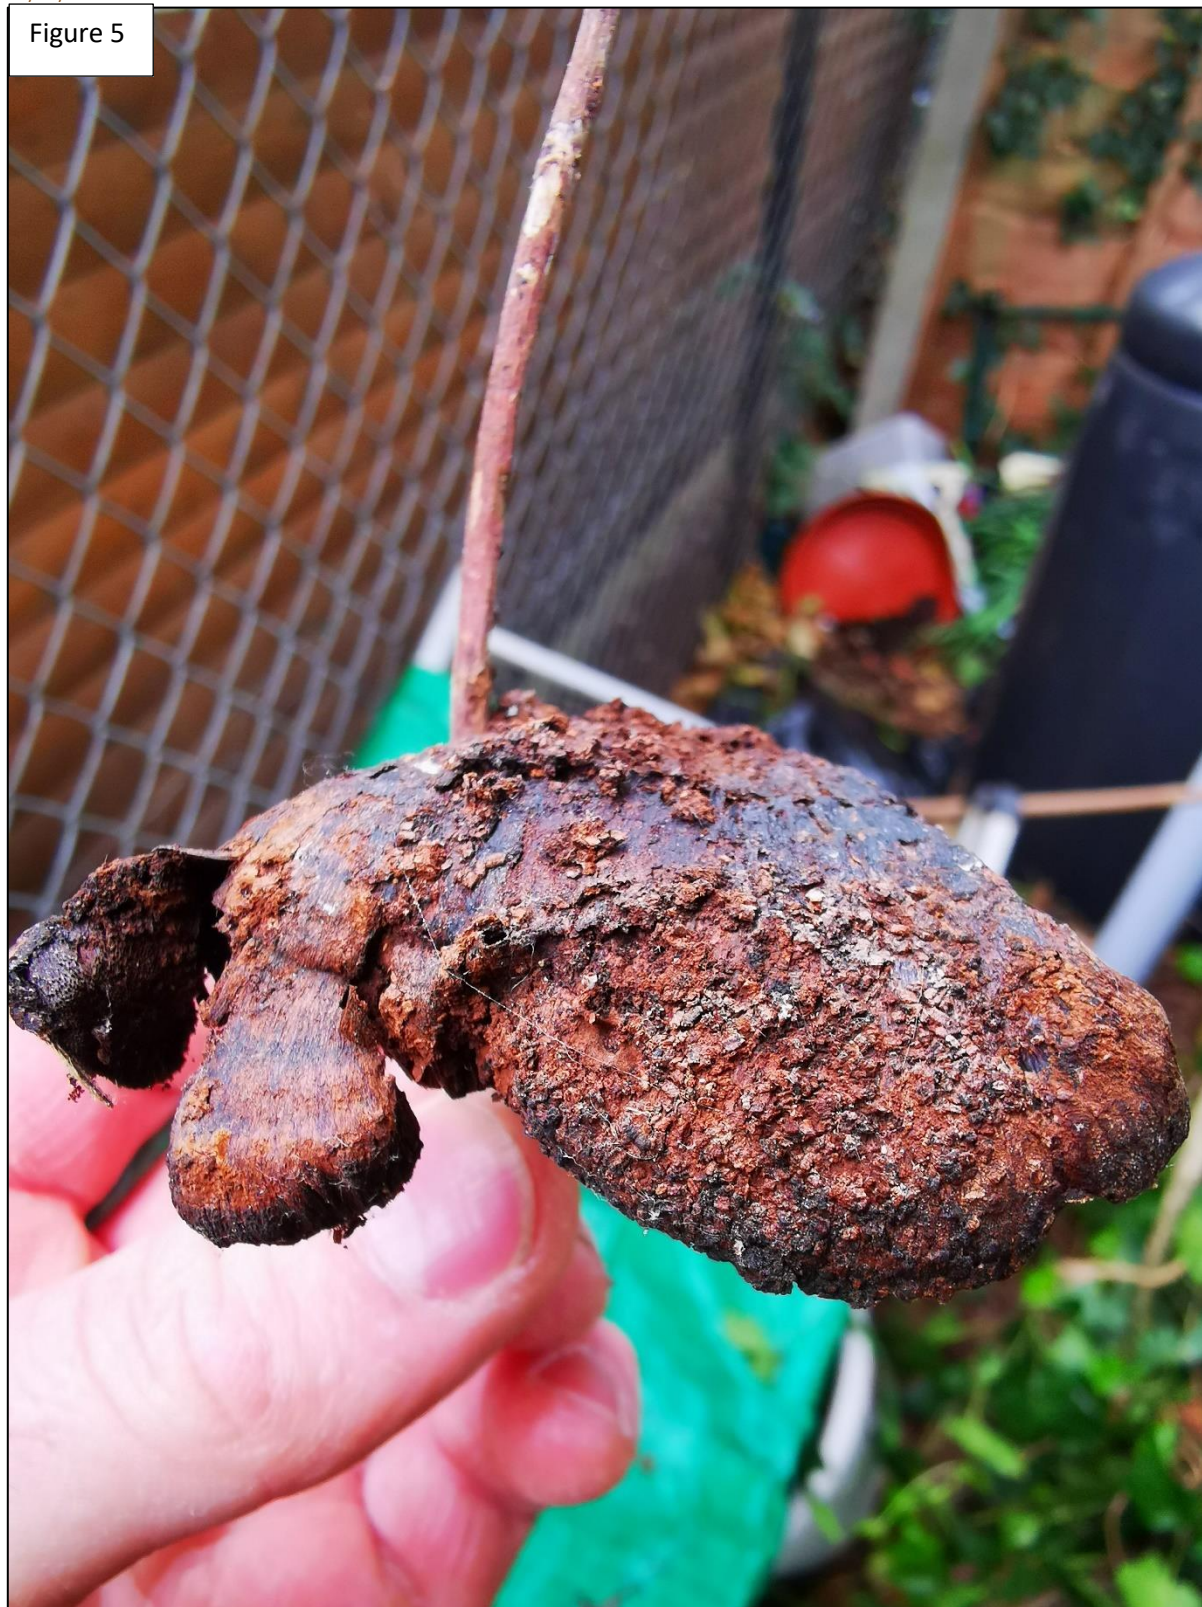
Figure 5

The known heartwood decay pathogen Beefsteak Fungus which was identified during the inspection is known to parasitise a wide range of broadleaved tree species including Field Maple. When this decay pathogen is hosted on tree species with a durable heartwood i.e., Common Oak it is known to be slow acting. Consequently, the interaction between the decay and host can be managed through pruning of faulted tree components or through crown reduction. Unlike Oak, Field Maple is not known to have a durable heartwood with comparatively lower amounts of Suberin and Polyphenols both of which are chemicals which have highly antifungal properties. As a result, the decay caused by Beefsteak fungus will proliferate at a much higher rate eventually resulting in biomechanical failure of the tree or component parts of its structure.

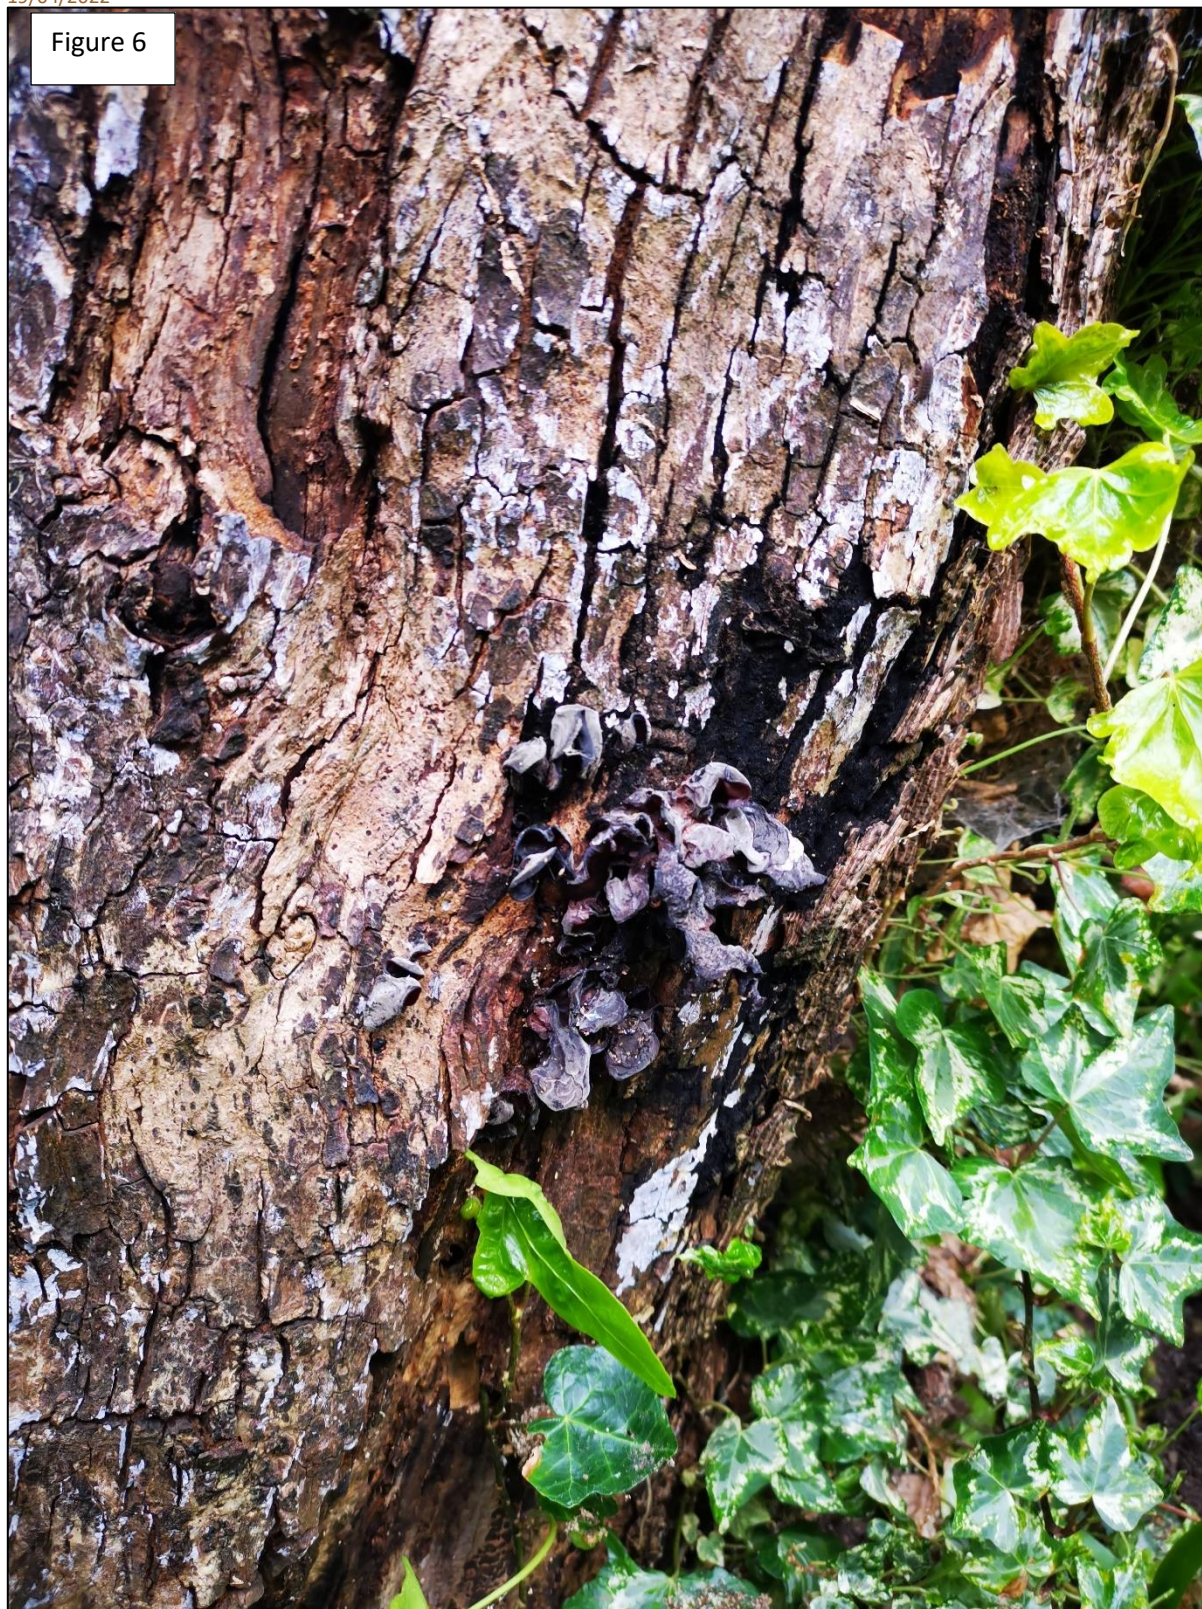
Figure 6

3.4.2. Further fungal fruiting bodies belonging to the saprophytic<sup>5</sup> fungi Jelly Ear (*Auricularia auricula-judae*) were present upon a further area of decay located on the southern side of stem 1 at an approximate height of 300mm above ground level<sup>6</sup>.

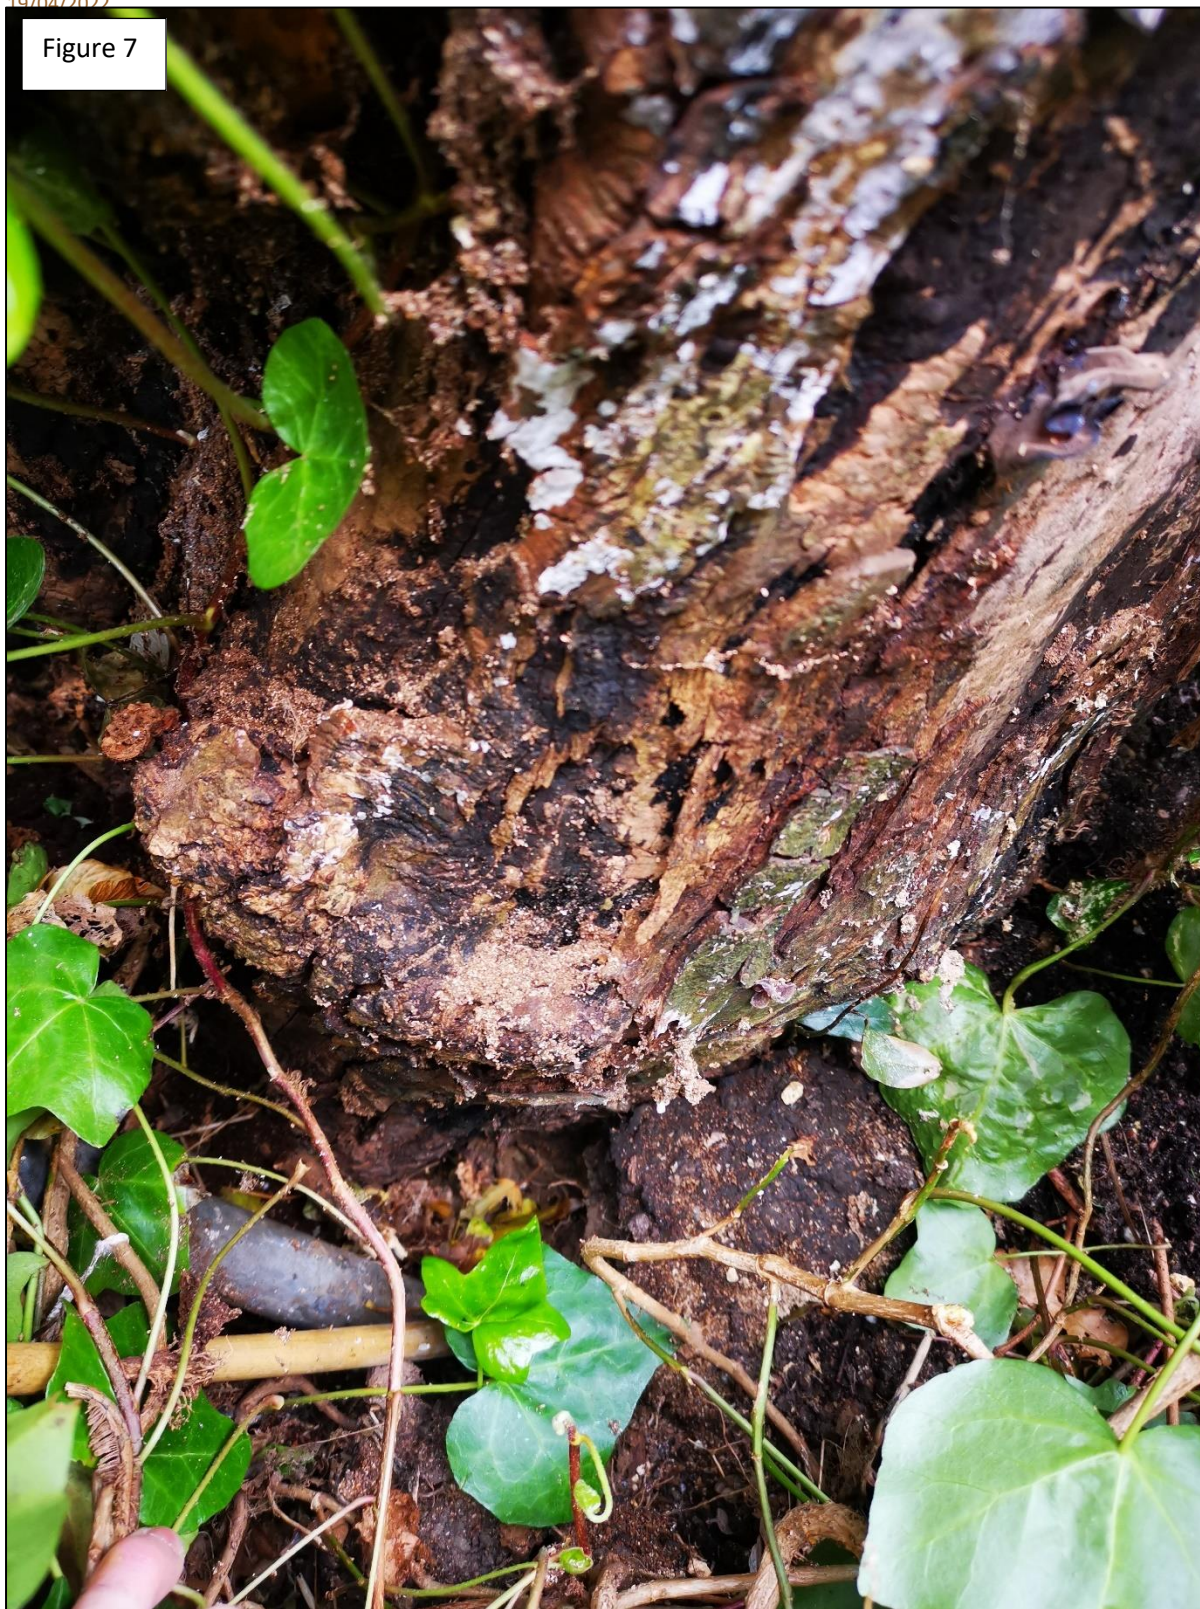
Figure 7

3.4.4. Bark necrosis is prevalent on the southern side of Stems 1 and 2<sup>7</sup>.

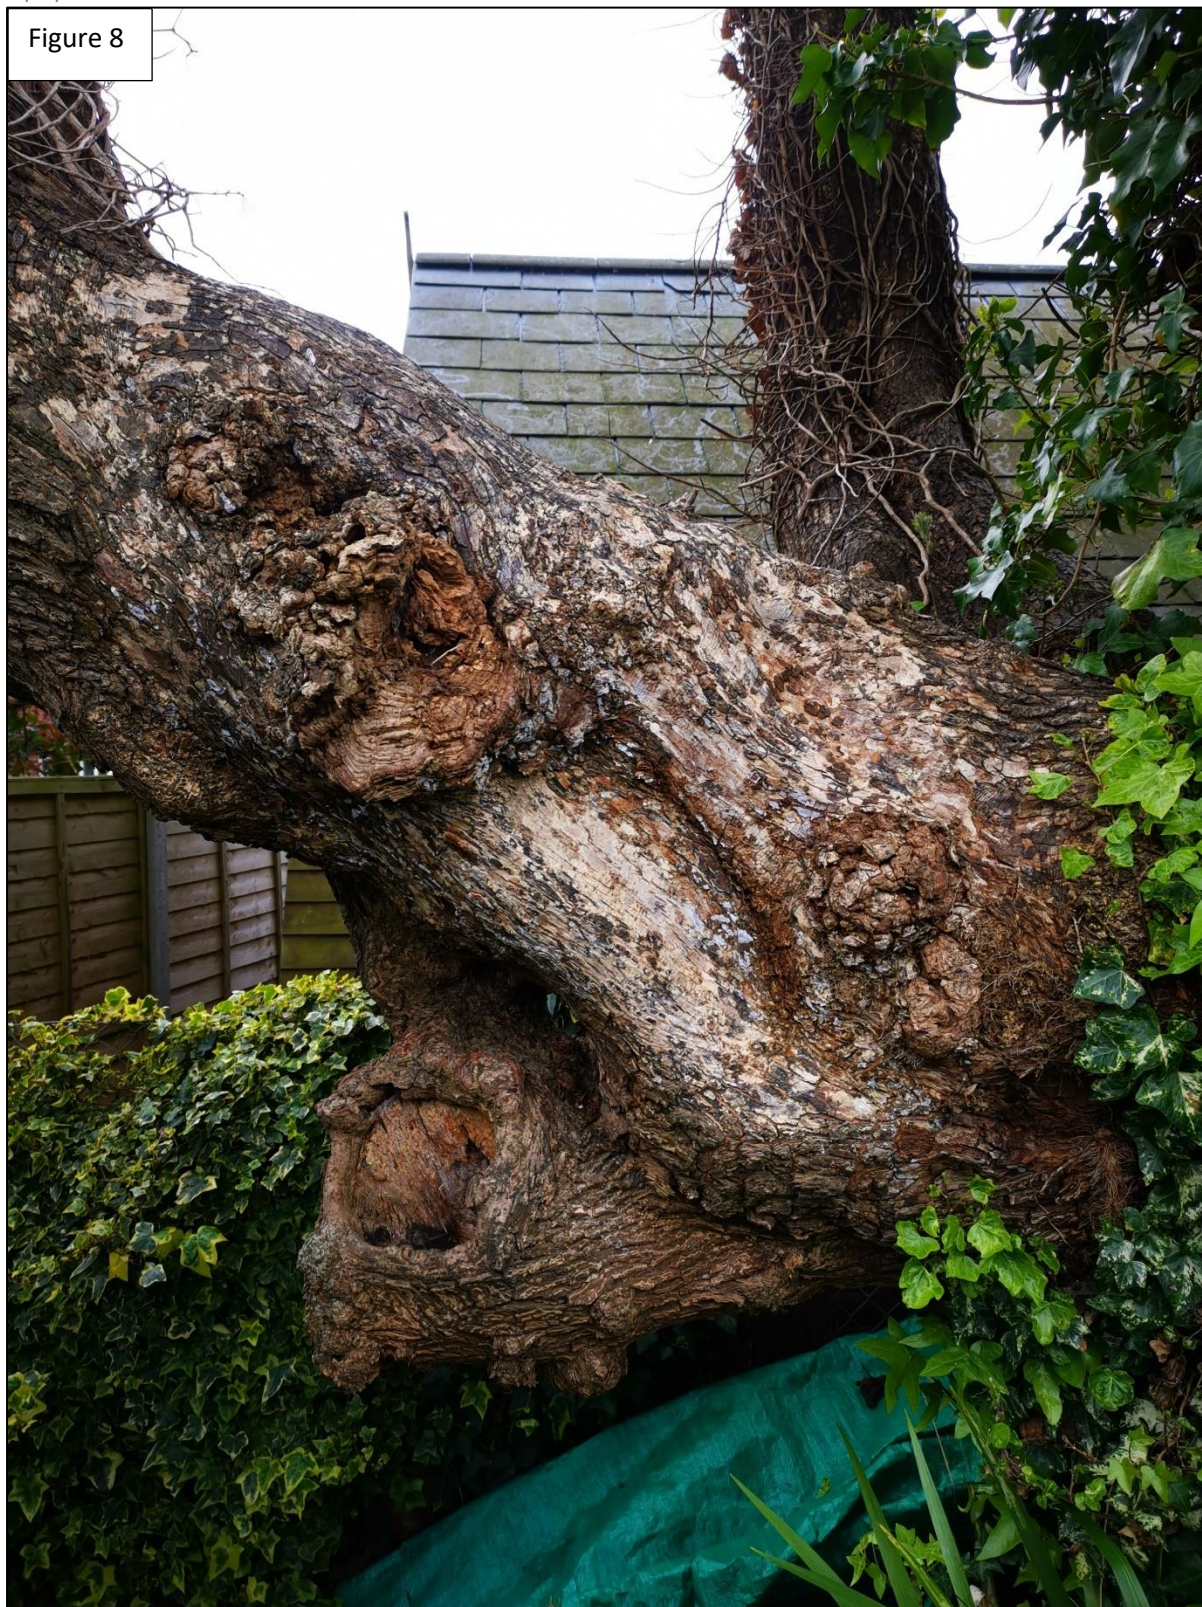
Figure 8

3.5.1. A large lateral limb projecting eastward from Stem 1 has significant decay and cavity formation<sup>8</sup>. Historic pruning wounds have failed to occlude leading to the formation of cavities and the propagation of decay<sup>9</sup>. The subject limb projects toward a small garden shed before changing direction and projecting vertically. The uppermost portion of this limb carries a significant amount of growth which makes up the easternmost extent of the tree's canopy. A black exudate was observed at the base of this limb where its branch attachment is made to the parent stem. Further decay is observable in this area accompanied by cambial dysfunction<sup>10</sup>.

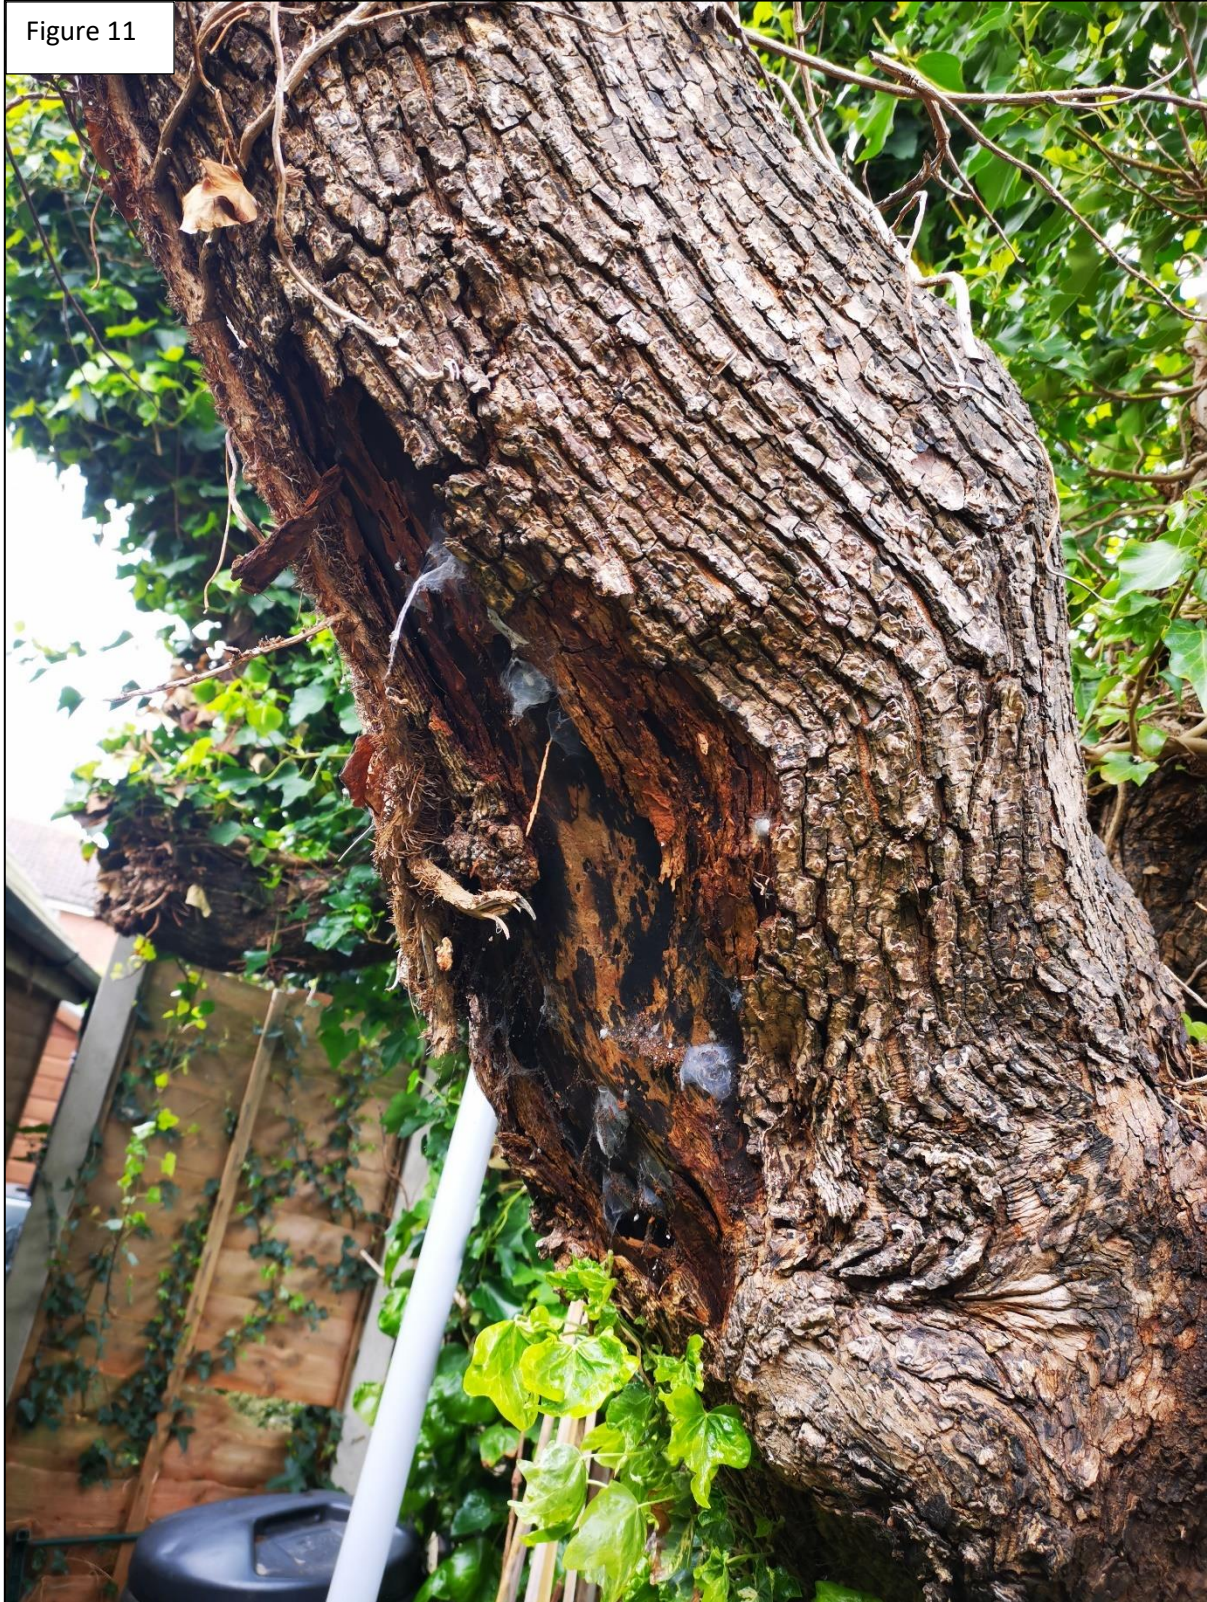
Figure 11

3.5.2. A branch emanating from Stem 1 at approximately 1.6m above ground level projects south over the neighbouring property and above a large garden shed. During my inspection of the limb, I observed exposed heartwood which is undergoing decay. I also noted dead bark which I was able to remove by hand. Removal of this dead bark revealed necrotic and dysfunctional cambium beneath<sup>11</sup>.
