FORMER LANGSTONE TECHNOLOGY PARK,  
LANGSTONE ROAD, HAVANT.  
WATCHING BRIEF VERIFICATION REPORT

| Document No | Issue Date | Description | Prepared By: | Reviewed By | Approved By |
|---|---|---|---|---|---|
| ESL/SSF/101 | September 2022 | Original | Simon Farr | David Slater | Neil McLeod |

## Watching Brief - Verification Report

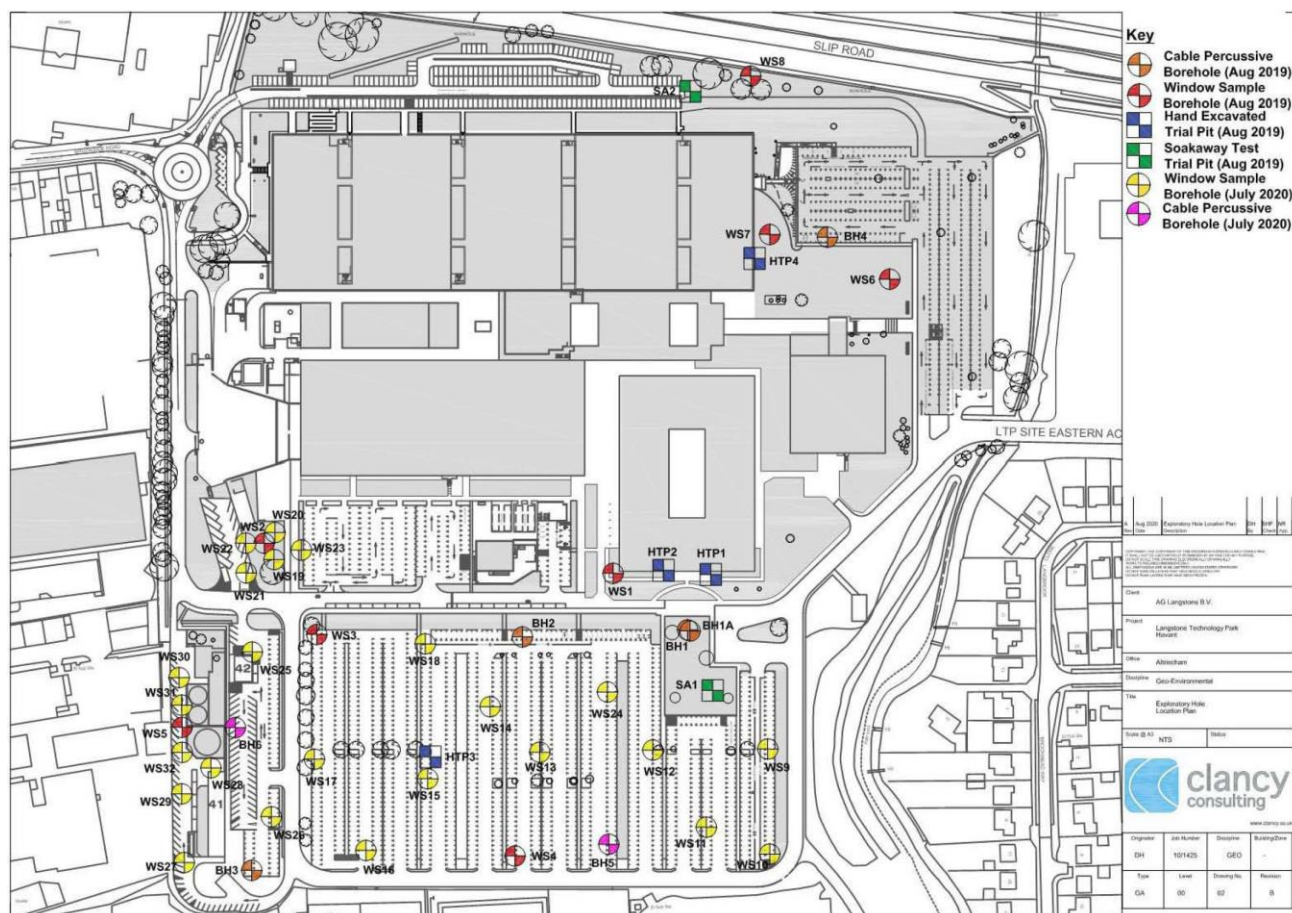
Figure 5 – SI locations.

In addition to the contamination in and around WS5, further potential soil contamination was noted around WS2, see figure 5 for respective locations.

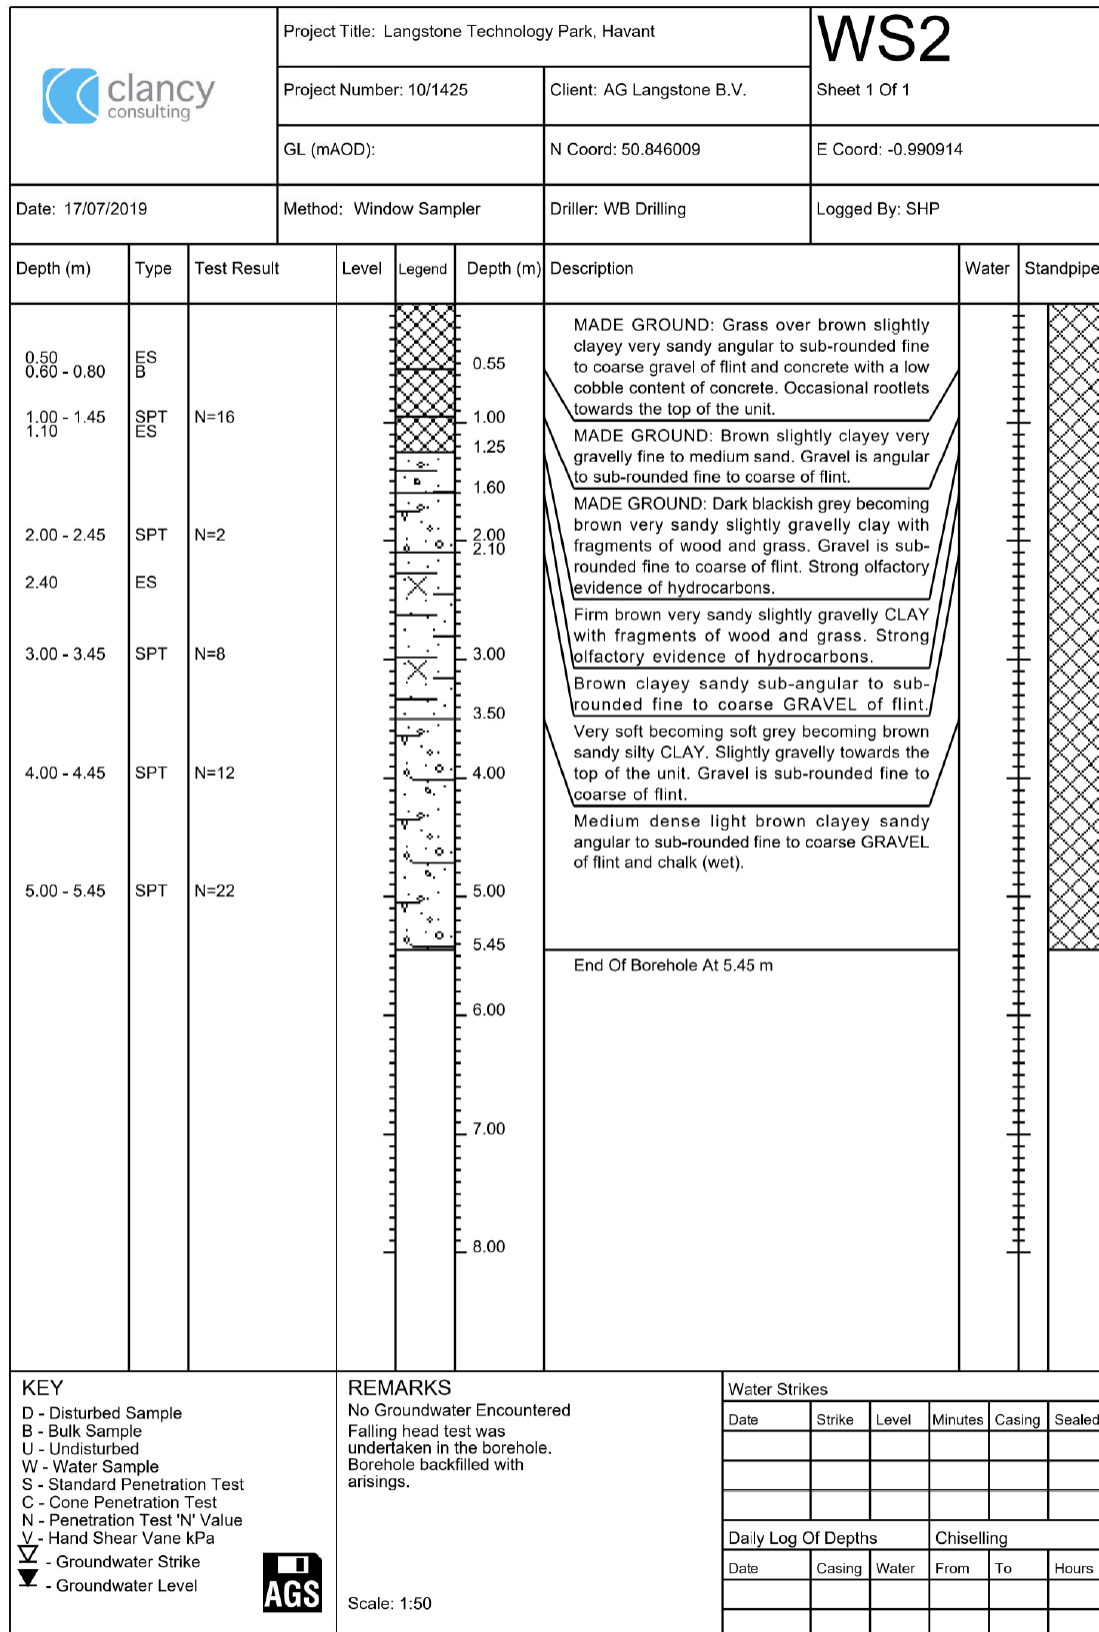
Figure 6 – Borehole Log WS2

Clancy noted strong olfactory evidence between 1.0m and 1.6m bgl, this was supported by laboratory testing of soils from 1.1m bgl. See figure 6 for borehole log and table 1 for summary of laboratory testing.

None of the additional borehole installations indicated any significant hydrocarbon contamination, indicating that any contamination located at WS2 as being small in volume and isolated. In addition, the laboratory testing of WS2 indicated the absence of short chain (mobile) contaminants. Therefore, presenting a low risk to groundwater.

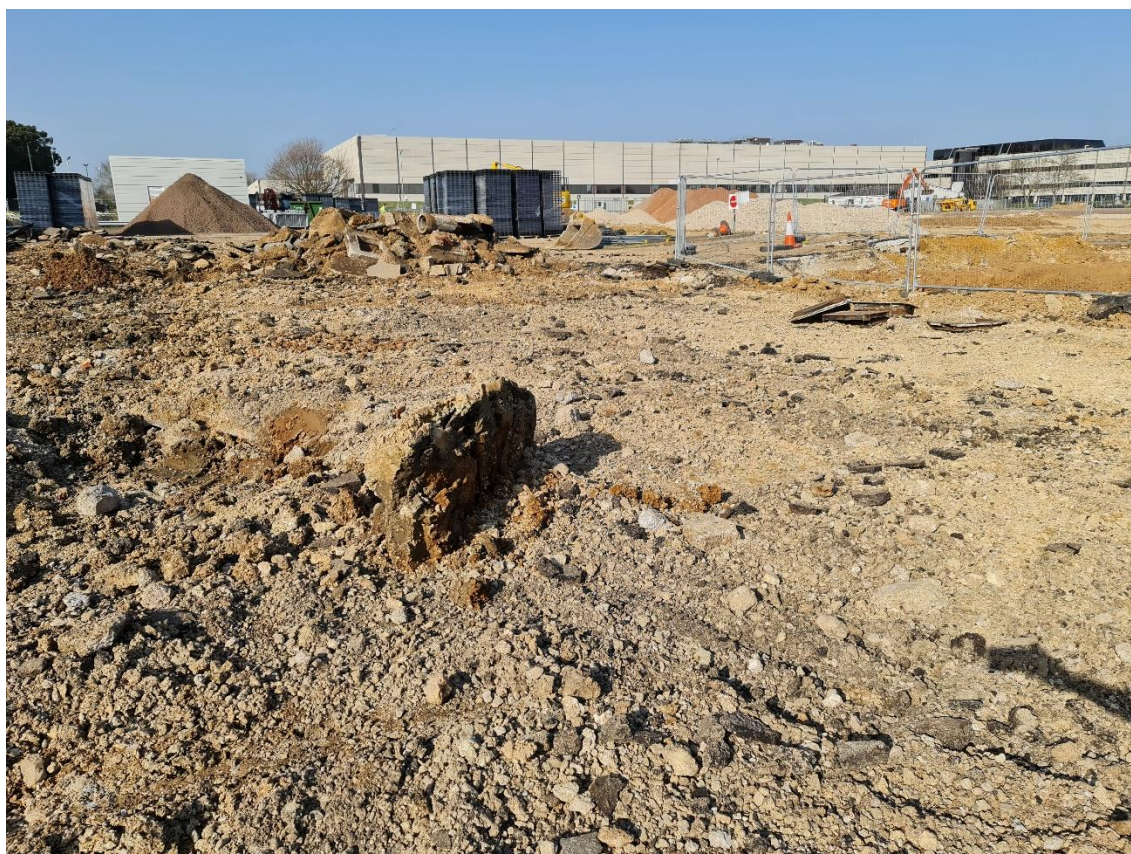
Figure 7 – Southwest development platform - Hardstanding and topsoil removed

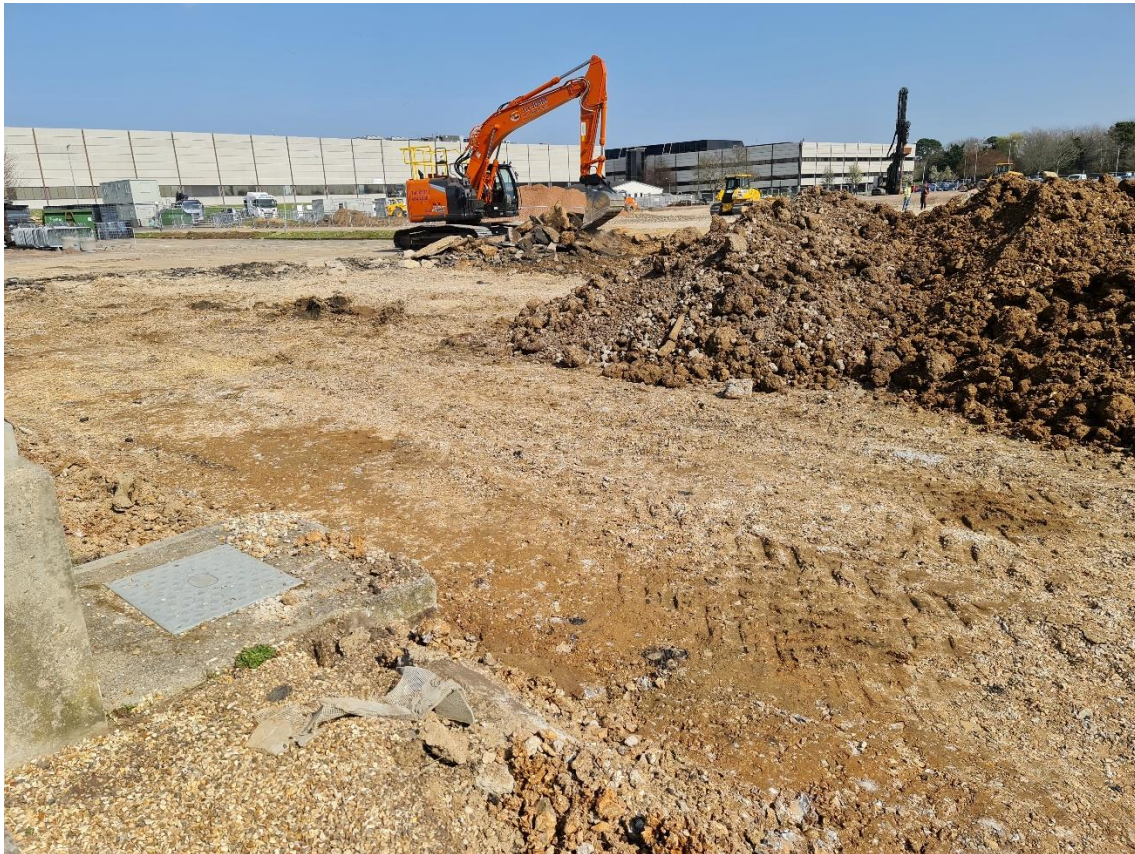
Figure 8 – Segregation of soils (made ground to be reused in SW and concrete for crushing in NE)

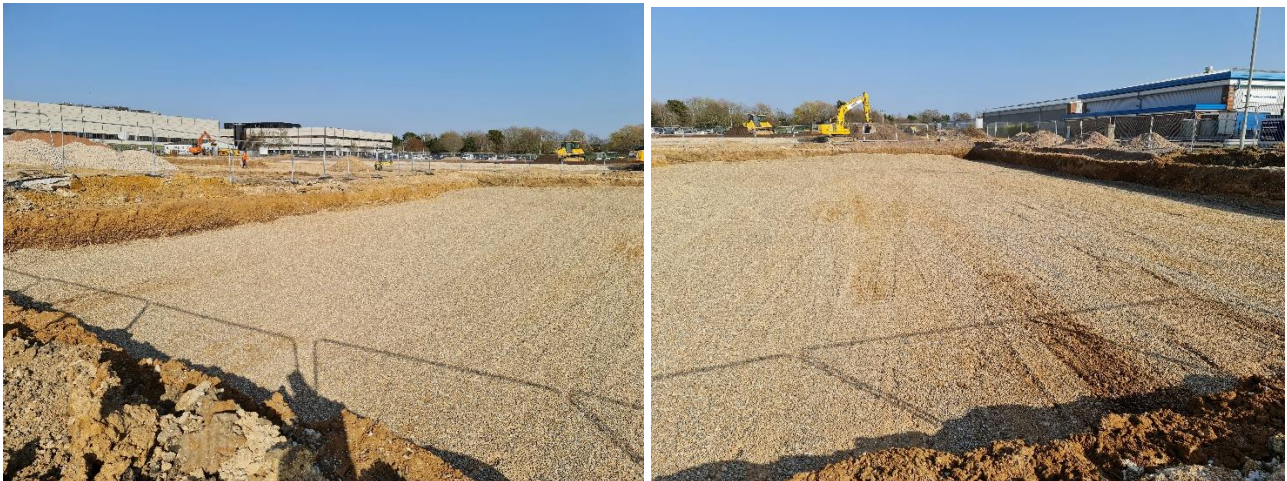
Figure 9 – Attenuation tanks (resulting in mostly natural soils)

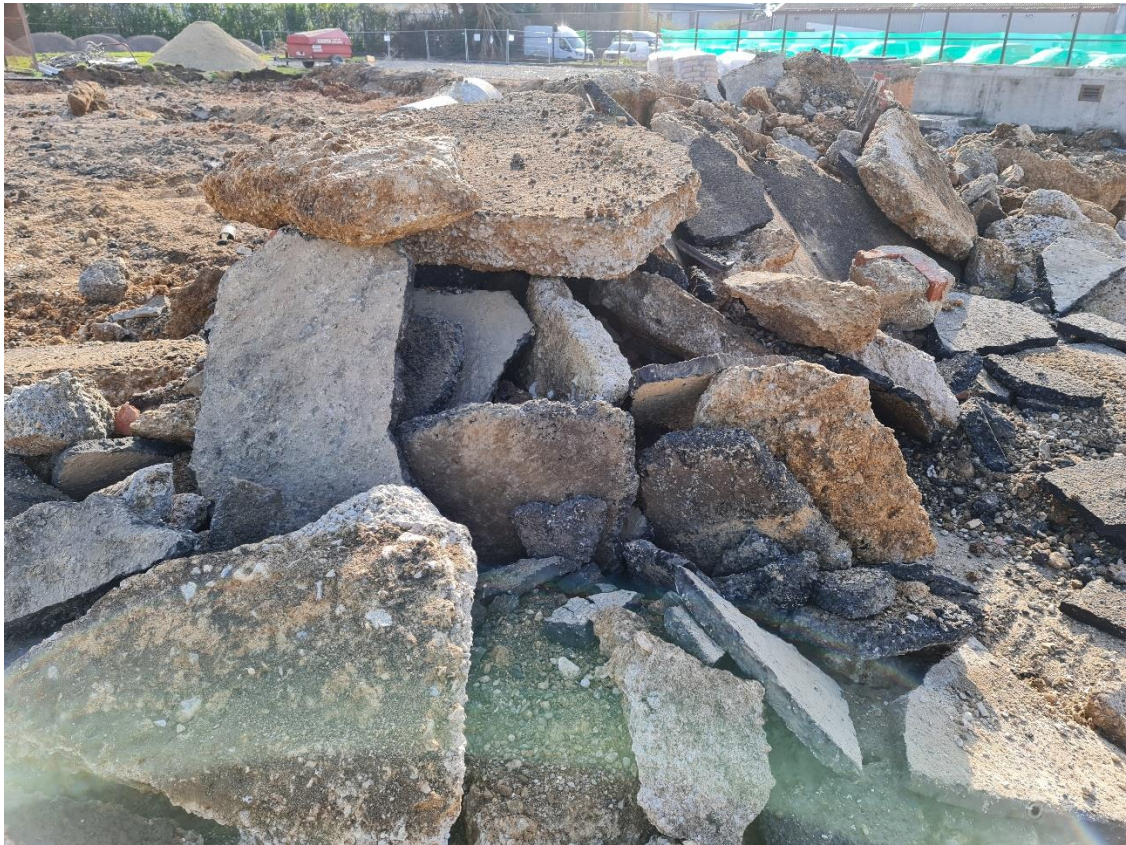
Figure 10 – Oversize and concrete for crushing (NE)

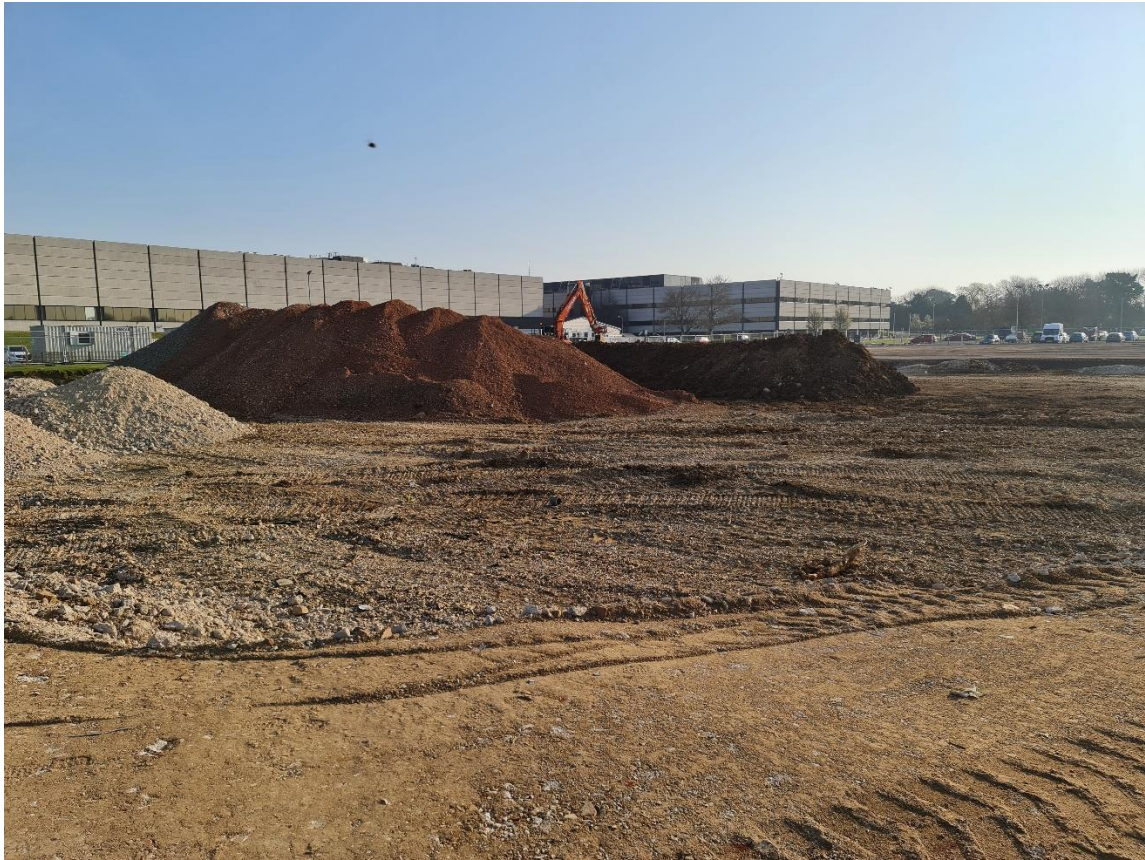
Figure 11 – Use of made ground and imported aggregate to create formation levels and subbase for building slab

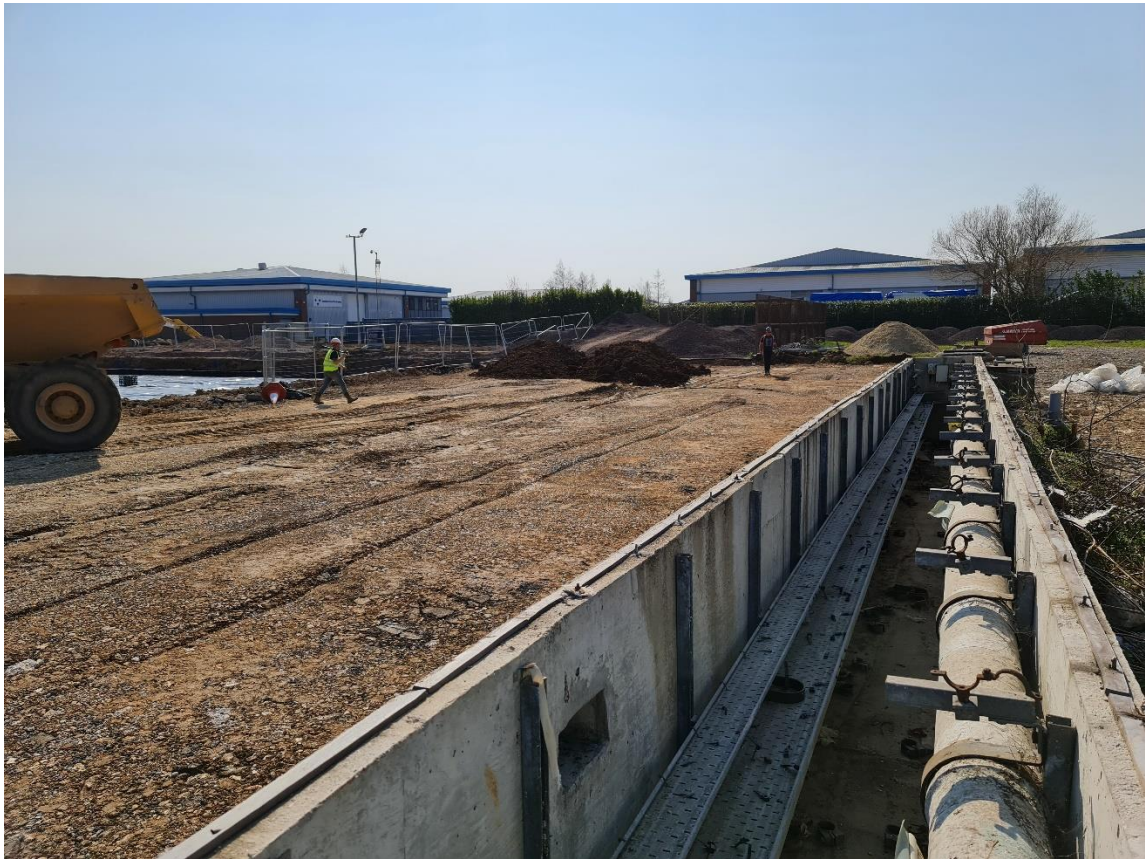
Figure 12 – Stockpiling (suitable) made ground to raise levels to formation

The above testing shows the suitability of the made ground for reuse on the Southwest development. No unsuitable soils were observed during the enabling works.

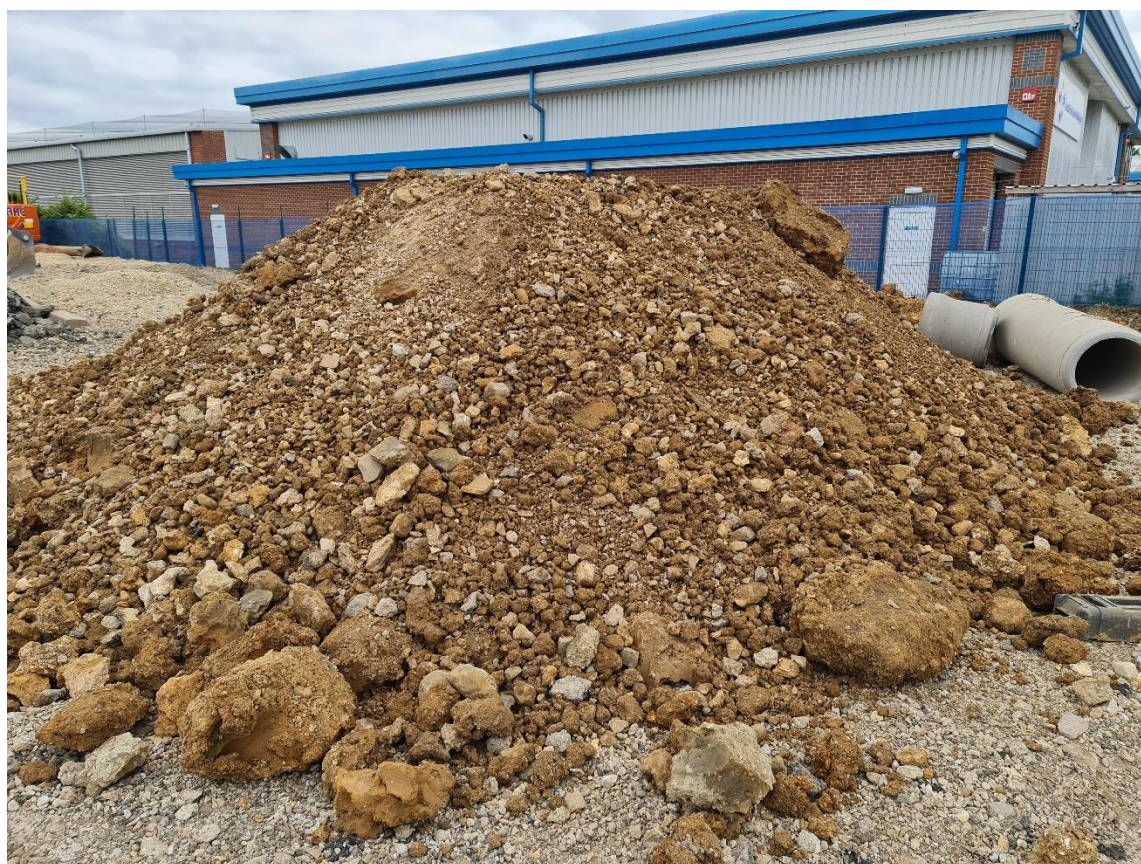
Figure 13 – Stockpiled drainage arisings

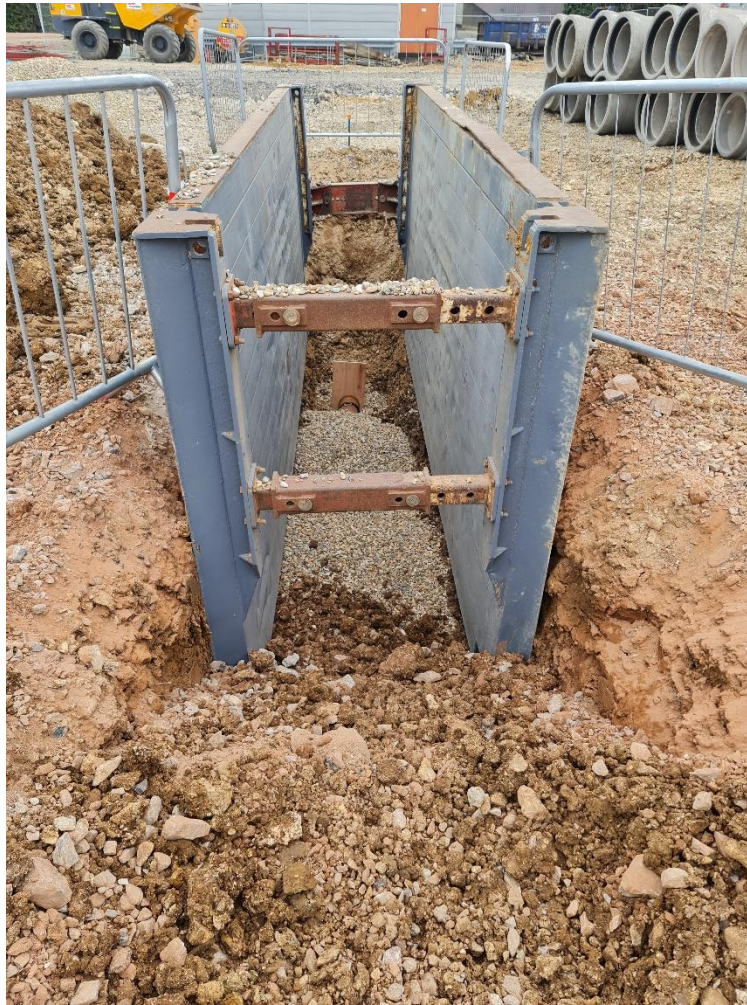
Figure 14 – Ongoing drainage works

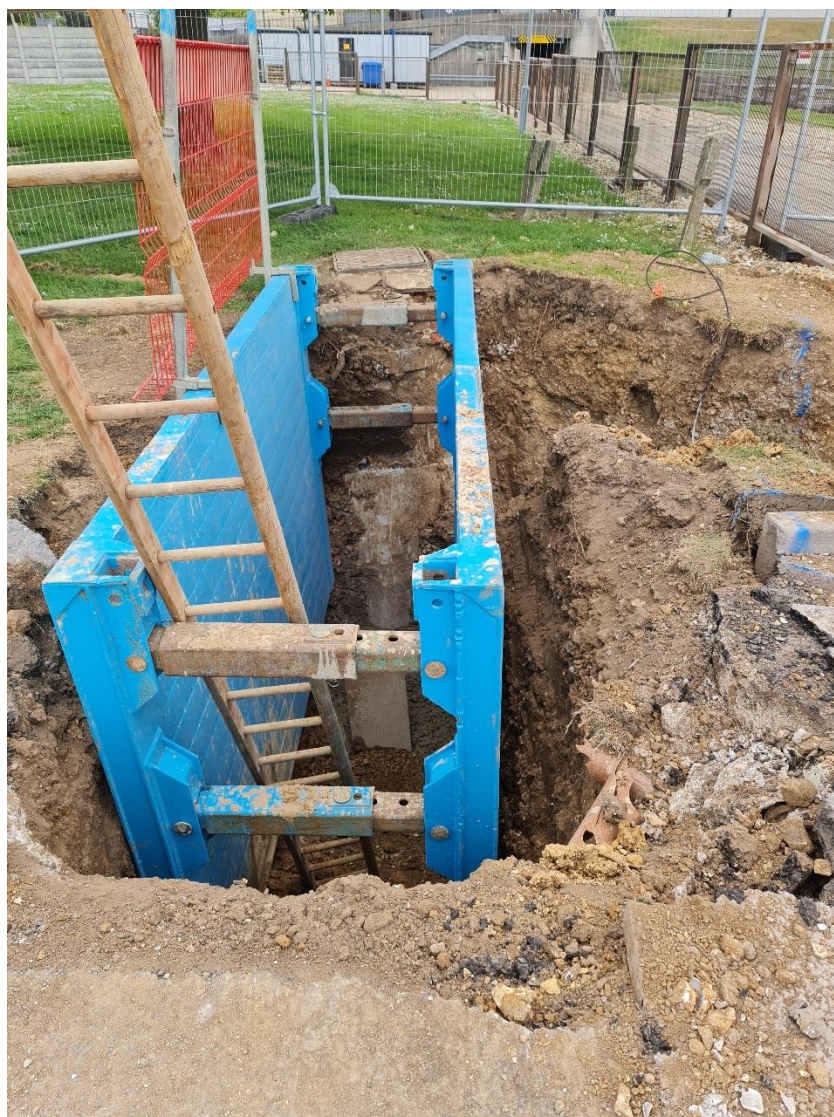
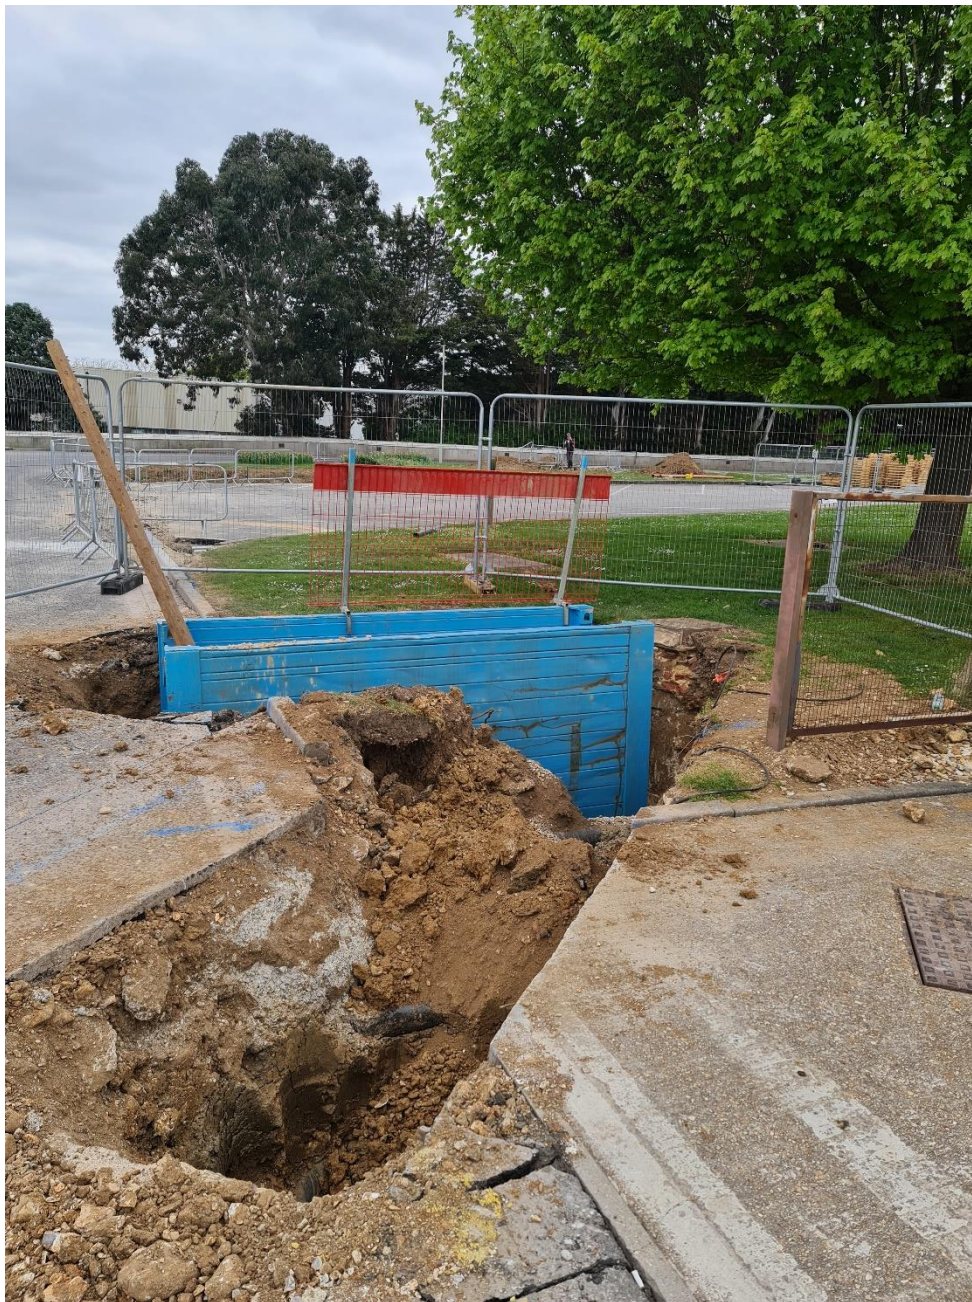
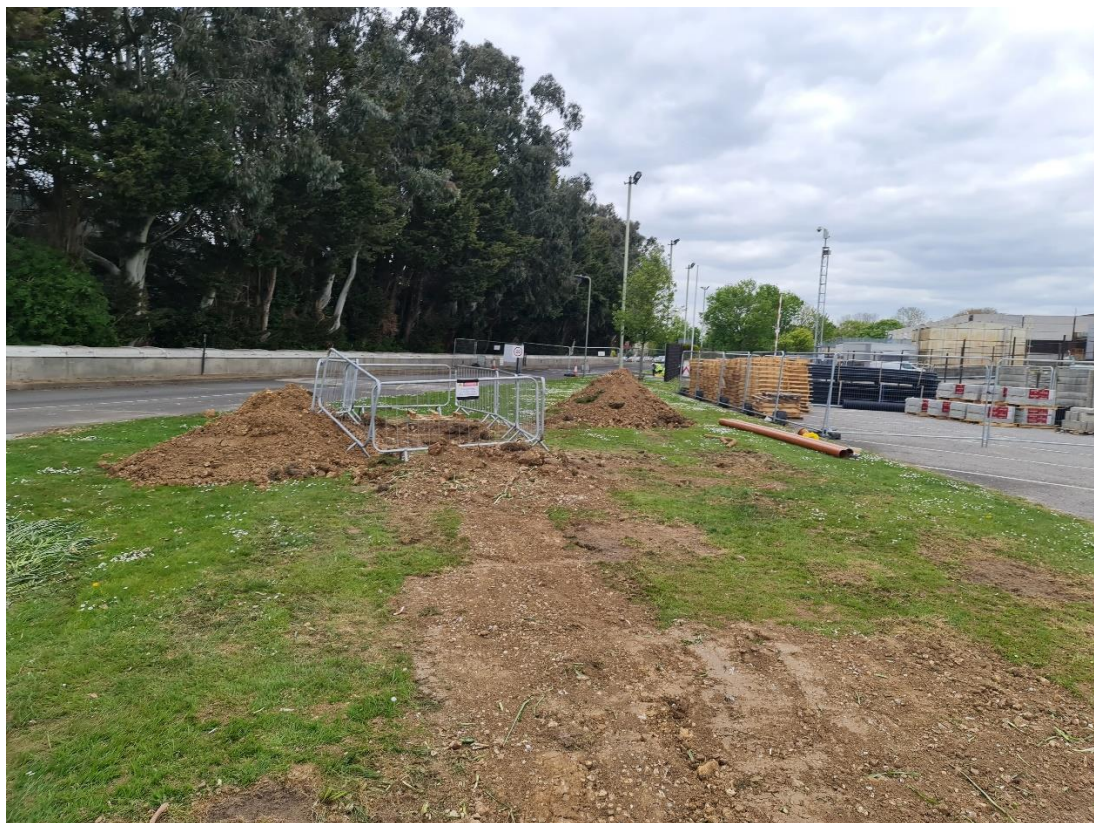
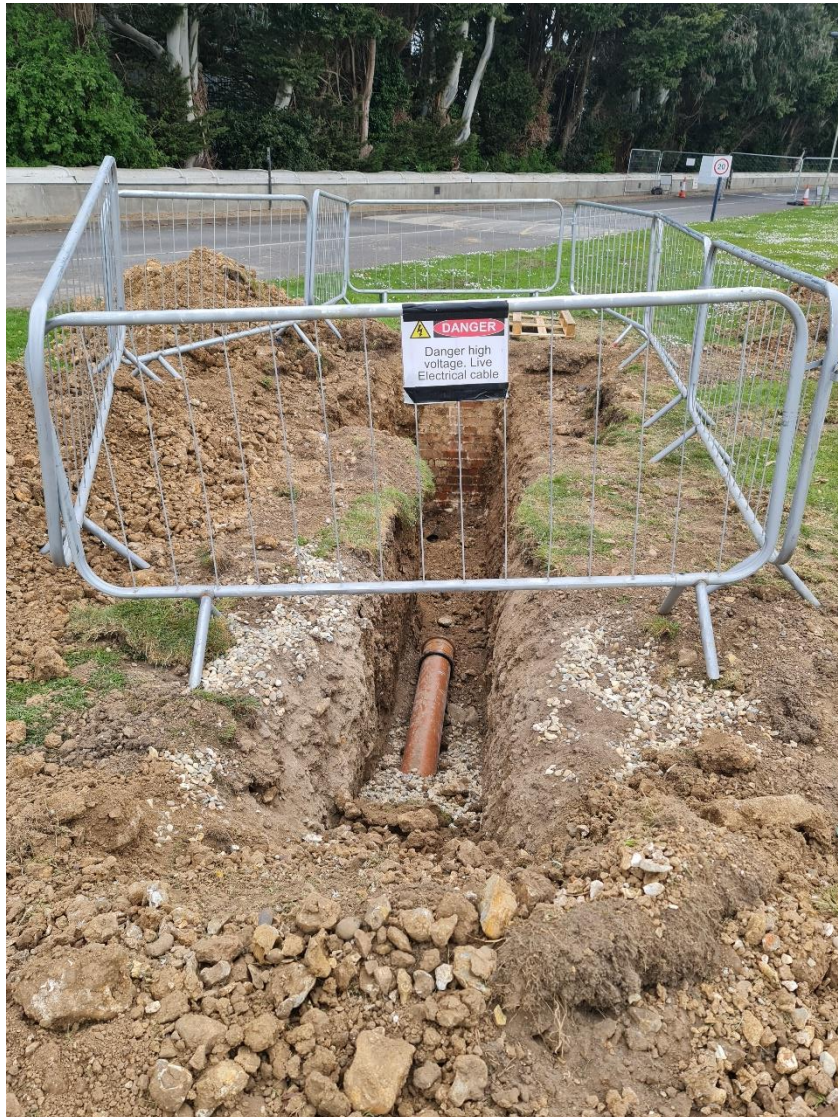
Envirotreat attended site for the duration of drainage works in and around WS2, all excavated soils and the sides / base of all excavations were assessed by visual, olfactory and headspace analysis (by PID).

No contamination was observed, and the excavated soils were reused to reinstate the excavations.

Figure 15 – Drainage work in and around WS2

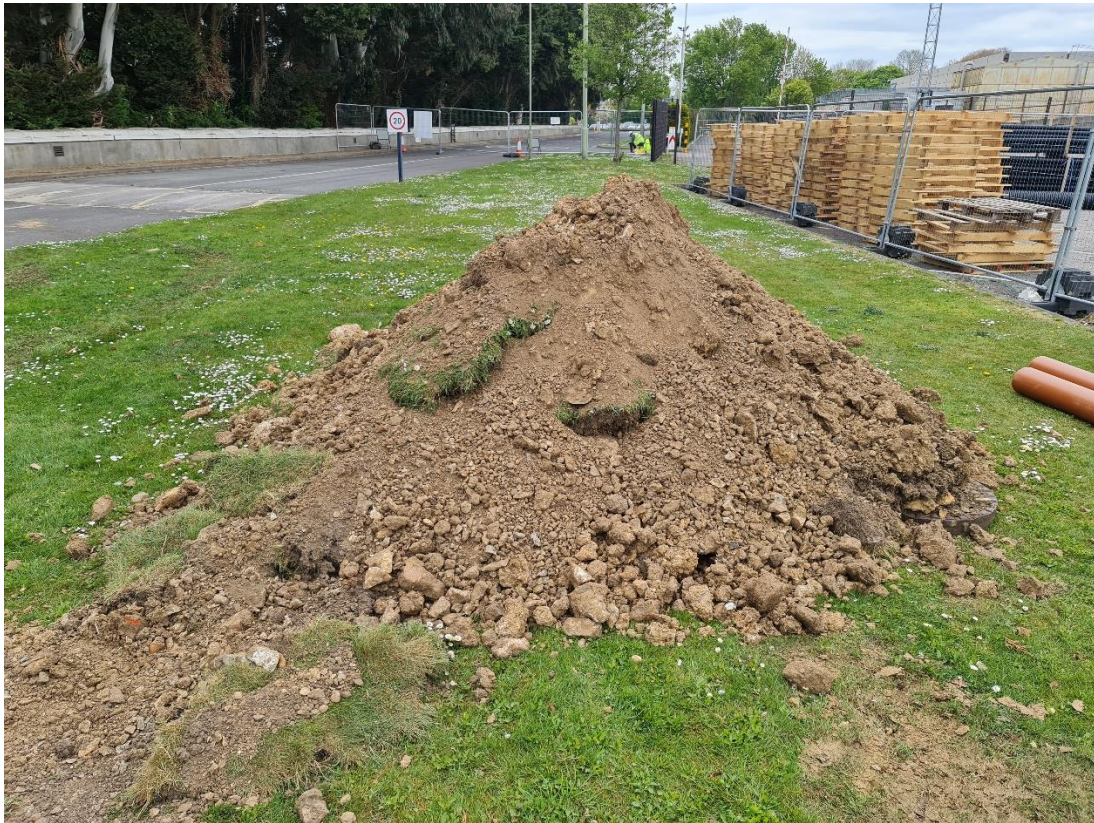
Figure 17 – Drainage arising from around WS2
