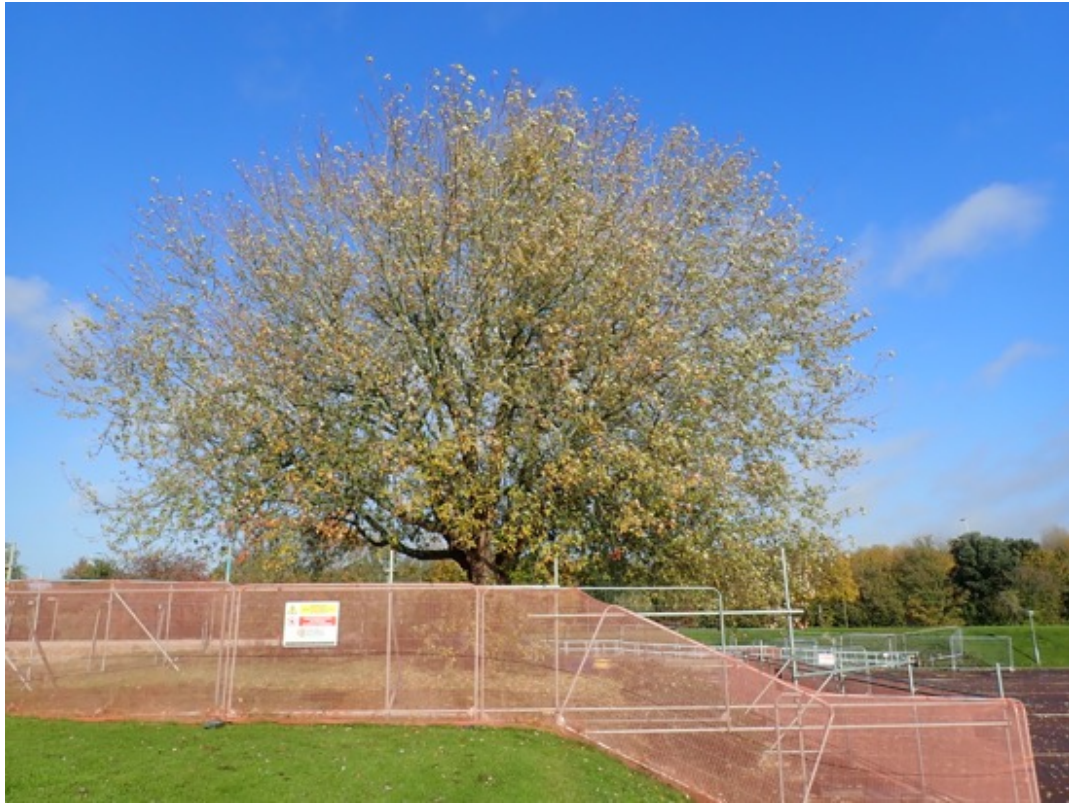
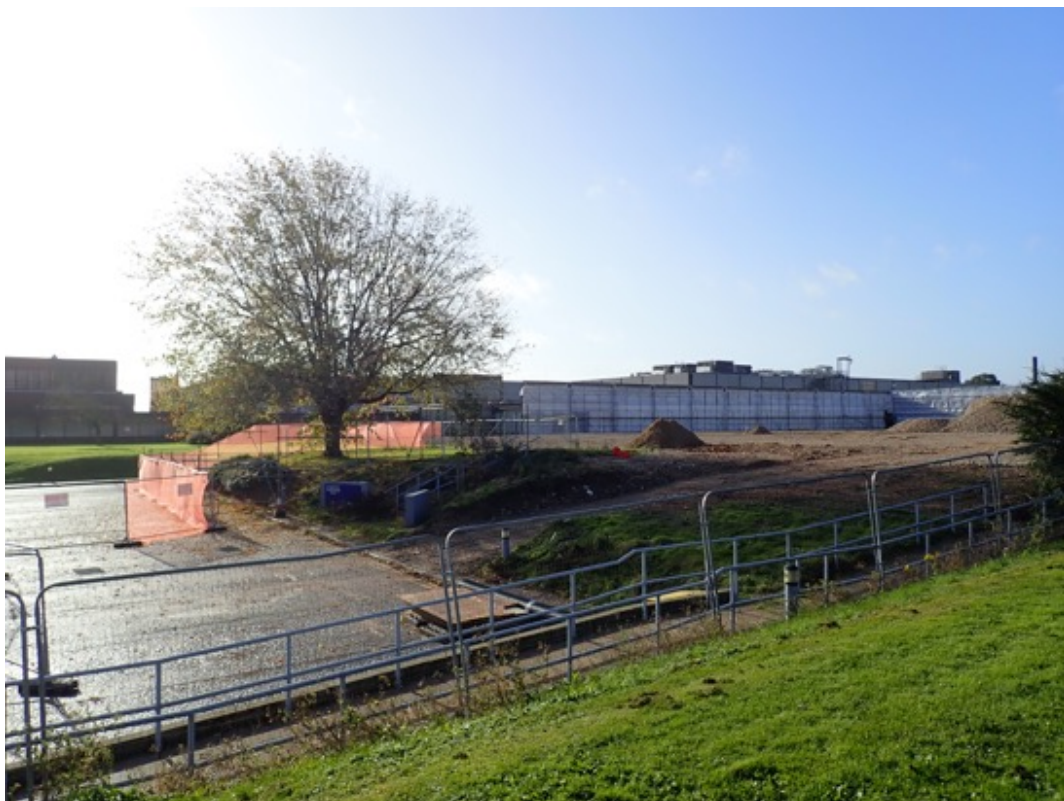
| Tree/<br>Group<br>No. | Species | Height<br>(m) | Stem<br>Diam. at<br>1.5m<br>(mm) | Branch Spread (m) | | | | Canopy<br>Clearance<br>(m) | Age<br>Class | Observations | Management<br>Recommendations | Estimated<br>Remaining<br>Contribution<br>(years) | BS 5837<br>Category<br>Grading | Protect-<br>ion<br>Distance<br>(m) | Root<br>Protect.<br>Area<br>(m2) |
|---|---|---|---|---|---|---|---|---|---|---|---|---|---|---|---|
| T46 | Silver maple | 12.5 | est 620 | 7 | 7 | 7 | 7 | 1.8 | Mature | In fenced off area - no access. Previously reduced. Large pruning wounds. Basal stem growth. Attractive crown shape. | Remove to facilitate devopment. | 20-40 | A2 | 7.4 | 174 |

Views of silver maple, T46, proposed for removal.
