# Geotechnical Survey Report

FSI Ref: 22485  
Issue Date: June 2021

Risk Address: 20 Pinetree Gardens  
Waterlooville  
PO8 8AE

Company: Claims Consortium Group  
Claim Ref: CH20218895

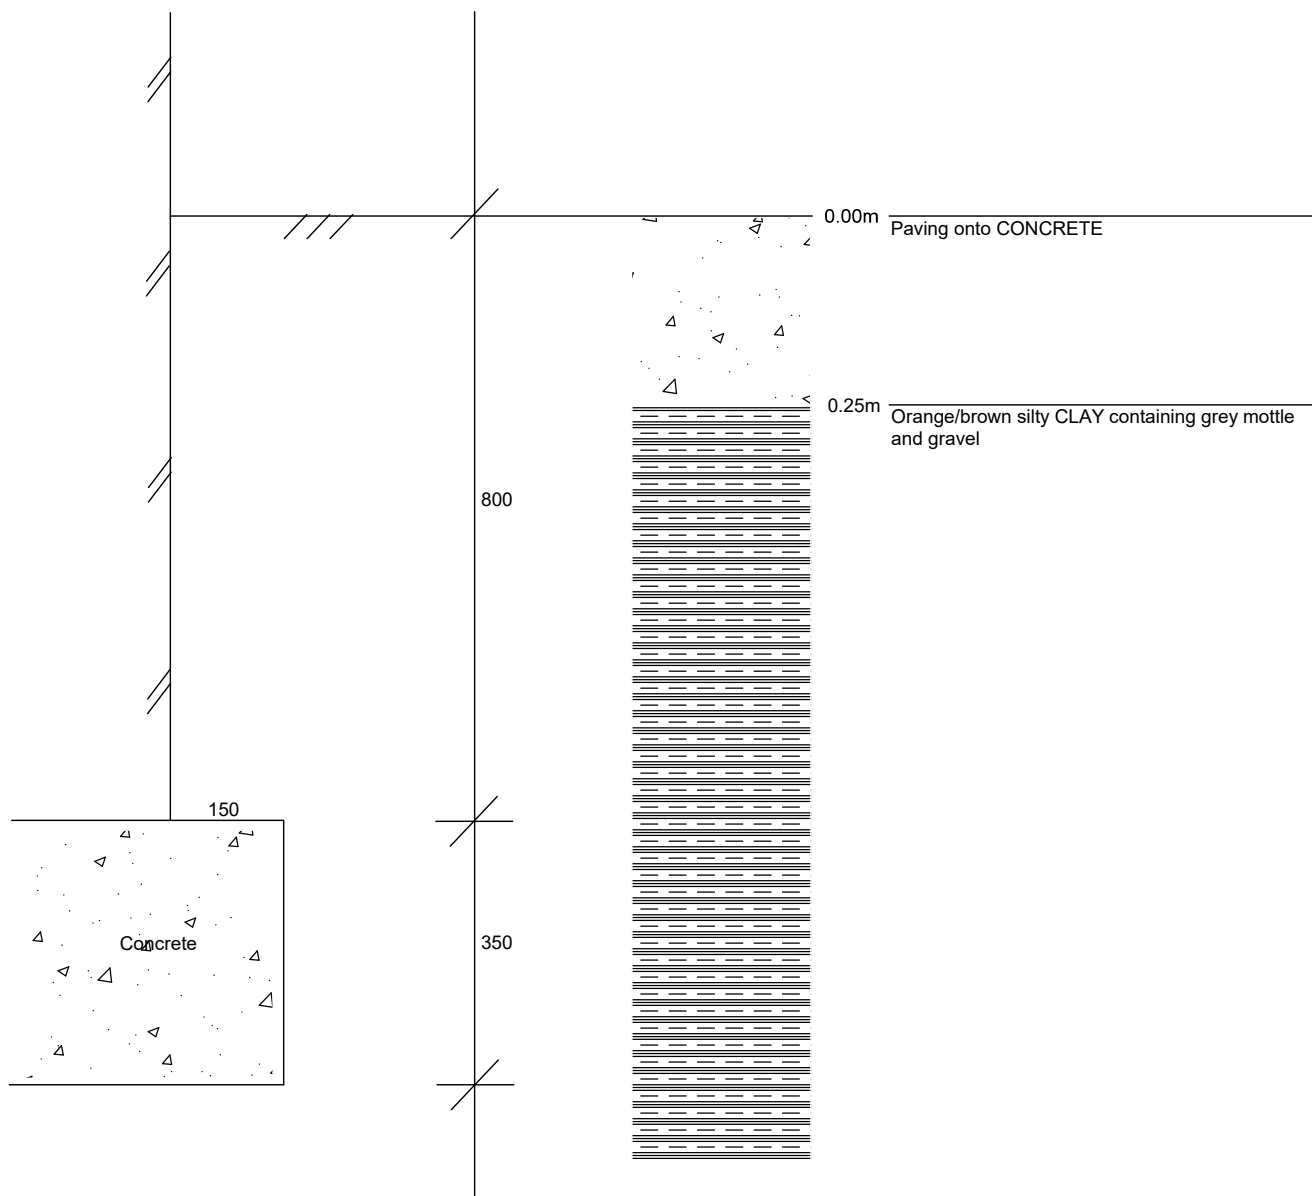
## TRIAL PIT 1

D1 @ F.L. (1.15m)

V = 56-56kPa

Founding strata: Orange/brown silty CLAY containing grey mottle and gravel

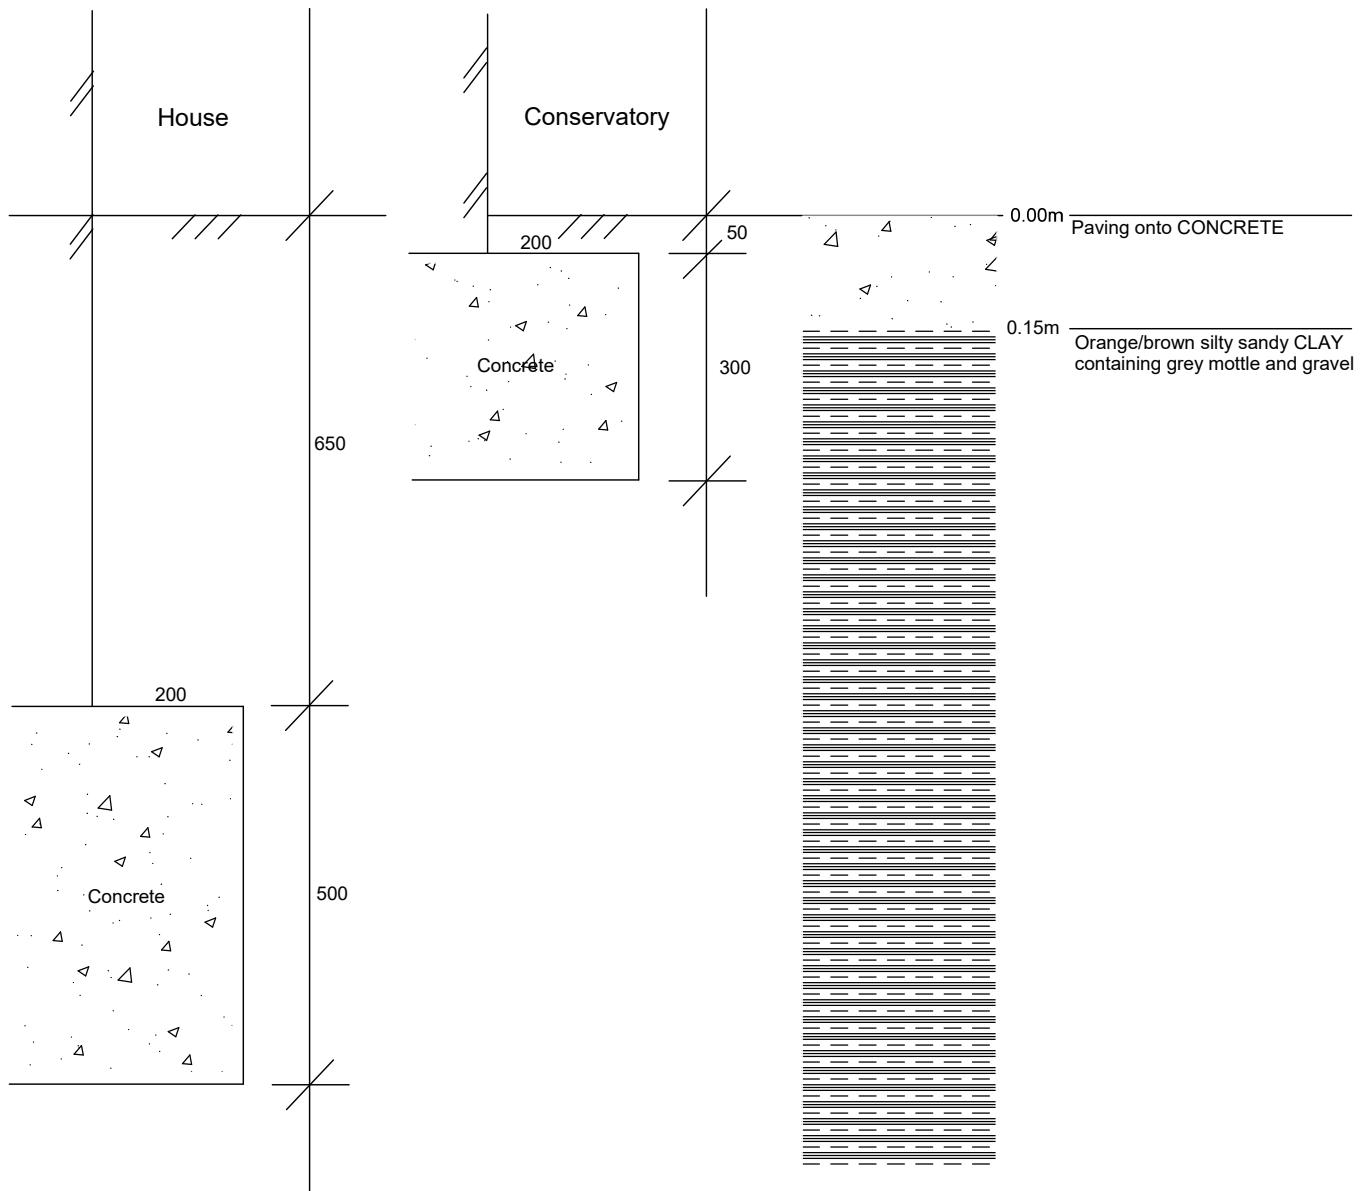
## TRIAL PIT 2

### House

D1 @ F.L. (1.15m)

V = 62-80kPa

Founding strata: Orange brown silty sandy CLAY containing grey mottle and gravel

### Conservatory

D1 @ F.L. (0.35m)

V = 34-30kPa

Founding strata: Orange/brown silty sandy CLAY containing grey mottle and gravel
