## Arboricultural Consultant Site Visit

| <b>Company:</b><br>SJ Stephens Associates Ltd | <b>Site:</b><br>Langstone Technology Park |
| <b>Consultant:</b><br>Simon Stephens | <b>Visit Date:</b><br>23.02.2022 |

| <b>Purpose of Visit:</b><br>To inspect and advise on tree protection measures |

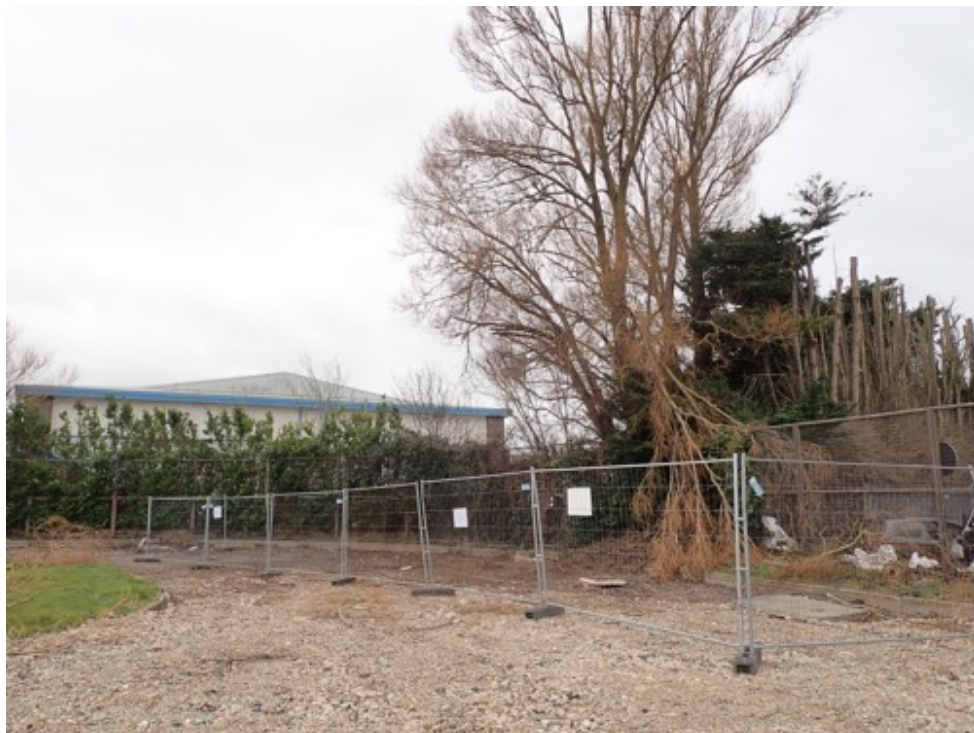
- 1) Heras fencing has been erected on site around a part of the root protection area of the willow G25. On the Tree Protection Plan the fence position is aligned along the edge of a soft surface verge within the root protection area, with the residual area outside the fence shown as protected by existing hard surfacing. Since preparation of the Tree Protection Plan the tarmac surface has been removed however the sub base is still in situ.

- 2) The depth of the residual sub base was discussed to see whether this would be sufficient to provide protection to the underlying roots. At the time of the visit there were no digging implements on site to investigate this further. It was decided that as an interim measure that the tree protection fencing would be extended around the entirety of the root protection area within the site.

Tree protection fencing erected outside root protection area of willow G25.

- 6) The tree protection fence was then extended to encompass the entirety of the root protection area of G25, and signage attached to the fencing identifying it as a tree protection zone.

- 1) The tree protection fence must be maintained in situ until site investigation is undertaken to determine the depth of the residual sub base. To establish this, a hole must be excavated to the depth of the sub base, using only hand tools. If roots are found in the sub base then these must be left in situ and their depth noted. Once this work has been undertaken SJ Stephens Associates must be contacted for confirmation that the fence can be set back to the position shown on the Tree Protection Plan.

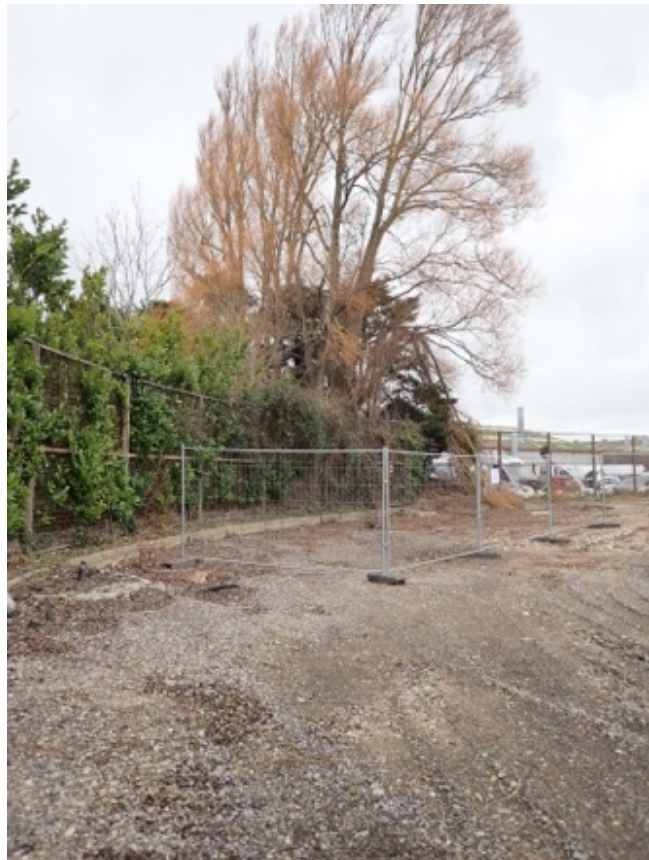
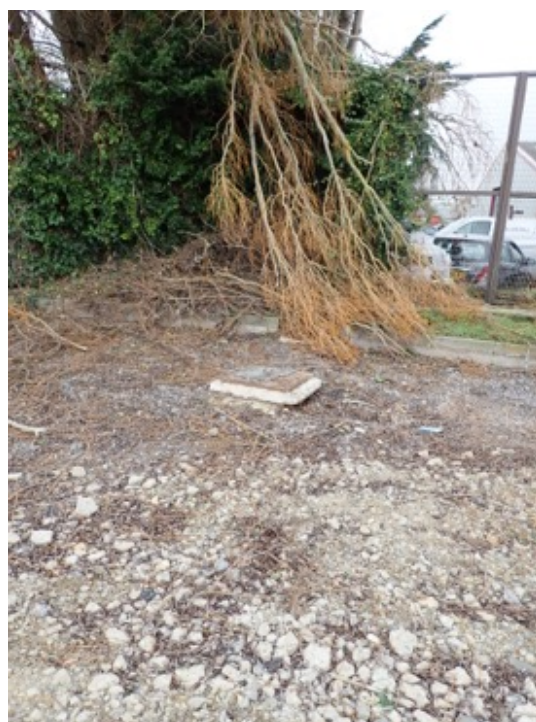
- 3) The willow tree closest to the site has suffered damage in the recent storm (Eunice). Small broken branches are scattered across the ground and a single upper stem has broken out and is hung up in the crown. Remedial works were discussed and it was agreed that the broken stem would be removed by tree surgeons whilst undertaking other works on the site. Clearance pruning work was discussed, as required to facilitate construction of the building. It was agreed that the lower crown branches could be cut back by 2m to provide clearance. Further works were discussed with Chris Hill to reduce the risk to people and property from future stem breakage. It was suggested that the trees' owner be contacted to discuss reducing the height of the willow to reduce the loading on the trees during high wind events.

Tarmac surface has been removed but the sub base is still in situ over the root protection area. Willow closest to the site has suffered storm damage, including breakage of one large stem which is hung up in the tree.
