## 22, The Kench - Cladding

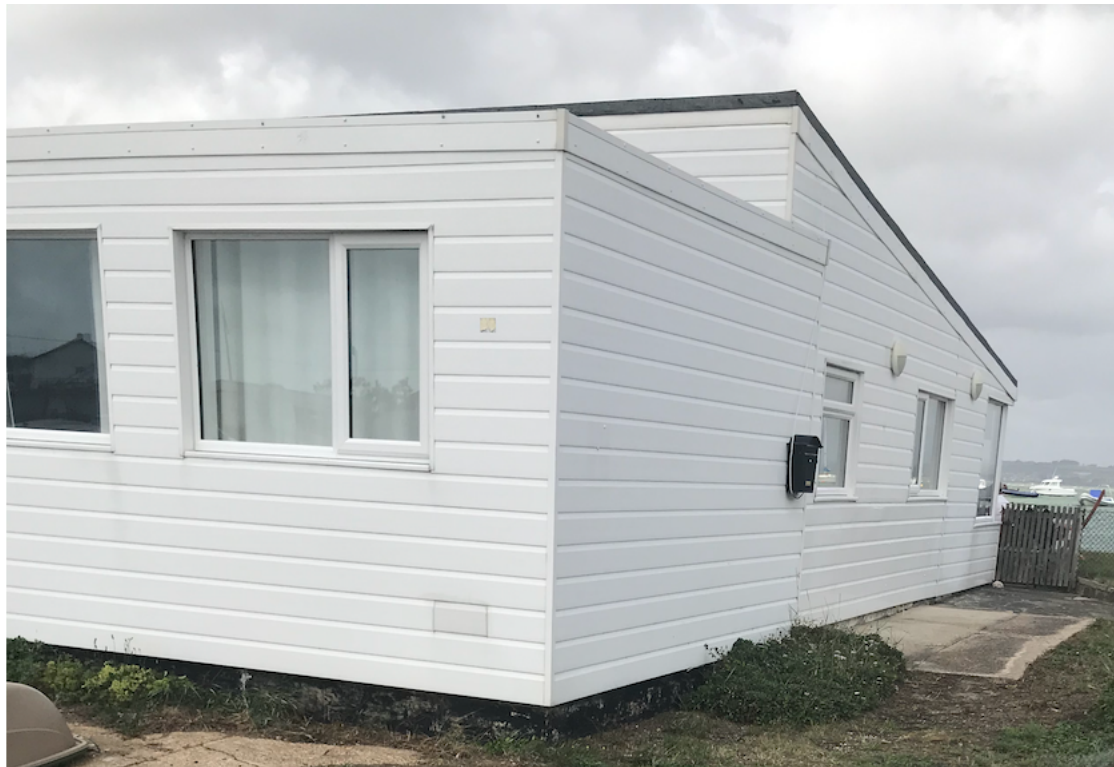
The cladding had become brittle and dis-coloured due to UV exposure and had multiple repairs and cracks. Due to lack of membrane and exposed position, the interior of the bungalow smelt of damp and in certain places there was evidence of water penetrating to the interior.

Photo 1: Looking south, original cladding showing poor quality of installation, repairs, and dis-colouration

To deal with the state of the original cladding and the interior dampness the existing cladding and battens were removed and replaced it with two layers of breathable membrane onto battens which were clad in modified, sustainable wood called Lignia, held in place using stainless steel screws. As with all wood finishes, Lignia will fade and silver up with time (this process has already started). Apart from re-instatement of the original locker (separate document), the building shape has not changed.

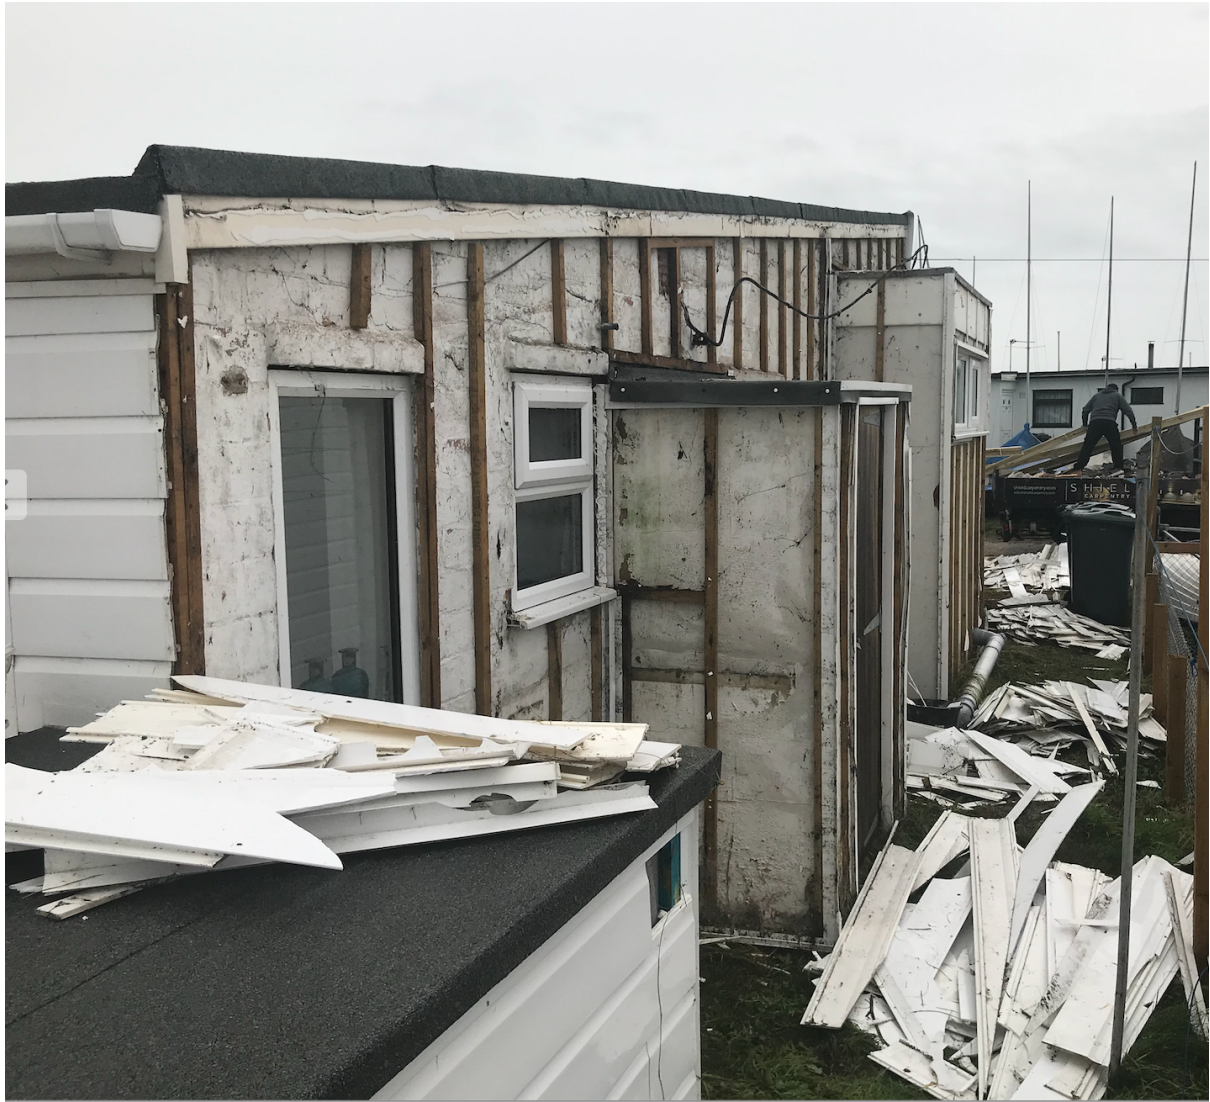
Photo 2: West elevation showing original brickwork and old battens, lack of membrane and state of the original cladding as it was removed.

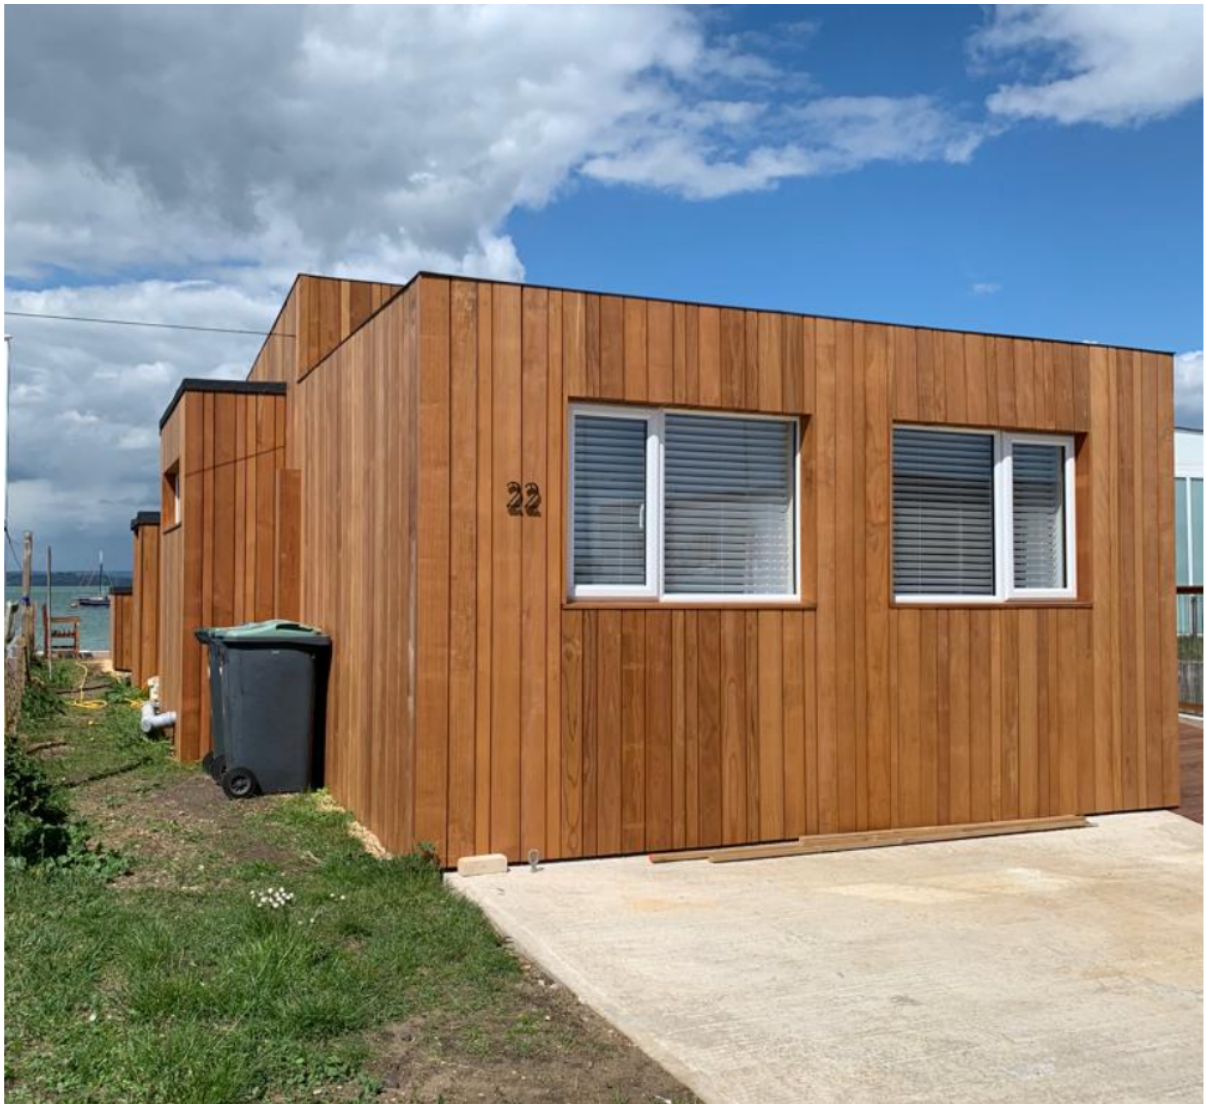
Photo 3: West elevation showing new wood cladding soon after fitting

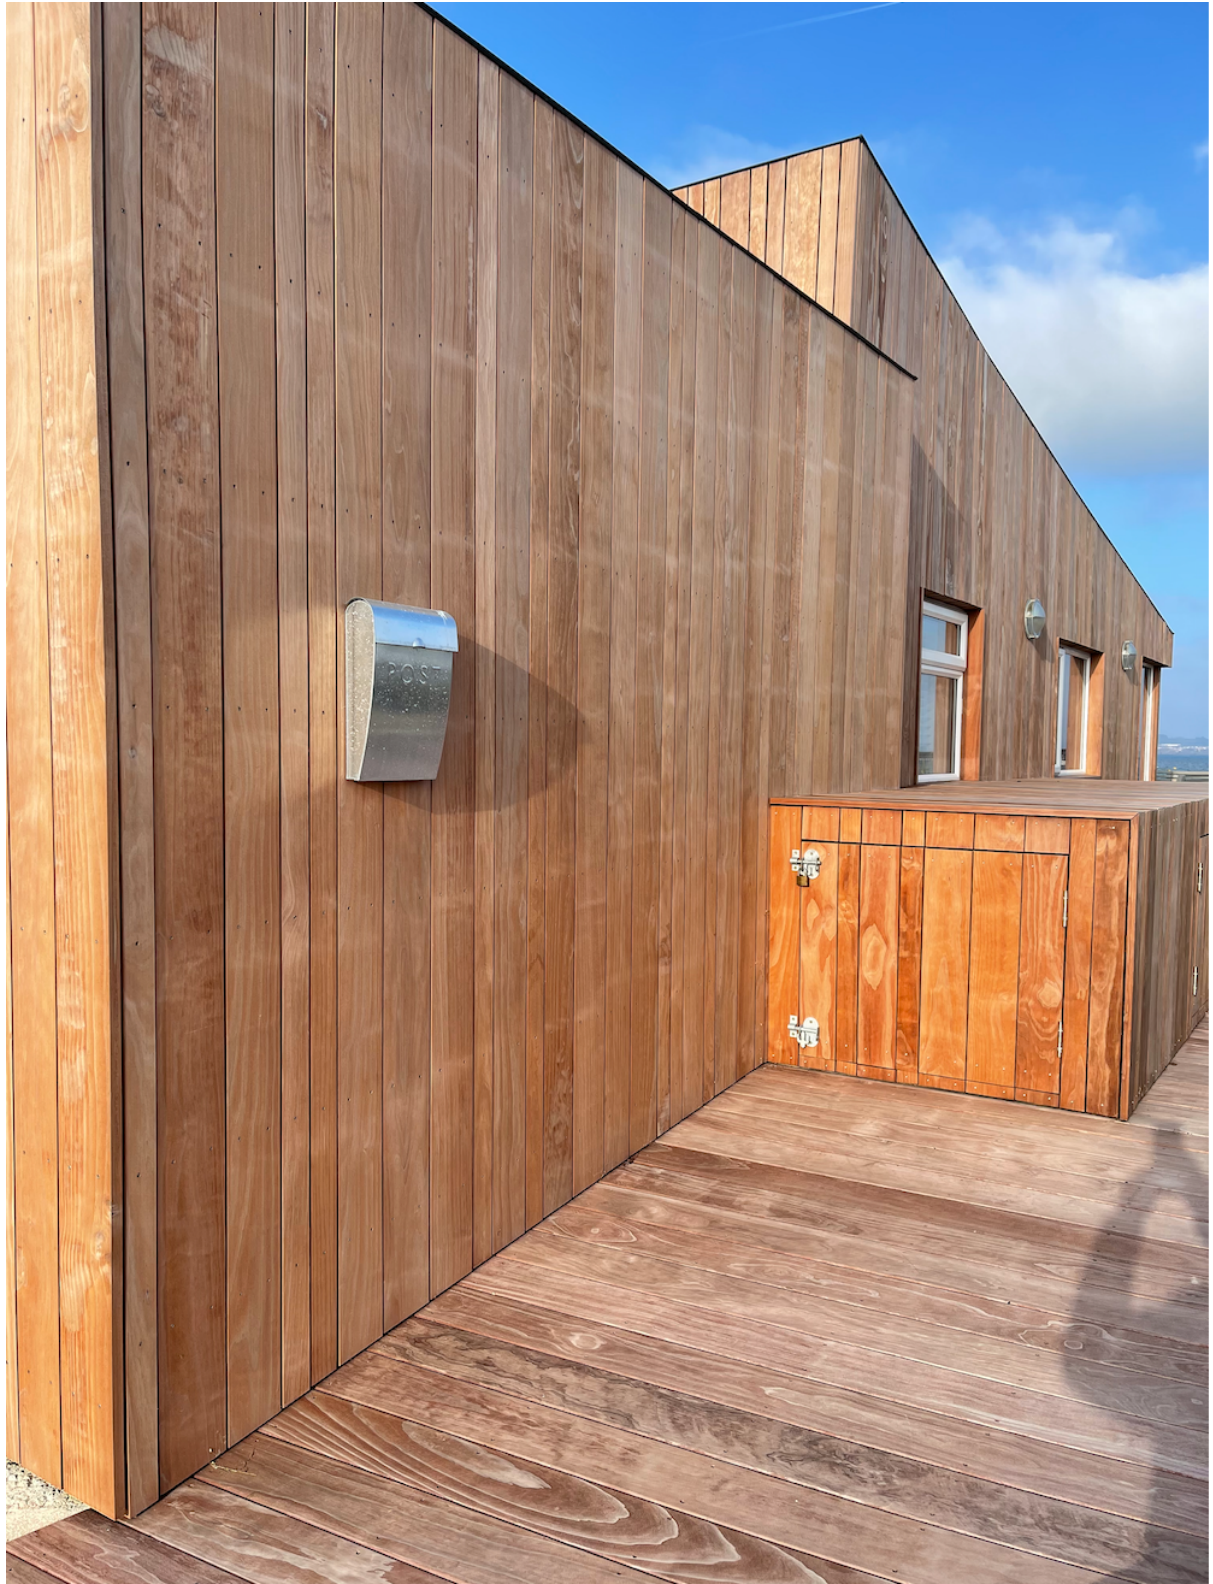
Photo 4: East elevation showing new wood cladding several months after installation. Wood is already fading and going silver. This process continues.

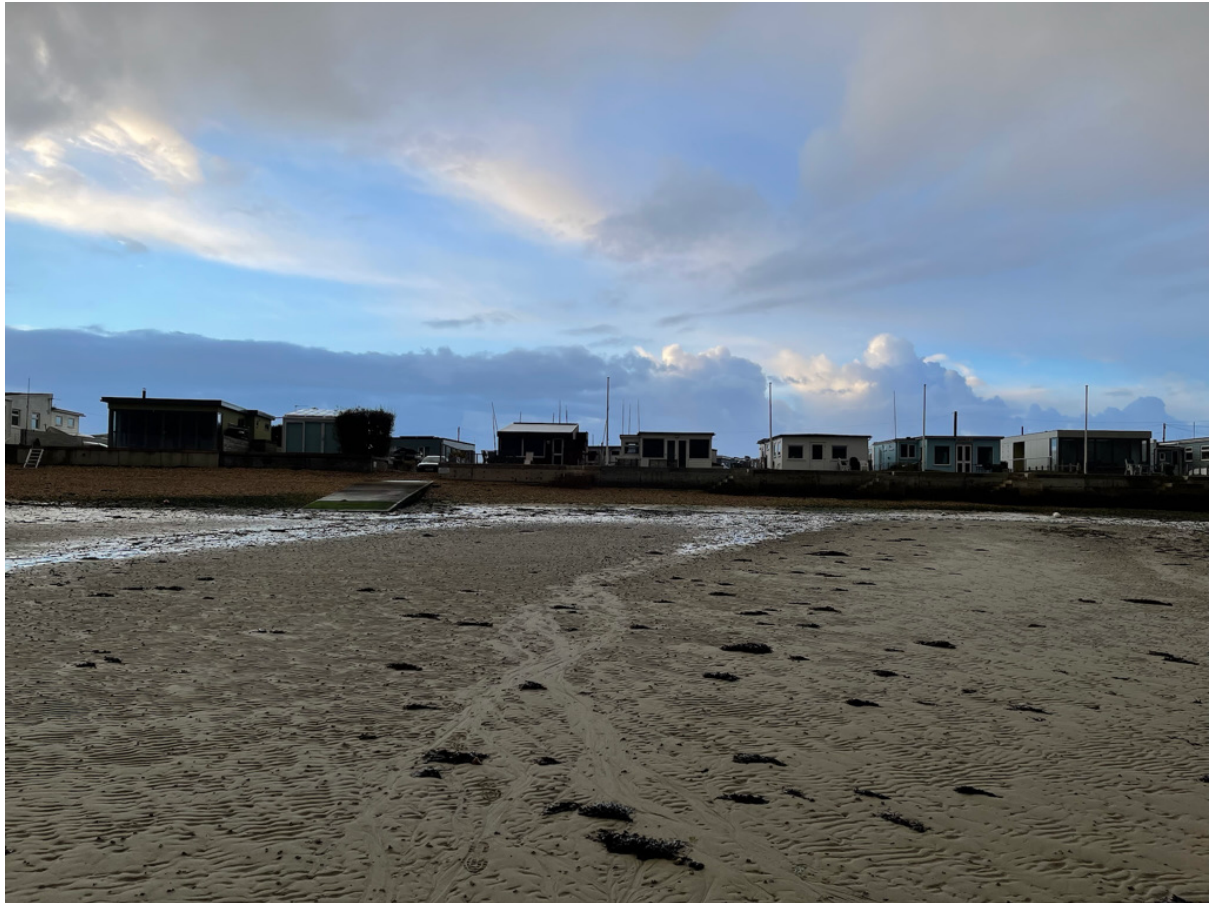
Photo 5: Looking south showing new wood cladding several months after installation showing how cladding has blended in with surrounding beach, slip and sea wall.
